Sanitary System Asset Management Plan

District of West Vancouver

Final Report

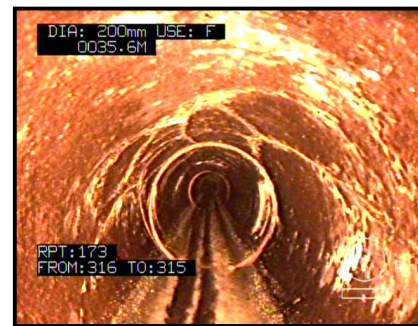
Figure 3.2: Cracks Multiple MH 316 to MH 315

Figure 3.2 shows multiple cracks from clock reference 9 to 3 o'clock in MH 316 to MH 315. Trenchless Point Repair (TPR) at this stage of deterioration is ideal and will restore the structural integrity of the pipe. Additional loading can further advance the defects to fractures and eventually broken or collapsed pipe; at which point, rehabilitation would likely involve external point repairs (EPR) which are more costly and disruptive to the public.

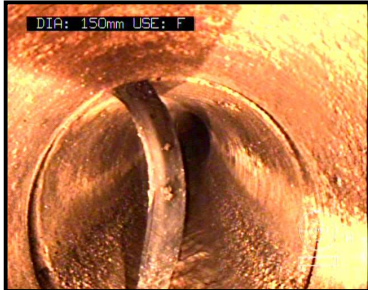
Figure 3.3: Protruding Gasket MH 495 to MH 494

Figures 3.3 and 3.4 are examples of obstructions found in the inspected sewers that will restrict flow and overtime will build up debris. Removal of these obstructions is recommended to ensure acceptable serviceability of the sewer pipe.

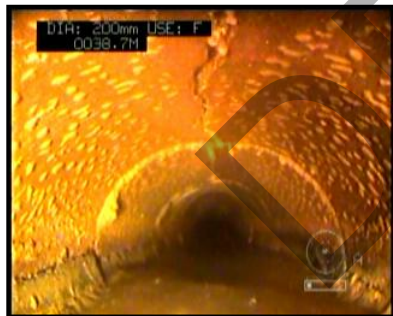
Figure 4.1: Fracture Longitudinal MH 180 to MH 179

MH 180 to MH 179 on Keith Road has numerous structural defects (cracks, fractures and broken pipe) for a majority of its length and is recommended for full segment lining. As shown in Figure 4.1, this section of sewer is experiencing the 4 point fracture and deformation of the pipe has begun. This is the ideal stage for undertaking trenchless technologies for rehabilitation. Once the deformation of rigid a pipe, such as AC pipe, exceeds ~10% the likelihood of collapse increases and the application of trenchless technologies for this type of work is eliminated. High flows were noted at the time of inspection and may be attributed to infiltration given the extent of cracks and fractures throughout the pipe.

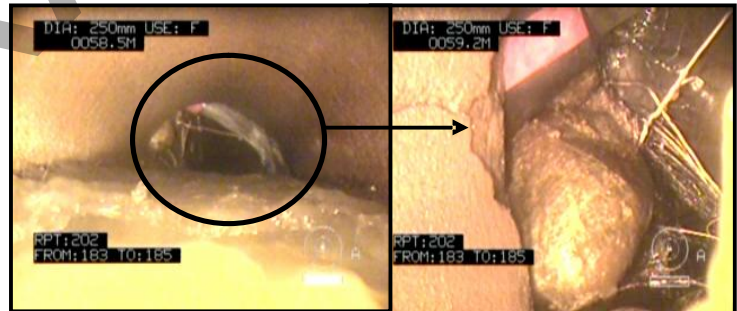
Figure 4.2: Hole in Sewer MH 183 to MH 185

Figure 4.2 shows a hole due to a defective connection (live) at 11 o'clock. Boulders are visible and an external point repair is recommended.

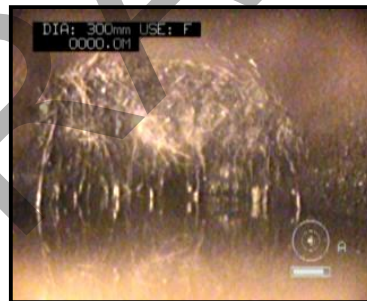
Figure 4.3: Root Mass at manhole to pipe interface MH 186

As shown in Figure 4.3, approximately 70% root mass at MH 186 to pipe interface was identified and requires root cutting to restore the serviceability of the pipe.
