**DISTRICT OF WEST VANCOUVER  
INTEGRATED STORMWATER MANAGEMENT PLAN FOR PIPE, WESTMOUNT,  
CAVE, TURNER AND GODMAN CREEKS**

**GOLDER HYDRO-GEOTECHNICAL STREAM ASSESSMENT REPORT**

# HYDRO-GEOTECHNICAL STREAM ASSESSMENT

**Report Number:** 08-1411-0126

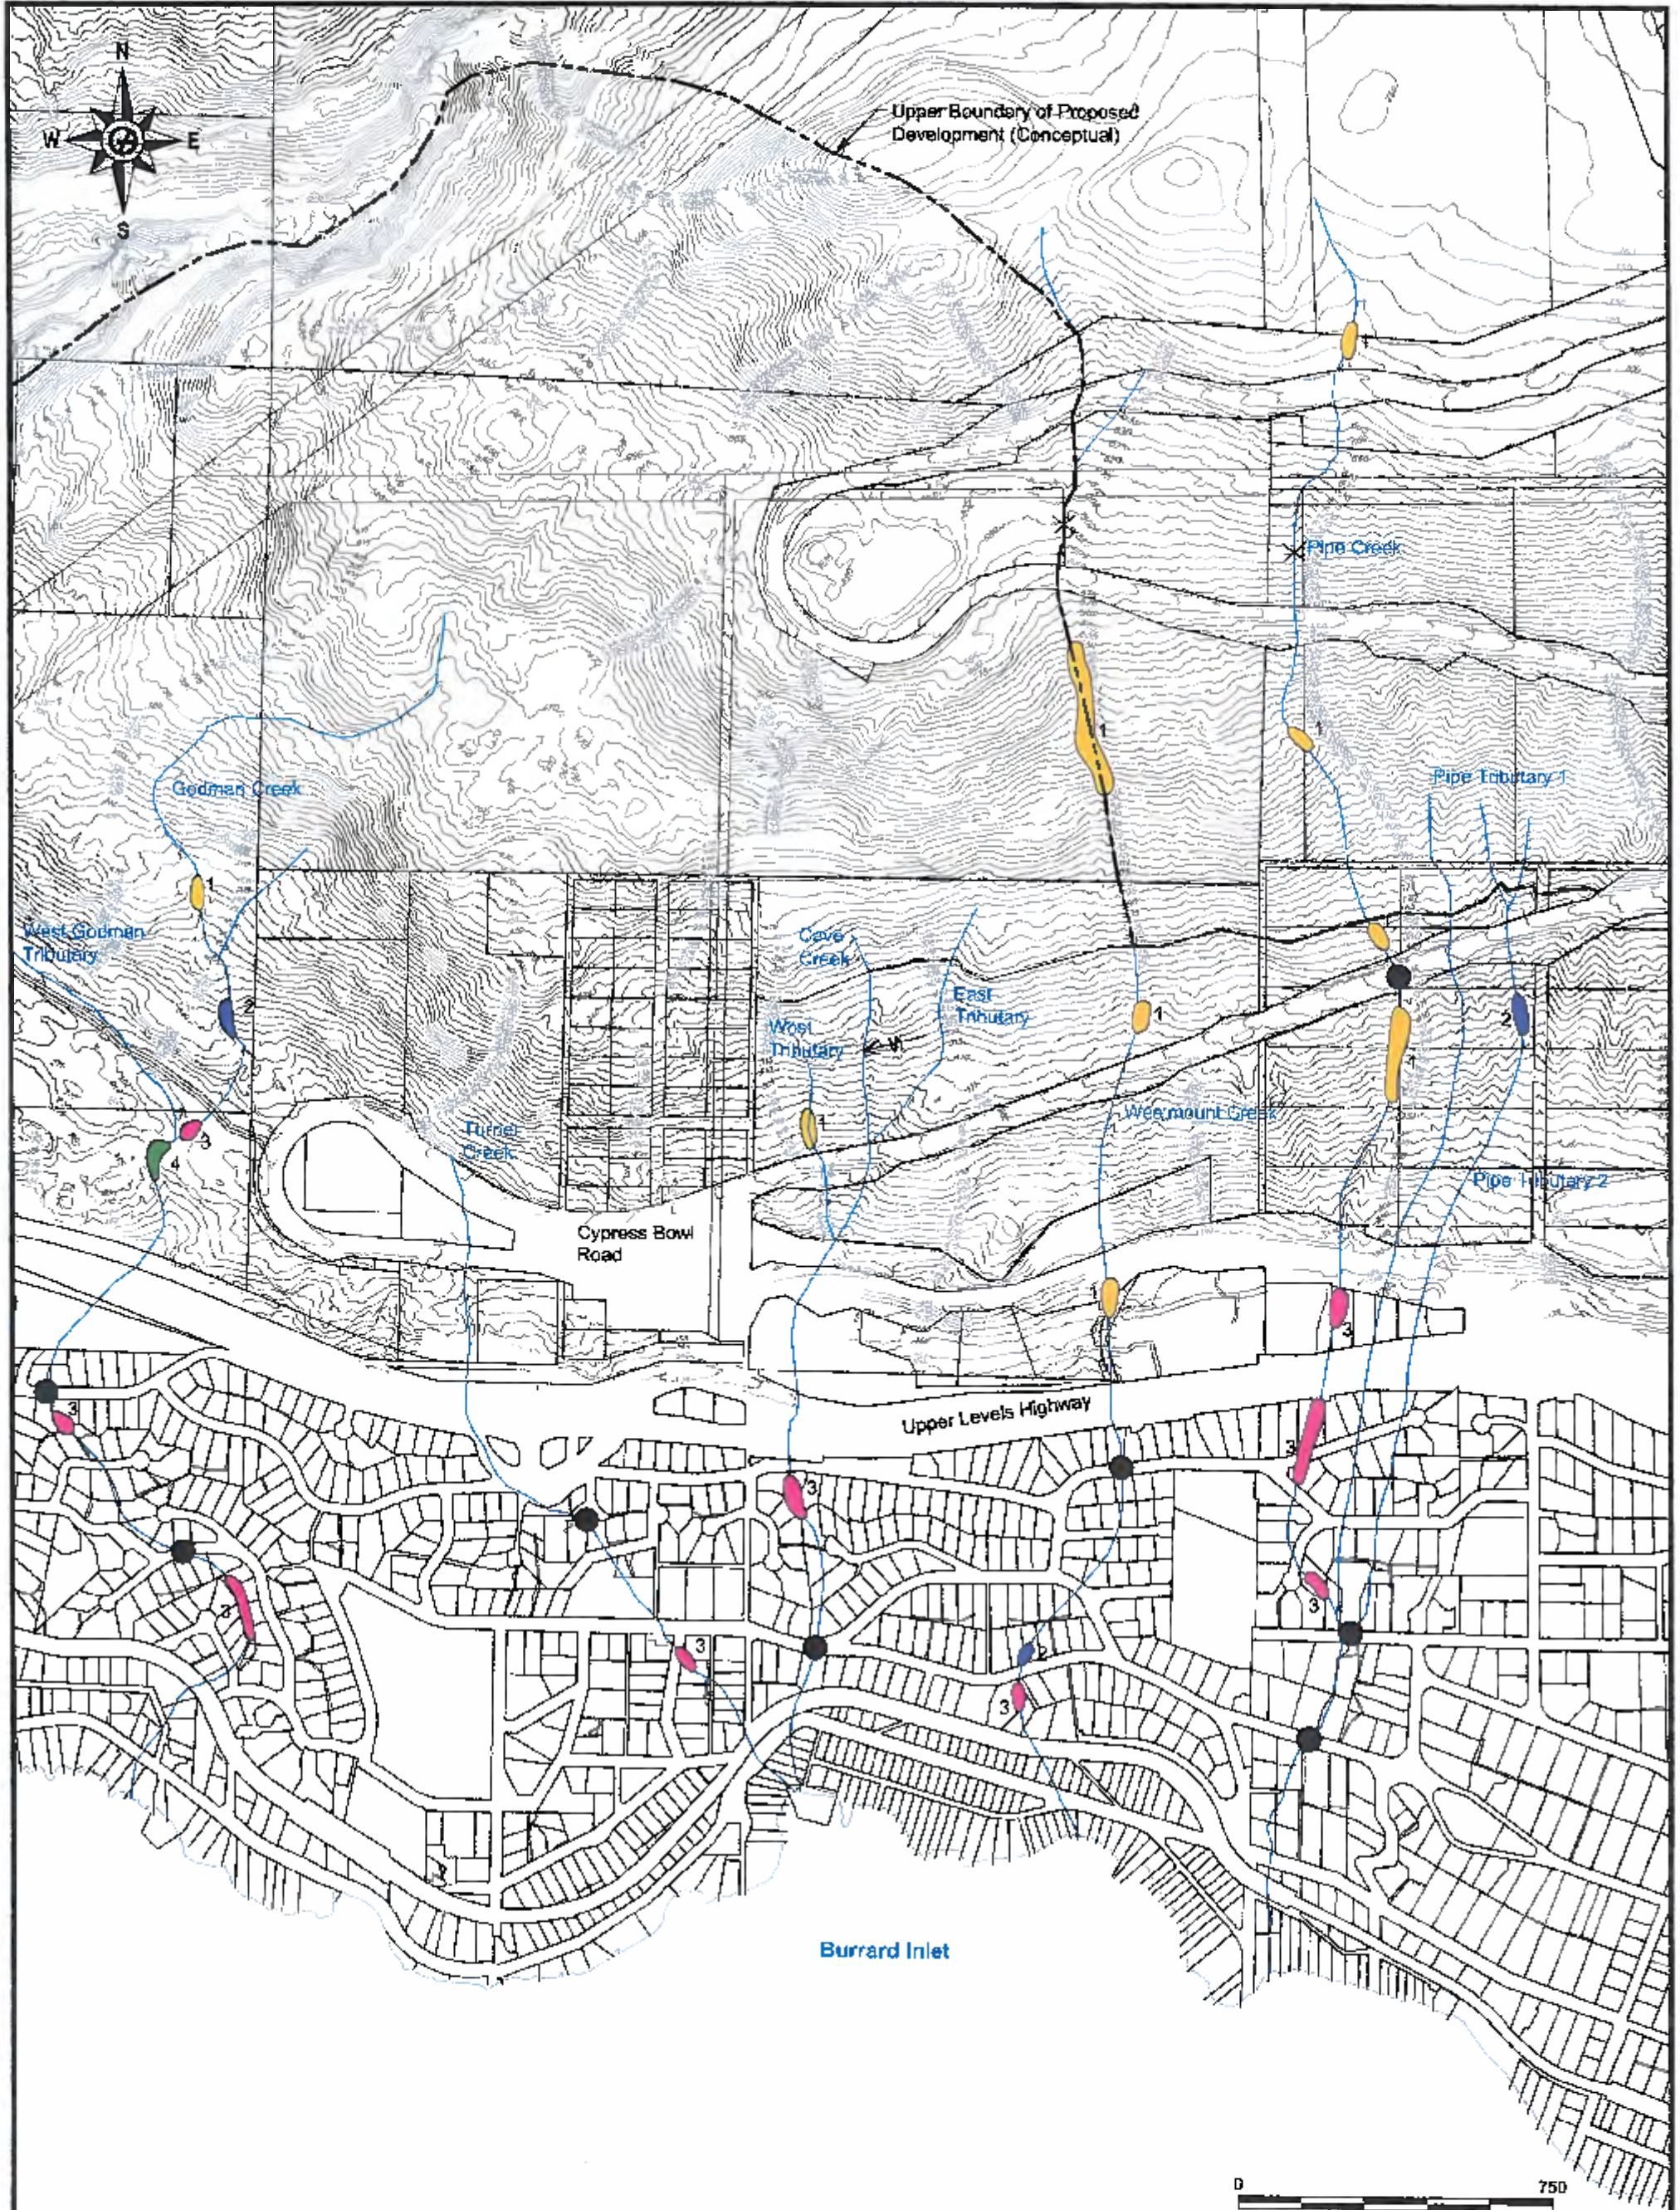
- 1 Potential for Erosion Where Stream Flow is Contained in Multiple Channels.
- 2 Potential for Avulsion and/or Flooding Due to Poor Channel Confinement.
- 3 Erosion of Natural Banks or Undermining of Constructed Walls Along Stream Bank.
- 4 Previous Channel Destabilization (Likely Due to Logging)
- Culvert Likely Undersized
- × Falling Wood Culvert
- ← Sidewall/Bank Failure
