# arboricultural report and inventory

**DUNDARAVE**  
**2452-2490 MARINE DRIVE, WEST VANCOUVER, BC**

**Project No:**  
19060 / 1.3

**Report Date:**  
Updated May 26, 2021

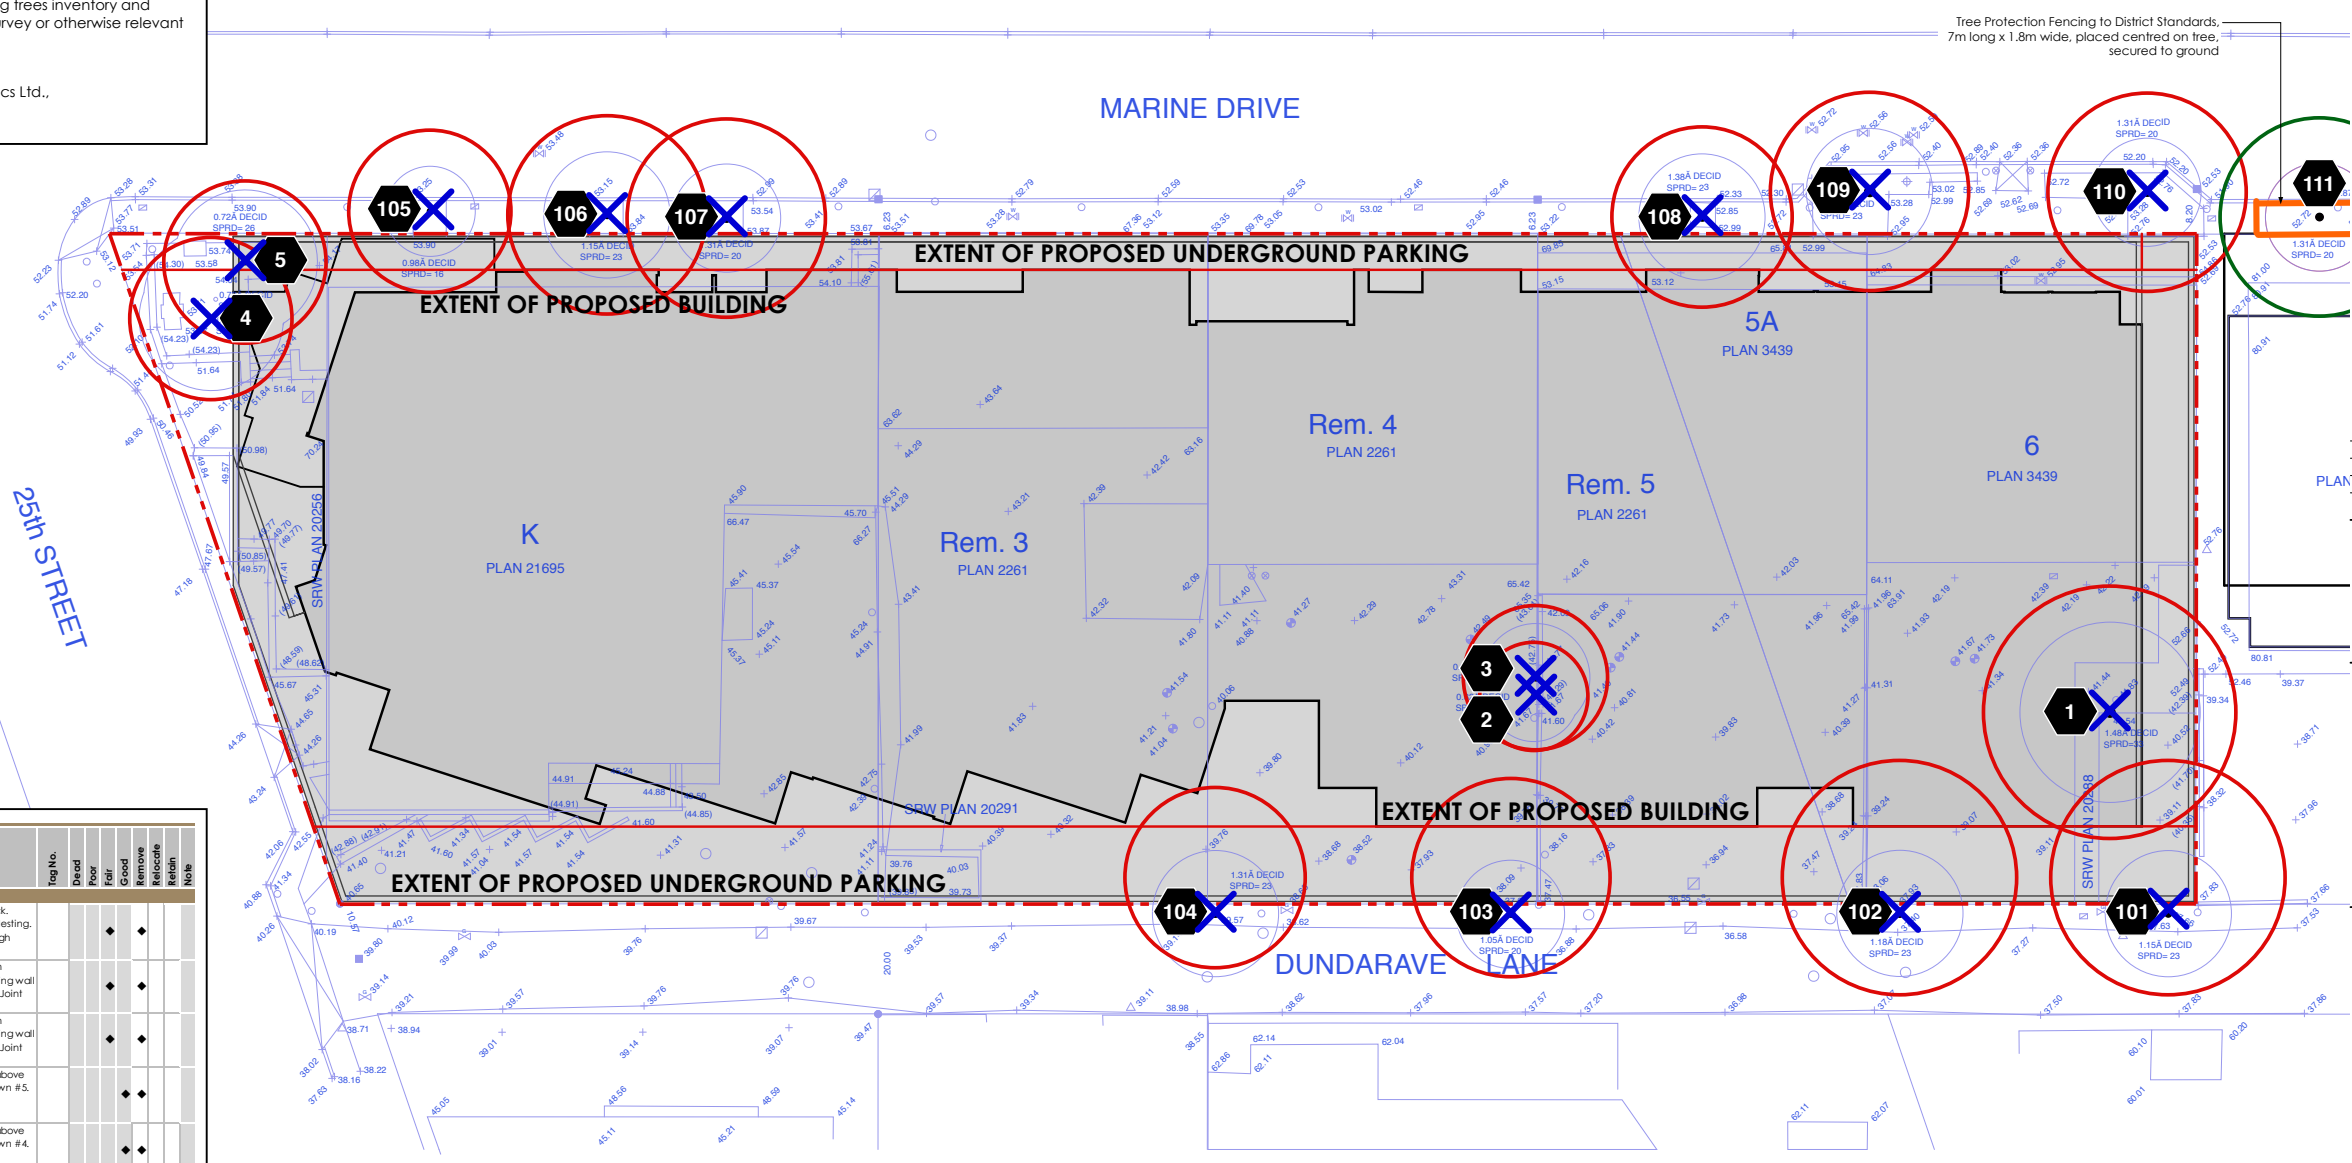
Drawn by: FF  
 Checked by: PK  
 Date: May 26, 2021  
 Scale: NTS  
 Drawing Title:  
**Existing Trees Management Plan**

Observations and recommendations by Florian Fisch, ISA Certified Arborist PN-7921A.  
 Observations made September 19, 2019.  
 This drawing shall be read in conjunction with Existing Trees Report for this site by Durante Kreuk, dated May 26 2021.

- a) Trees #1 - #4 are falling within or immediately next to the proposed footprint of the underground parking structure. These trees are recommended for removal.

- b) Trees #101 - #104 are falling immediately next to the proposed footprint of the underground parking structure. These trees are recommended for removal.

- c) Tree #105 - #110 are falling immediagely next to the proposed footprint of the underground parking structure and within an area of significant off site improvements. These trees are recommended for removal.

- d) Tree #111 is located within the street frontage of the adjacent lot. The critical root zone of this tree will not be impacted by the proposed development and off site improvements. No work is proposed within the street frontate of the adjacent site and businesses within this building will be operating. Tree Protection Fencing as shown on complementing Tree Management Plan shall be installed to District Requirements.
