# Arborist Report

2859 Bellevue Ave  
District of West Vancouver, BC

October 24, 2018

**T A L U S**  
arboriculture & landscape architecture  
Talus Consulting ● 604-354-7799 ● [talusbc@gmail.com](mailto:talusbc@gmail.com)  
J.D. McLeod - ISA Certified Arborist # SO-4337A  
Tree Risk Assessment Qualified (TRAQ)

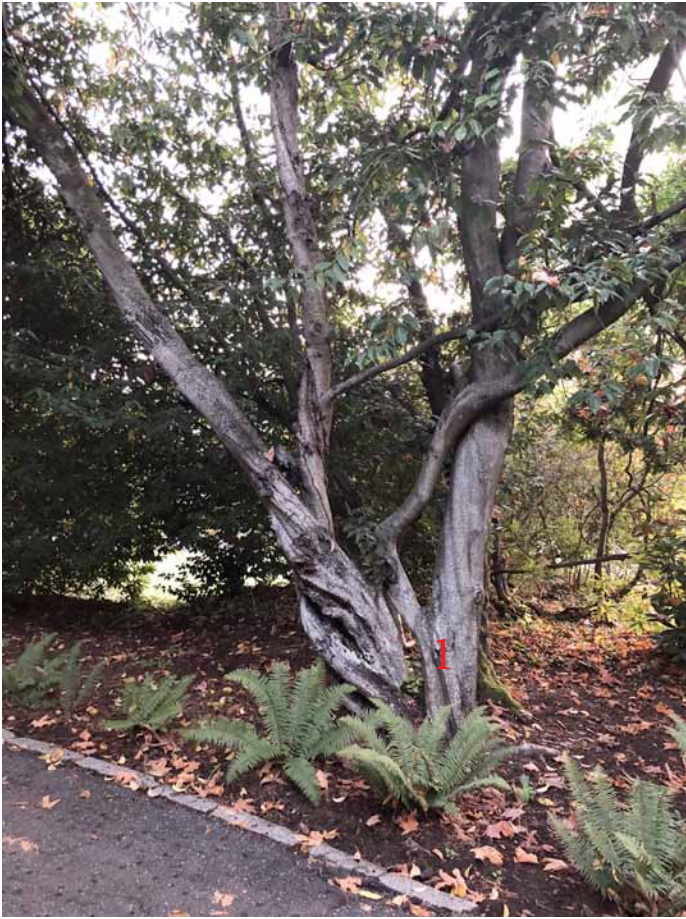
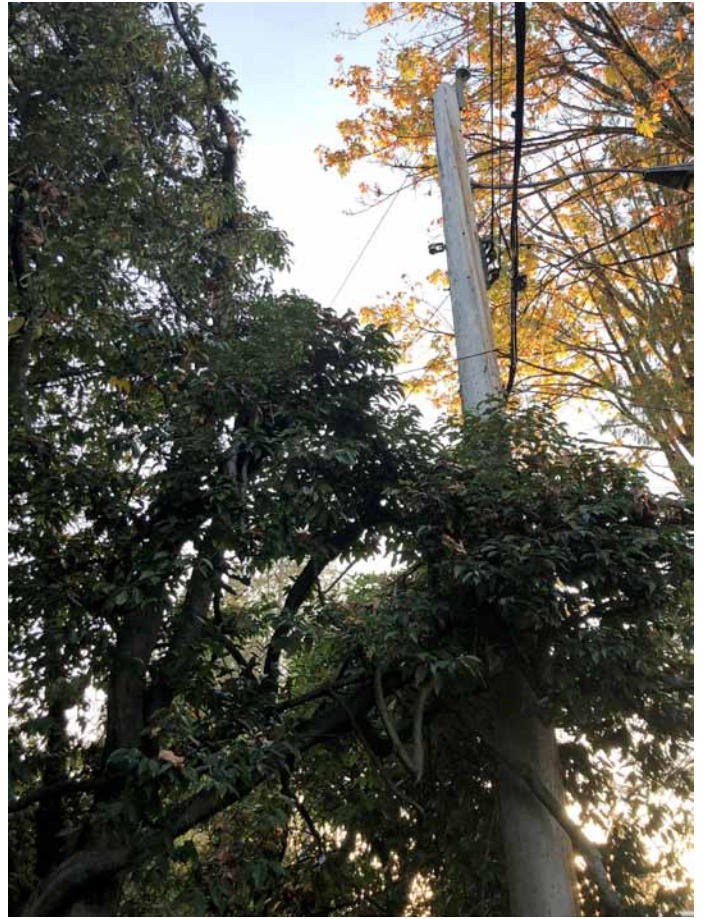
The trees along the driveway represent Tree #1 - #4. The driveway extends along the east property edge and has open soil volumes on each side. Tree #1 is marginal with poor structure and decay pockets persistent throughout the base of the stem. Tree #2 and #3 are very similar in the sense that they are growing proximate to one and other and working as a cohort with integrated canopies. They are also larger diameter specimens with large canopies. Tree #4 is a smaller ornamental specimen with good form and a healthy canopy. In summary, the condition of these site trees is as follows:

Tree #	Common	Latin	DBH (cm)	Height (m)	Condition	Health Ranking Spectrum (1 = great) (5 = very poor)					Comments	TPZ (m)
						1	2	3	4	5		
1	Laurel	<i>Prunus spp.</i>	multistem: 35/31/24	8	Poor				X		Tree is located <1m from driveway; twisted co-dominant stems; abundant crossing branches; utility line runs through edge of canopy and canopy has been pruned back aggressively; abundant decay in base of stems; splits in crotch of codominant stems.	3.6
2	Western Red Cedar	<i>Thuja plicata</i>	88	22	Good		X				Tree is located 3m from driveway; stem divides into two co-dominant stems at 16m height; evidence of sapsucker damage; abundant English ivy growing up stem; softscape at base.	10.6
3	Lawson Cypress	<i>Chamaecyparis lawsoniana</i>	108	22	Good		X				Tree is located <2m from driveway; five co-dominant stems emerge at 3m height; tufts of browning in foliage suggesting drought stress from past summer; abundant English ivy; softscape at base.	13.0

View eastward to Tree #1.

Tree #1 adjacent to power lines on Bellevue Ave.

**Tree #1** (Laurel) - Action: **Remove & Replace** with more appropriate specimen

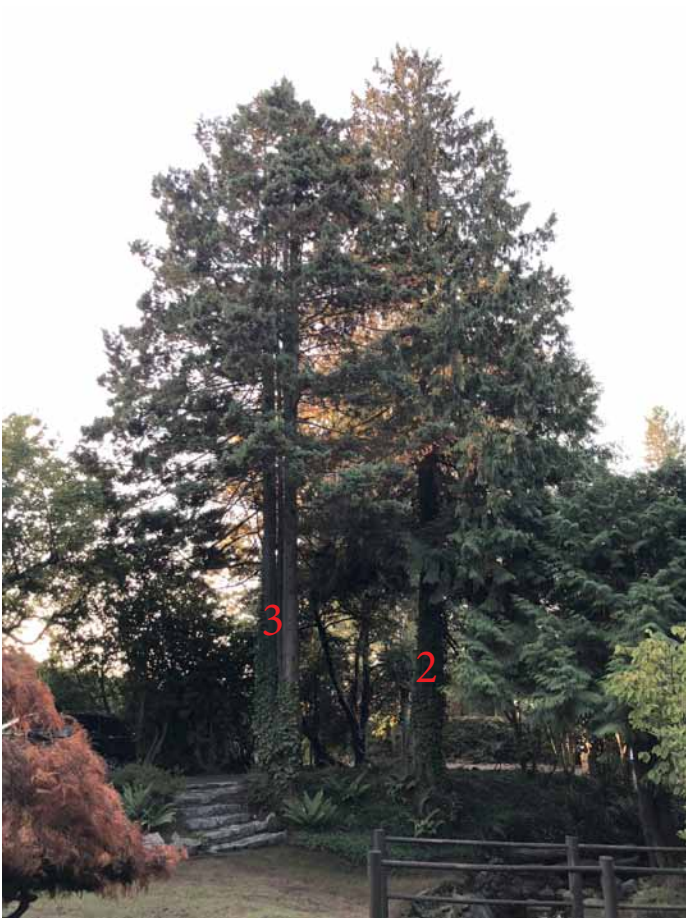
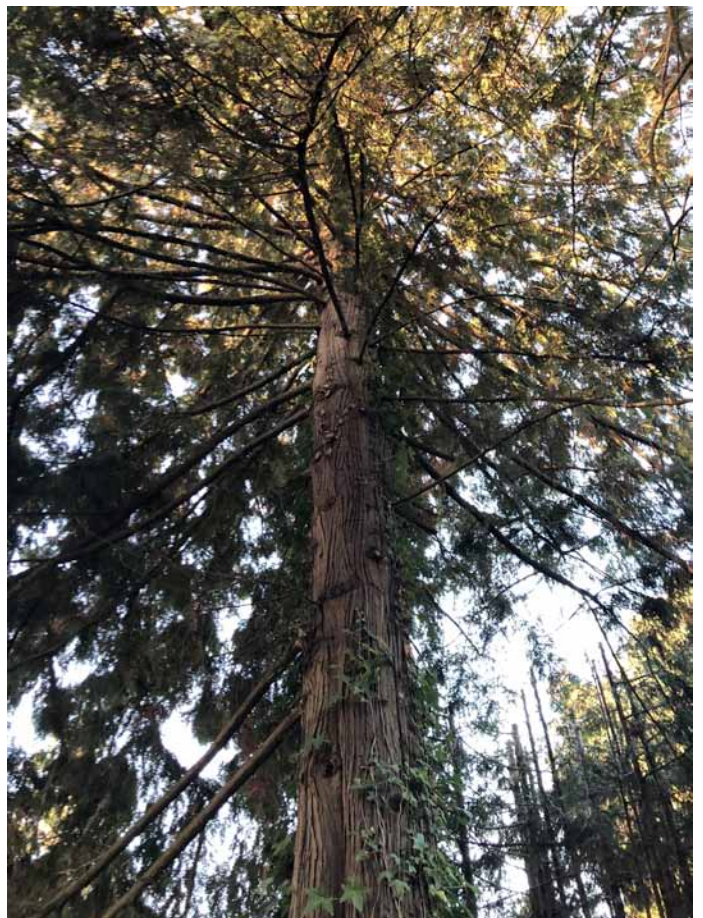
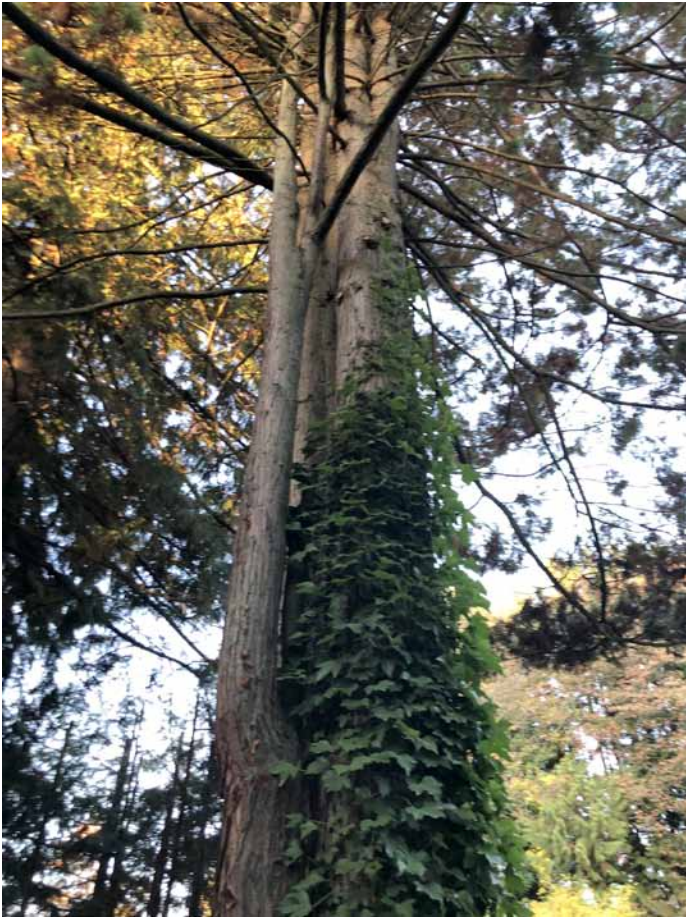
View southeast to Tree #2 & #3 from front yard.

Canopy of Tree #2.

Canopy of Tree #3.

**Tree #2** (Western Red Cedar) - Action: **Retain & Prune** for structure and deadwood

**Tree #3** (Lawson Cypress) - Action: **Retain & Prune** for structure and deadwood

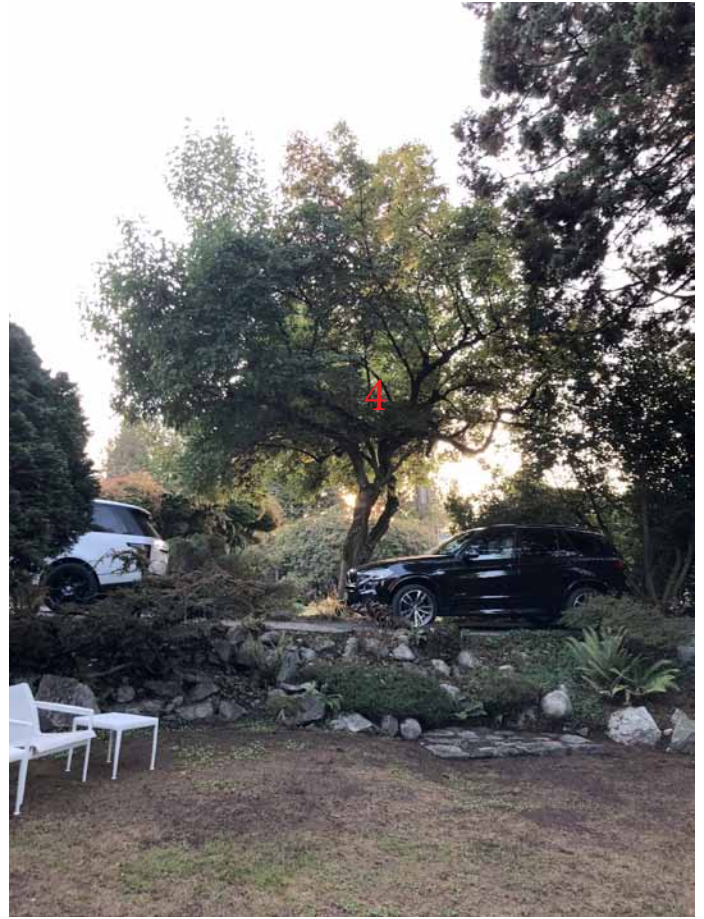
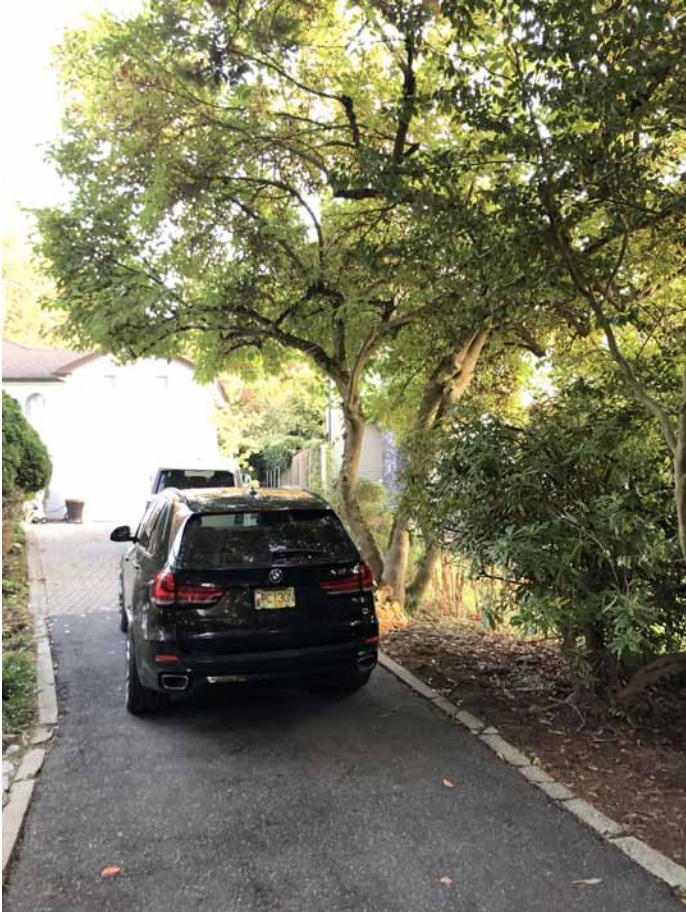
4	Magnolia	<i>Magnolia spp.</i>	multistem: 19/25/23	6	Good		X				Tree is located <1m from driveway; co-dominant stems typical of the species; canopy is healthy.	2.4
5	Western Red Cedar	<i>Thuja plicata</i>	81	18	Good		X				Tree is located above stone wall in landscaped area outside of backyard; canopy is well developed with some browning from summer drought stress; stem has well developed English ivy growing into canopy; stem appears monopodial.	9.7
6	Lawson Cypress	<i>Chamaecyparis lawsoniana</i>	77	22	Fair			X			Tree is located on edge of concrete paver patio within landscaped area; abundant dieback of internal branches; base of stem is lifting pavers; English ivy growing up stem; stem divides into at least three co-dominant stems at 5m height.	6.0
7	Western Red Cedar	<i>Thuja plicata</i>	multistem: 47/56/42/85	18	Fair			X			Tree is located just off the northwest corner of the property and is multi-stemmed growing off of an old decayed stump; the northernmost stem has been wrapped with a large metal chain (rusted) and the stem is being girdled; upper canopy above girdling chain is showing signs of stress.	6.0

View east to Tree #4.

View north to Tree #4.

**Tree #4** (Magnolia) - Action: **Retain**

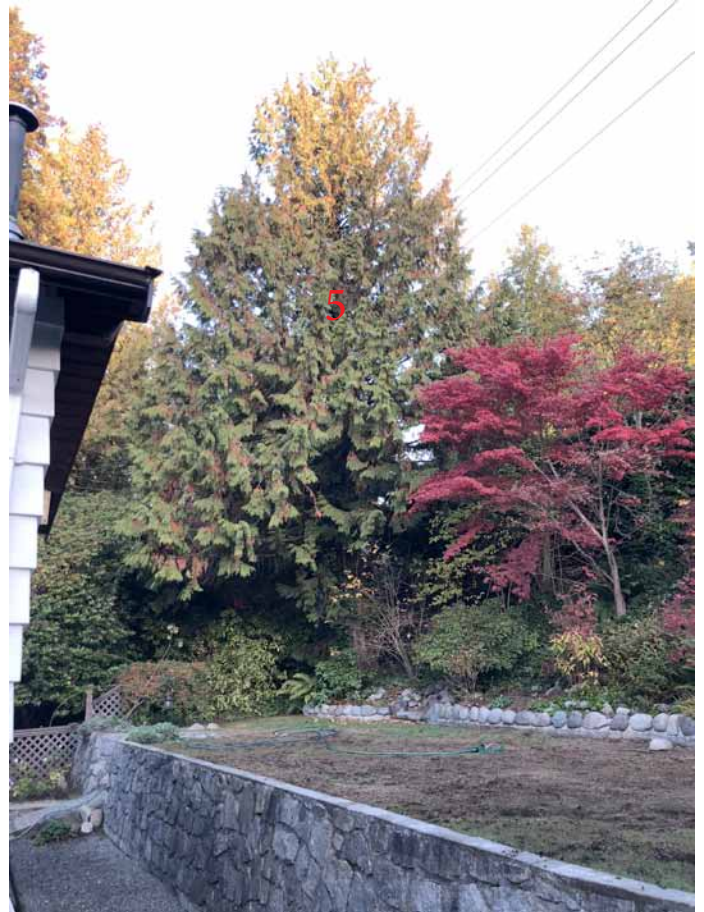
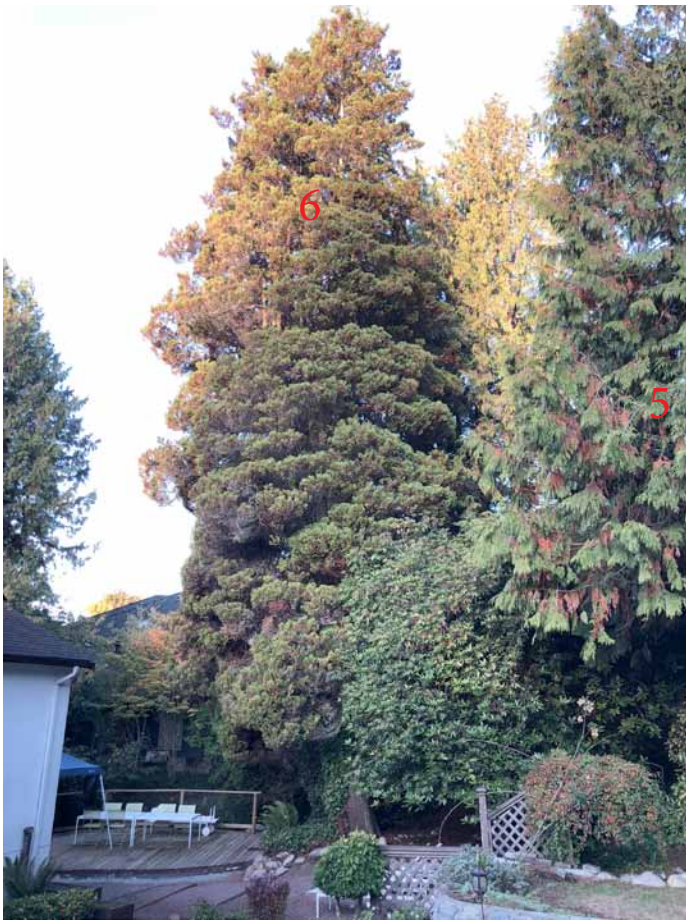
There are three trees at the northwest extent of the study site - two of these are off property and include Tree #5 and #7. These trees are exhibiting signs of summer drought stress. Tree #7 has an old rusted anchor chain that was wrapped around the stem years ago and is in the process of girdling the stem unless removed. Tree #6 is on property and exhibiting signs of drought stress with abundant browning in the canopy as well as internal dieback of branches. Tree #6 is also multi-stemmed above 3m height and not appearing vigorous. In summary, the condition of these trees is as follows:

View northwest to Tree #5.

View west to Tree #5 & #6.

**Tree #5** (Western Red Cedar) - Action: **Retain & Prune** for structure and deadwood

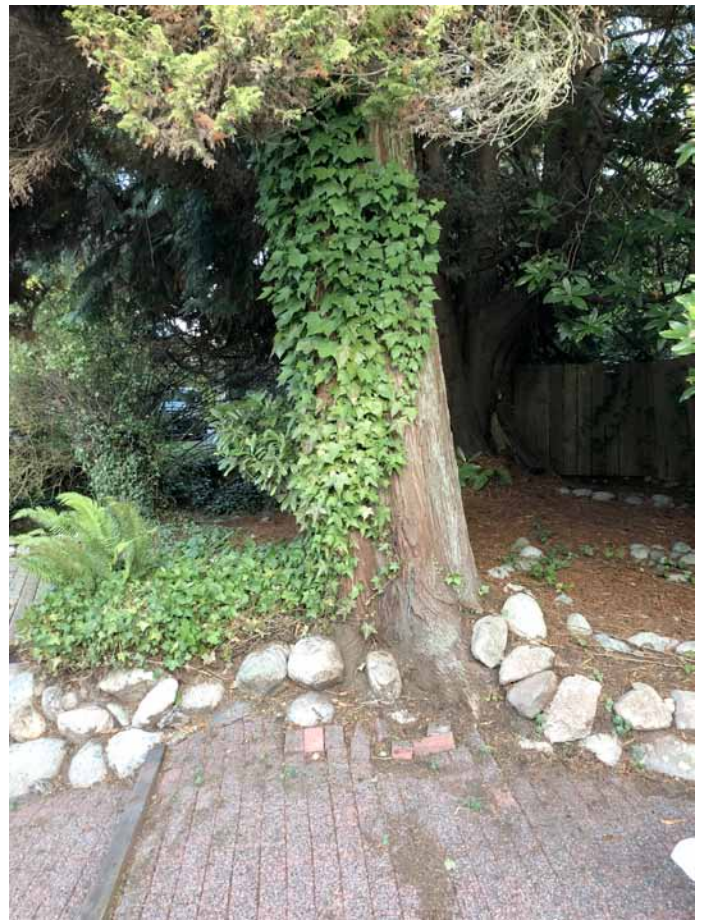
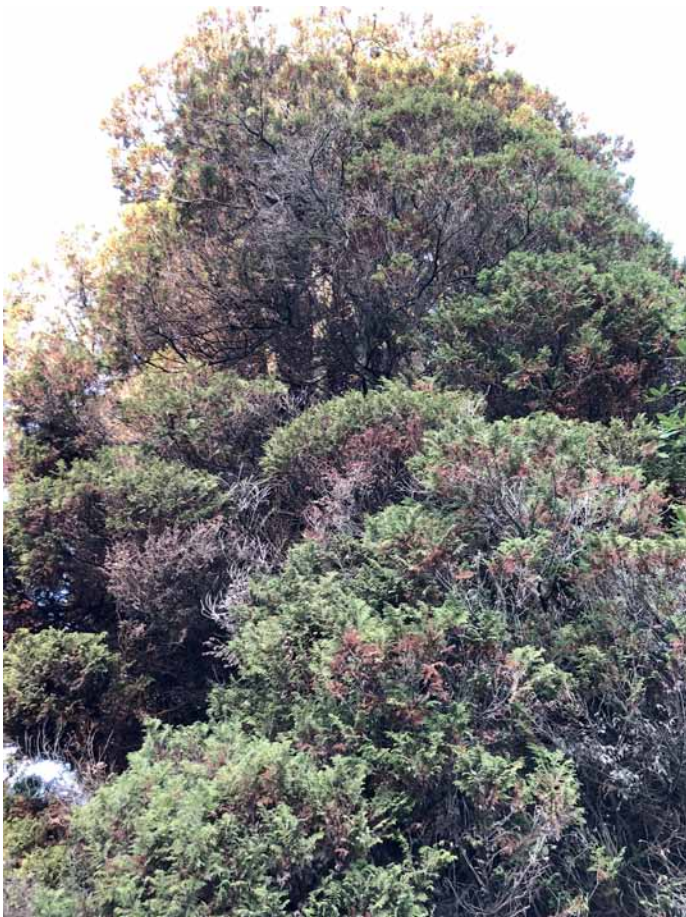
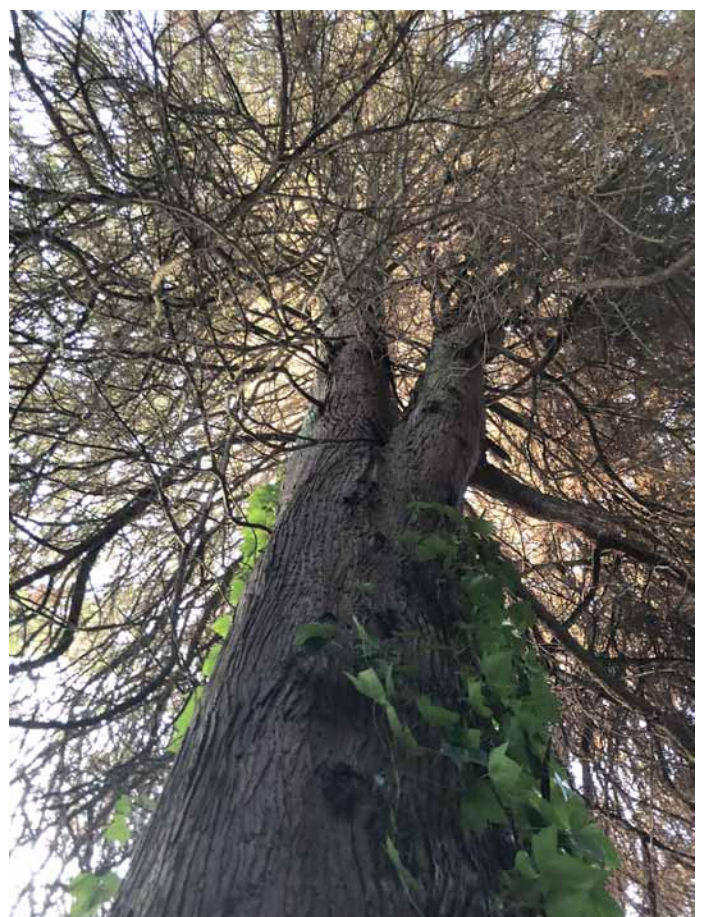
Base of Tree #6.

Canopy of Tree #6.

Internal canopy of Tree #6.

**Tree #6** (Lawson Cypress) - Action: **Remove & Replace** with more appropriate specimen

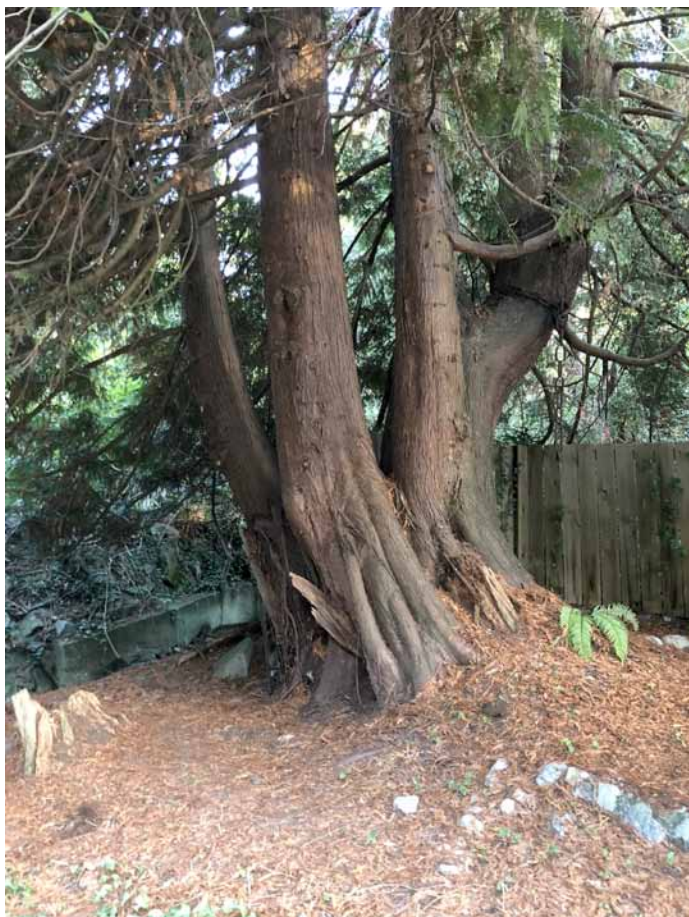
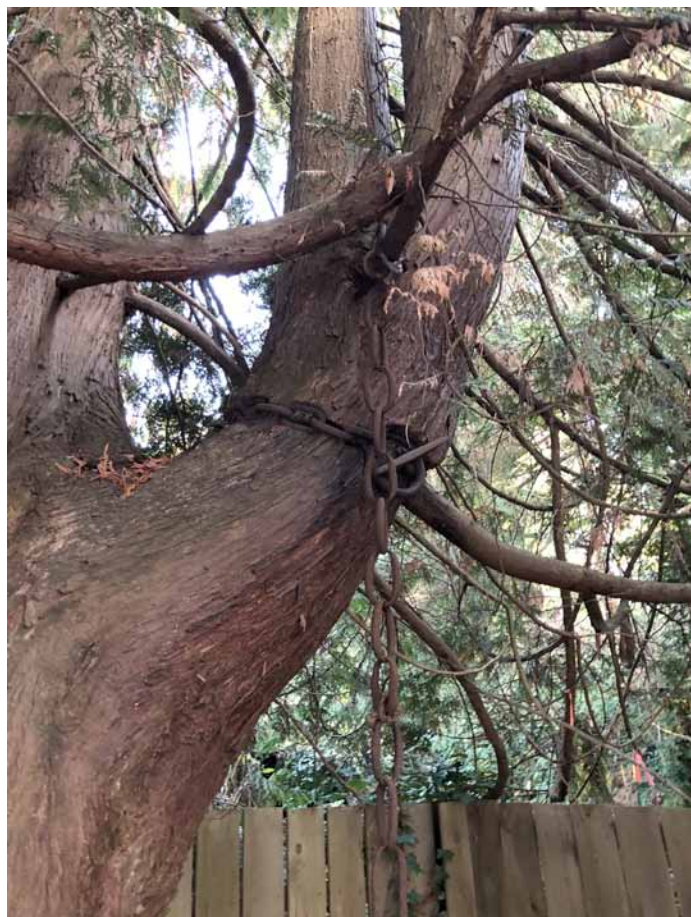
Base of Tree #7.

Stem being girdled by rusty chain on Tree #7.

**Tree #7** (Western Red Cedar) - Action: **Retain & Prune** for structure and deadwood AND remove anchor chain

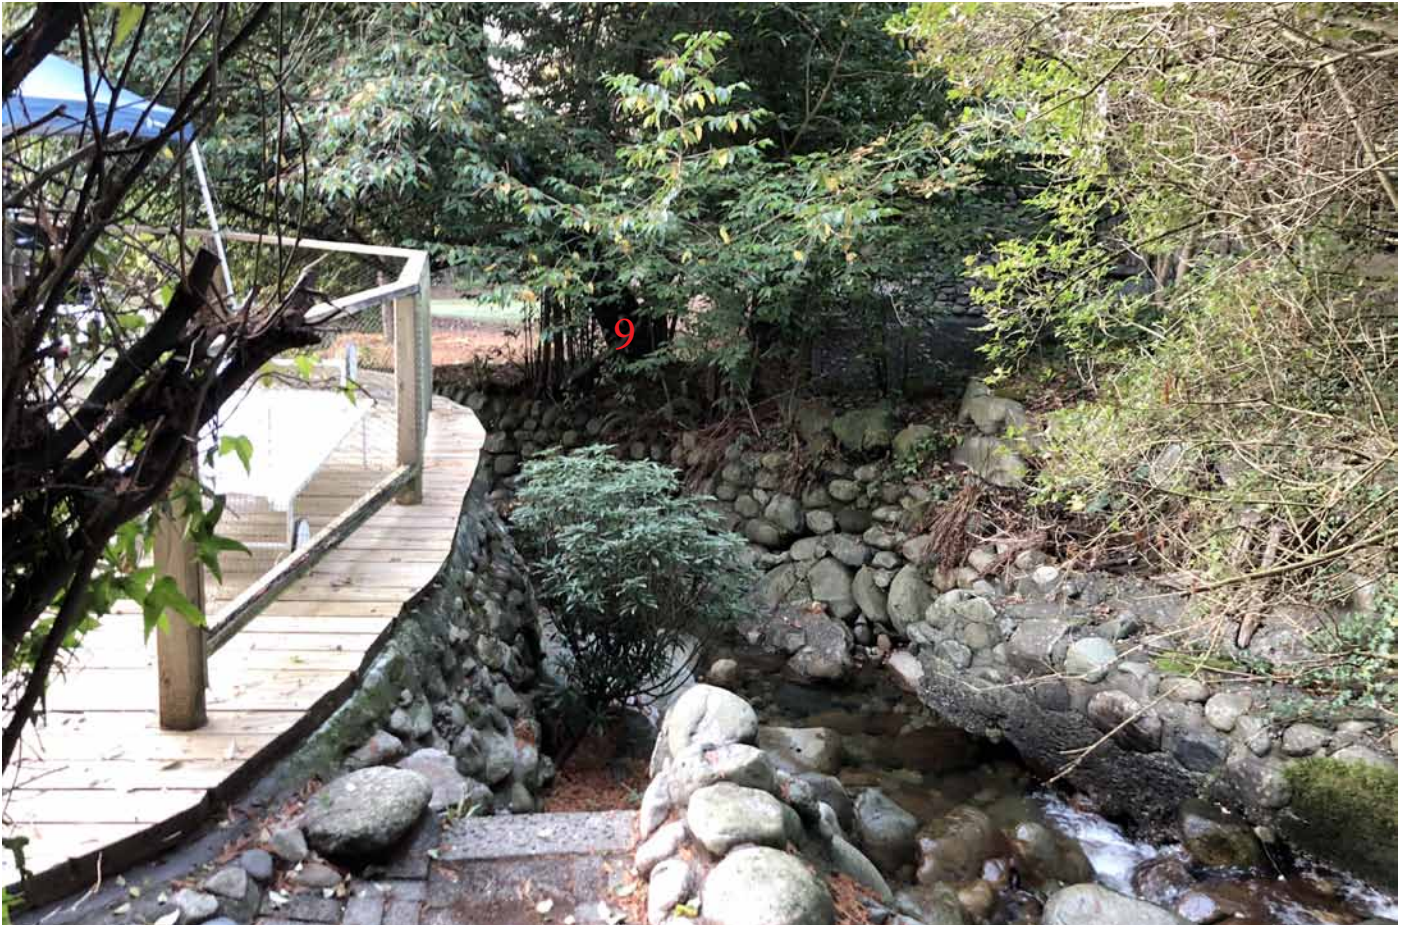
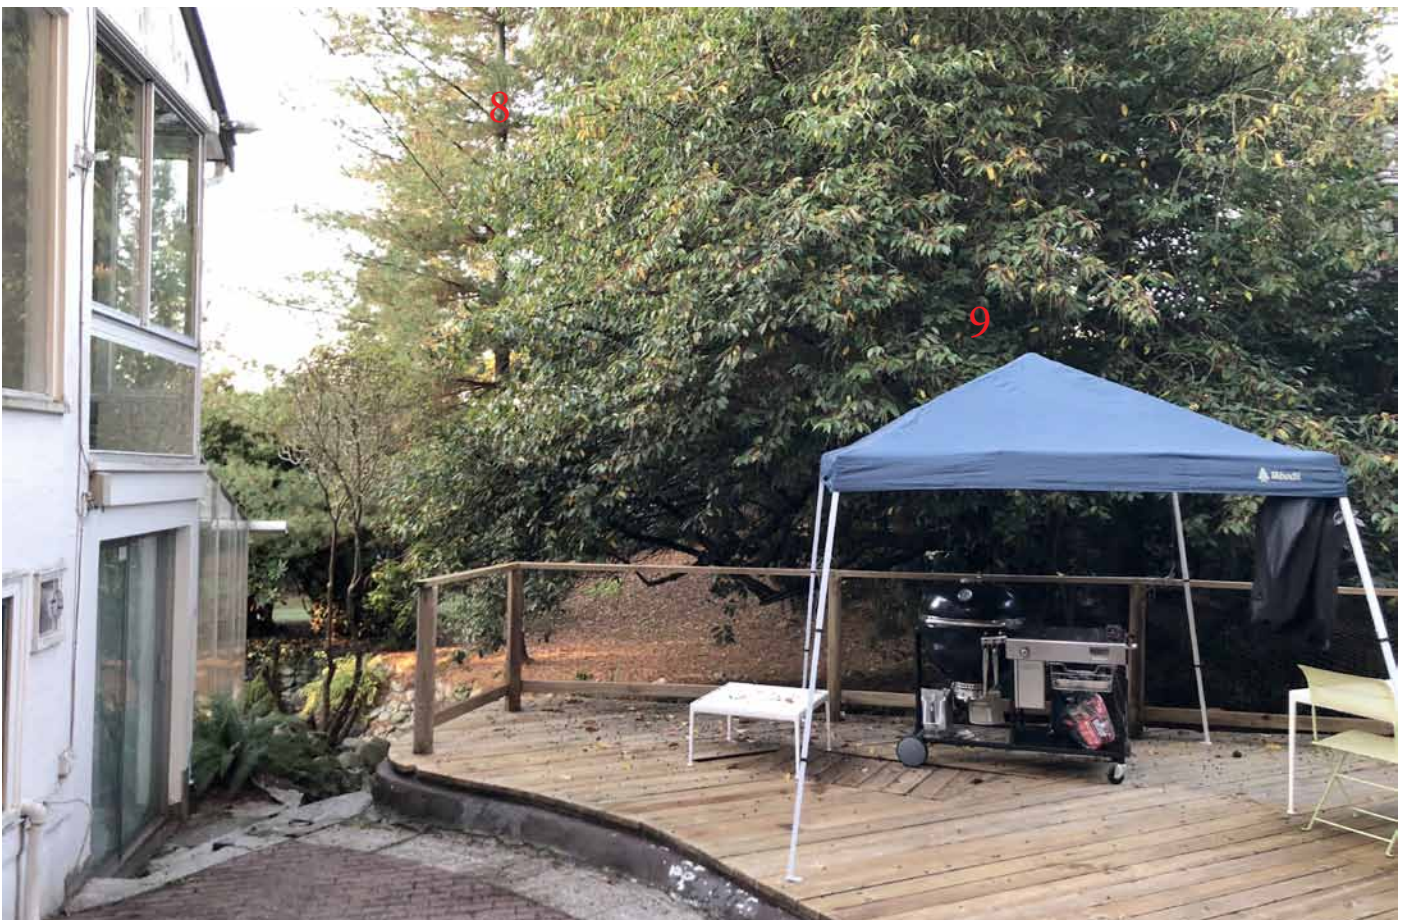
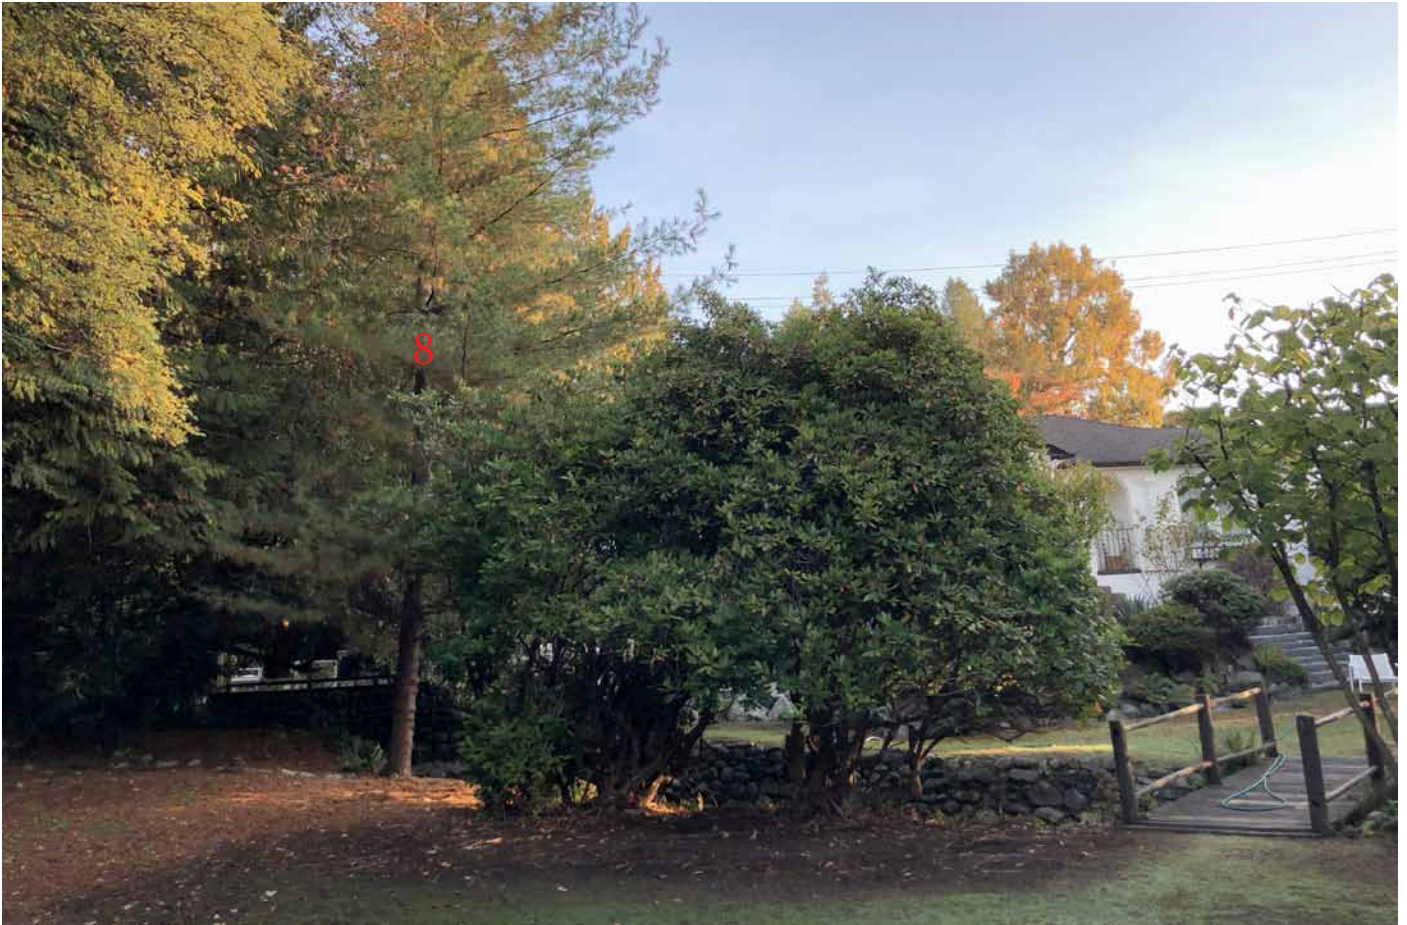
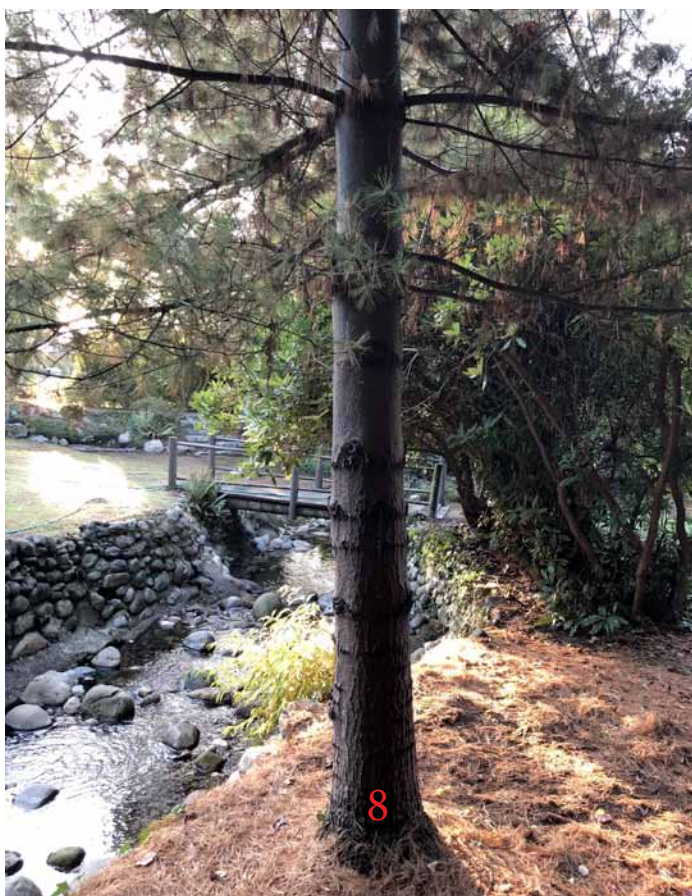
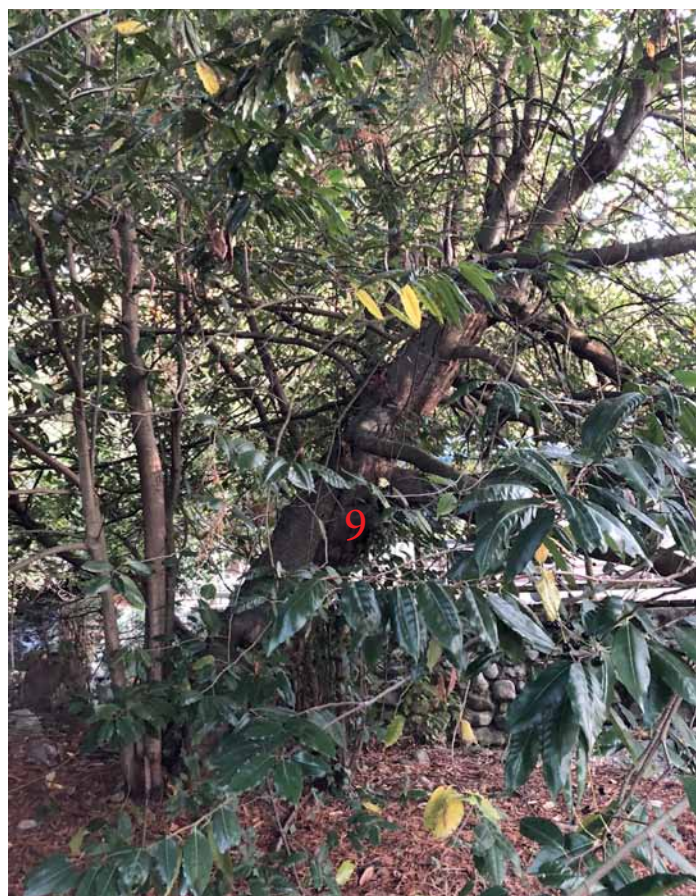
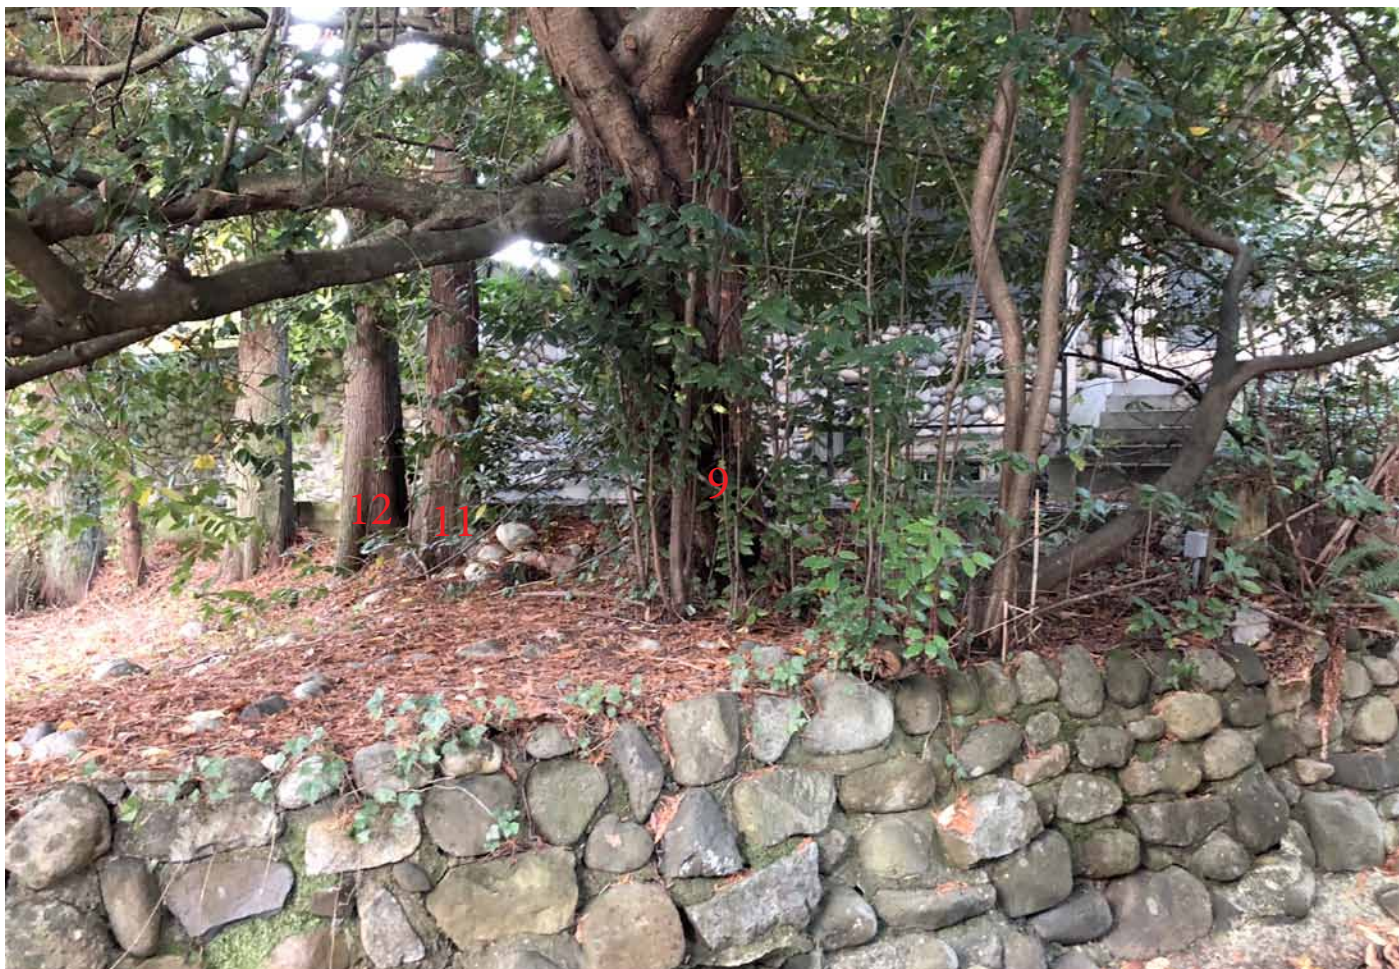
The trees along the creek vary in species and in health. It is likely that the western white pine (Tree #8) will eventually be infected with white pine blister rust and die, therefore successional planting should be planned for to ensure no permanent loss of riparian canopy. Tree #9 is providing

abundant mast for birds and several species were witnessed eating the fruit. This tree should be retained due to habitat value and shading capacity. Finally, Tree #41 is a topped cedar that may be a candidate for structural pruning to re-establish a new apically dominant leader. The tree is currently providing bank stabilization and shading to the creek. In summary, the recommended actions for each of these site trees is as follows:

View southward along creek from back patio. Tree #9 (cherry laurel) located in middle of photo on opposite bank.

View southward from back patio to Tree #8 and Tree #9.

View northward to Tree #8 with smaller shrubs along the southside top of bank.

Base of Tree #8.

Base of Tree #9.

Base of Tree #9 in foreground with cedars in background.

**Tree #8** (Western White Pine) - Action: **Retain & Plant** other long-lived, native riparian trees

**Tree #9** (Cherry Laurel) - Action: **Retain**

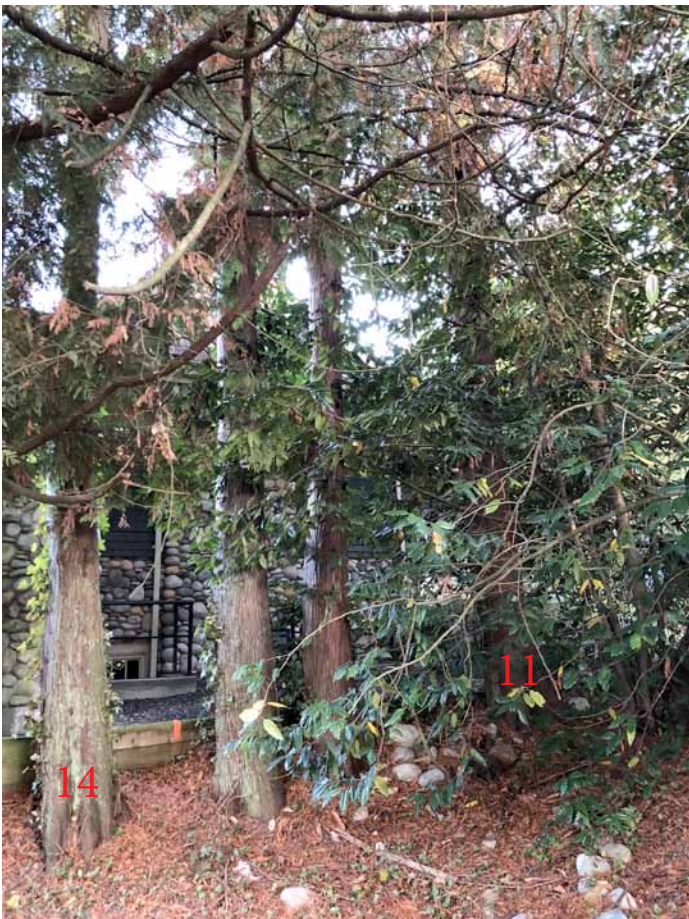
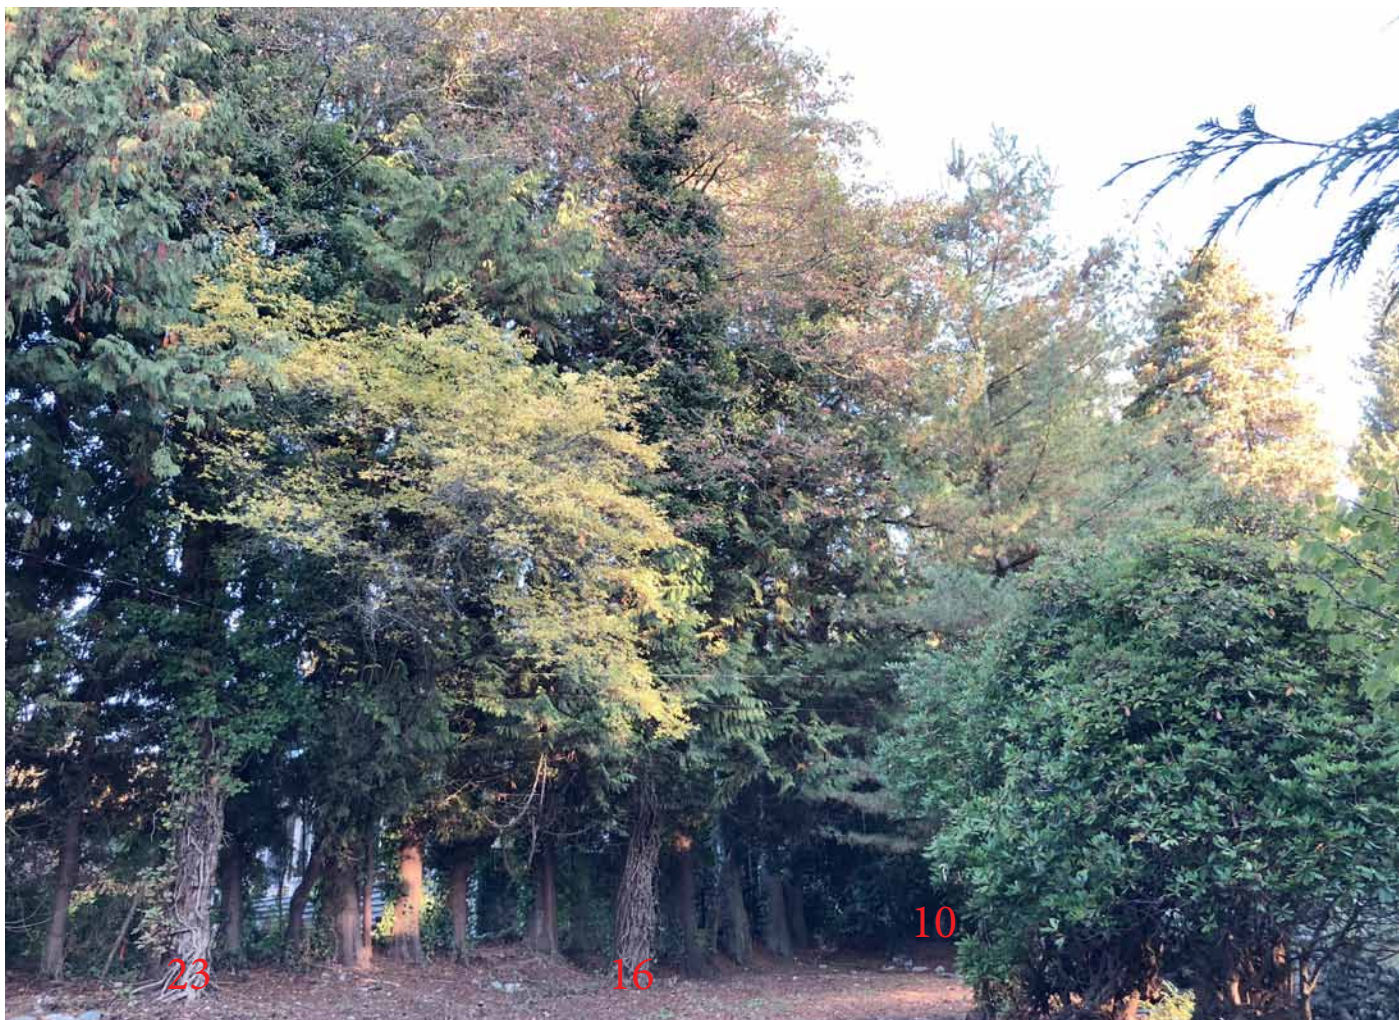
The majority of the trees in the front yard on the west property are western red cedars that have been topped and had a long history of poor management. Additionally, there are two large dogwoods that are located immediately adjacent to these cedars - both dogwoods have major infestations of English ivy, but the southernmost specimen (Tree #23) has major decay in the stem and appears vulnerable to failure. In summary, the condition of these trees is as follows:

View northwest from front yard toward trees along western property edge.

Cedars along western property edge.

With the exception of the two western flowering dogwoods (Tree #16 & #23), the cedar trees in the front yard on the west property edge are planted too close together considering their size. These trees were planted years ago at a spacing suitable to the establishment of a cedar hedge. The trees were traditionally topped to achieve a hedge form, however the trees have not been managed consistently at the topped, hedge height for over 15-20-years - the trees have now adopted a tree form with many containing co-dominant stems above the original topping height. Many of these cedars are stressed and retained trees will be candidates for thinning to allow remaining dominant stems to release and grow larger root systems and canopies. Currently it appears that Tree #10 - #17 will not be impacted by the proposed building, but some of these trees may be candidates for thinning. If thinning is supported as a management prescription from a tree health and riparian health standpoint, Talus Consulting should be retained to work hand-in-hand with an operations crew to select preferred trees for retention and subordinate trees for thinning removal. Any remaining cedar trees should also be pruned to establish a new leader, where possible, and improve monopodial stem structure. Tree #23 should be removed due to health issues as it is at risk of structural failure. Many of the remaining trees in this former hedge will be impacted by the current footprint of the proposed building and driveway. Some of the remaining trees, including Tree #18 - #22 and Tree #24 - #29, could be retained, thinned and pruned, however they will need to be removed to accommodate the new building and resulting construction footprint. In summary, the recommended actions for each of these site trees is as follows:

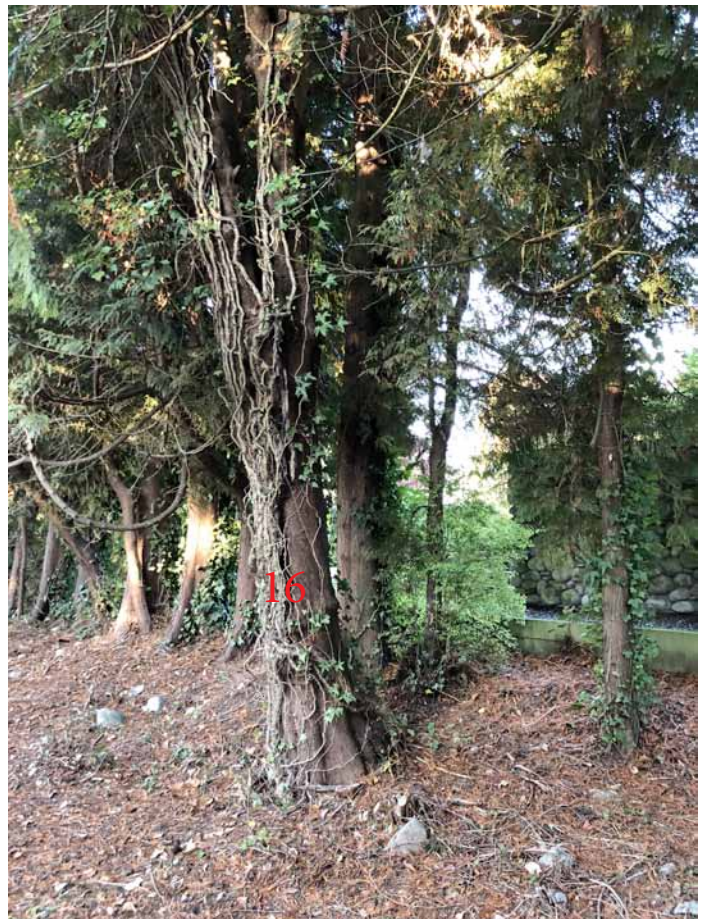
Tree #16.

**Tree #16** (Western Dogwood) - Action: **Retain & Prune** for structure and deadwood

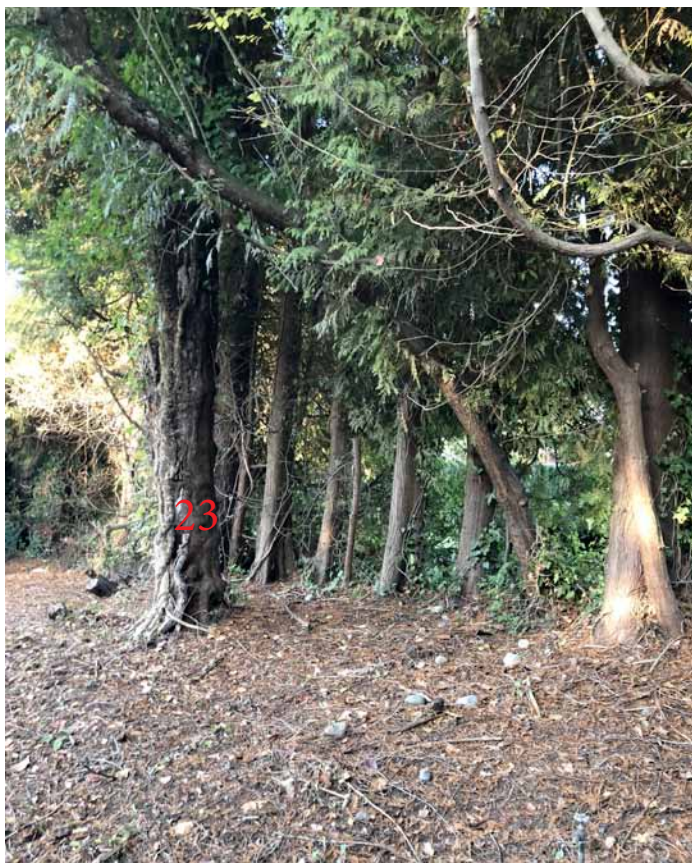
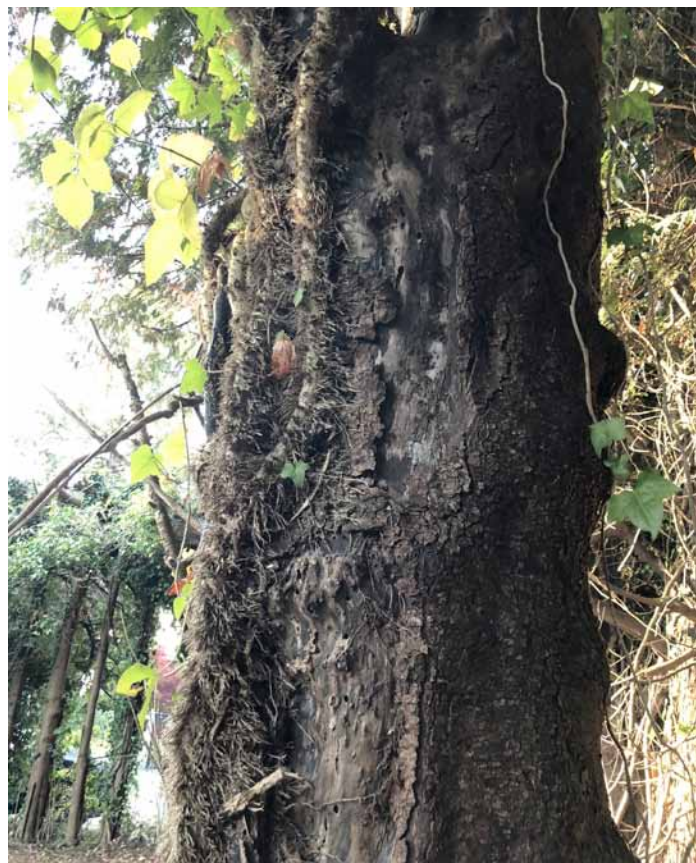
View southwest to Tree #23.

Note extensive decay in base of Tree #23.

**Tree #23** (Western Flowering Dogwood) - Action: **Remove & Replace** riparian canopy
