# Arborist Report

2859 Bellevue Ave  
District of West Vancouver, BC

October 24, 2018

**T A L U S**  
arboriculture & landscape architecture  
Talus Consulting ● 604-354-7799 ● [talusbc@gmail.com](mailto:talusbc@gmail.com)  
J.D. McLeod - ISA Certified Arborist # SO-4337A  
Tree Risk Assessment Qualified (TRAQ)

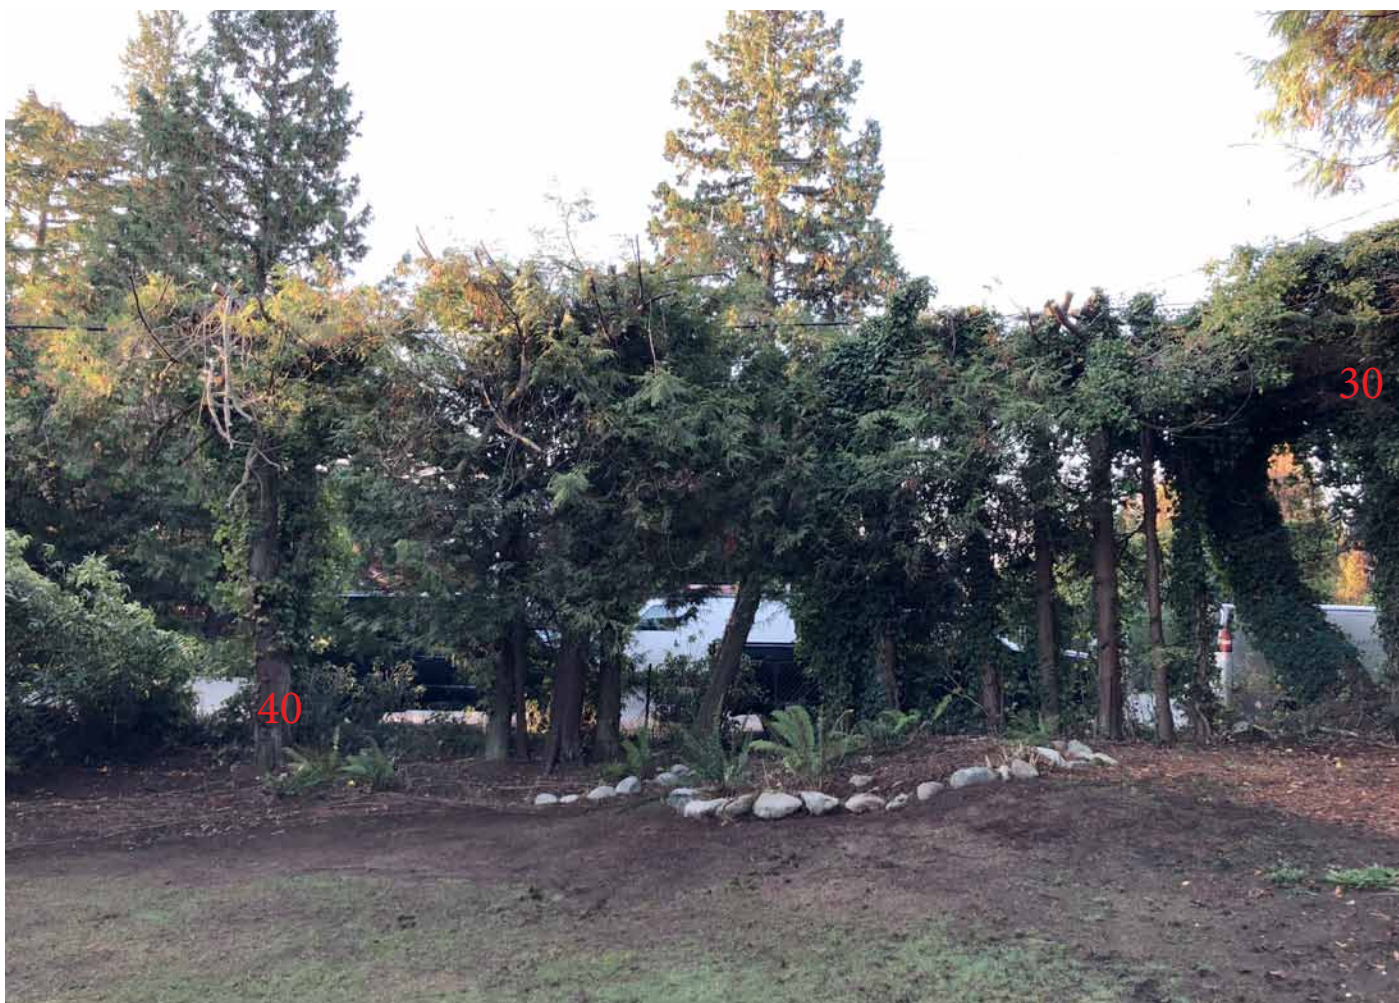
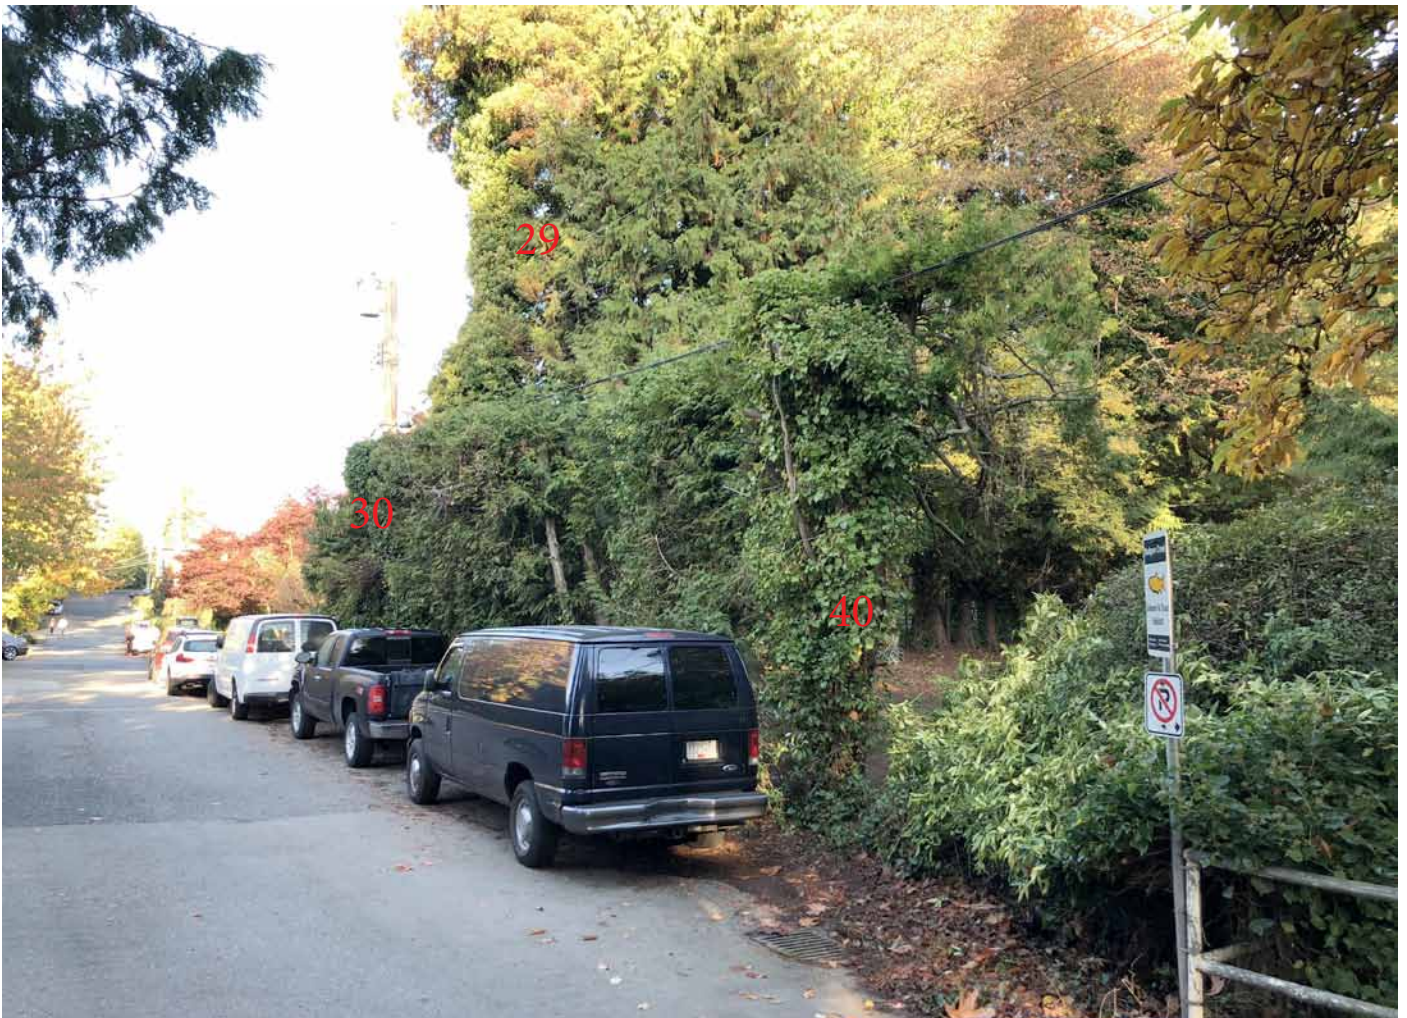
All of the trees in the front yard immediately adjacent to Bellevue Ave are located in a row beneath utility wires. These trees have a long history of aggressive pruning in the form of topping and shearing. These trees are all 5m or less in height and are irreversibly stressed with permanent poor form. In summary, the condition of these trees is as follows:

View southward to Tree #30-#40. These trees are all topped in the foreground beneath utility lines.

View northwest along front of property including topped cedars beneath overhead utility.

Regardless of any development impacts, the current condition of these topped cedars is irreversibly degraded. All of these trees should be removed and additional native riparian planting should be planted throughout the site and more height appropriate specimens planted beneath utility wires. In summary, the recommended actions for each of these site trees is as follows:

- Tree #30** (Western Red Cedar) - Action: **Remove & Replace** riparian canopy
- Tree #31** (Western Red Cedar) - Action: **Remove & Replace** riparian canopy
- Tree #32** (Western Red Cedar) - Action: **Remove & Replace** riparian canopy
- Tree #33** (Western Red Cedar) - Action: **Remove & Replace** riparian canopy
- Tree #34** (Western Red Cedar) - Action: **Remove & Replace** riparian canopy
- Tree #35** (Western Red Cedar) - Action: **Remove & Replace** riparian canopy
- Tree #36** (Western Red Cedar) - Action: **Remove & Replace** riparian canopy
- Tree #37** (Western Red Cedar) - Action: **Remove & Replace** riparian canopy
- Tree #38** (Western Red Cedar) - Action: **Remove & Replace** riparian canopy
- Tree #39** (Western Red Cedar) - Action: **Remove & Replace** riparian canopy
- Tree #40** (Western Red Cedar) - Action: **Remove & Replace** riparian canopy

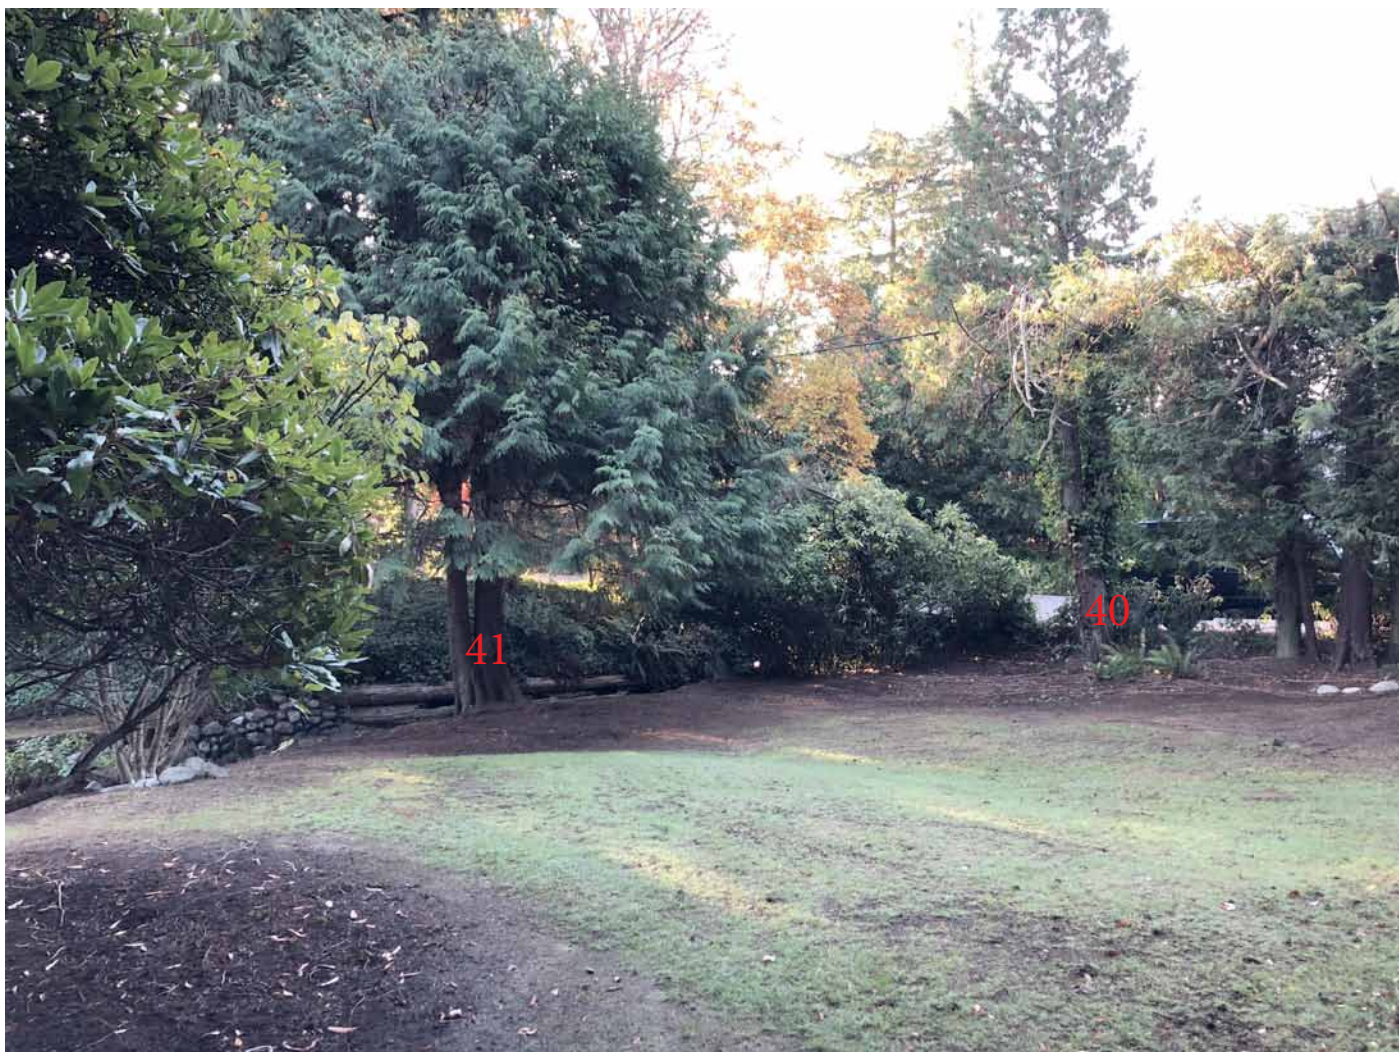
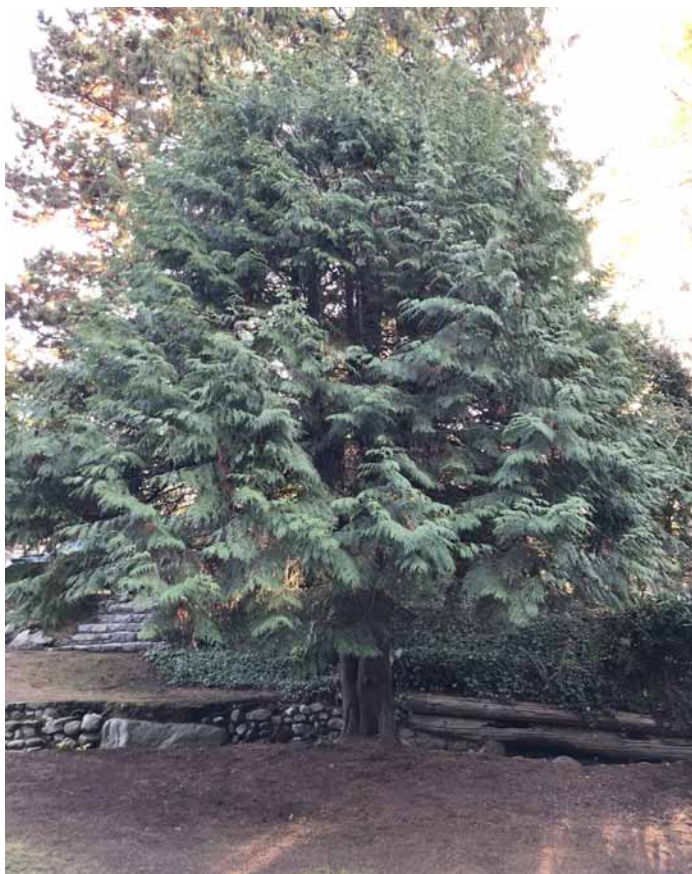
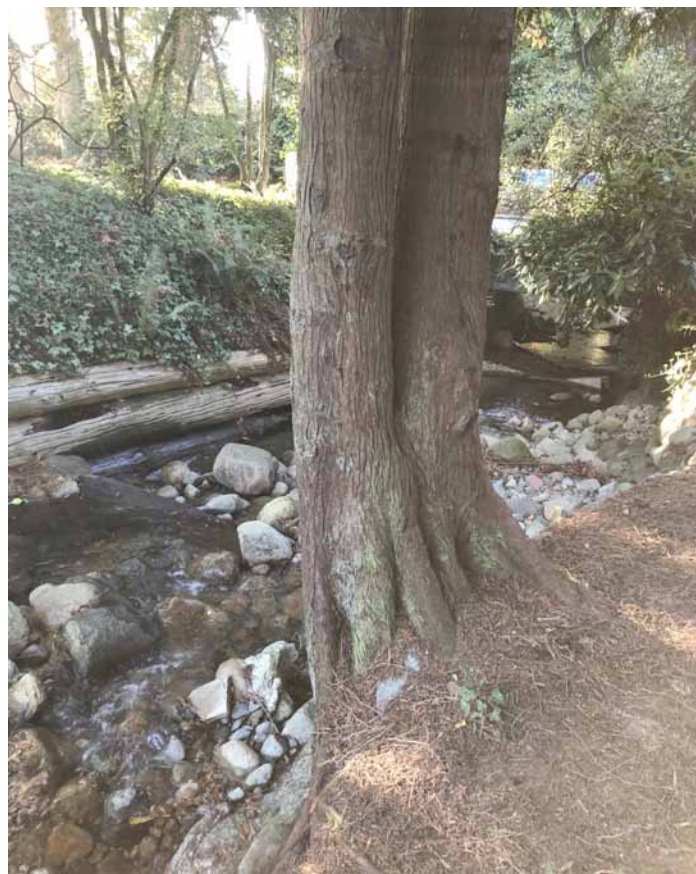
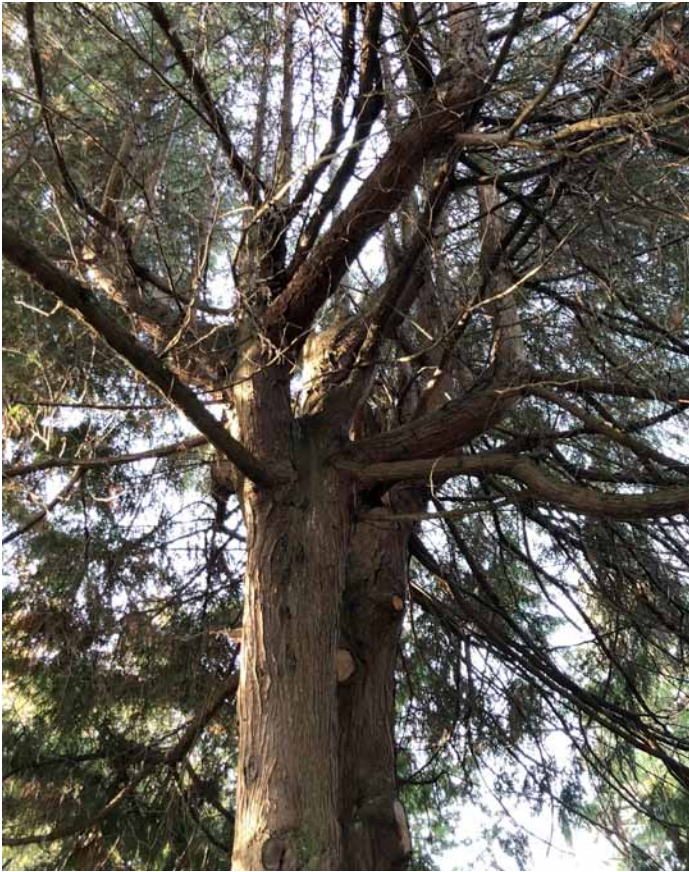
View southeast to Tree #41. Topped trees to the right.

View east to Tree #41.

Base of Tree #41 along top-of-bank.

Canopy of Tree #41.

**Tree #41** (Western Red Cedar) - Action: **Retain & Prune** to establish a new leader stem

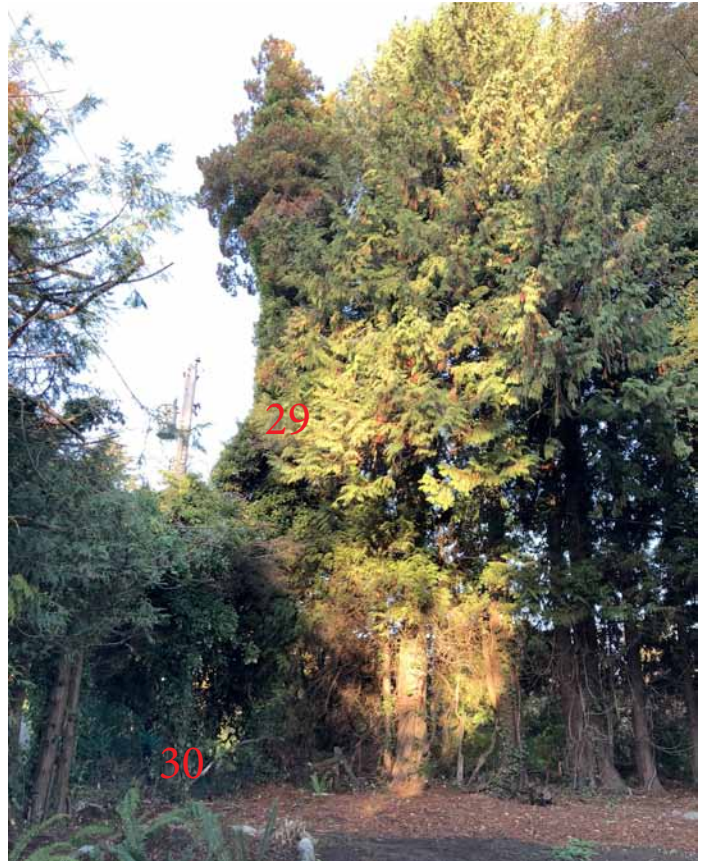
Abrupt edge formed at utility line clearance corridor along Bellevue Ave R.O.W.
