Conservation Approach

The Woyat-Bowie Building 660 Clyde Avenue, West Vancouver, BC

Condition Assessment

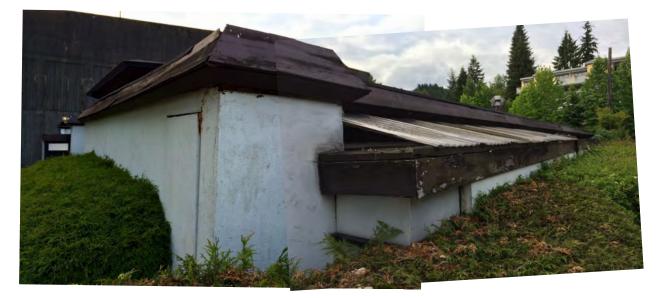
The stucco and wood-framed walls have some water damage and staining. The wooden cap on the perimeter wall has warped and split over the years. In places the cap is missing key pieces. Plant growth has been allowed to grow into spaces between the trim and stucco, and in places climbing vines such as wisteria, have been planted and if not checked will provide future maintenance issues. The courtyards on the east side of the building have been covered in part with fibreglass sheets.

The south east corner of the building showing the warped and split wood wall caps, fibreglass panels cover the courtyard. Plant growth is right up against the building walls

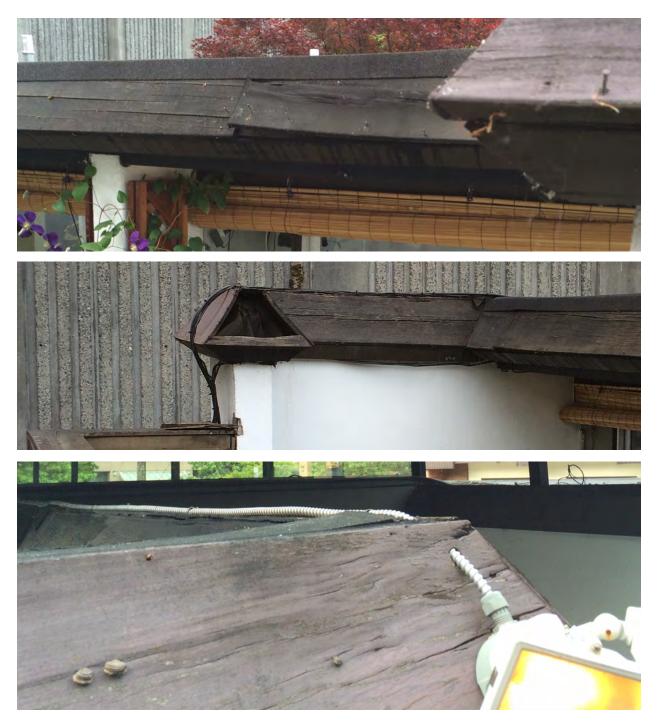
One of the roof repairs saw contractors add gutters and downspouts to the building. The downspouts were placed without regard to the building's overall design and negatively impact important visual aspects of the building. Asphalt shingles have been added to the top of the wood wall caps in places.

Unsympathetic placement of items such as security lights and electrical boxes have damages some of the building's fabric.

Top: warped boards of the wall cap with asphalt shingle overlap and popped nailsMiddle: missing pieces of the wall cap, electrical wires and stucco damageBottom: localized rot at the corners due to rusting nails and more electrical cable damage

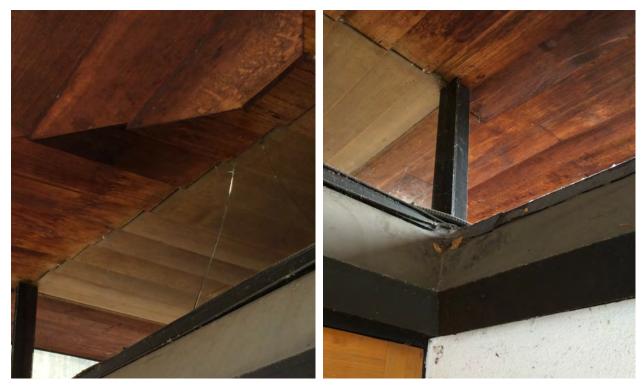
The roof is in good condition, though there are signs of some slight slumping, notably at the south end of building. There is some minor water staining on the ceiling where it meets the clerestory glass. Some of the clerestory glass panes have cracked and there is some minor glass damage at the doors.

Cracked glass in the clerestory

Water stains and electrical cables at the clerestory
