Diamond Head Consulting Ltd. Tree Assessment

For: 4719 Pilot House Road
West Vancouver, BC

April 2, 2014

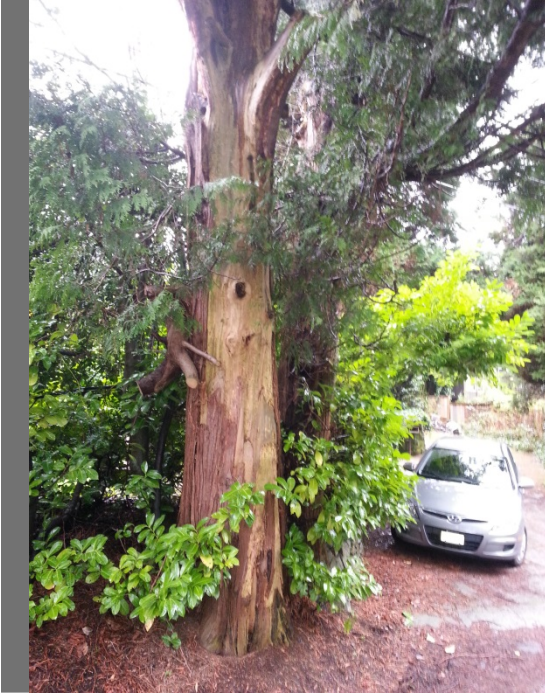
Photo 1: The subject tree has significant wounds on both trunks most likely from historic vehicle damage.

Tag #	Common Name	DBH (cm)	Ht (m)	Overall Condition	Retention Suitability	Comments
						<p>(replacement leaders).</p> <ul style="list-style-type: none"> In addition it appears that one of these replacement leaders has previously failed from north stem, leaving a cavity in the main stem. There are significant decay cavities and necrotic bark wounds located on the main trunks from what appears to be historic vehicle damage. Note the necrotic bark extends into the upper crown.

The subject tree has several severe structural defects and health issues as a result of decades of cyclical power line clearance pruning and topping, as well as the harsh growing environment provided by its road side location. This tree cannot be restored and given its severe decline in health and close proximity to Pilot House Road, adjacent property, and the BC Hydro power line I strongly recommend this to be removed. This is a District owned tree, and will require District approval for its removal.

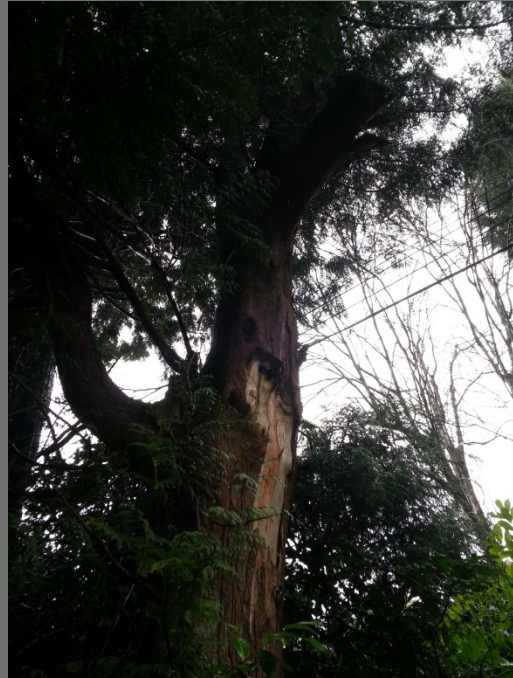
Photo 2: View of a previous replacement leader failure.

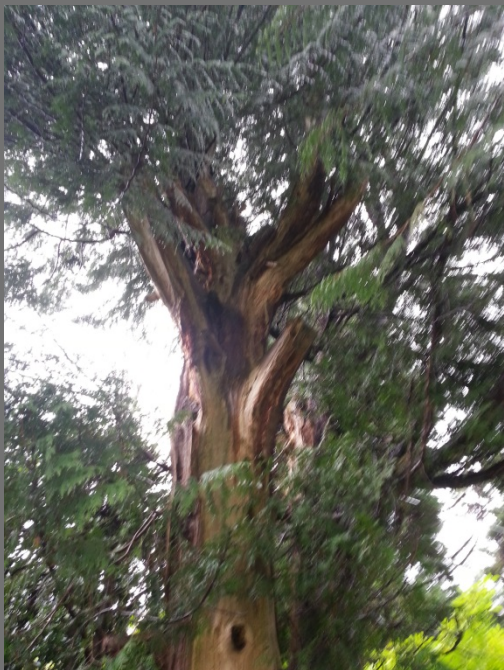
Photo 1: View of the very poor structural condition and the previously topped form of the subject tree. Note the necrotic bark extends from the base to into the top.

Tag #	Common Name	DBH (cm)	Ht (m)	Overall Condition	Retention Suitability	Comments
7059	Western redcedar	71+69	16	Very poor	Unsuitable	<ul style="list-style-type: none"> This tree is comprised of two main stems that join at the basal union. Both stems have been previously topped at approximately 4m and 6m above grade to accommodate the overhead Hydro power line. The main scaffold limbs have been headed to stubs as well. This topping has resulted in the formation of replacement leaders that are attached to the decaying unions. These replacement leaders have topped a several different heights. Decay is visible at the historic topping sites

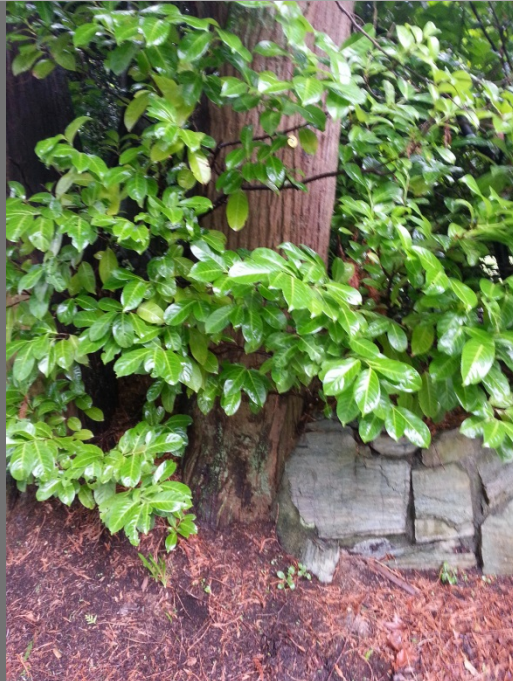
Photo 2: The existing rock wall is embedded into the trees trunk.
