MOUNTAIN MAPLE GARDEN & TREE SERVICE LTD.  
#200, 8208 SWENSON WAY  
DELTA, BC V4G 1J6  
PHONE: 604 - 488 - 4455  
MOUNTAIN.MAPLE@HOTMAIL.COM

**RE: Arborist Report for Formwerks Architectural Inc. - For property located at 1195 12 St., West Vancouver, BC**

**Applicant:** Formwerks Architectural Inc.  
C/o: Matt Mauza  
**Phone:** 604 – 683 - 5441  
**Email:** matt@formwerks.net

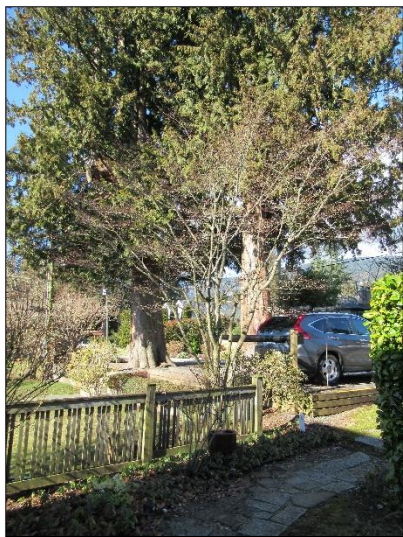
**Tree #1**

<u>TREE</u>	<u>SPECIES</u>	<u>DBH</u>	<u>HEIGHT</u>	<u>CRZ</u>	<u>Condition</u>	<u>OBSERVATIONS &amp; RECOMMENDATIONS</u>
#		(cm)	(m) est.	radius (ft.)		
1	Japanese Maple ( <i>Acer palmatum</i> )	26 combined (11+9+6)	5	5.4'	Good	This tree belongs to the neighbouring property. It was not included on the site survey; therefore, its approximate location has been identified. It has four stems commencing at 2ft; overall, it appears typical of its species. The Critical Root Zone radius is 5.4ft. It is located 4ft from the west property line and an existing wood fence. The Critical Roots pose a 1.4ft encroachment into the subject site. <b>RECOMMENDATIONS:</b>
2	Dogwood ( <i>Cornus sp.</i> )	36 combined (15+11+10)	7	7.4'	Good	This tree has four stems commencing at 2ft; overall, it appears typical of its species. <b>RECOMMENDATIONS:</b>
3	Laurel ( <i>Prunus laurocerasus</i> )	-	2	3'	Good	This hedge may be shared ownership with the Municipality. It appears to have been maintained regularly. <b>RECOMMENDATIONS:</b>

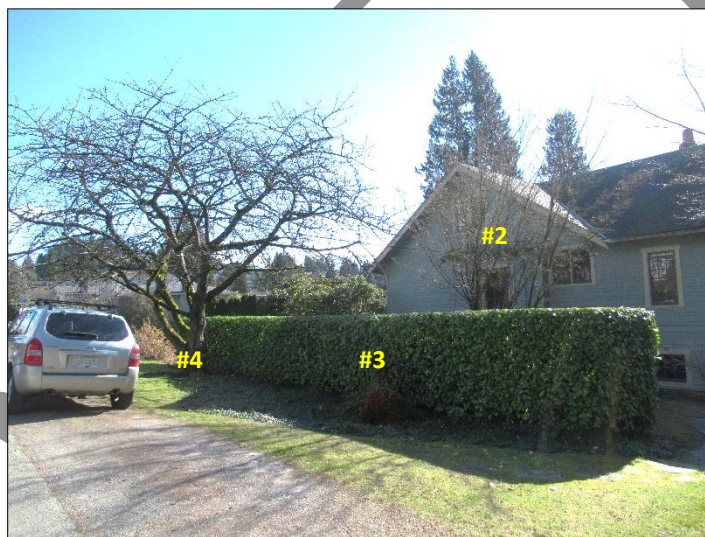
**Trees #2 & #4, and Hedge #3**

4	Cherry ( <i>Prunus sp.</i> )	96 combined (43+28+25)	7	19.8'	Fair	This tree belongs to the Municipality. It has three stems commencing at 3ft. These stems are somewhat irregular; areas along the stems appear somewhat sunken in and swollen. It has been previously topped at multiple heights, and cut back on all sides to contain. There are surface roots visible on all sides of the stem. The communication cables to the subject site pass through the lower canopy on the west side of the stem. <b>RECOMMENDATIONS:</b>
5	Laurel ( <i>Prunus laurocerasus</i> )	-	2	3'	Good	This hedge may be shared ownership with the City. It appears to have been maintained. <b>RECOMMENDATIONS:</b>
6	Rhododendron ( <i>Rhododendron sp.</i> )	57 combined (20+18+9)	4	11.8'	Good/fair	This shrub is a mature specimen. It has six stems commencing at the base. There is a column of decay within the southeast stem commencing at 1ft, which extends upwards to 3ft. It has been previously topped at multiple heights, and cut back to provide clearance to the existing walkway, which is 3ft from the southwest side of the stem. It has an 8ft canopy spread on the north, south and east sides of the stem. There are multiple pruning wounds throughout, which have not fully callused over, and decay is present. The Critical Root Zone radius is 11.8ft. The corner of the existing building is 12ft from the west side, the corner of the existing porch is 9.5ft from the south side and 4ft from the west side of the stem, and the existing wood

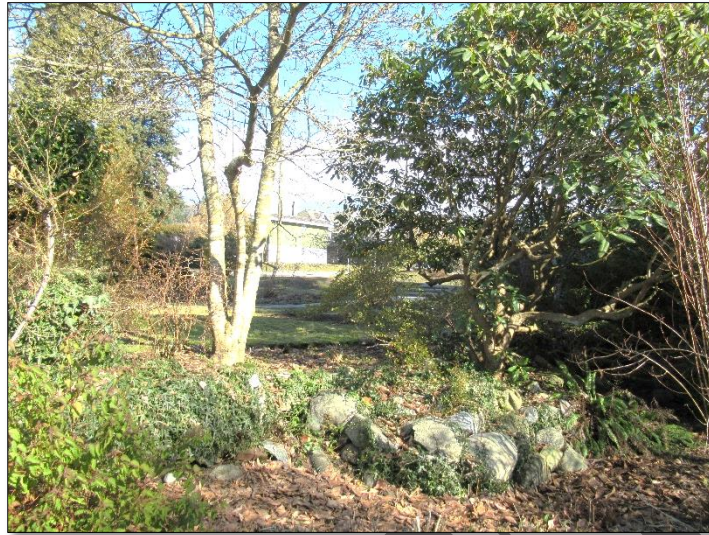
**Tree #7 &**

<u>TREE</u>	<u>SPECIES</u>	<u>DBH</u>	<u>HEIGHT</u>	<u>CRZ</u>	<u>Condition</u>	<u>OBSERVATIONS &amp; RECOMMENDATIONS</u>
#		(cm)	(m) est.	radius (ft.)		
						staircase is 12ft from the south side of the stem. <b>RECOMMENDATIONS:</b>
7	Magnolia ( <i>Magnolia sp.</i> )	34 combined (14+13+7)	18	8.2'	Good	This tree has three stems commencing at 1.5ft; overall it appears typical of its species. The Critical Root Zone radius is 8.2ft. There is an existing stacked rock retaining wall 1.5ft from the south side of the stem; the grade on the south side of the wall is 1.5ft lower. <b>RECOMMENDATIONS:</b>
8	Rhododendron ( <i>Rhododendron sp.</i> )	23 combined (10+7+6)	3	4.5'	Good	This shrub has multiple stems commencing at the base; overall, it appears typical of its species. The Critical Root Zone radius is 4.5ft. There is an existing stacked rock retaining wall adjacent to the south side of the stem; the grade on the south side of the wall is 1.5ft lower. <b>RECOMMENDATIONS:</b>

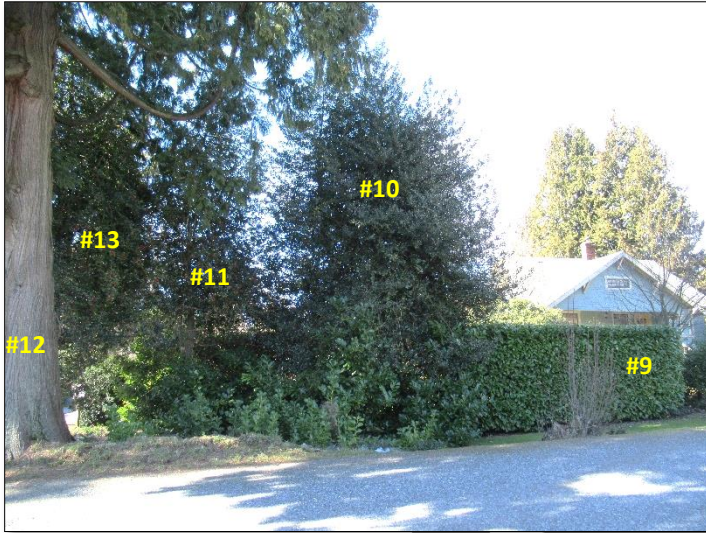
**Hedge #9, and Trees #10 - #13**

9	Laurel  ( <i>Prunus laurocerasus</i> )	-	3	4'	Good	This hedge may be shared ownership with the Municipality. It has been maintained. <b>RECOMMENDATIONS:</b>
10	Holly ( <i>Ilex sp.</i> )	71 combined (28+25+18)	9	14.6'	Fair	This tree has three stems commencing at 2ft; the central stems are intertwined. It has been previously topped at 20ft. It is partly located within Hedge #9. <b>RECOMMENDATIONS:</b>
11	Holly ( <i>Ilex sp.</i> )	21	8	4.3'	Fair	This tree is tall and spindly. It has two stems commencing at 15ft. It has a phototropic lean to the west, and is somewhat suppressed due to the spreading canopies of the adjacent trees. It is located within Hedge #9. <b>RECOMMENDATIONS:</b>
12	Cedar ( <i>Thuja plicata</i> )	140	22	29.2'	Good/fair	This tree has three stems commencing at 25ft; narrow stem attachments were observed. The west stem divides again at 30ft. There is a large diameter candelabra limb commencing at 12ft on the east side of the stem; it has sustained minor surface damage due to vehicular traffic. This limb has been previously topped at 25ft. There are also three large diameter candelabra limbs commencing at 15ft, 16ft and 18ft on the southwest side of the stem. The canopy has been raised to provide clearance to the roadway and laneway. The Critical Root

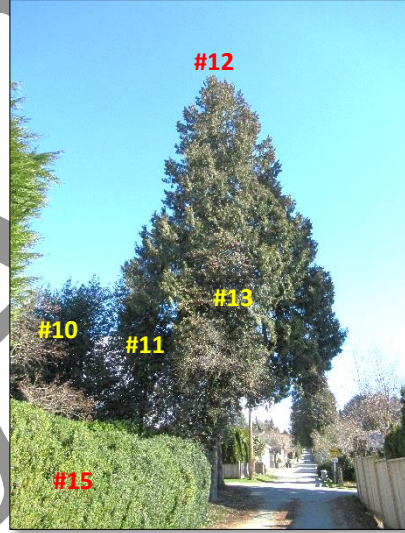
**Hedge #15, & Trees #10 - #13**

<u>TREE</u>	<u>SPECIES</u>	<u>DBH</u>	<u>HEIGHT</u>	<u>CRZ</u>	<u>Condition</u>	<u>OBSERVATIONS &amp; RECOMMENDATIONS</u>
#		(cm)	(m) est.	radius (ft.)		
						Zone radius is 29.2ft. There is excess soil within the Critical Root Zone on the north and west sides of the stem. <b>RECOMMENDATIONS:</b>
13	Holly ( <i>Ilex sp.</i> )	31	12	6.4'	Fair	This tree belongs to the Municipality. It has two stems commencing at 15ft. It has a phototropic lean to the west, due to the spreading canopies of the adjacent trees. The lower canopy appears rather spare and lacks vigor. There is Holly blight disease, and branch and twig dieback throughout the lower canopy; this disease will eventually cause the tree to decline. <b>RECOMMENDATIONS:</b>
14	Mountain Ash ( <i>Sorbus sp.</i> )	21	7	4.3'	Good/fair	This tree has a phototropic lean to the west, due to the spreading canopies of the adjacent trees. The canopy is asymmetrical, and is heavily weighted to the west. <b>RECOMMENDATIONS:</b>

15	Boxwood ( <i>Buxus sp.</i> )	-	2	4'	Good/fair	This hedge may be shared ownership with the Municipality. It has been maintained. There is a ditch adjacent to the south side of the stems. <b>RECOMMENDATIONS:</b>
16	Cypress ( <i>Chamaecyparis sp.</i> )	-	4	4'	Fair	This hedge maybe shared ownership with the Municipality. It has been previously topped at 15ft. The lower canopy has been cut back hard to provide clearance to the laneway, exposing bare twigs and branches on the south side of the hedge. There is a ditch adjacent to the south side of the stems. <b>RECOMMENDATIONS:</b>
17	Magnolia ( <i>Magnolia sp.</i> )	47 combined (31+16)	6	9.7'	Fair	This tree has two stems commencing at 4.5ft. The canopy has been cut back on all sides to contain. There is a callusing wound along the east side of stem commencing at the base to 1ft. The Critical Root Zone radius is 9.7ft. There is an existing stacked rock retaining wall 8ft from the south side of the stem; the grade difference is about 2ft. There is an existing concrete surface, and an existing raised deck, which has been supported by wood posts 4.5ft from the northeast side of the stem. There is an existing gravel pathway within the Critical Root Zone on the northeast and east sides of the stem. There is also an existing wood fence adjacent to the west side of the stem. <b>RECOMMENDATIONS:</b>

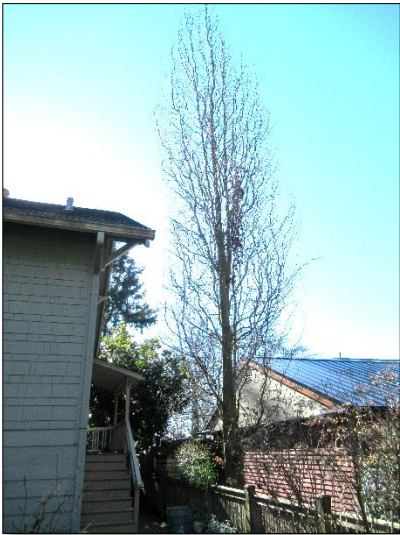
Tree #18

<u>TREE</u>	<u>SPECIES</u>	<u>DBH</u>	<u>HEIGHT</u>	<u>CRZ</u>	<u>Condition</u>	<u>OBSERVATIONS &amp; RECOMMENDATIONS</u>
#		(cm)	(m) est.	radius (ft.)		
18	Beech ( <i>Fagus sp.</i> )	41 combined (32+9)	10	8.5'	Good	This tree belongs to the neighbouring property. It is a columnar variety. It has two stems commencing at 3ft, which are fused to 6ft; otherwise, it appears typical of its species. The Critical Root Zone radius is 8.5ft. There is an existing wood fence adjacent to the east side of the stem. <b>RECOMMENDATIONS:</b>
19	Plum ( <i>Prunus sp.</i> )	23 combined (10+9+4)	6	4.5'	Good	This tree was not included on the site survey; therefore its approximate location has been identified. It has a slight lean to the east; overall, it appears typical of its species. <b>RECOMMENDATIONS:</b>
