Arborist Report

File #:	22-077
Date:	22 July 22
Weather:	Overcast
Client:	Somerset Homes
Telephone:	604-671-5202
Email:	shawn@somersetcustomhomes.ca
Site Address:	2225 Folkestone Way, West Vancouver, British Columbia V7S 2Y6

Burley Boys Tree Service Ltd. has been contracted to provide a preliminary tree removal/retention outline for the property at 2225 Folkestone Way, West Vancouver, BC. Plans for the property include the redevelopment of the existing commercial building on the property & construction of a new multi-unit, mixed use building.

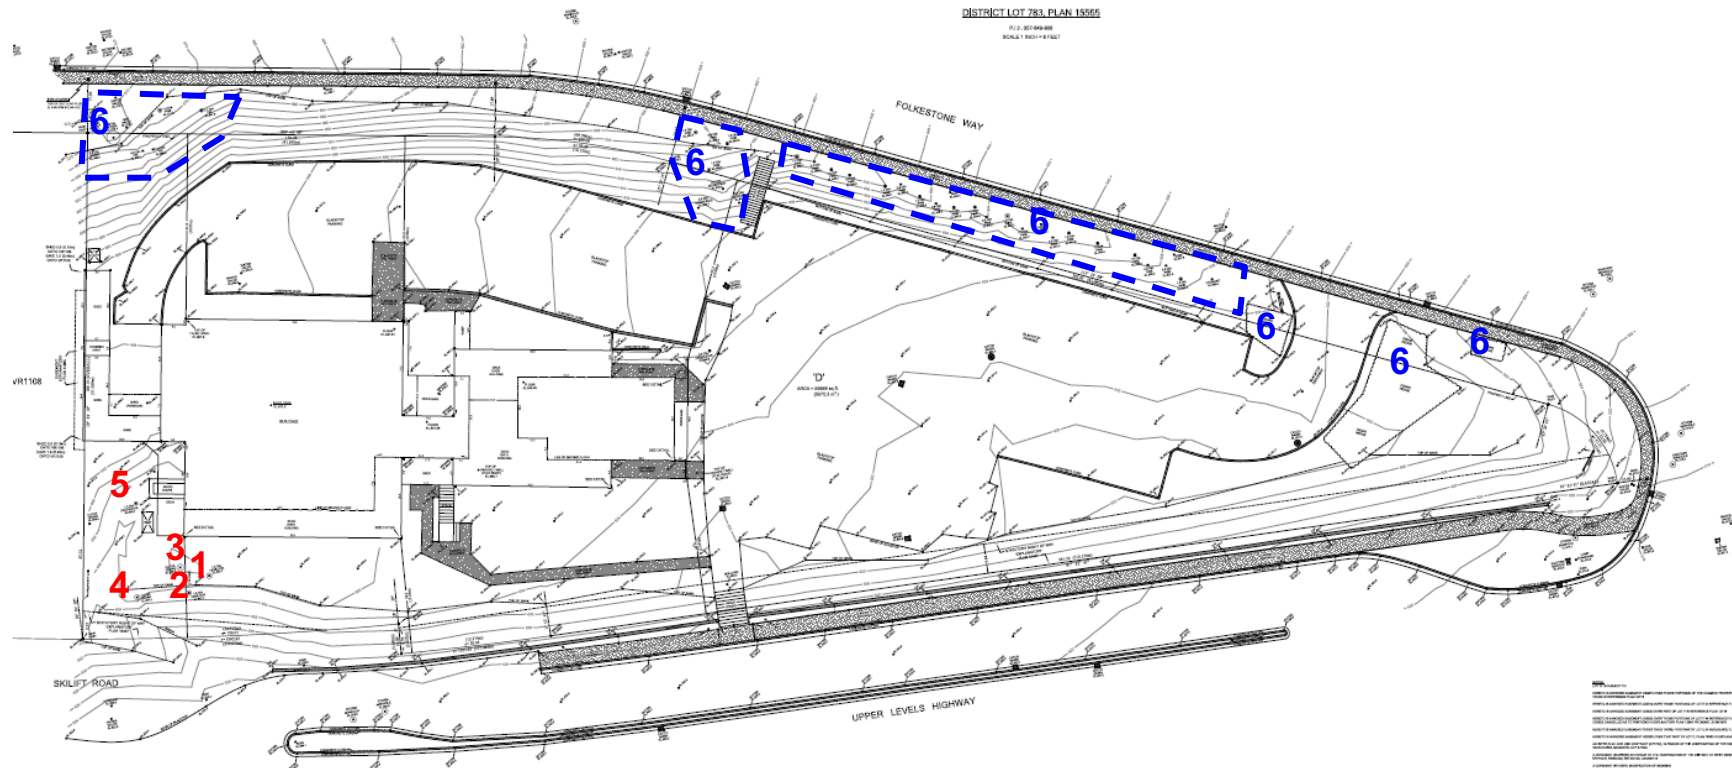
Site Survey:

The below site survey plots tree locations and outlines removal / retention recommendations (*Retain*, *Remove*).

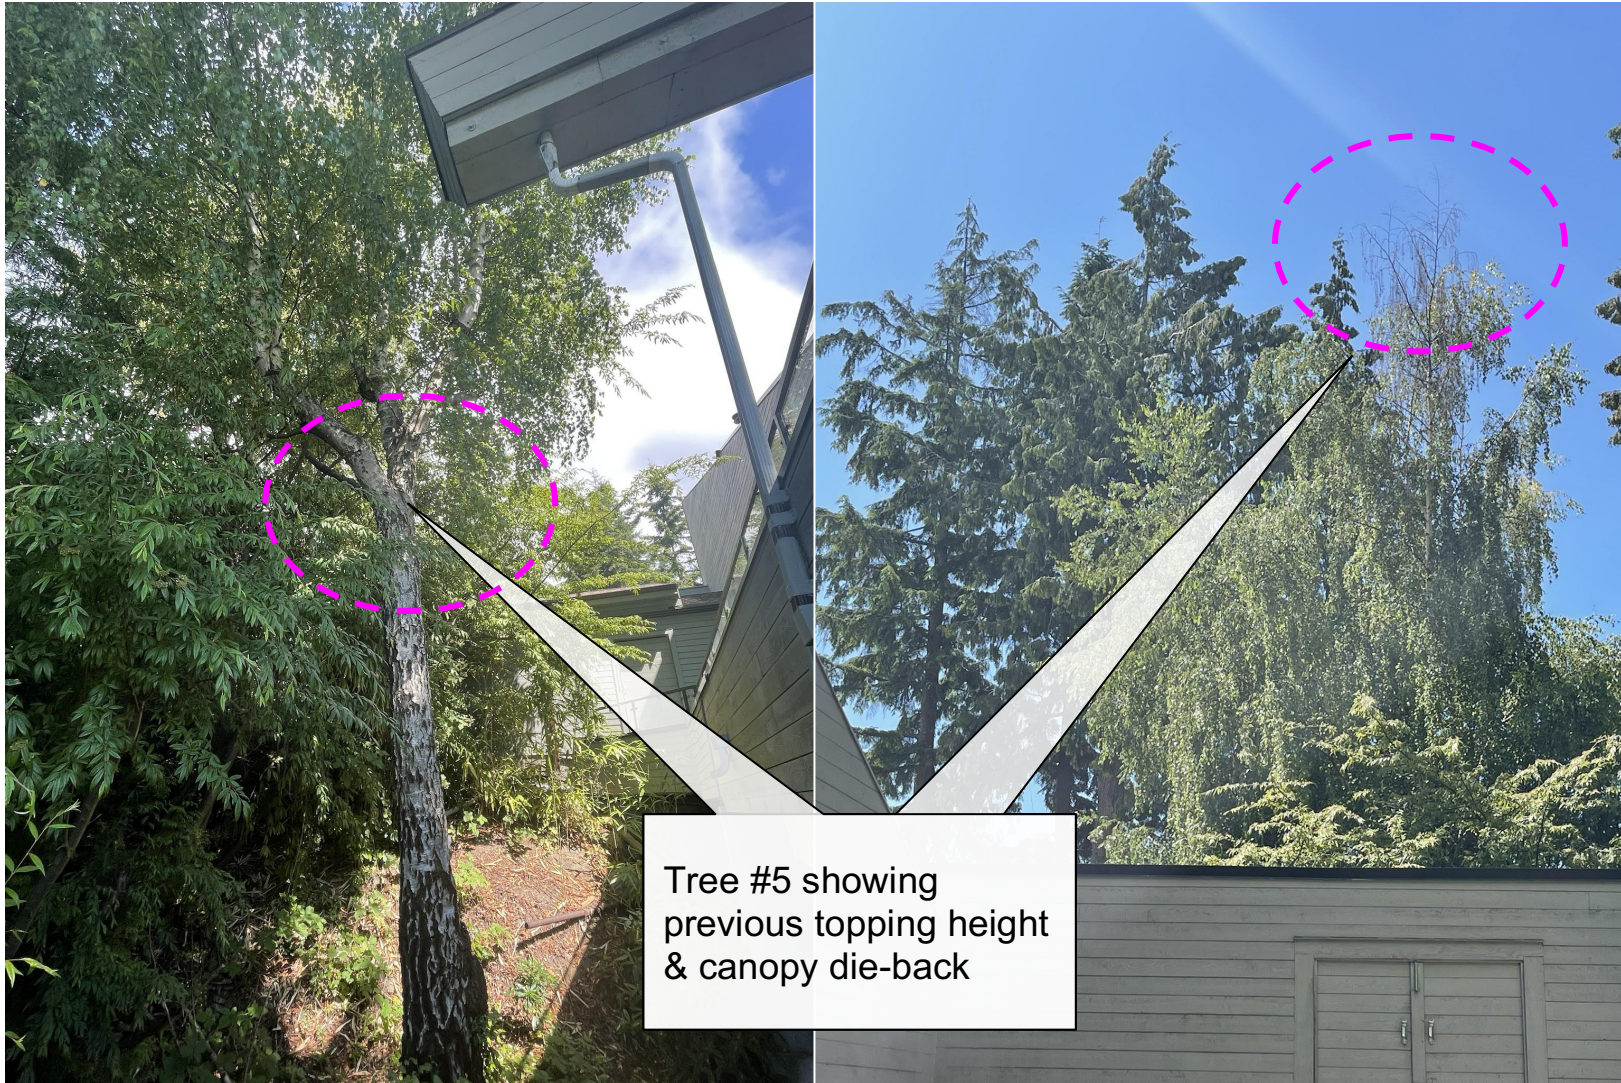
Tree #5 is a 39 cm DBH birch. This tree is in poor condition; it has a history of previous topping cuts, and evidence of tip dieback due to suspected bronze birch borer. This tree is in conflict with the proposed excavation area & will require removal to facilitate the development.

5	Birch	39	Poor	Unsuitable	2.34	4.68	<ul style="list-style-type: none"> Previously topped Evidence of dieback; suspected bronze birch borer Conflict with required excavations Recommend: <ul style="list-style-type: none"> Remove to facilitate proposed development
6	Fir, Pine, Cedar, Birch, Arbutus, Maple (36)	20-60	Fair	Moderate	1.20-3.60	2.40-7.20	<ul style="list-style-type: none"> Mixed row of trees at north perimeter & north blvd; 6 private, 3 shared with DWV, 27 DWV blvd. Recommend: <ul style="list-style-type: none"> Retain, install tree protection barrier at edge of sidewalk/parking area

Tree #5 showing
previous topping height
& canopy die-back

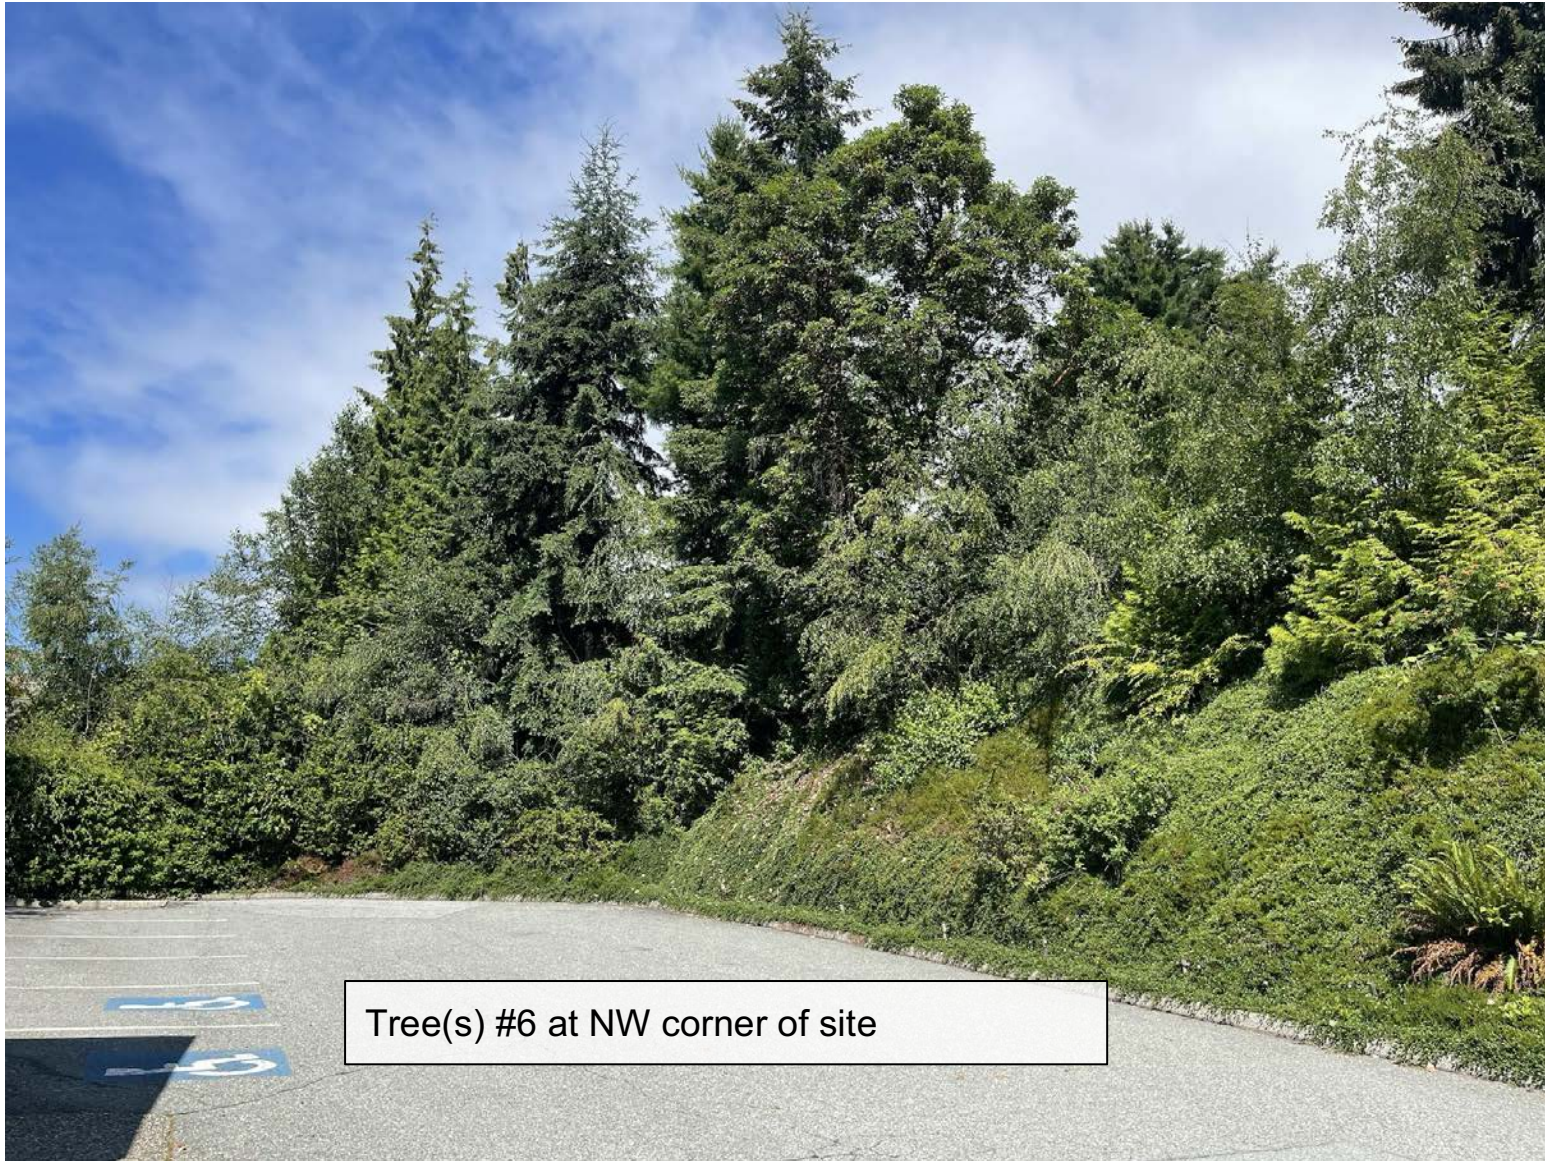
Tree #6 is a mixed row of approximately 36 trees growing at the north perimeter of the property and on the DWV blvd; 6 are on private property, 3 are shared with DWV property and 27 are on District property. They consist of fir, pine cedar, birch, arbutus and maple. These trees measure 20-60cms DBH and are in fair condition overall. They are to be retained; tree protection barriers are to be placed at the edge of sidewalk & parking area to allow for pedestrian & site access. This will provide safe retention of these trees; the existing concrete parking area will have prevented significant root growth into the site. No disruption is anticipated to their CRZ, provided the TPB remains intact during the development.

Tree(s) #6 at NW corner of site

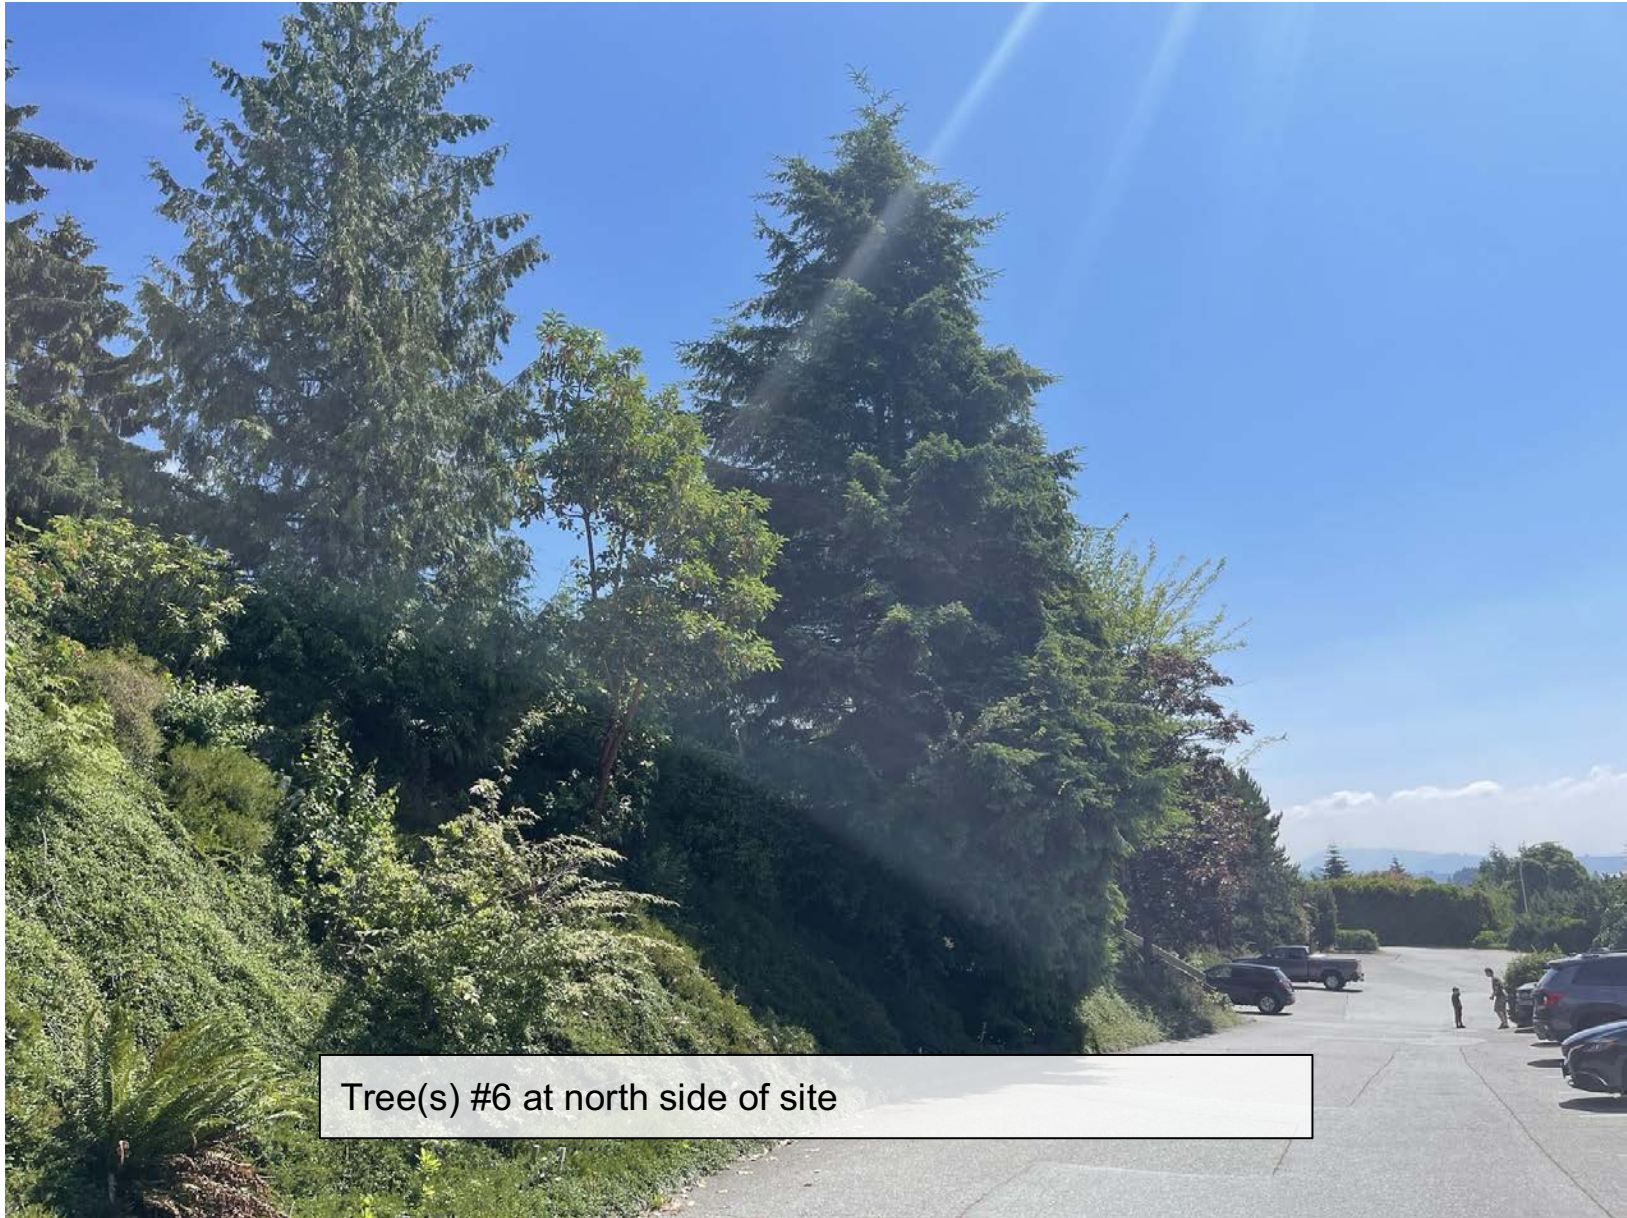
Tree(s) #6 at north side of site

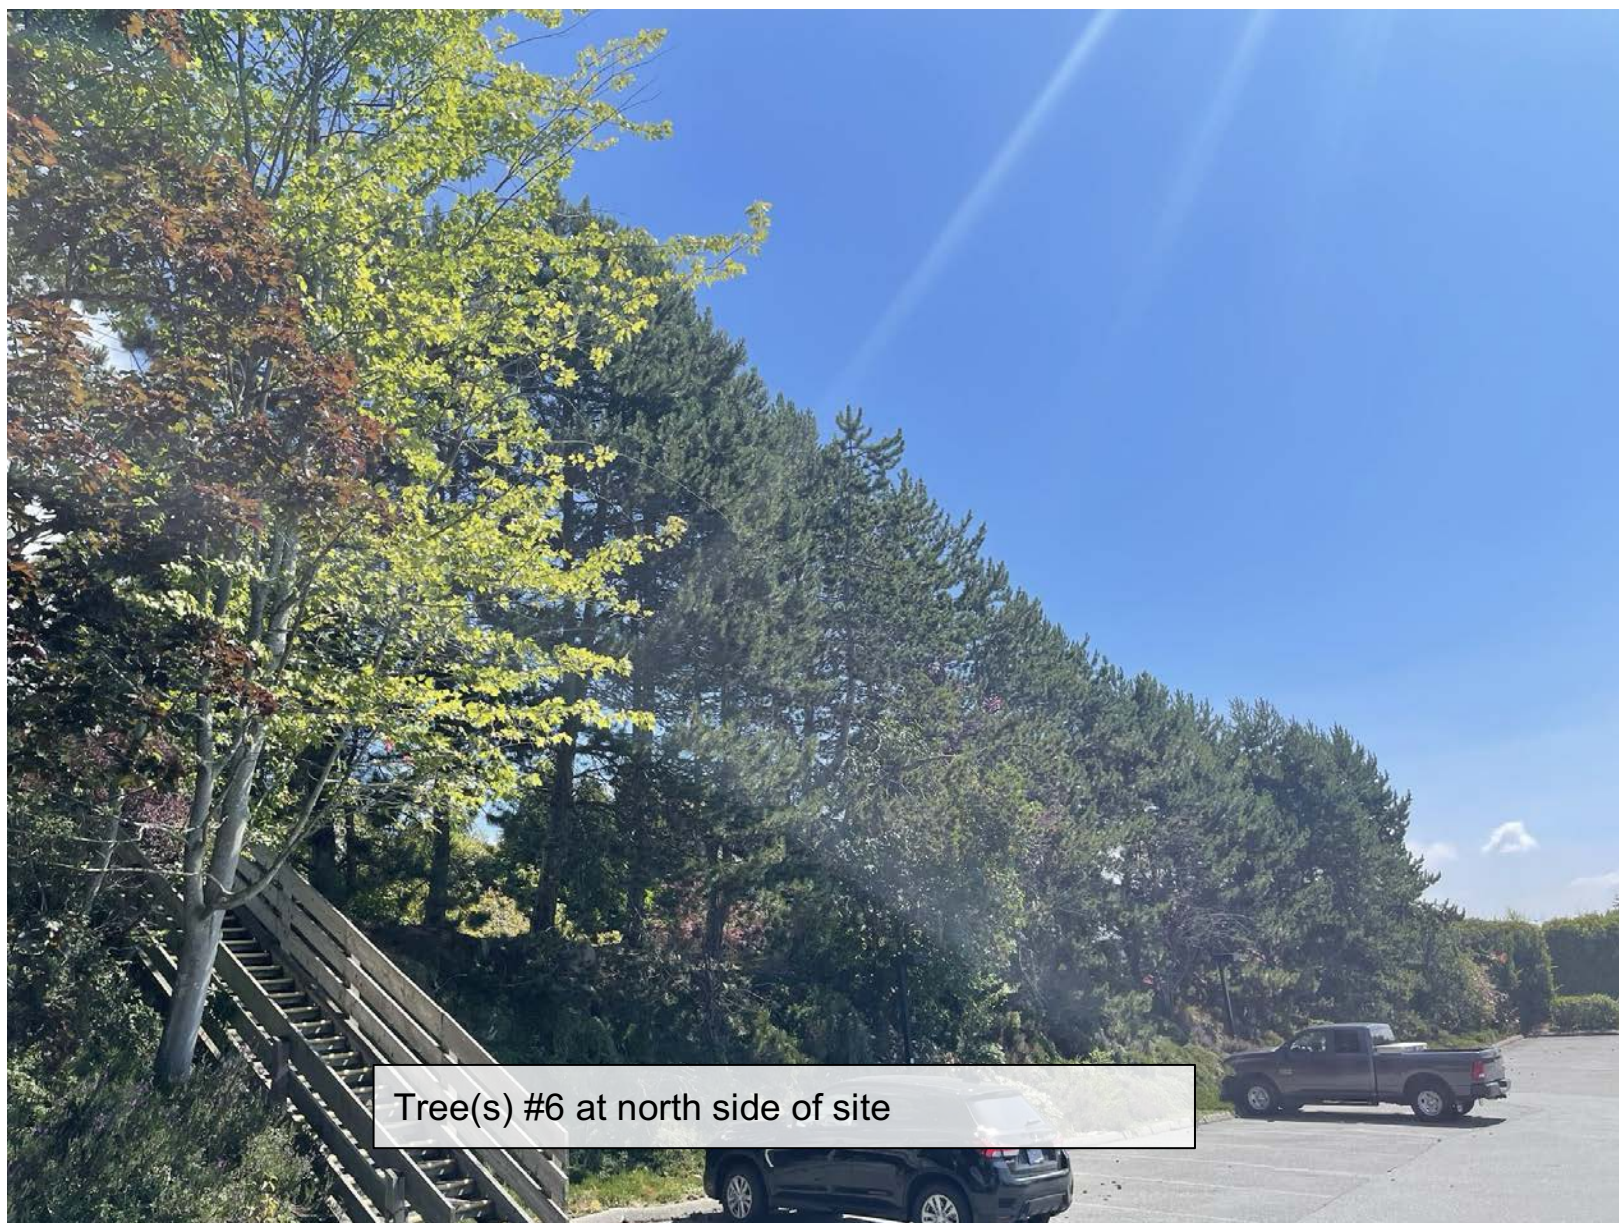
Tree(s) #6 at north side of site
