October 6, 2022
File: 1558 Rev 2

**RE: Preliminary Landslide Hazard Assessment – Proposed Subdivision
5600 Block, Daffodil Drive, West Vancouver, BC**

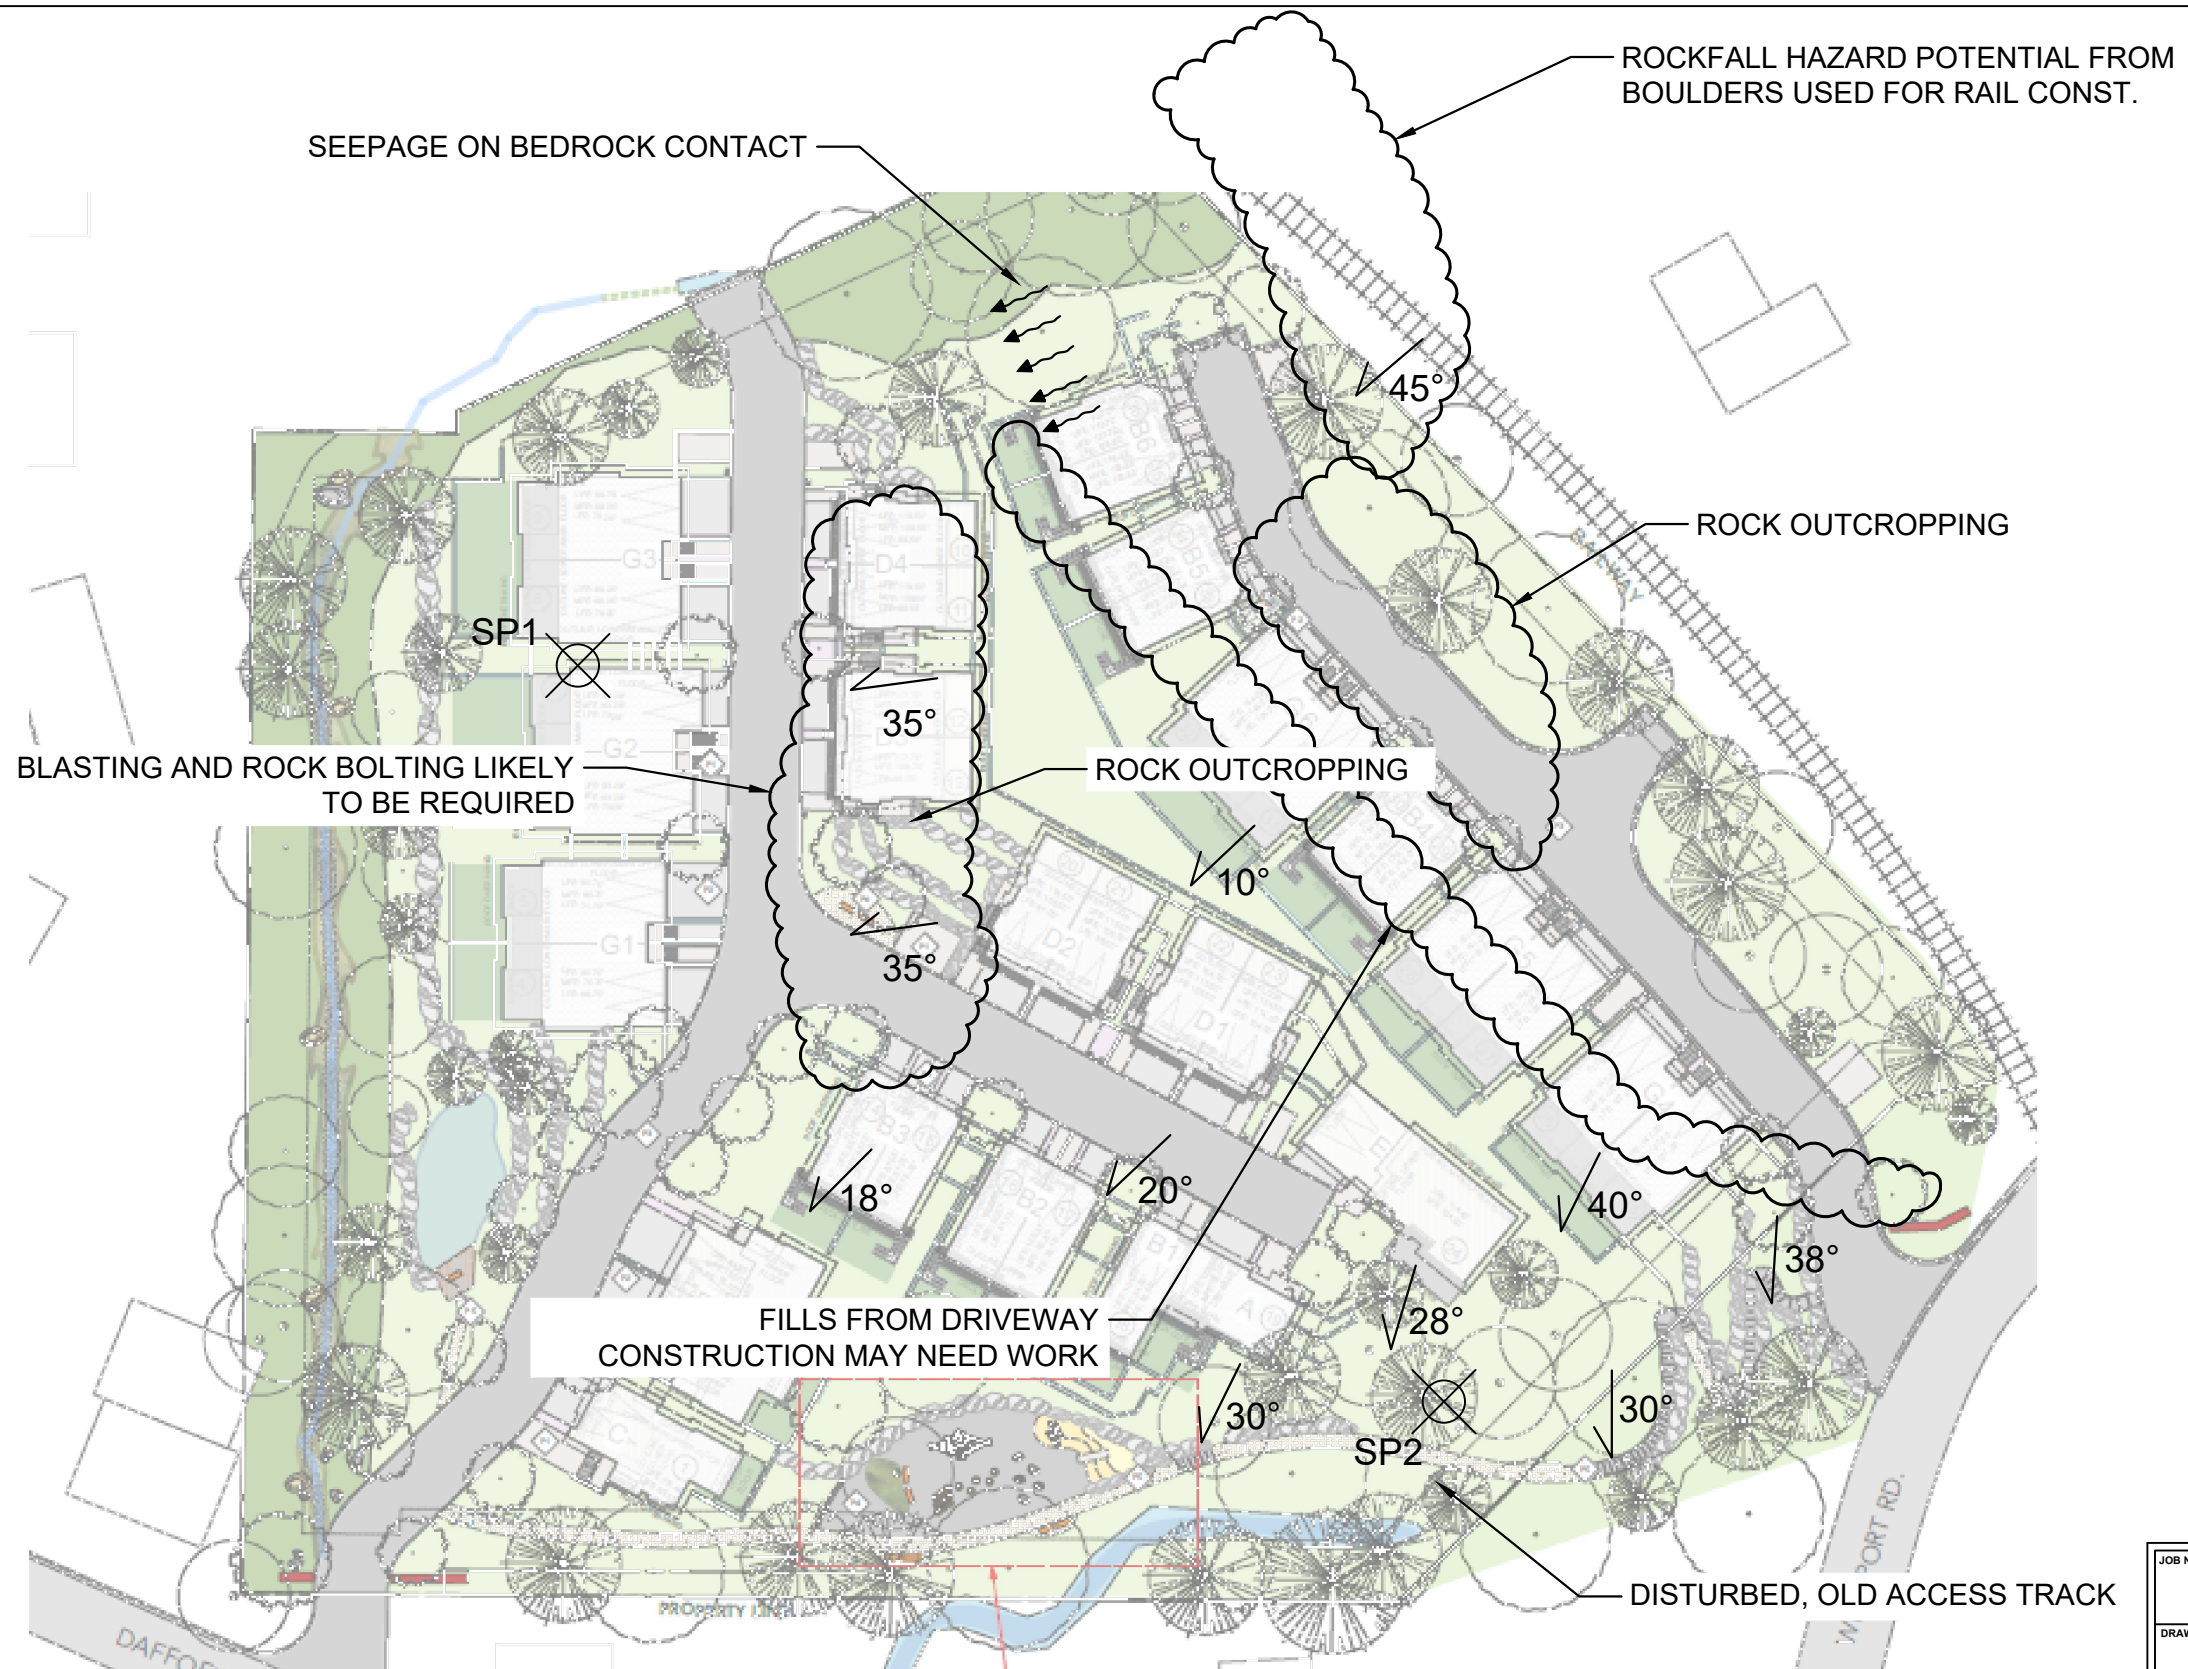
JOB NO: 1558	
DRAWING NO: 1558-1	
SCALE: NTS	DATE: MARCH 10, 2020
DRAWN BY: RB	DESIGNED BY: DS
CHECKED BY: SF

Steeper terrain, defined as greater than 35 degrees, was generally isolated to natural rock-outcropping or disturbed ground related to the BC Rail Line or existing roadway from Westport Road. No active or historic evidence of landslide were noted. Surficial soil creep was evident in juvenile and mature trees across the slope.

Rock outcrops were noted on proposed Lot's B5, B6, G6, B4, G5, G4, D4, D3, B3. The rock can generally be described as blocky with several persistent joint sets with a possibility for toppling on west aspect cuts. No major rock instability was noted at the time of the review.

Persistent groundwater seepage was noted at the bedrock contact in the northern corner of the property adjacent to a small creek (north side of proposed Lot B6).

A summary of the field review observations are provided on a marked up plan of the proposed sub-division on Drawing 1558-1 following the text of this report.

Relevant notes from the site reconnaissance are provided on Drawing 1558-1 including the identification of an area of groundwater seepage, rock-outcropping and areas that may provide a potential rockfall hazard for the proposed development.

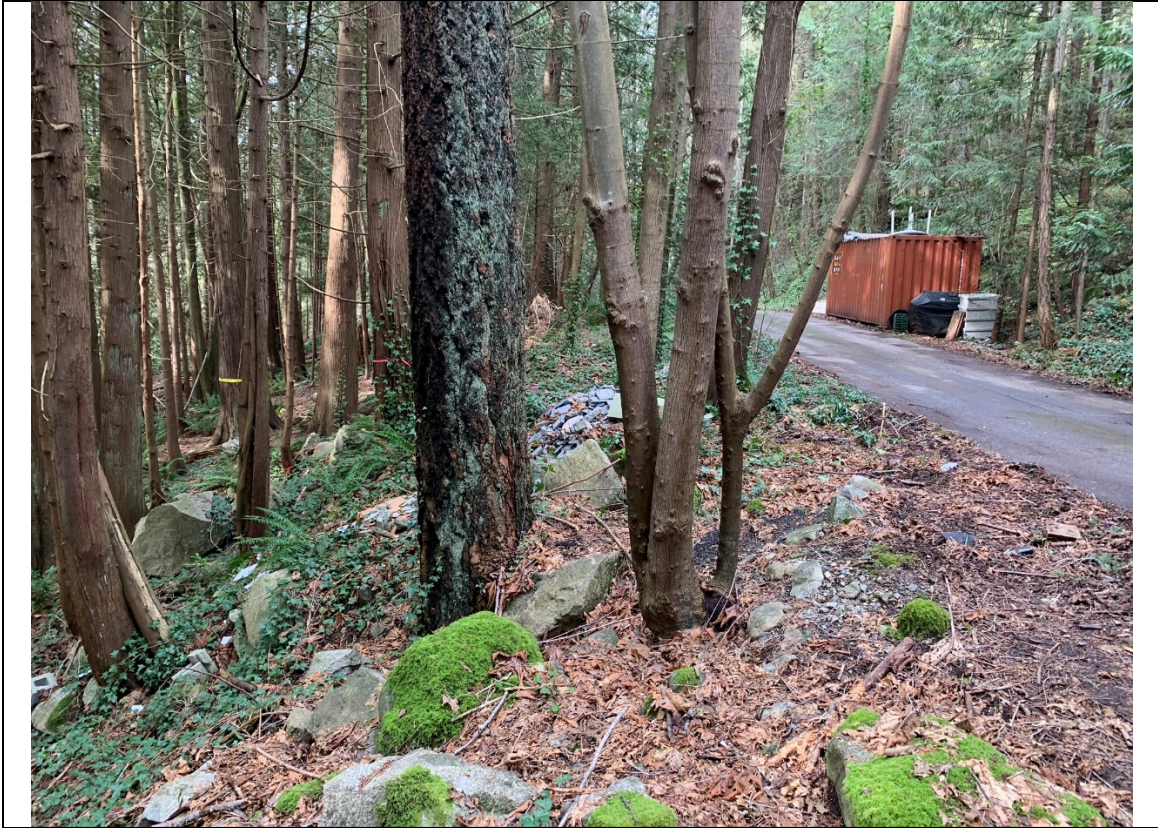
Slope beneath the driveway off Westport Road, looking northwest

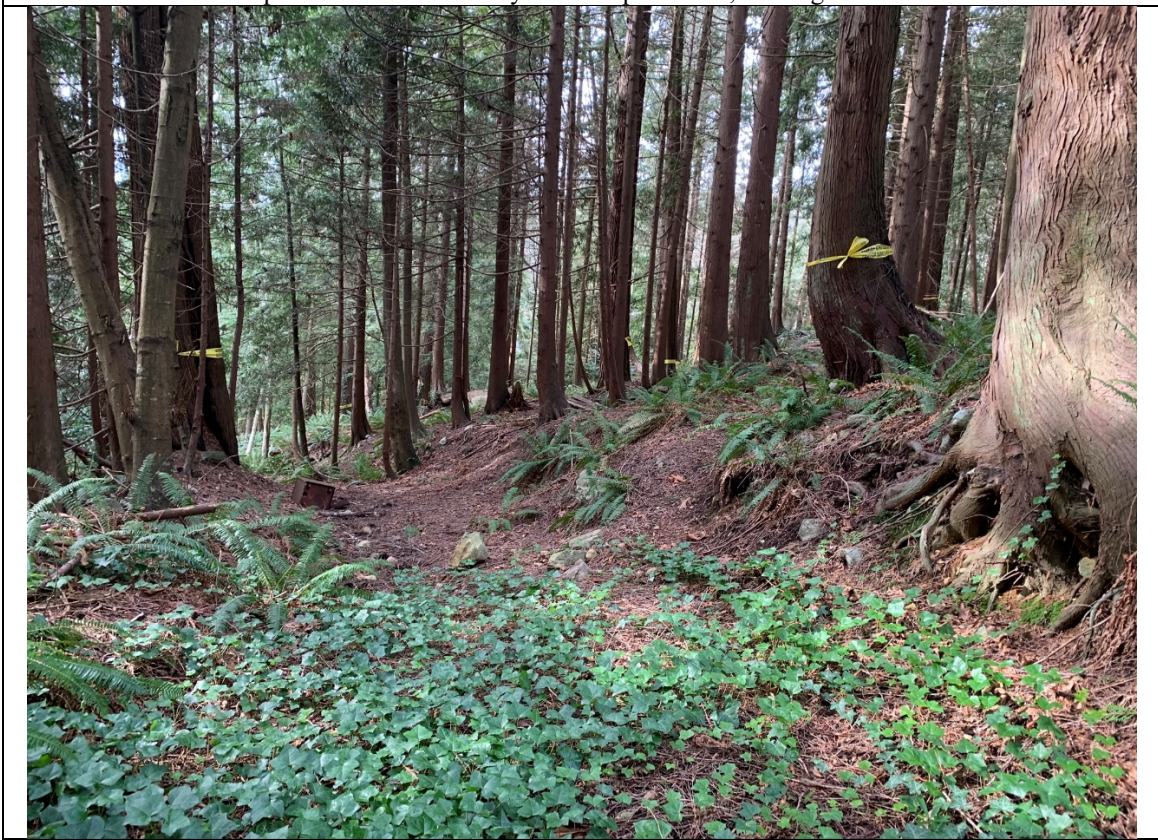
Pistol-butting of mature Cedar indicating shallow surface creep

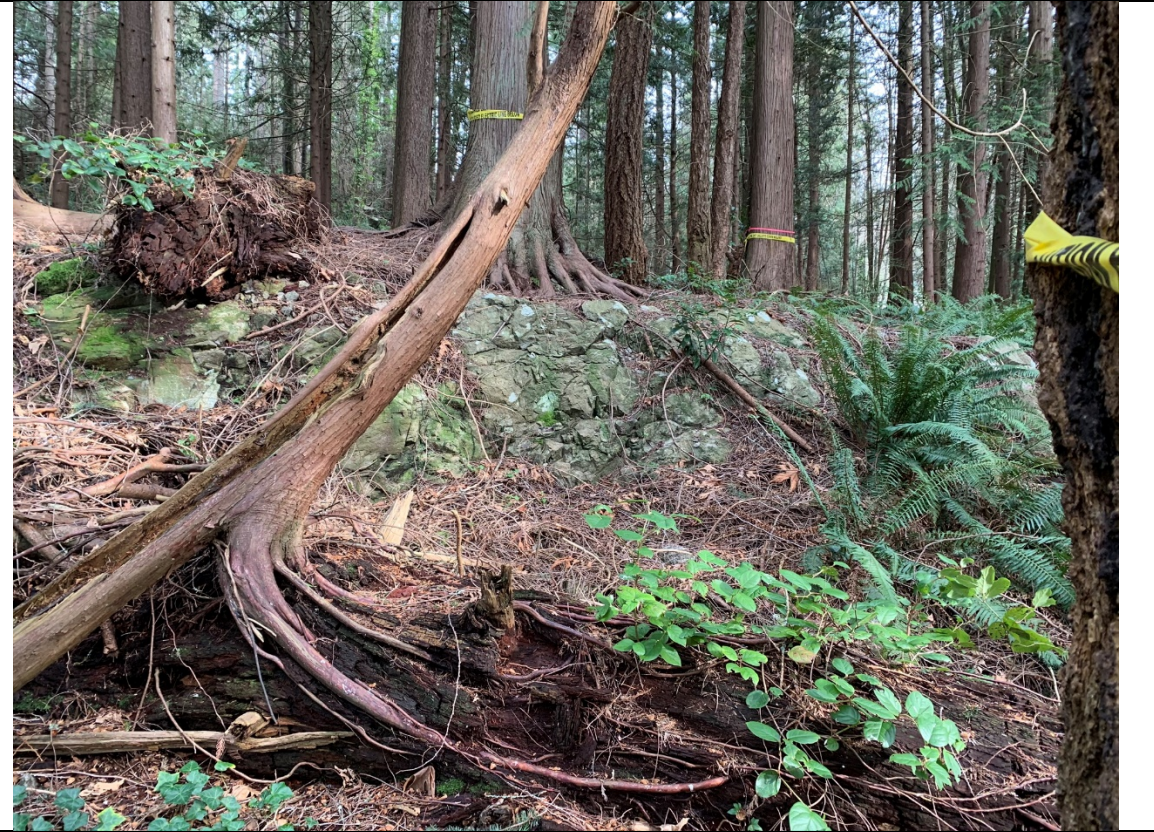
The rock outcrops also lie within the proposed alignment for the roads into the development via Westport Road and Daffodil Drive.

Rock-outcropping upslope of proposed road from Daffodil

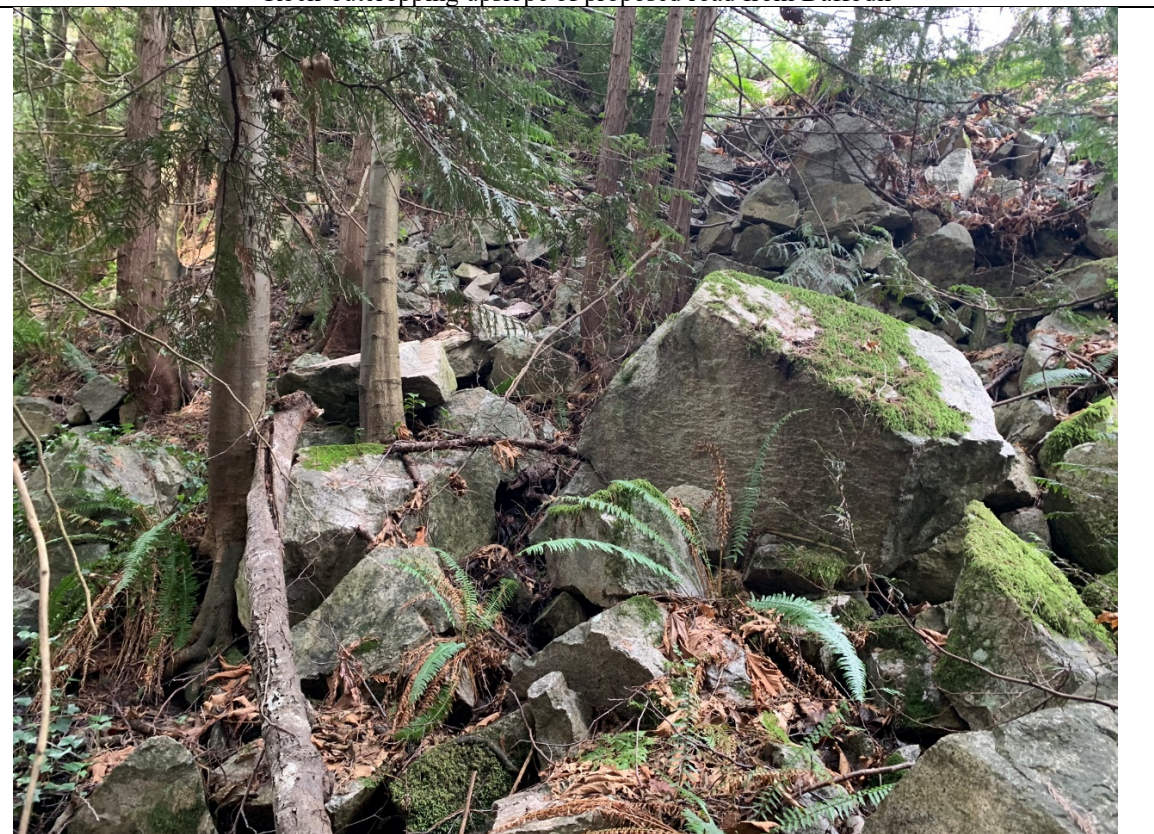
Shot rock forming the southwest embankment of the BC Rail line on the upslope side of the proposed development is sloped at approximately 45 degrees.

Rockfall hazard potential from BC Rail construction

Once grades and rock cut depths have been finalized, we recommend that the rockfall risk is reviewed and that recommendations are provided with respect to rockfall mitigation as required during the detailed design phase of the subdivision.

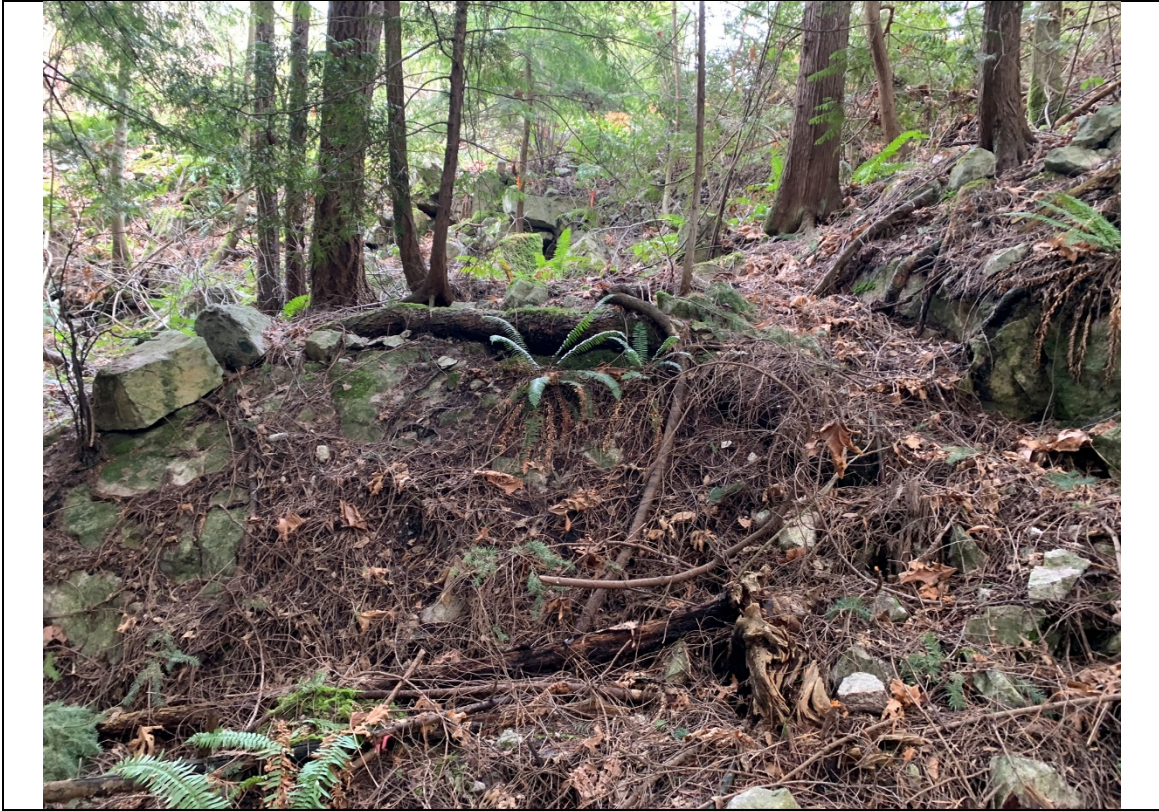
Rock outcropping Lot 4.

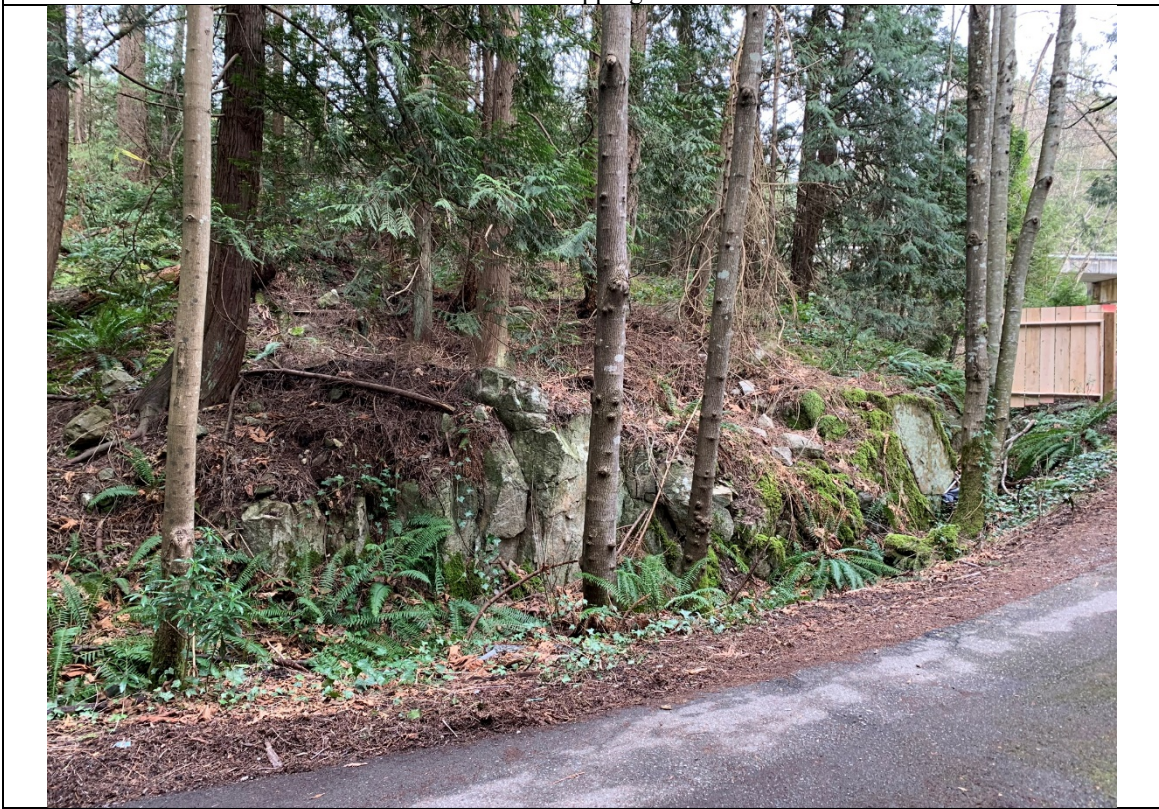
Rock outcropping Lot 5, entrance from Westport Rd.
