DISTRICT OF WEST VANCOUVER
750 17TH STREET, WEST VANCOUVER BC V7V 3T3

COUNCIL REPORT

Date:	January 20, 2026
From:	Matthew O'Connor, Bylaw and Licensing Services Manager
Subject:	6507 Nelson Avenue – <i>Community Charter</i> Remedial Action Requirement

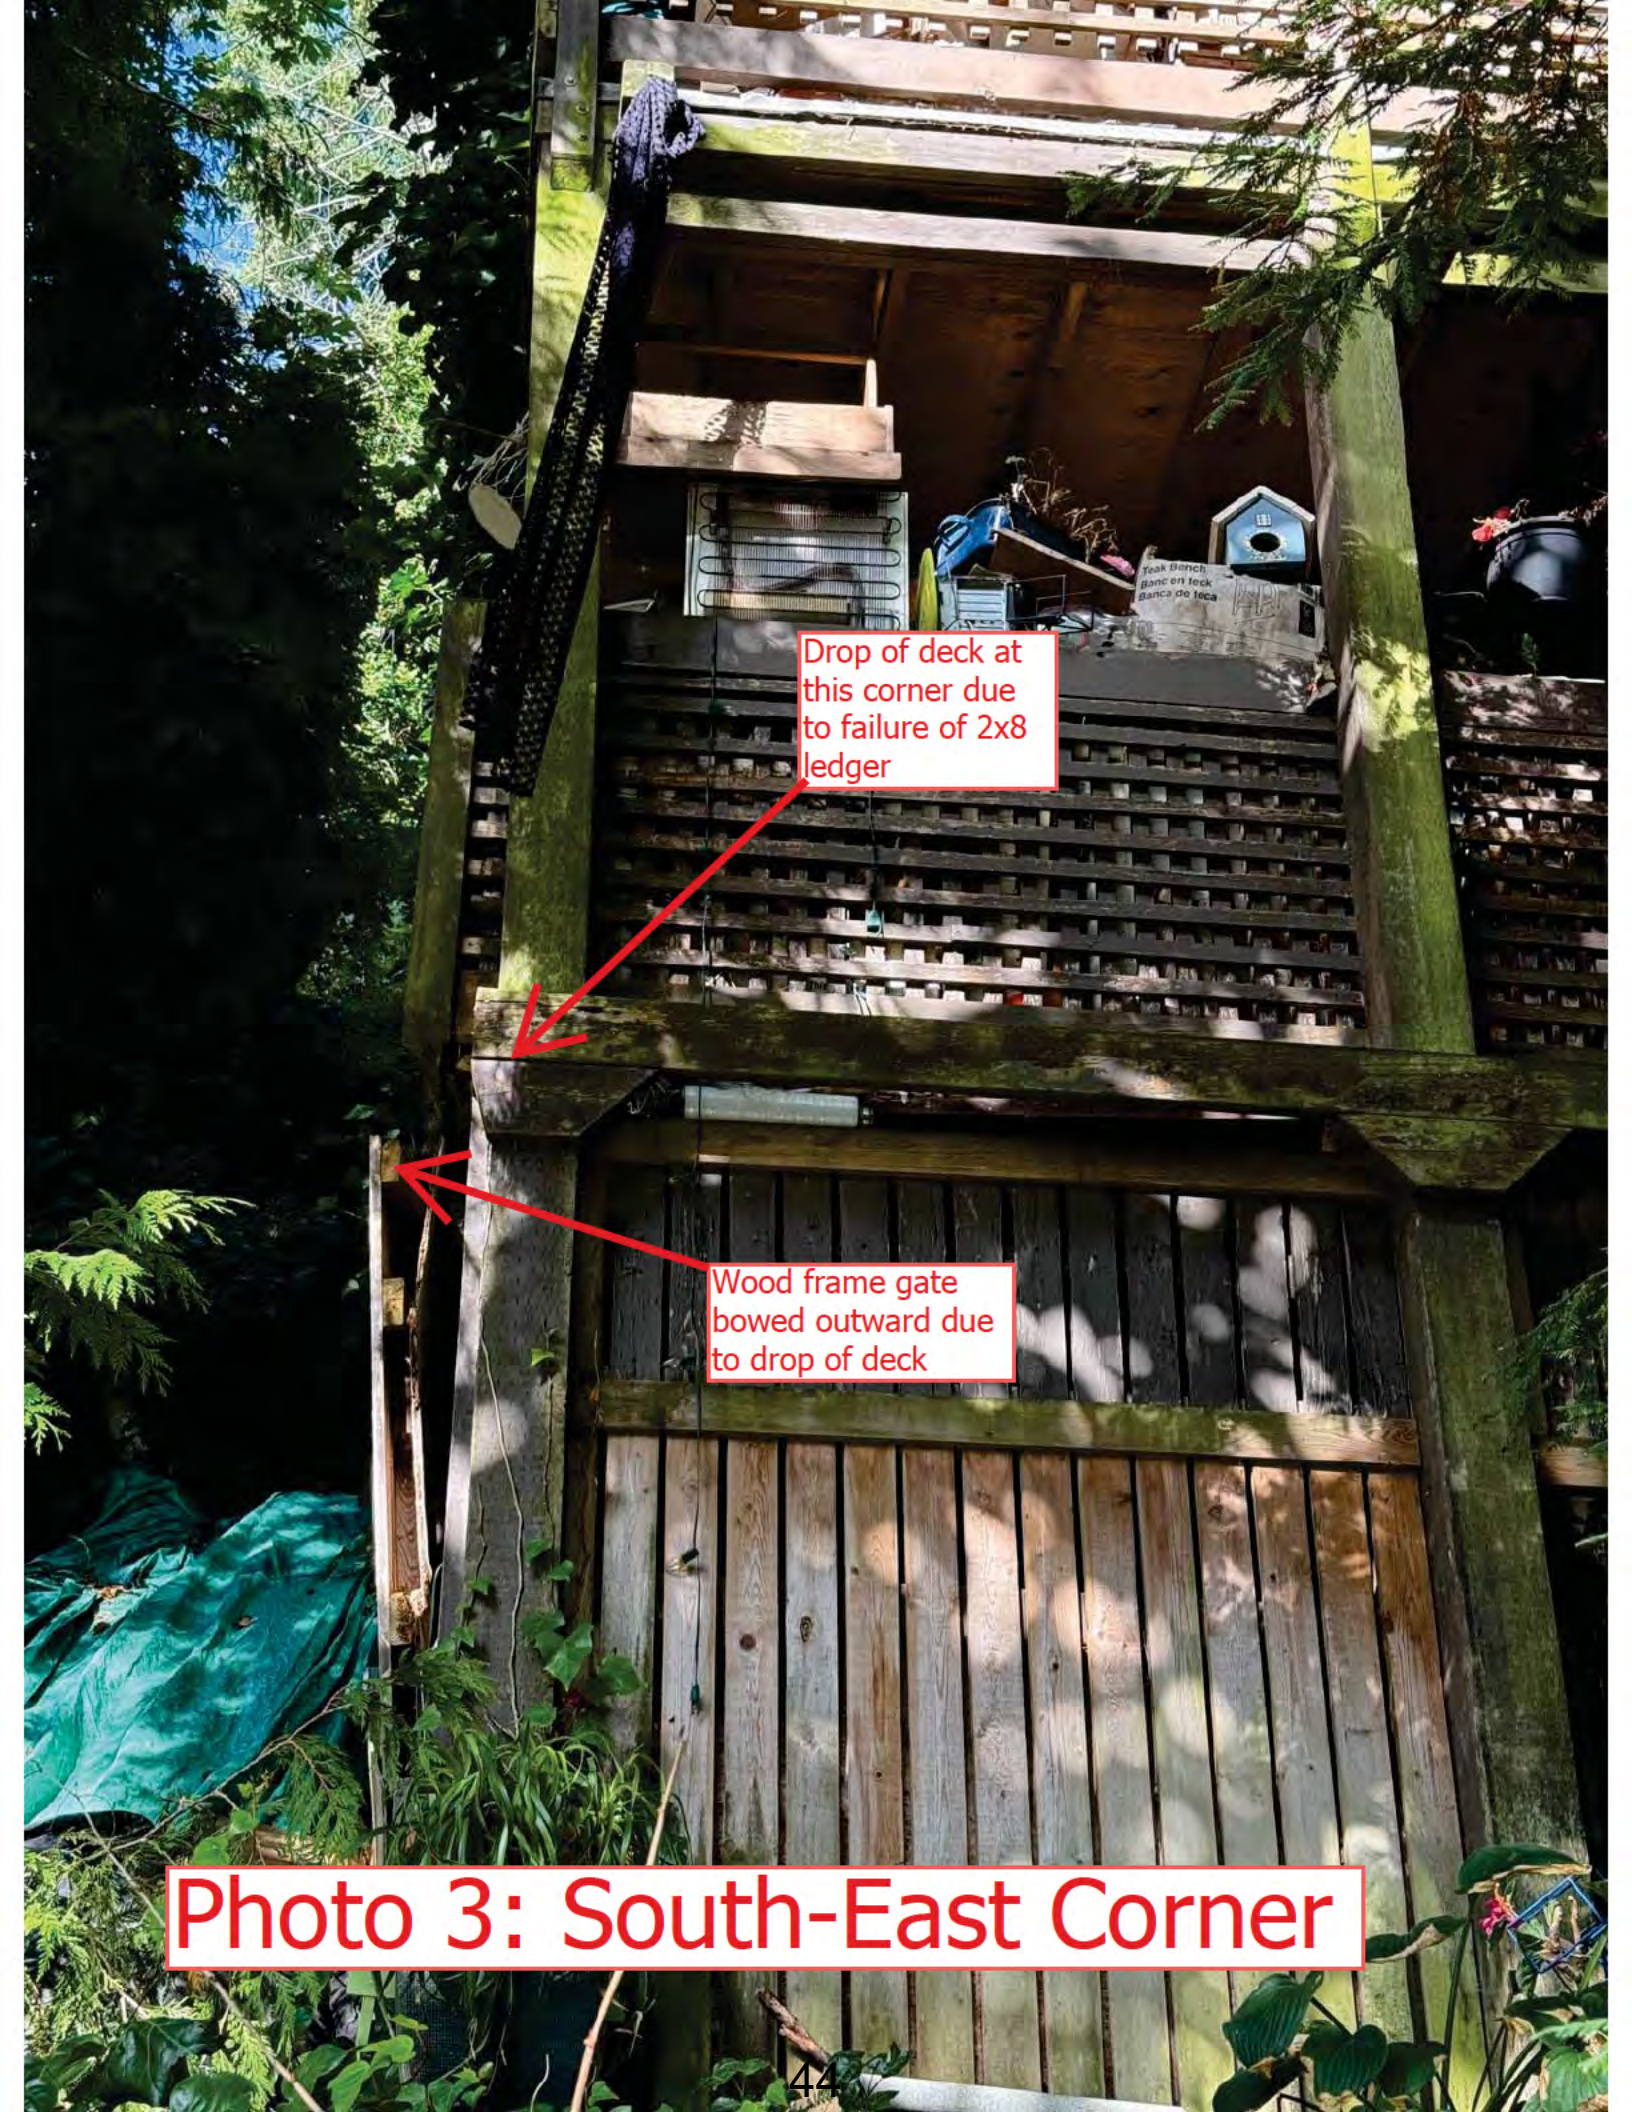
Photo 2: Base of Stair

1. The stairs were fully covered and loaded with a significant amount of household items that had to be climbed over to access the deck and entrance into the building (see Photo 1)
2. The 2x12 stair stringer that could be seen showed significant signs of rot and simple probe testing with an awl confirmed that the wood fibers have decomposed to a compromised state, indicating a possible structural failure under an occupancy live load of 40 pounds per square foot as per the British Columbia Building Code 2024 ("BCBC") (see Photo 2)
3. The exposed ends of double 2x6 stair treads that could be seen displayed significant signs of rot confirmed by probe testing indicating a possible structural failure under live load as per the BCBC (see Photo 2)

Wood rot of 2x6 stair tread

Wood rot at base of 2x12 stringer

Conclusion: The exterior stairs are structurally compromised and present a hazard, and access must be restricted. If required, temporary shoring should be installed so that all items can be removed from the stairs so that a full structural assessment can be made.

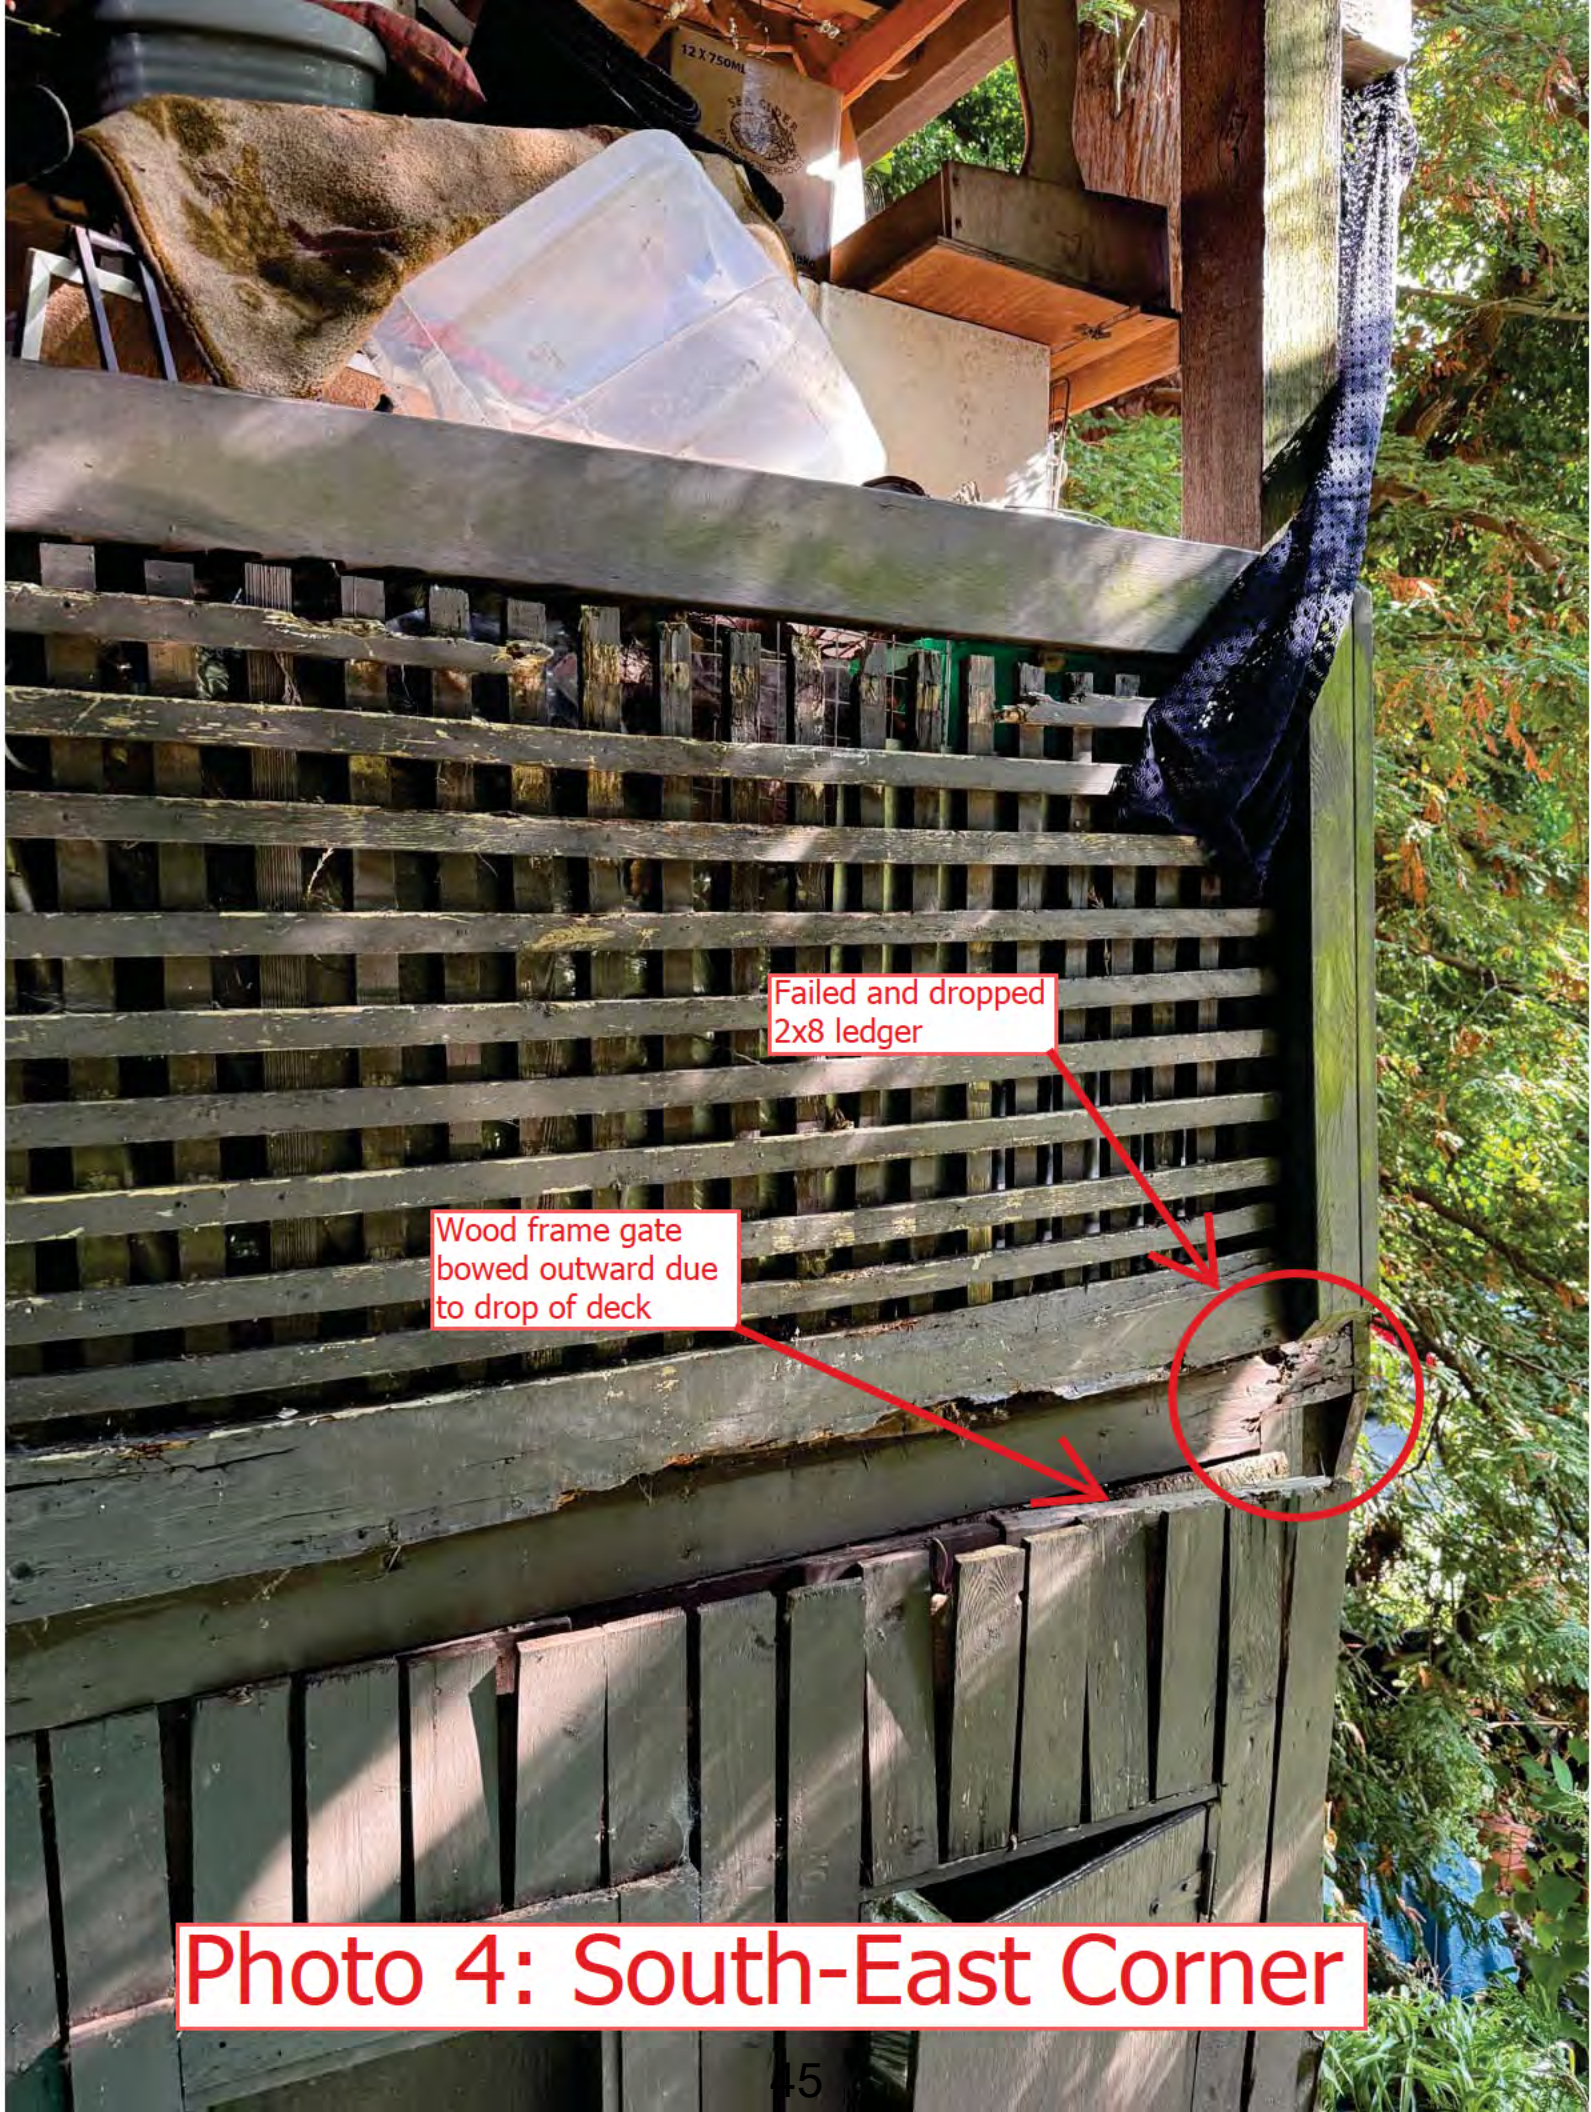
Photo 3: South-East Corner

1. The deck was fully covered and loaded with a significant amount of household items that had to be climbed over to access the entrance into the building located at the south end of the deck (see Photo 3)
2. Visible decay and shear failure of the 2x8 ledger supporting the 2x6 wood decking boards was noted at the south end of the deck (see Photos 4 and 5)
3. The south end of the deck has not failed because the failed 2x8 ledger is currently being supported on a non-load bearing wood frame gate that has noticeably bowed outward from the edge of the deck (see Photos 4 and 5)
4. The exposed ends of the 2x6 wood decking boards at the south end of the deck displayed significant signs of rot indicating a possible structural failure under live load as per the BCBC (see Photo 5)

Drop of deck at this corner due to failure of 2x8 ledger

Wood frame gate bowed outward due to drop of deck

Conclusion: The deck is structurally compromised and presents a hazard, and access must be restricted. If required, temporary shoring should be installed so that all items can be removed from the deck so that a full structural assessment can be made.

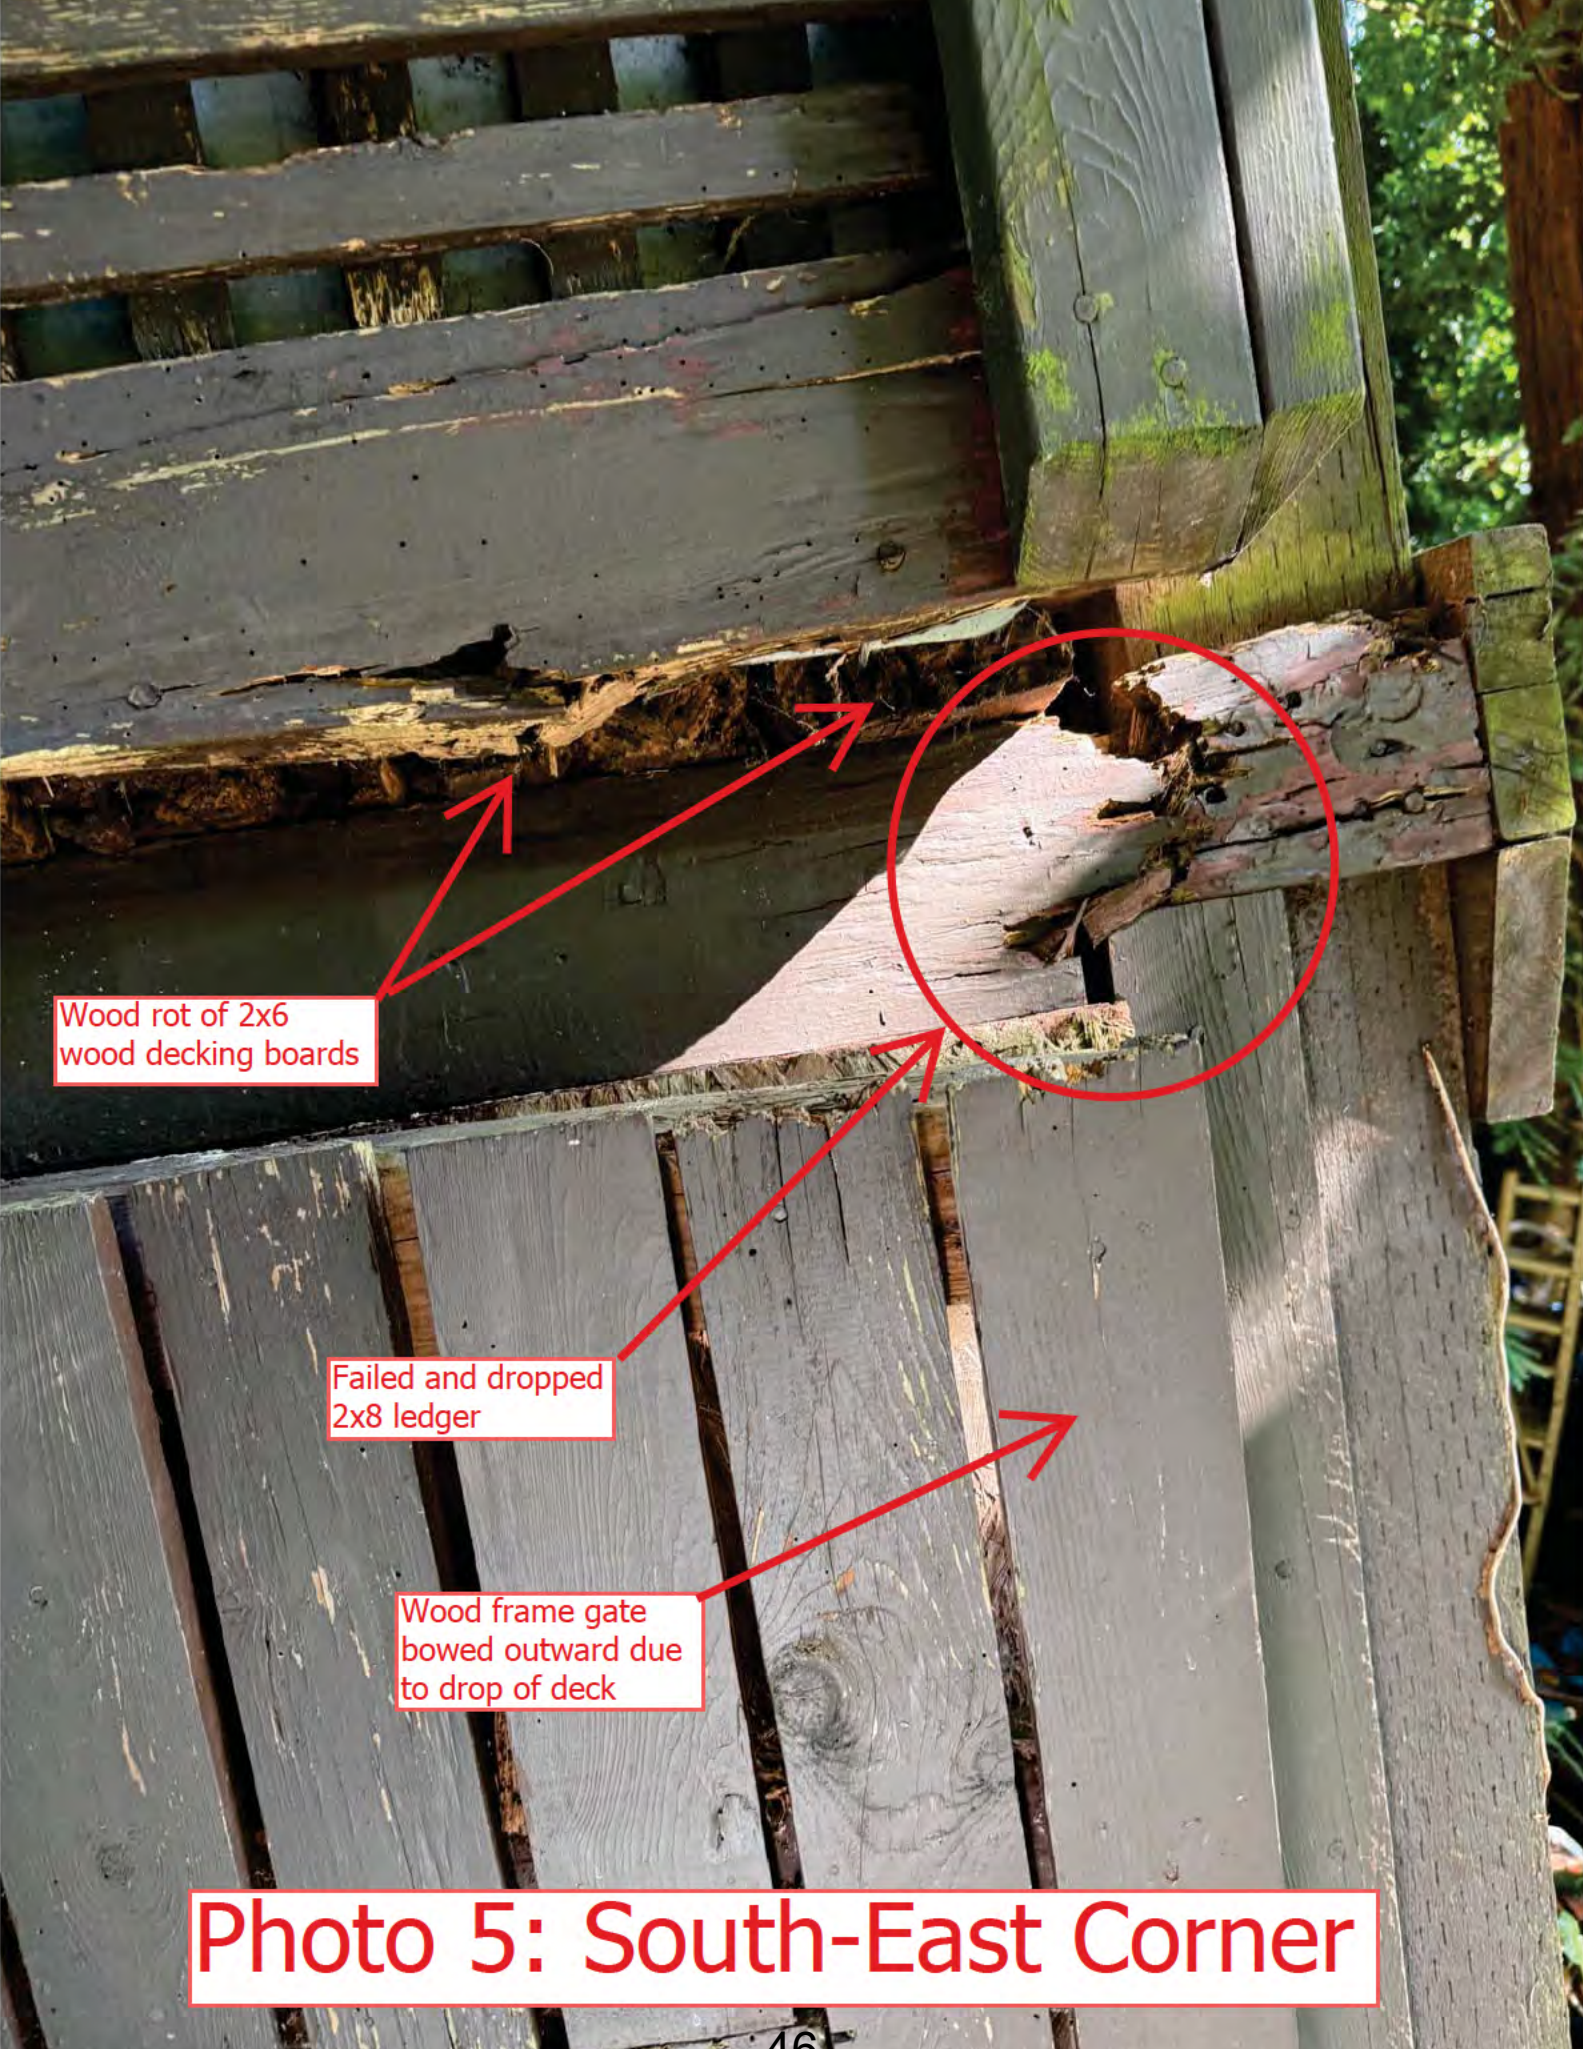
Photo 4: South-East Corner

Failed and dropped
2x8 ledger

Wood frame gate
bowed outward due
to drop of deck

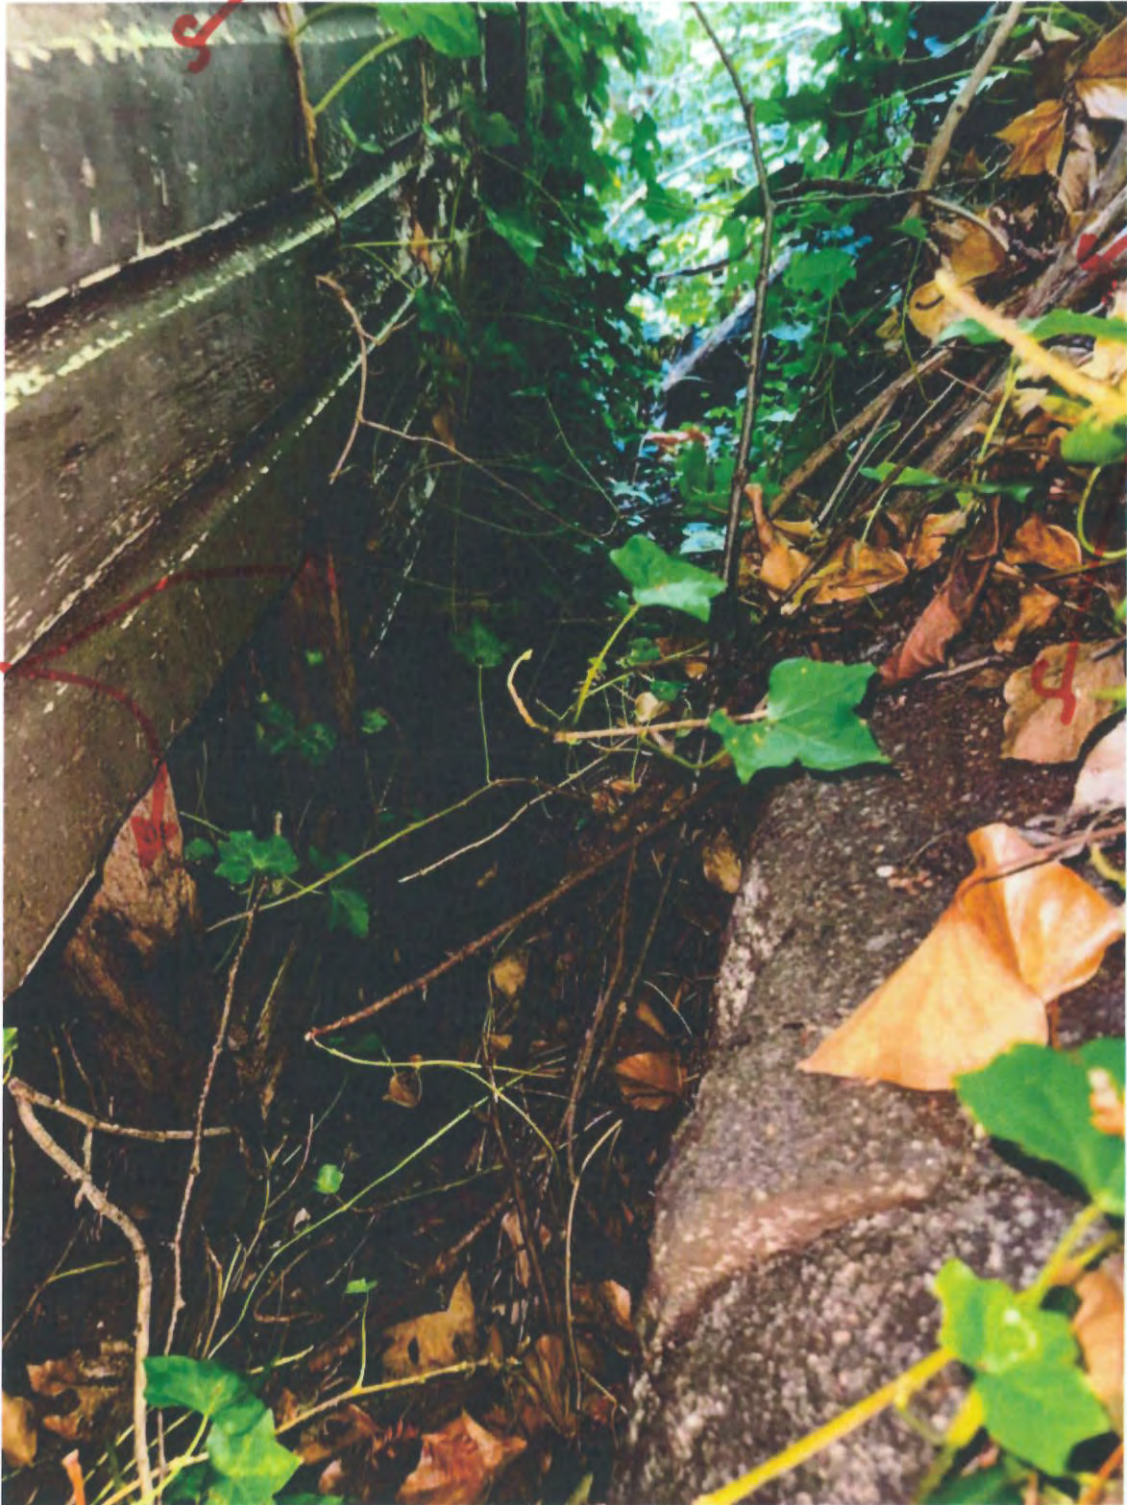
Photo 6 - LOOKING SOUTH

The rear load-bearing wood frame wall of the Building shows signs of visible decay of the studs and bottom plates, causing the wall to visibly drop and tilt horizontally outwards to the west, causing cracks in finishes on the interior side of the wall and the binding of an interior door.

DAMAGE
@ BASE
OF WALL

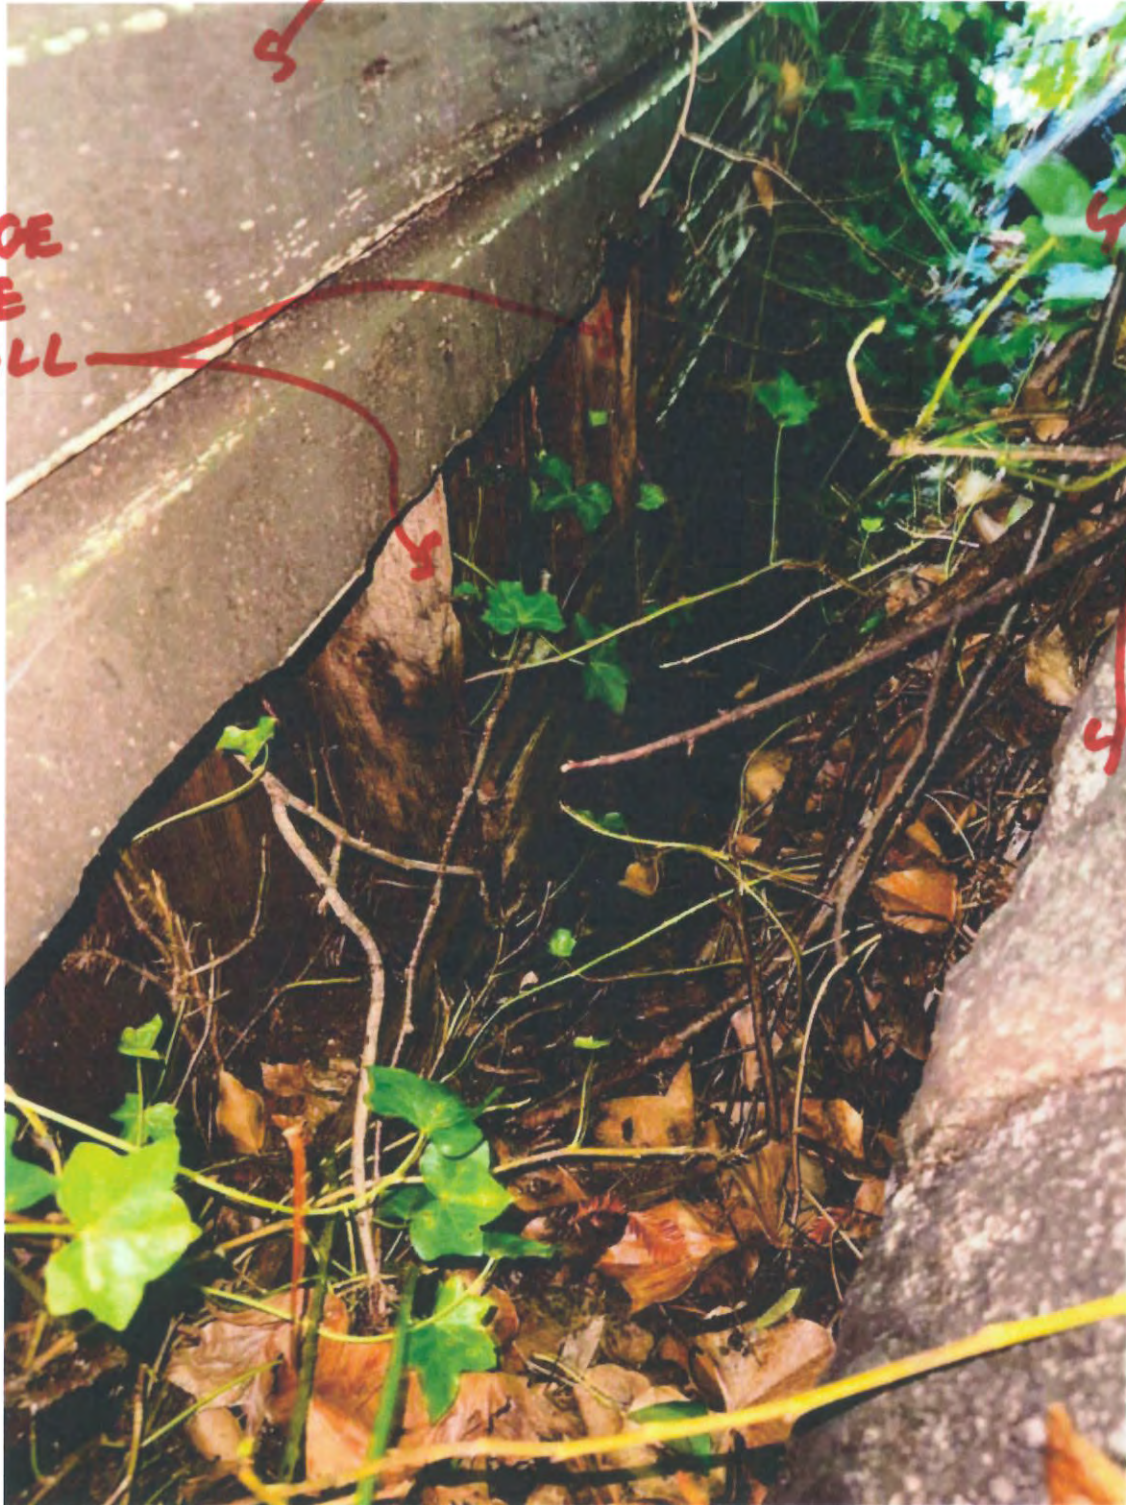
DAMAGE @ BASE OF WALL

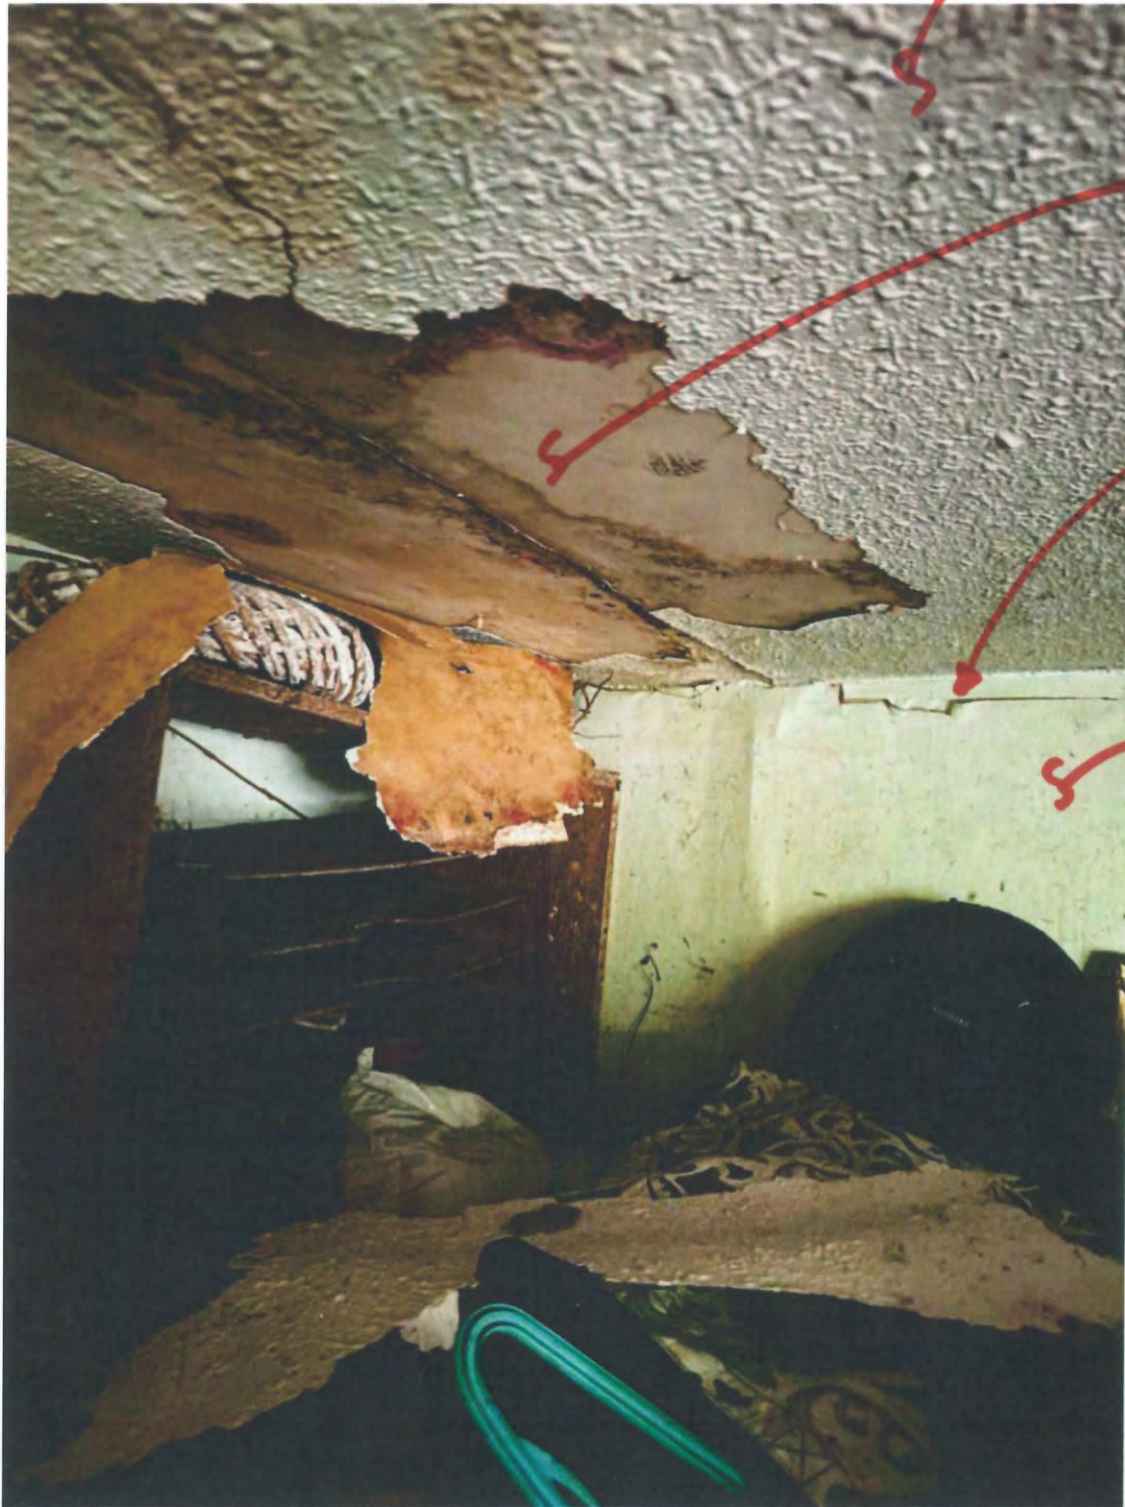
Photo 8 - LOOKING SOUTH

At points throughout the structure where the ceiling was compromised, there was observable water damage, indicating that the roofing membrane had previously failed and is potentially currently failing, causing concerns of ceiling failure.

FLAT WOOD-FRAME
CEILING

SIGNS OF
SIGNIFICANT
WATER
DAMAGE

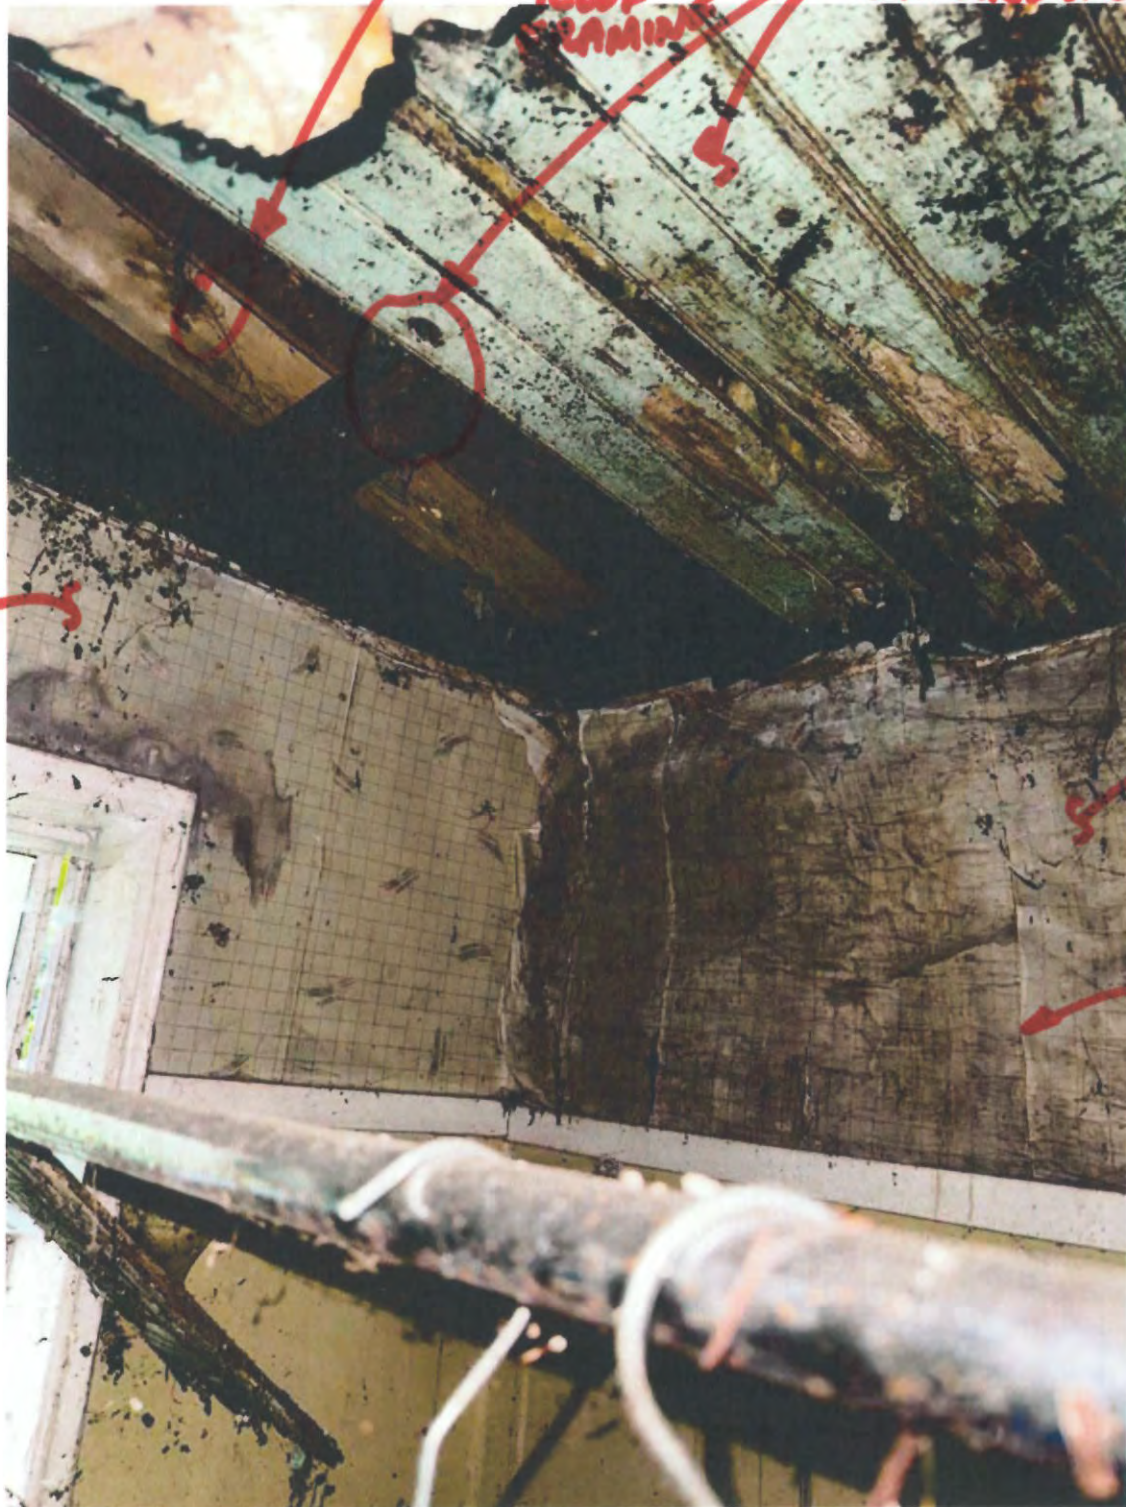
Photo 9 - LOOKING WEST

NEW PLYWOOD
ROOF SHEATHING
ON NEW
SLOPED
ROOF
FRAMING

ROTTEN WOOD-FRAME
CEILING & CEILING
FINISHES

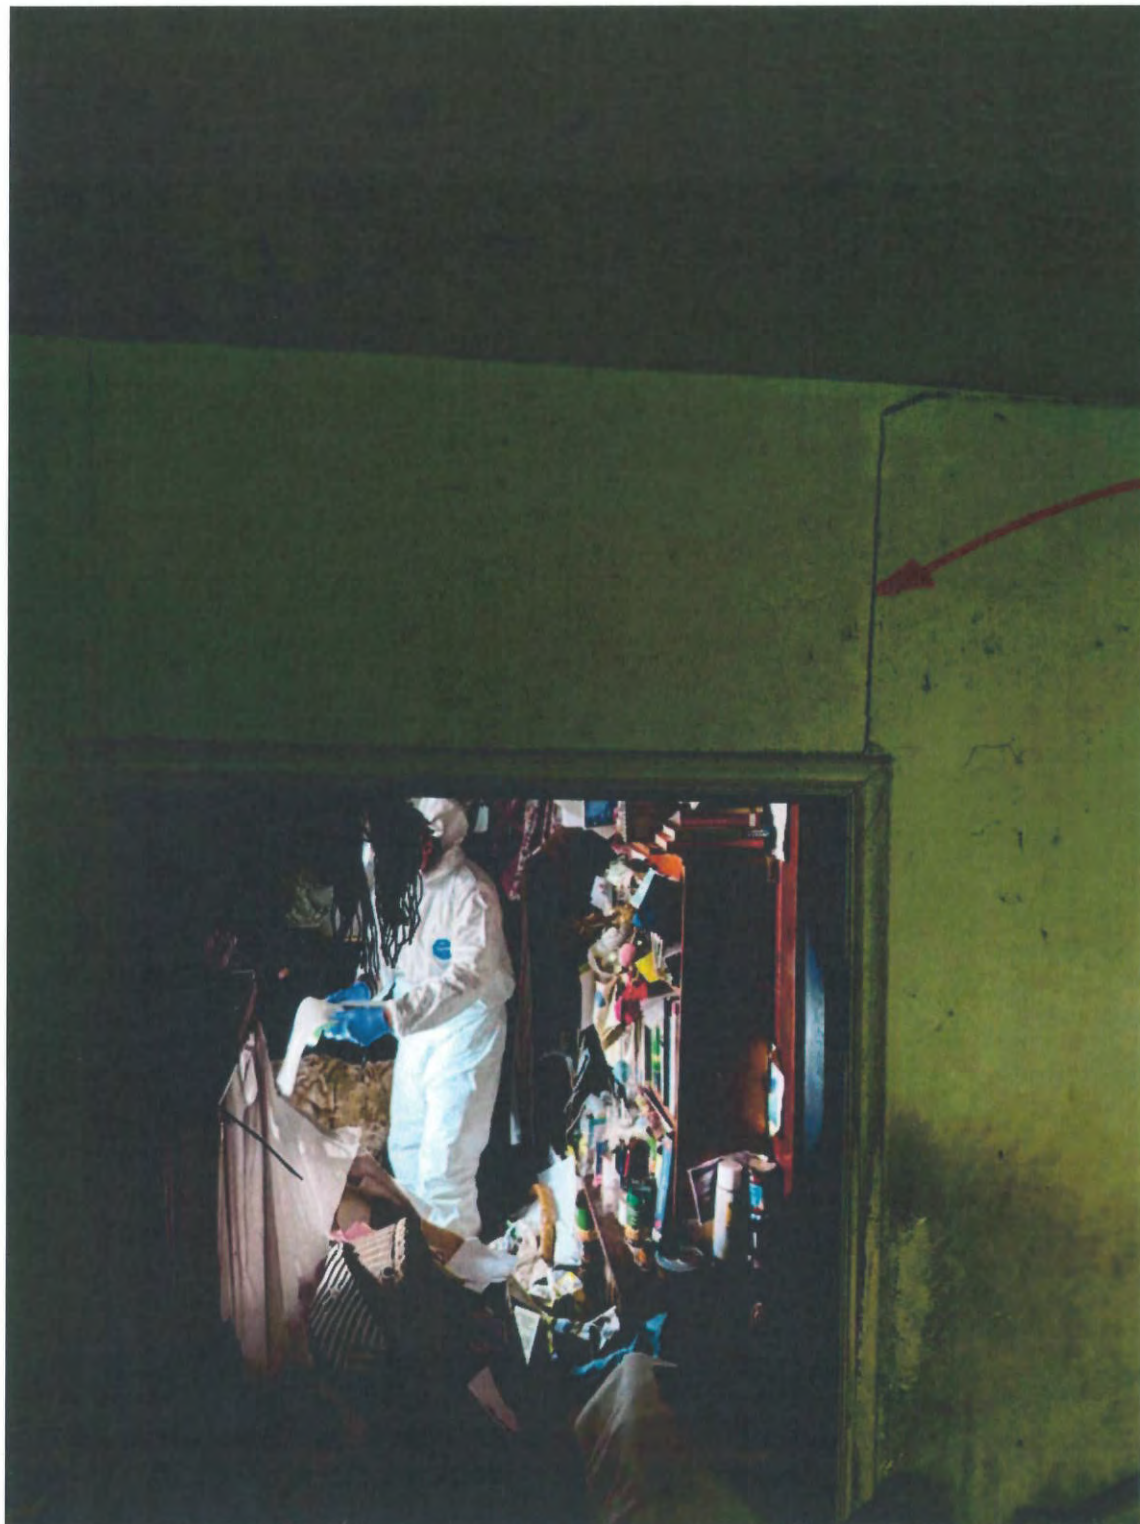
Photo 10 - AT 2nd FLOOR BATHROOM

CRACKING
DUE TO
BINDING
OF
INTERIOR
DOOR

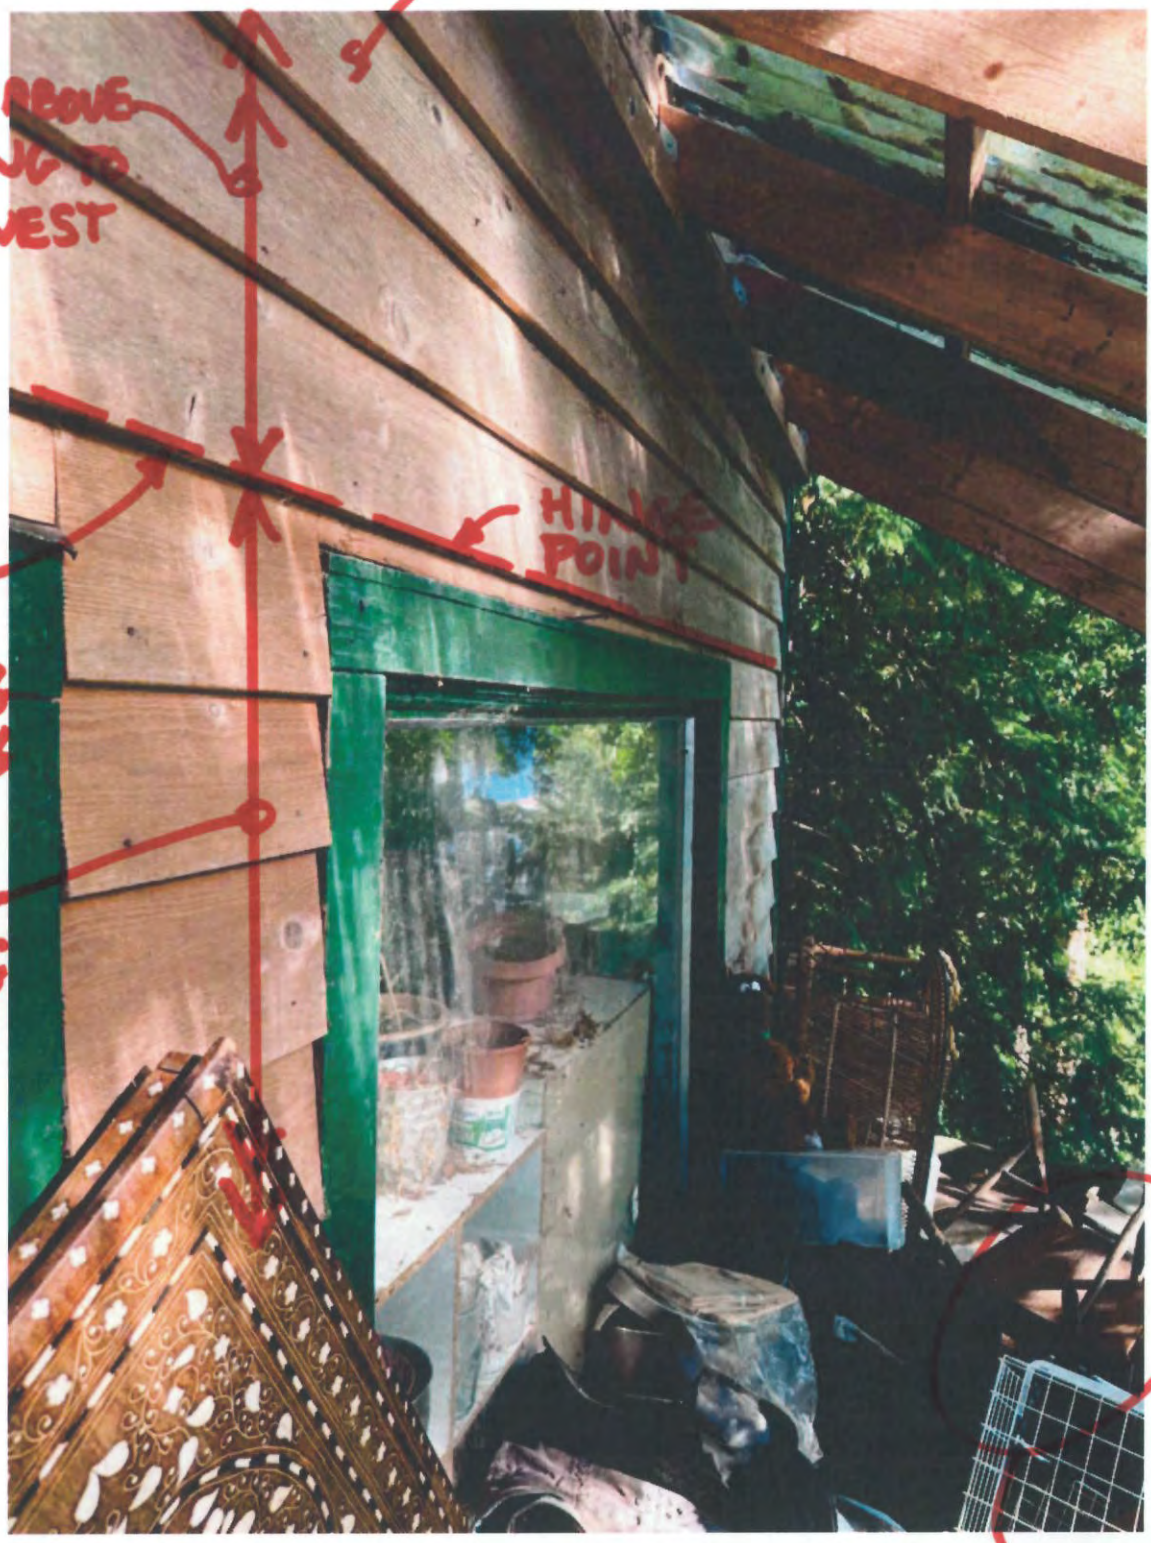
Photo 13 - LOOKING NORTH

WALL
TILTING
TO THE
EAST

HINGE
POINT

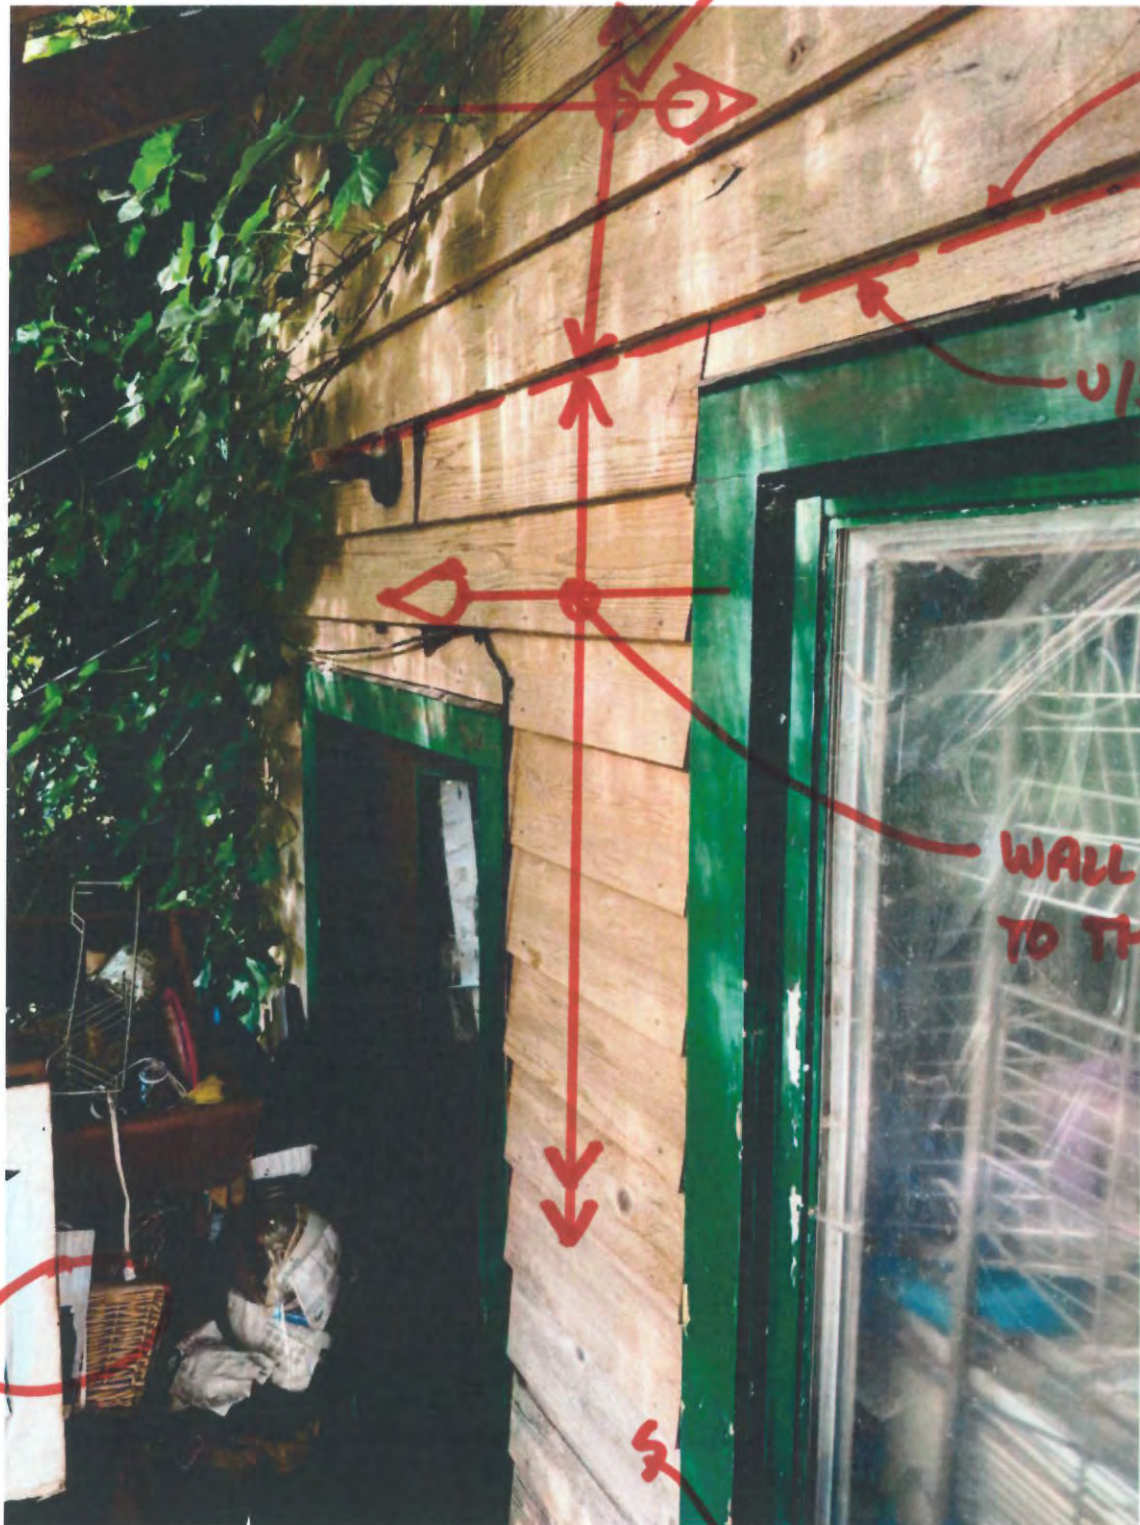
Photo 14 — LOOKING NORTH

DEBRIS ON
DECK

WALL TILTING TO THE WEST

HINGE POINT
