DISTRICT OF WEST VANCOUVER
750 17TH STREET, WEST VANCOUVER BC V7V 3T3

COUNCIL REPORT

Date:	January 20, 2026
From:	Matthew O'Connor, Bylaw and Licensing Services Manager
Subject:	6507 Nelson Avenue – <i>Community Charter</i> Remedial Action Requirement

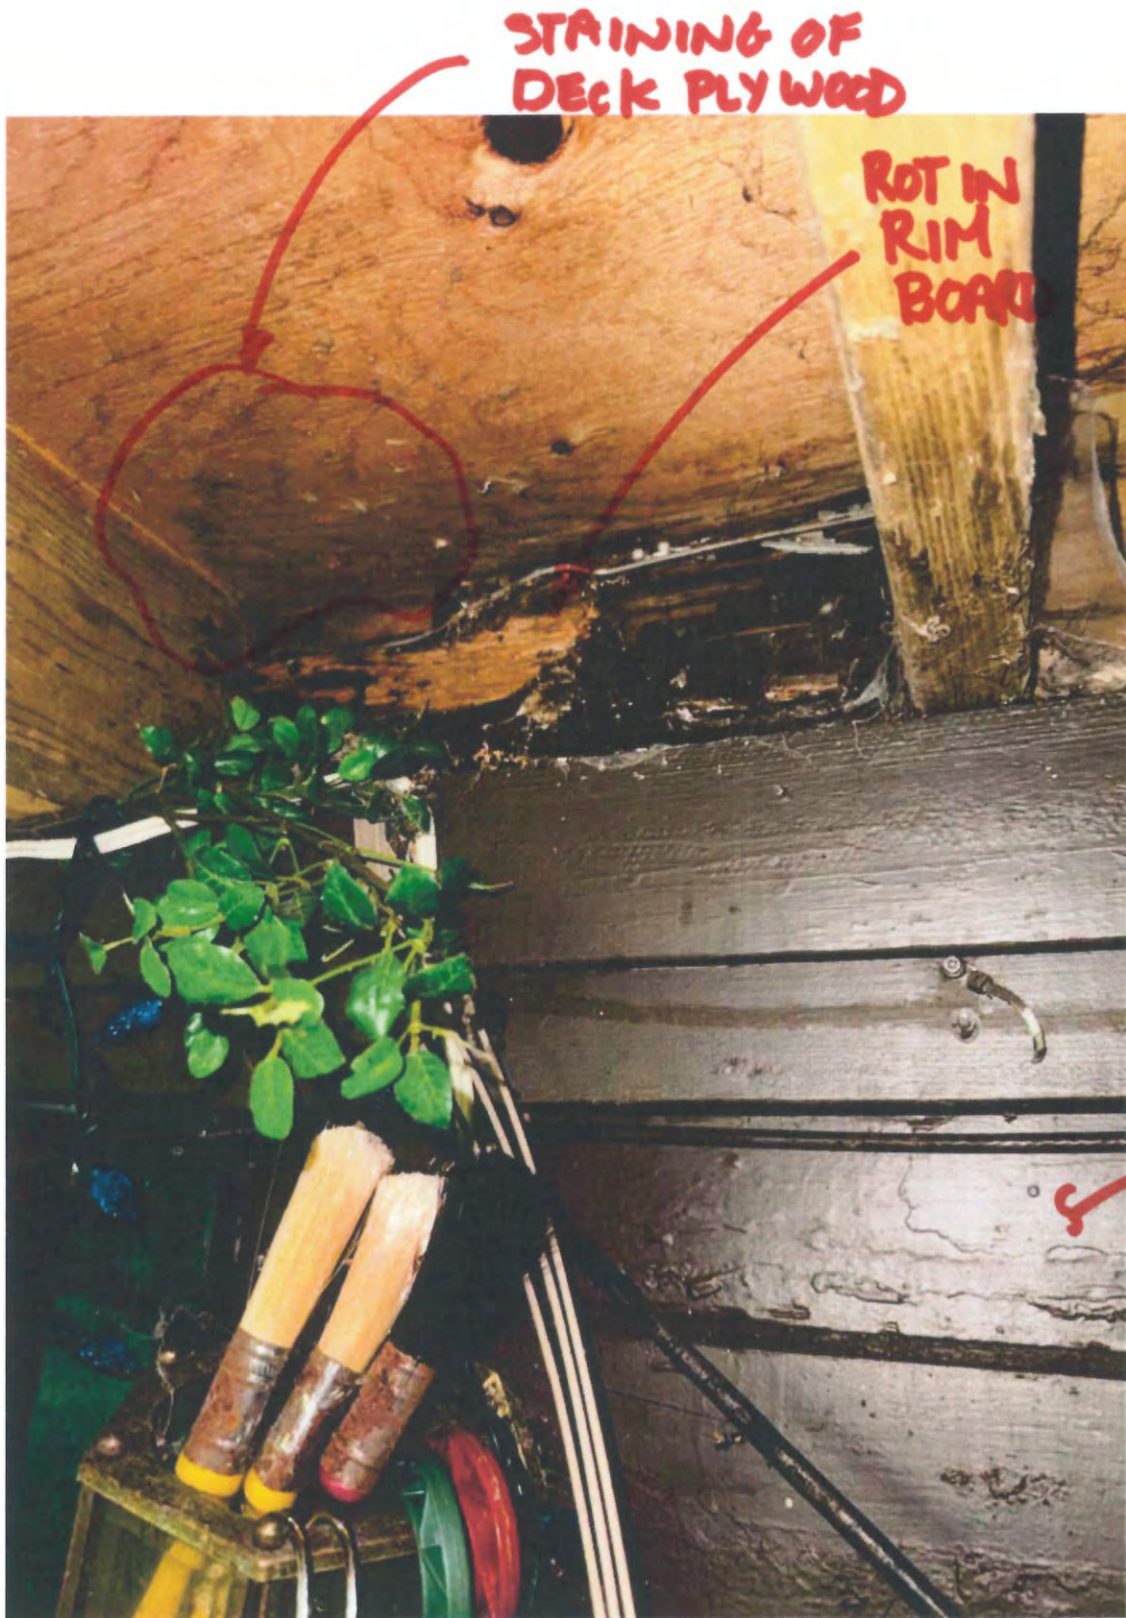
Photo 15 - Looking South

The front load bearing wood-frame wall of the building at the main and second floor levels, exhibits signs of settlement and horizontal movement that are likely due to advanced rot at the base of the wall and at the second floor rim board.

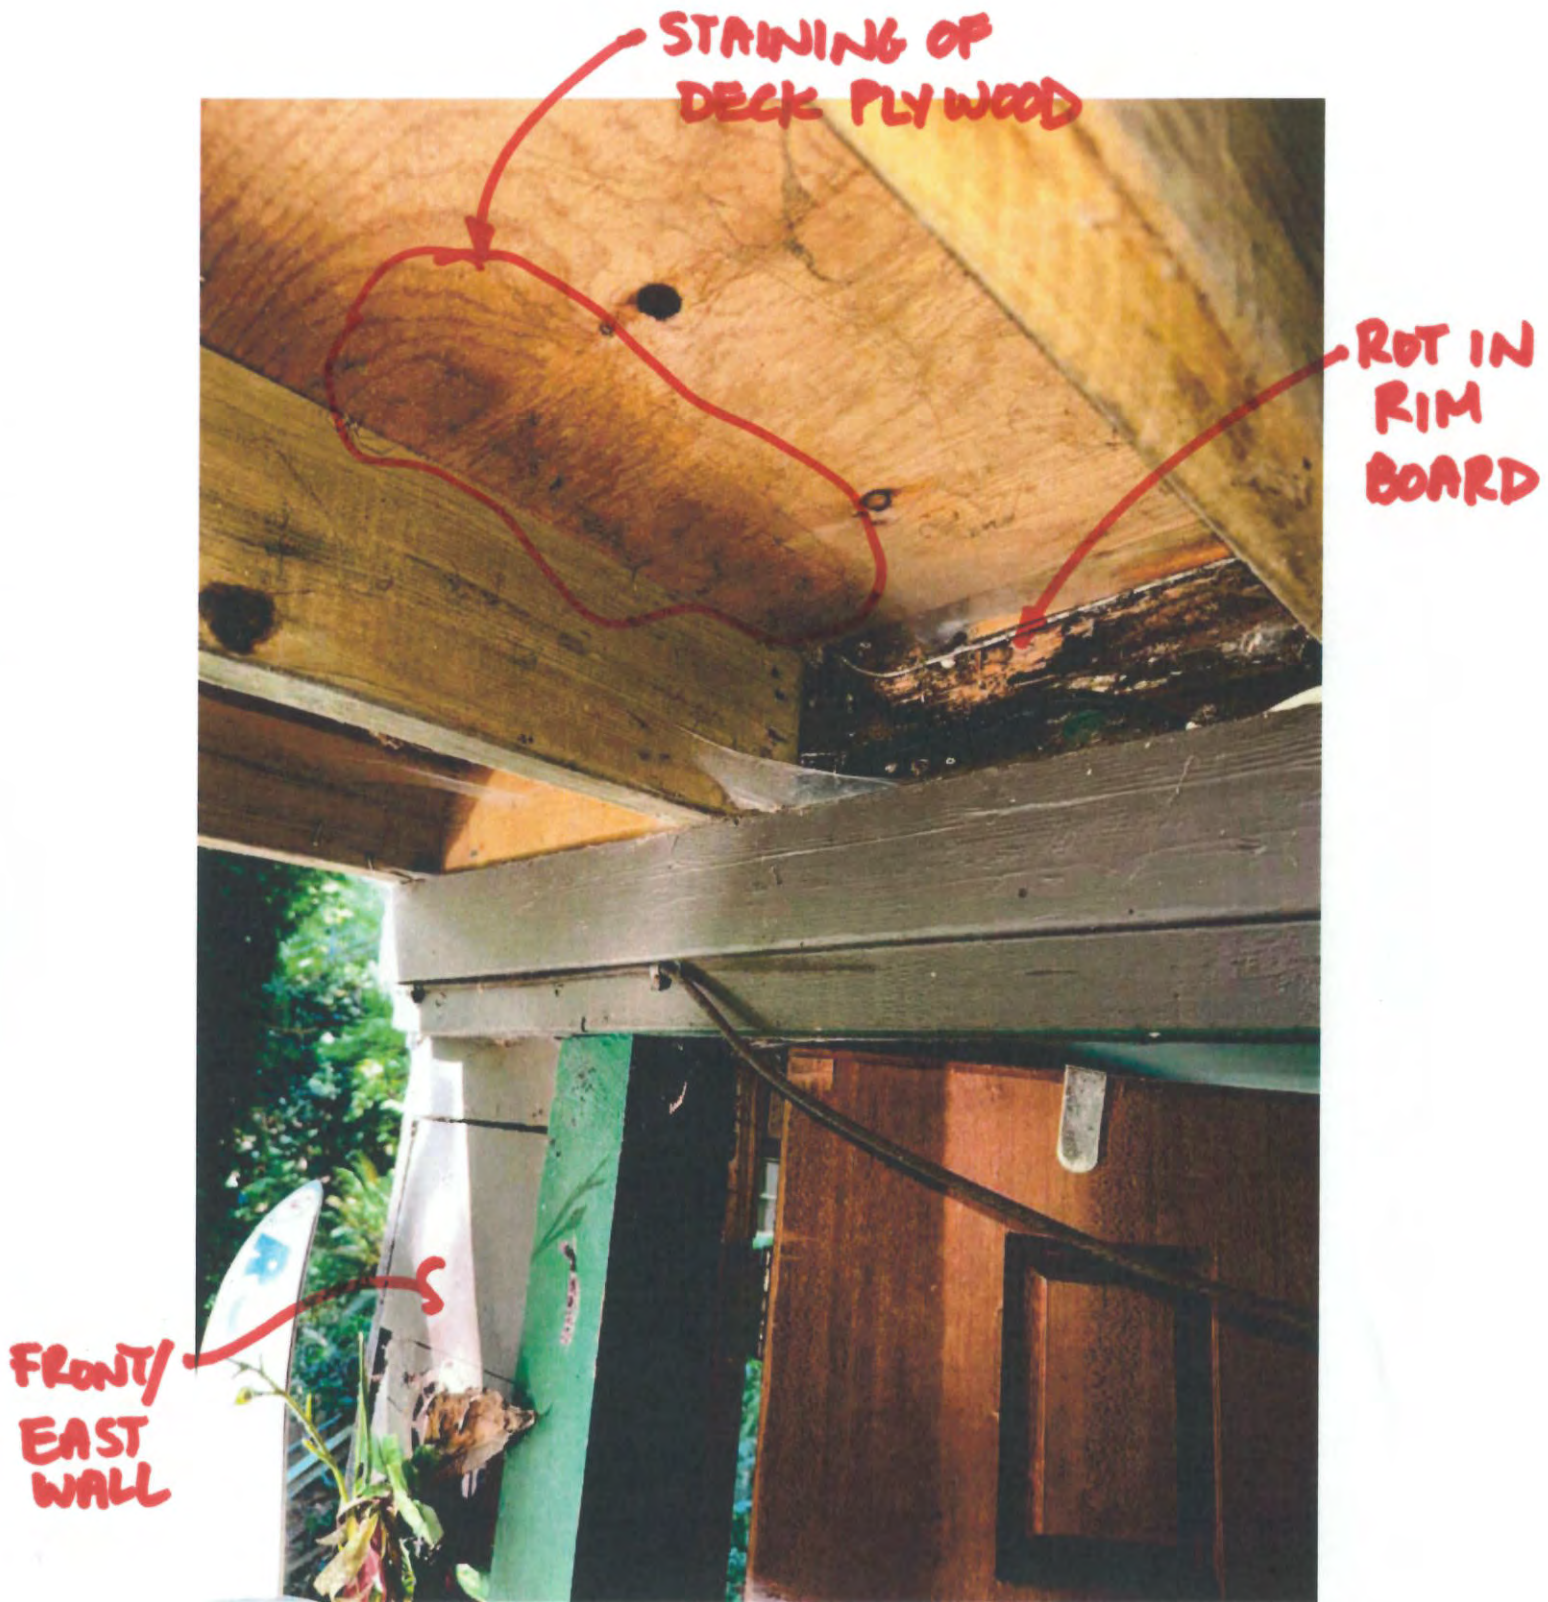
Photo 16- LOOKING WEST

2nd FLOOR DECK & RIM BOARD

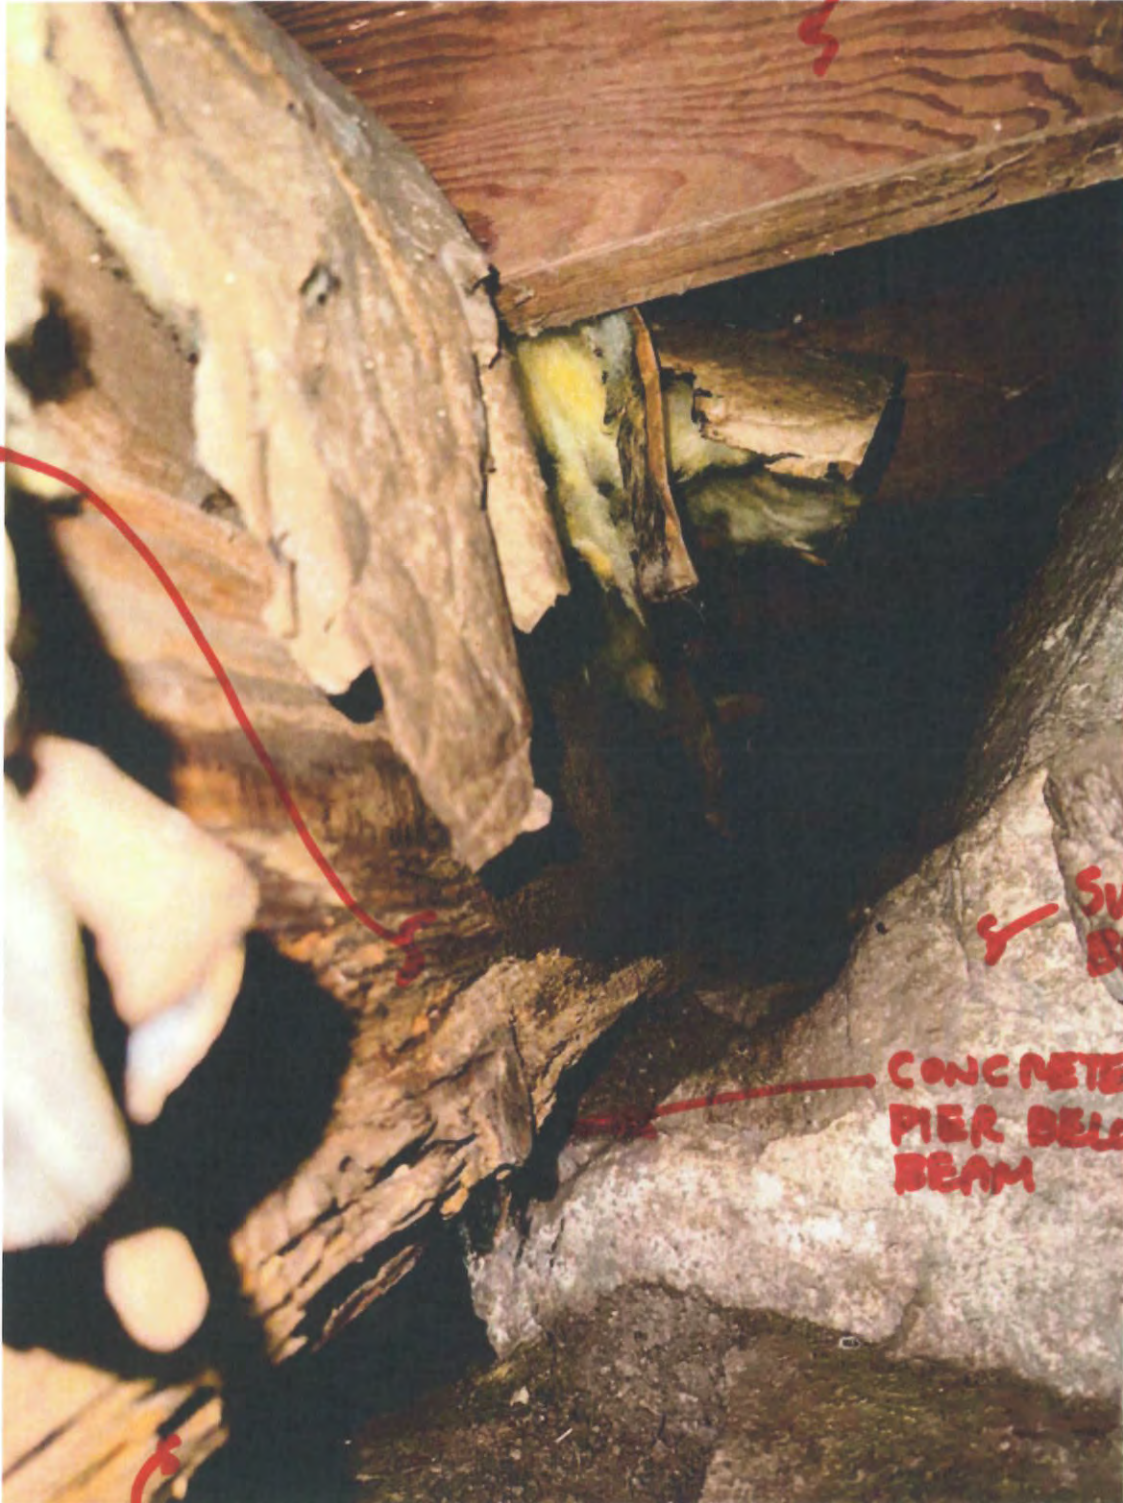
Photo 18- LOOKING SOUTH-EAST

6. Advanced rot of the central north-south wood beam supporting the main floor joists
7. Noticeable damage to the exterior brick chimney at the north side of the building

ROT IN
MAIN
FLOOR
BEAM

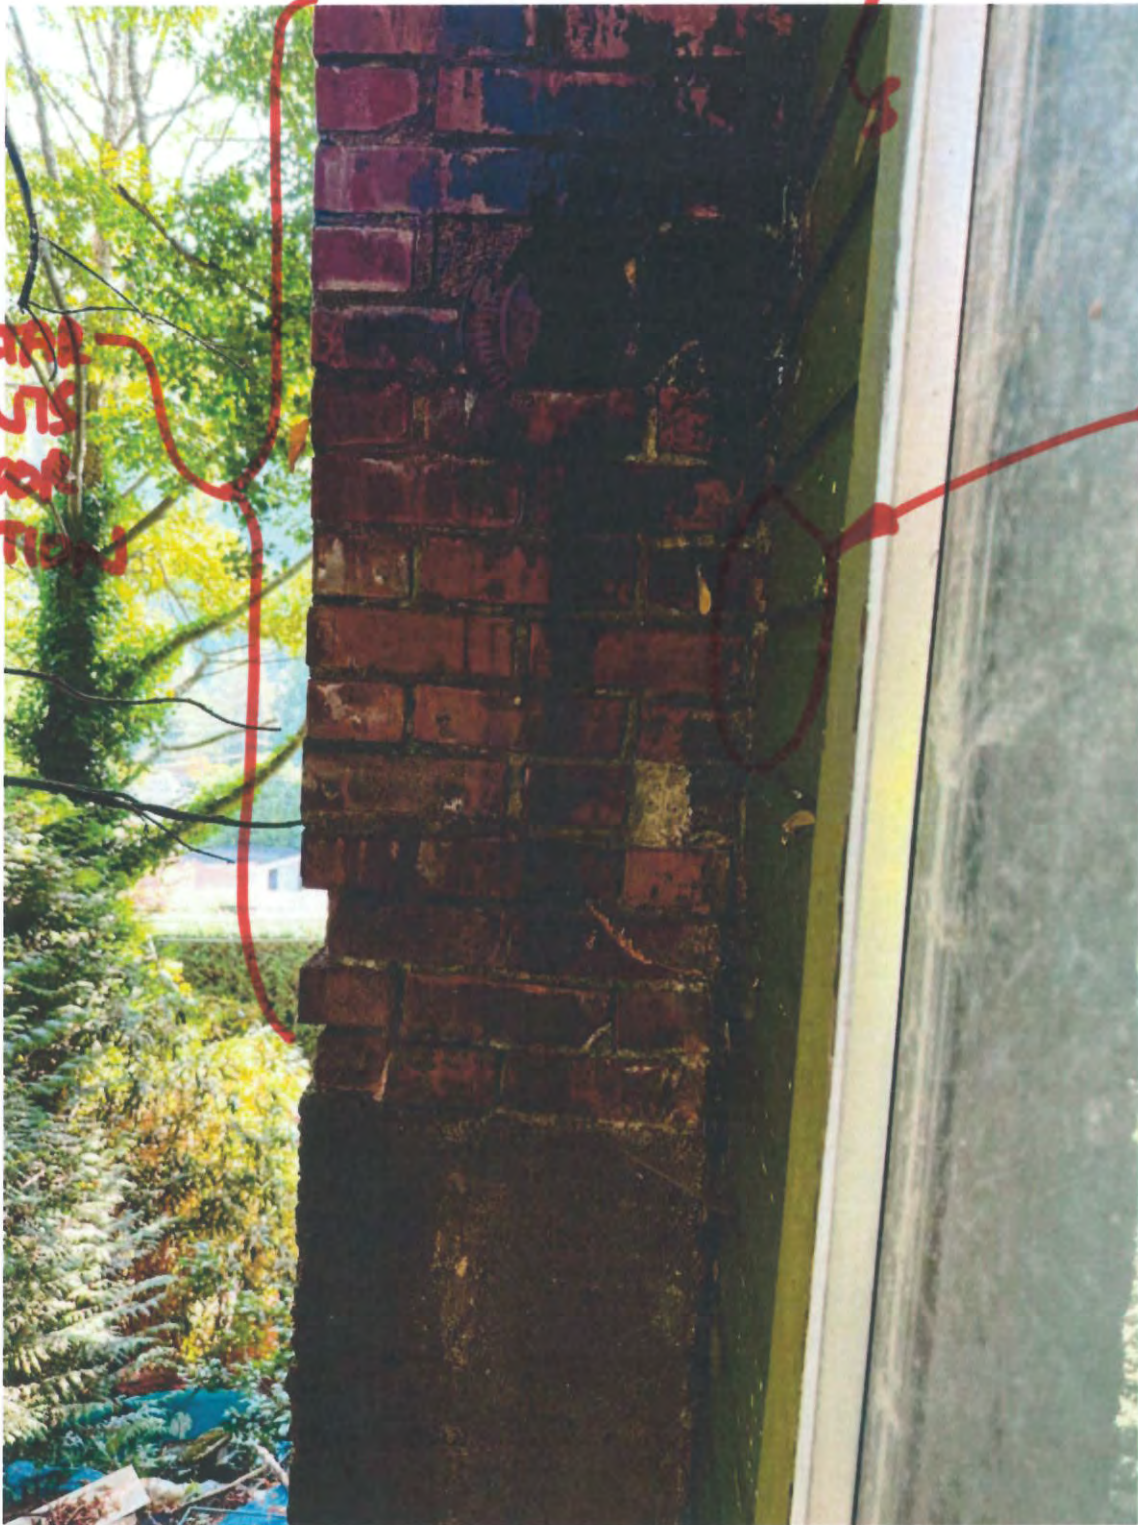
The exterior brick chimney at the north side of the building exhibits signs of advanced deterioration of mortar joints and the construction of the chimney immediately up against the north wood-frame wall is likely to have caused rot in the wall. The chimney also exhibits signs of overall instability to resist seismic loads.

MORTAR
JOINTS
IN POOR
CONDITION

CHIMNEY
AGAINST
WOOD
SIDING
ON WALL
