Date:	April 20, 2026
From:	Erika Syvokas, Community Planner
Subject:	Heritage Designation of the Navy Jack House

# NAVY JACK HOUSE

1768 ARGYLE AVENUE, WEST VANCOUVER, BC

**5 - PRELIMINARY CONDITION ASSESSMENT & OUTLINE CONSERVATION RECOMMENDATIONS**

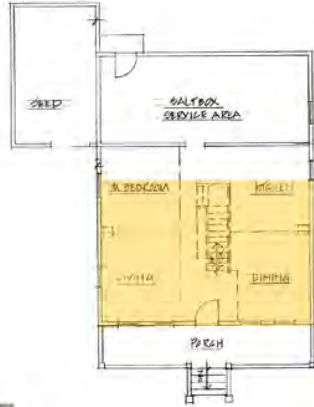
**GROUND FLOOR REFLECTED CEILING PLAN**  
NAVY JACK HOUSE  
1768 ARGYLE AVENUE

■ SURVIVING PLANK CEILING

■ INTACT ROOF FRAMING, NAILING STRIPS AND SHINGLES

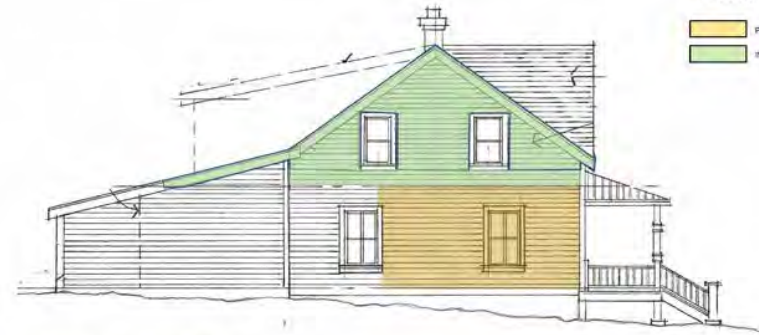
**WEST ELEVATION**

■ PARTIALLY INTACT FRAMING  
■ INTACT FRAMING & SIDING

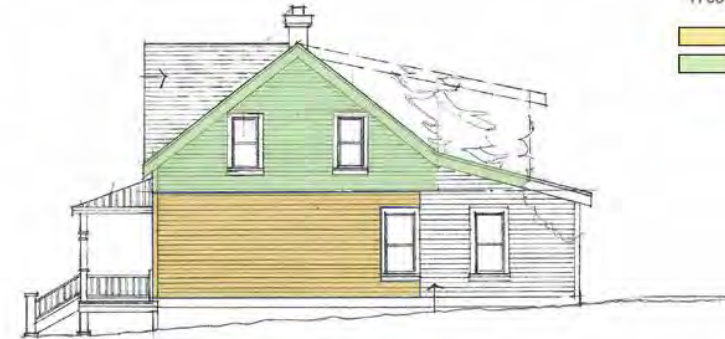
**EAST ELEVATION**

■ PARTIALLY INTACT FRAMING  
■ INTACT FRAMING & SIDING

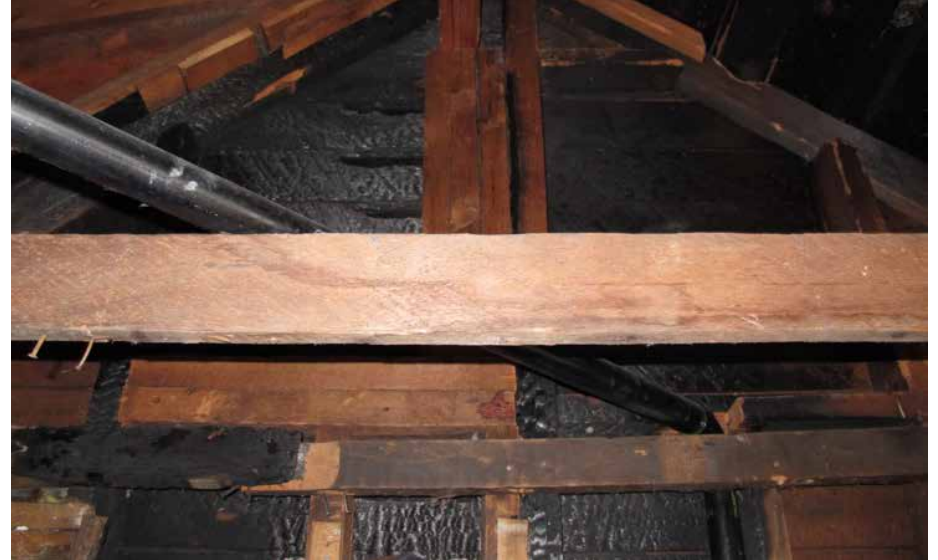
*Evidence of chimney fire in the East Gables.*

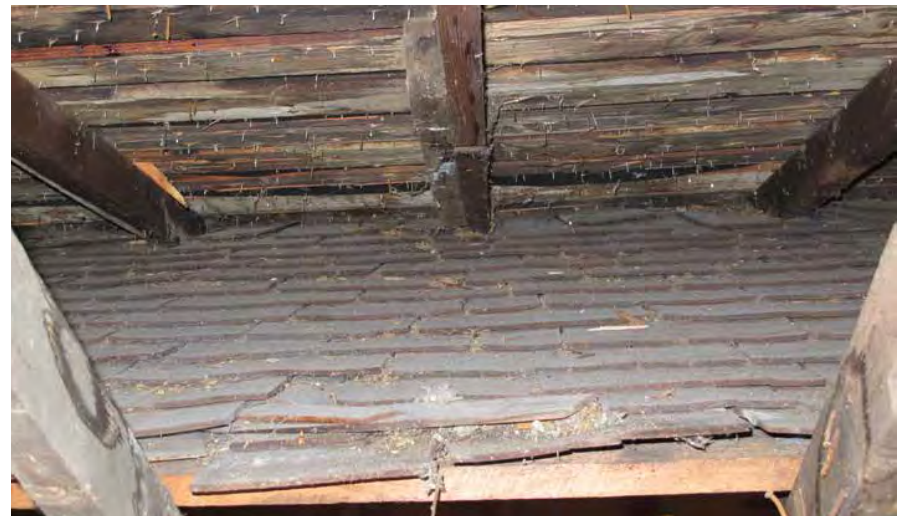
Evidence of chimney fire in the East Gables.
