Heritage Designation Bylaw No. 5459, 2026

NAVY JACK HOUSE

1768 ARGYLE AVENUE, WEST VANCOUVER, BC

5 - PRELIMINARY CONDITION ASSESSMENT & OUTLINE CONSERVATION RECOMMENDATIONS

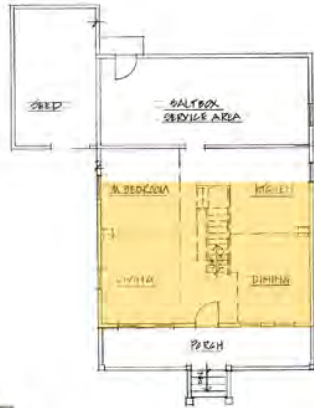
GROUND FLOOR REFLECTED CEILING PLAN
NAVY JACK HOUSE
1768 ARGYLE AVENUE

■ SURVIVING PLANK CEILING

■ INTACT ROOF FRAMING, NAILING STRIPS AND SHINGLES

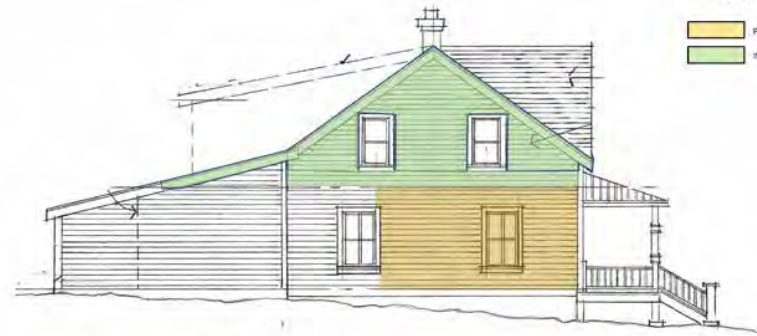
WEST ELEVATION

■ PARTIALLY INTACT FRAMING
■ INTACT FRAMING & SIDING

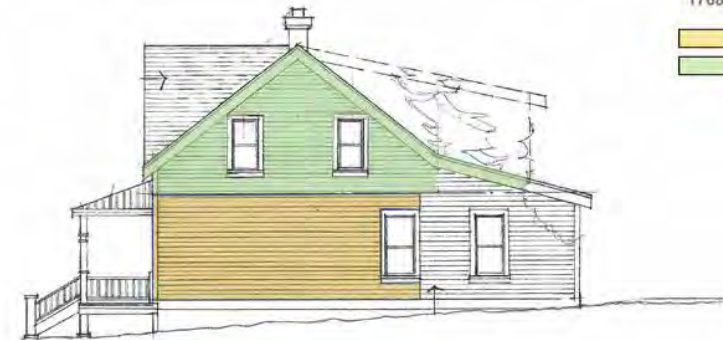
EAST ELEVATION

■ PARTIALLY INTACT FRAMING
■ INTACT FRAMING & SIDING

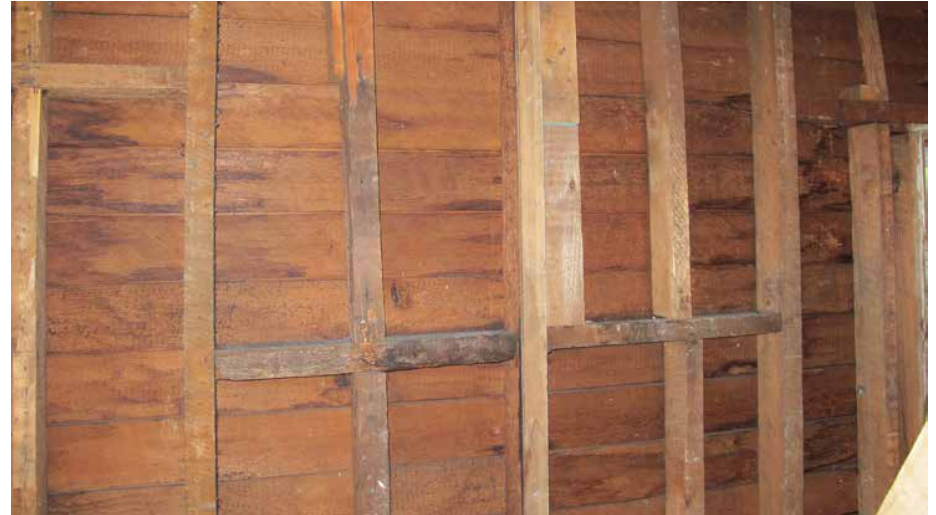
Backside of exterior cladding.

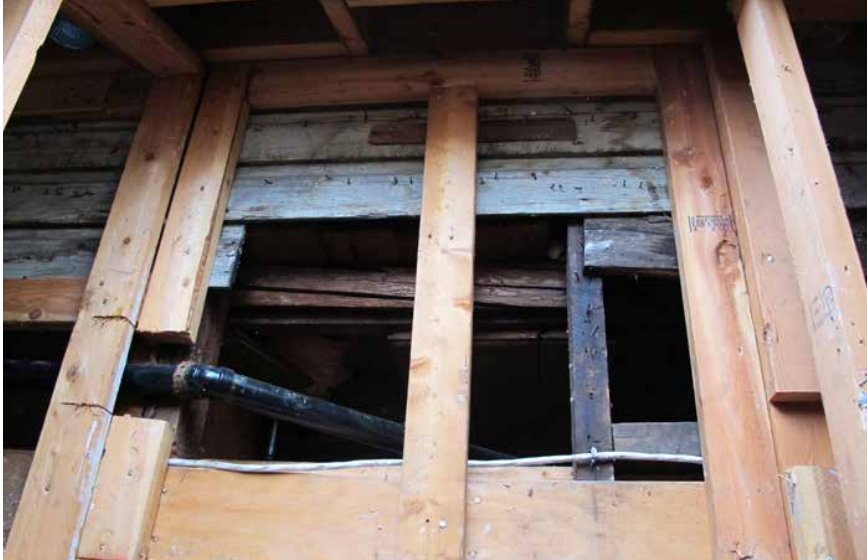
Siding behind later construction, Ground Floor East Side

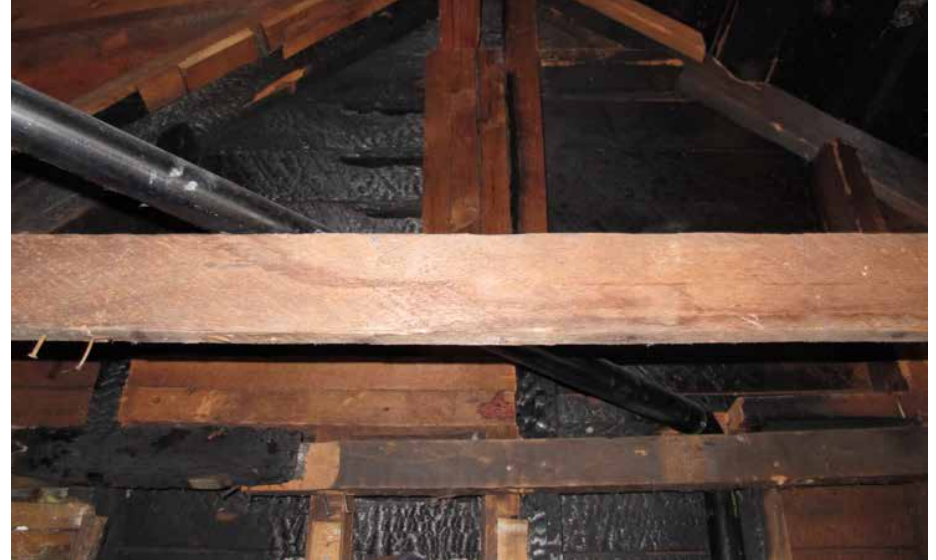
Evidence of chimney fire in the East Gables.

EXISTING ELEMENTS (CDE = CHARACTER DEFINING ELEMENT)	PRELIMINARY CONDITION ASSESSMENT	CONSERVATION TREATMENT	CONSERVATION RECOMMENDATION
5.8	CHIMNEYS <ul style="list-style-type: none"> Two later added chimneys circa 1909 	DISTURBED (DEMOLISHED) <ul style="list-style-type: none"> West chimney appears to be intact. East chimney has been removed. 	Restoration	28. Using archival images, reconstruct both east and west chimneys limited to above the roofline, which were added on in the 1909 period when the property was acquired by the Lawson family and instituted additions.

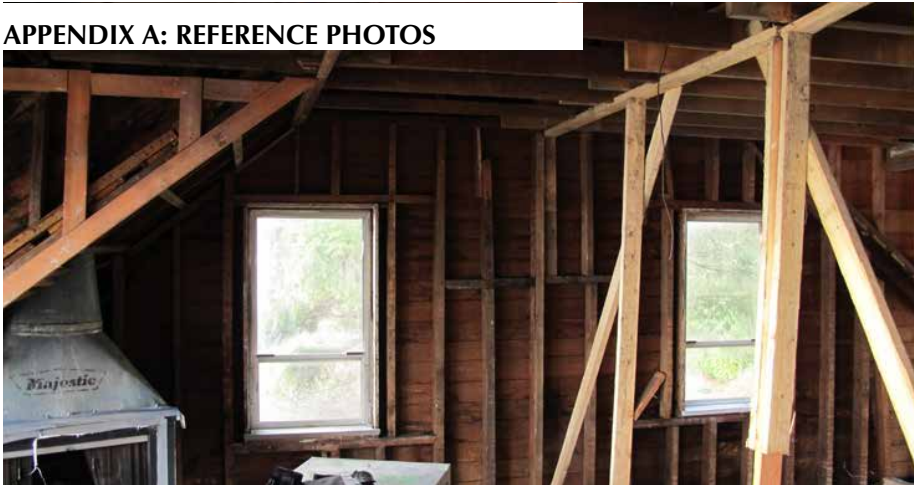
None of the window frames or assemblies have survived, but the window openings are clearly evident on the second floor and provide measurements for how the windows can be restored. Original double-hung configuration as per archival photos.

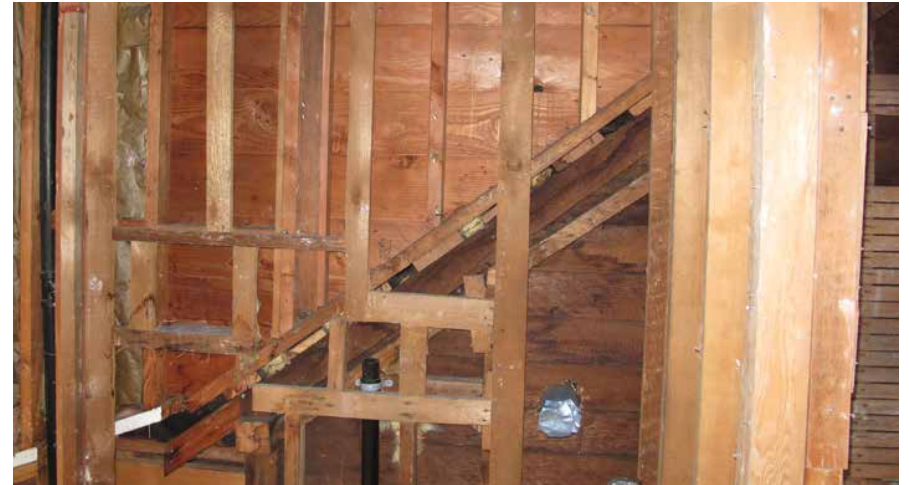
Although the roof framing has been cut out in several locations, virtually all of the planking that formed the exterior soffits were left in place, and can be traced on the east and west sides of the house.

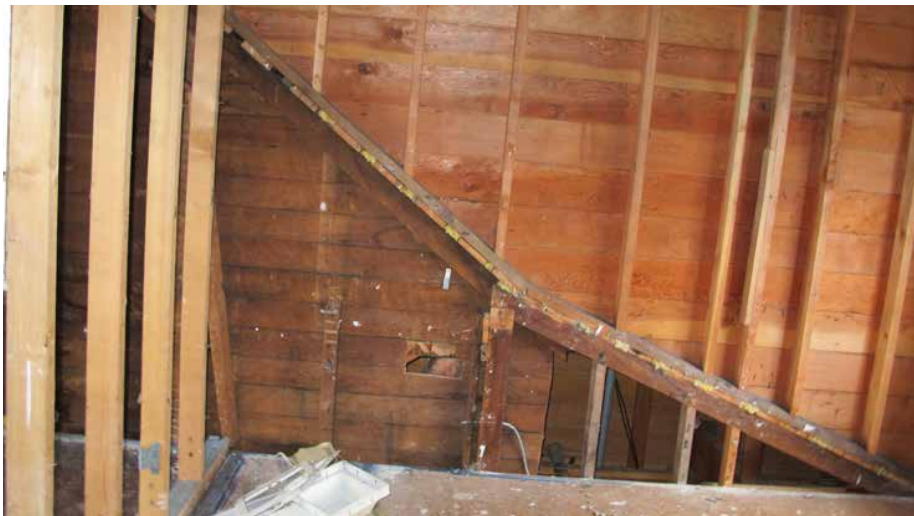
Siding behind later construction, Ground Floor East Side

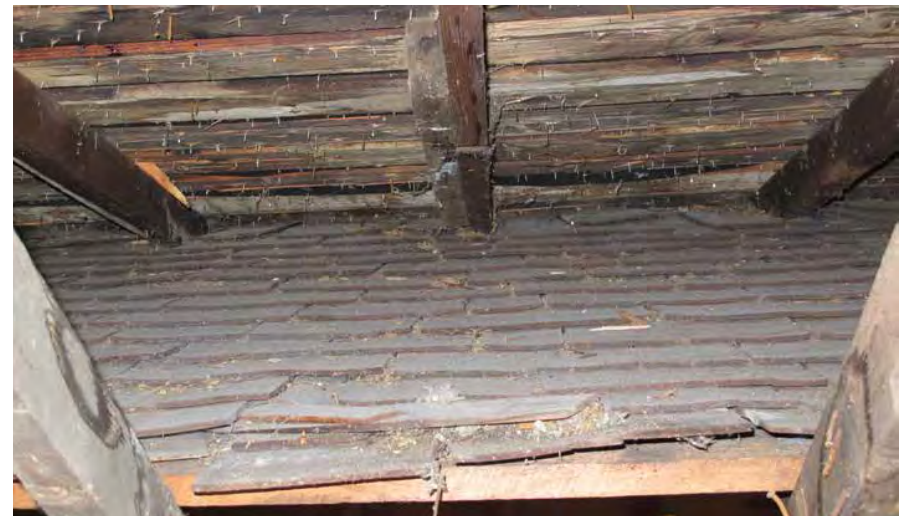
Evidence of chimney fire in the East Gables.

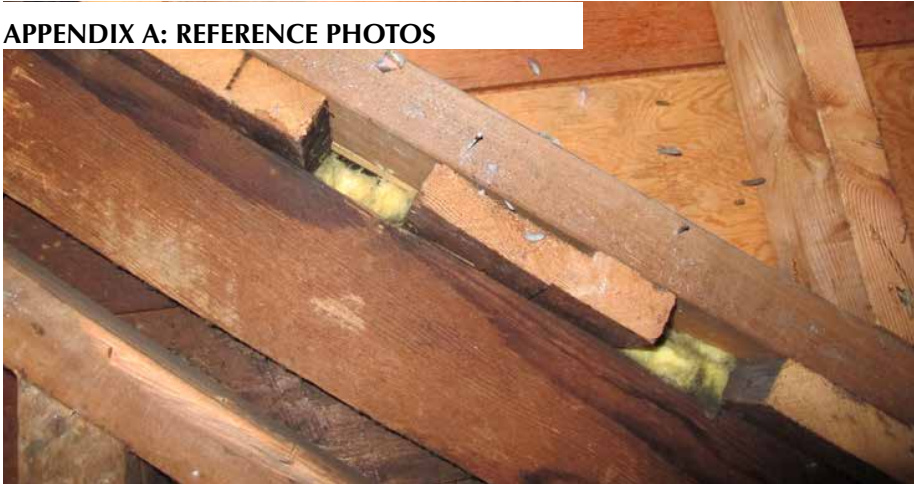
Cut-through roof structure showing original nailing strips.

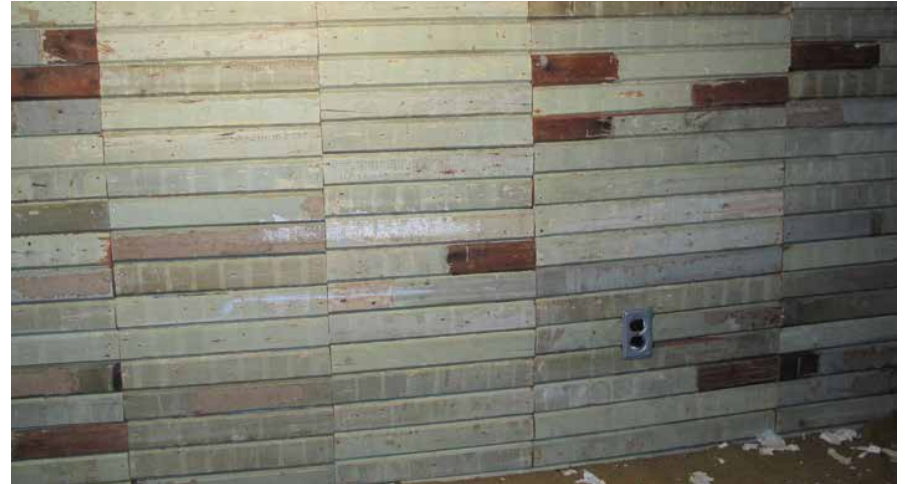
Basement Level wood sidings repurposed as cladding

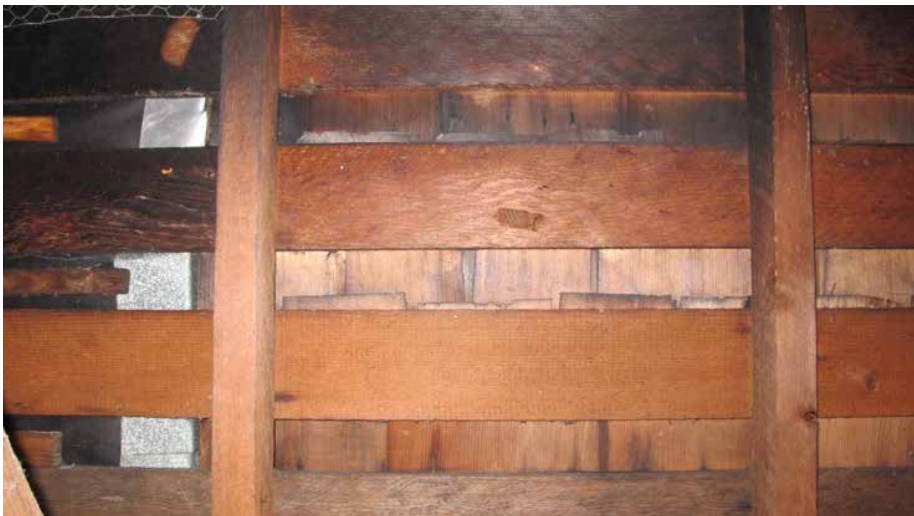
Underside of intact cedar shingle roofing

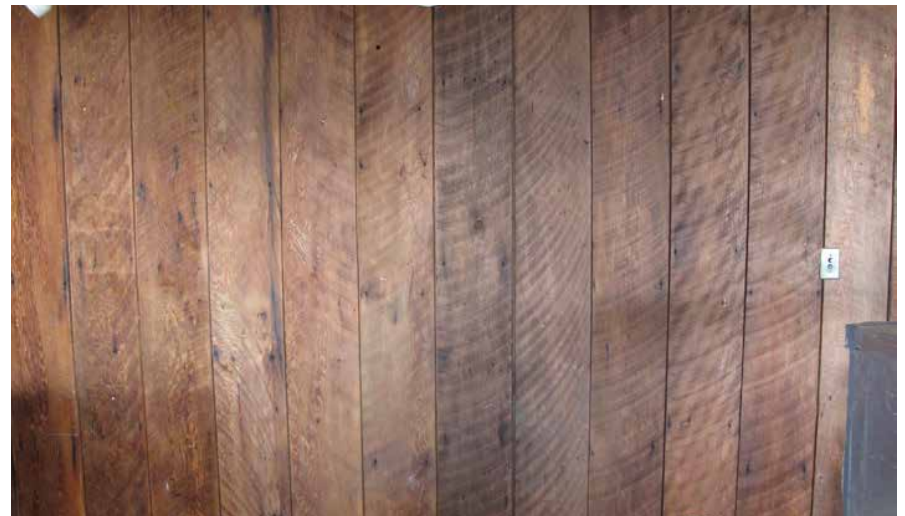
Living Room Sawn Lumber repurposed by homeowners
