Heritage Designation Bylaw No. 5459, 2026

A bylaw to designate 1768 Argyle Avenue as protected heritage property.

NAVY JACK HOUSE

1768 ARGYLE AVENUE, WEST VANCOUVER, BC

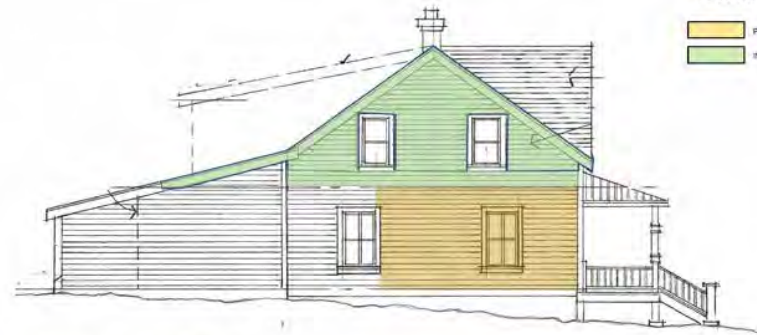
NAVY JACK HOUSE
1768 ARGYLE AVENUE

■ PARTIALLY INTACT FRAMING
■ INTACT FRAMING & SIDING
