DISTRICT OF WEST VANCOUVER
750 17TH STREET, WEST VANCOUVER BC V7V 3T3

COUNCIL REPORT

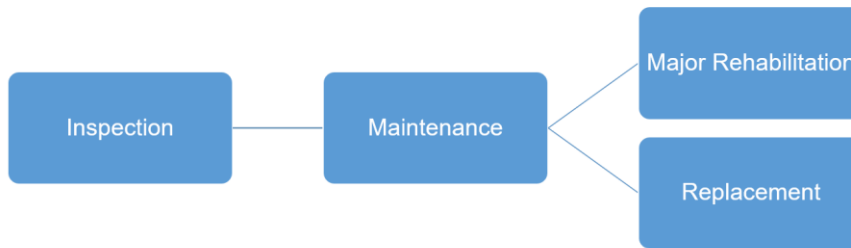
Figure 1 – Asset Management Strategy – Flow Chart

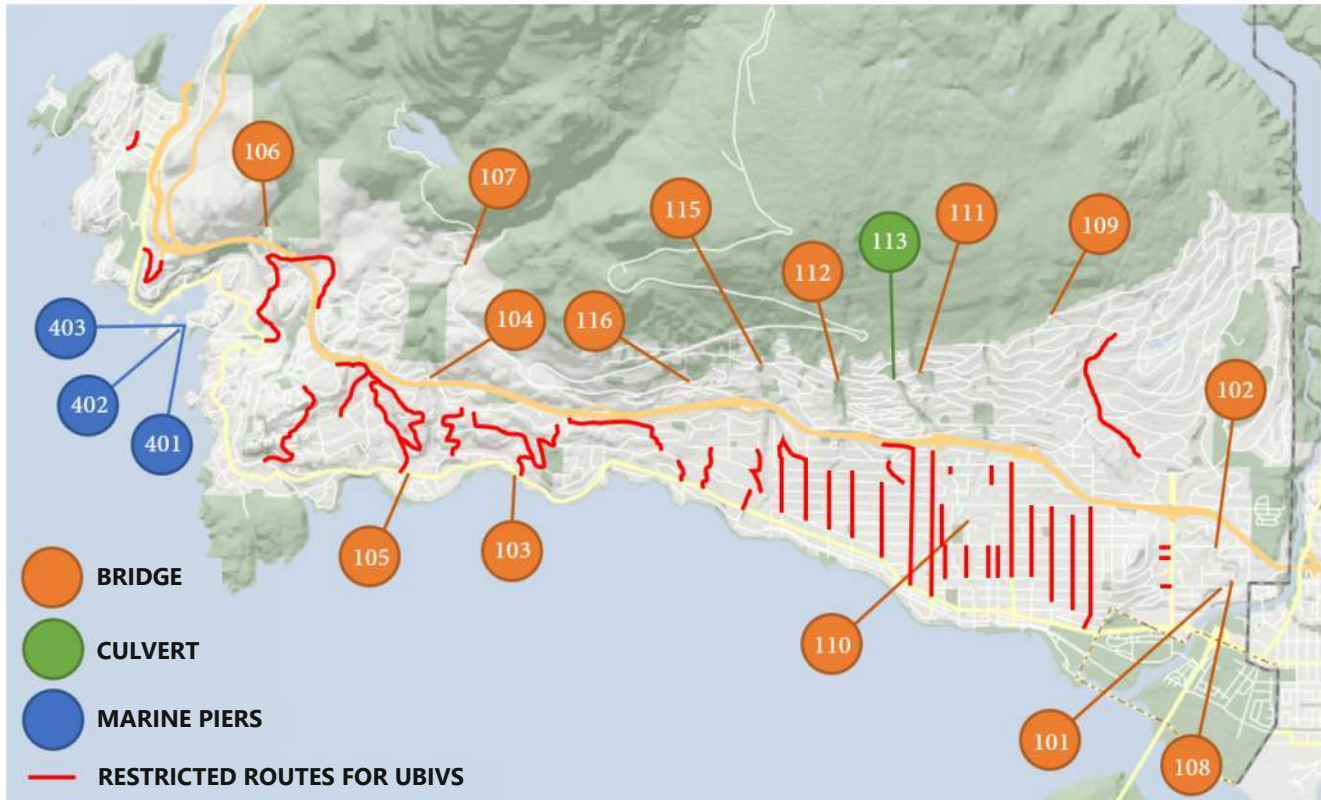
101	Keith Road Bridge (1952)	110	Sinclair Court Bridge (1995)
102	Inglewood Road Bridge (1986)	111	Chippendale Road/McDonald Creek Bridge (2002)
103	Marine Drive/Sandy Cove Bridge (1939)	112	Chippendale Road/Marr Creek Bridge (2004)
104	Almondel Road (2008)	113	Chippendale Road/McDonald Creek Culvert (2005)
105	Marine Drive/Cypress Creek Bridge (1940, 1977)	115	Chippendale Road/Rodgers Creek Bridge (2010)
106	Nelson Canyon Bridge (1956)	116	Burfield Place Bridge (2014)
107	Eagle Lake Road Bridge (1984)	401	Mainland Pier (2015)
108	Keith Place Bridge (1991)	402	Eagle Island Pier (2015)
109	Millstream Road Bridge (1964)	403	Mainland Service Float (2015)

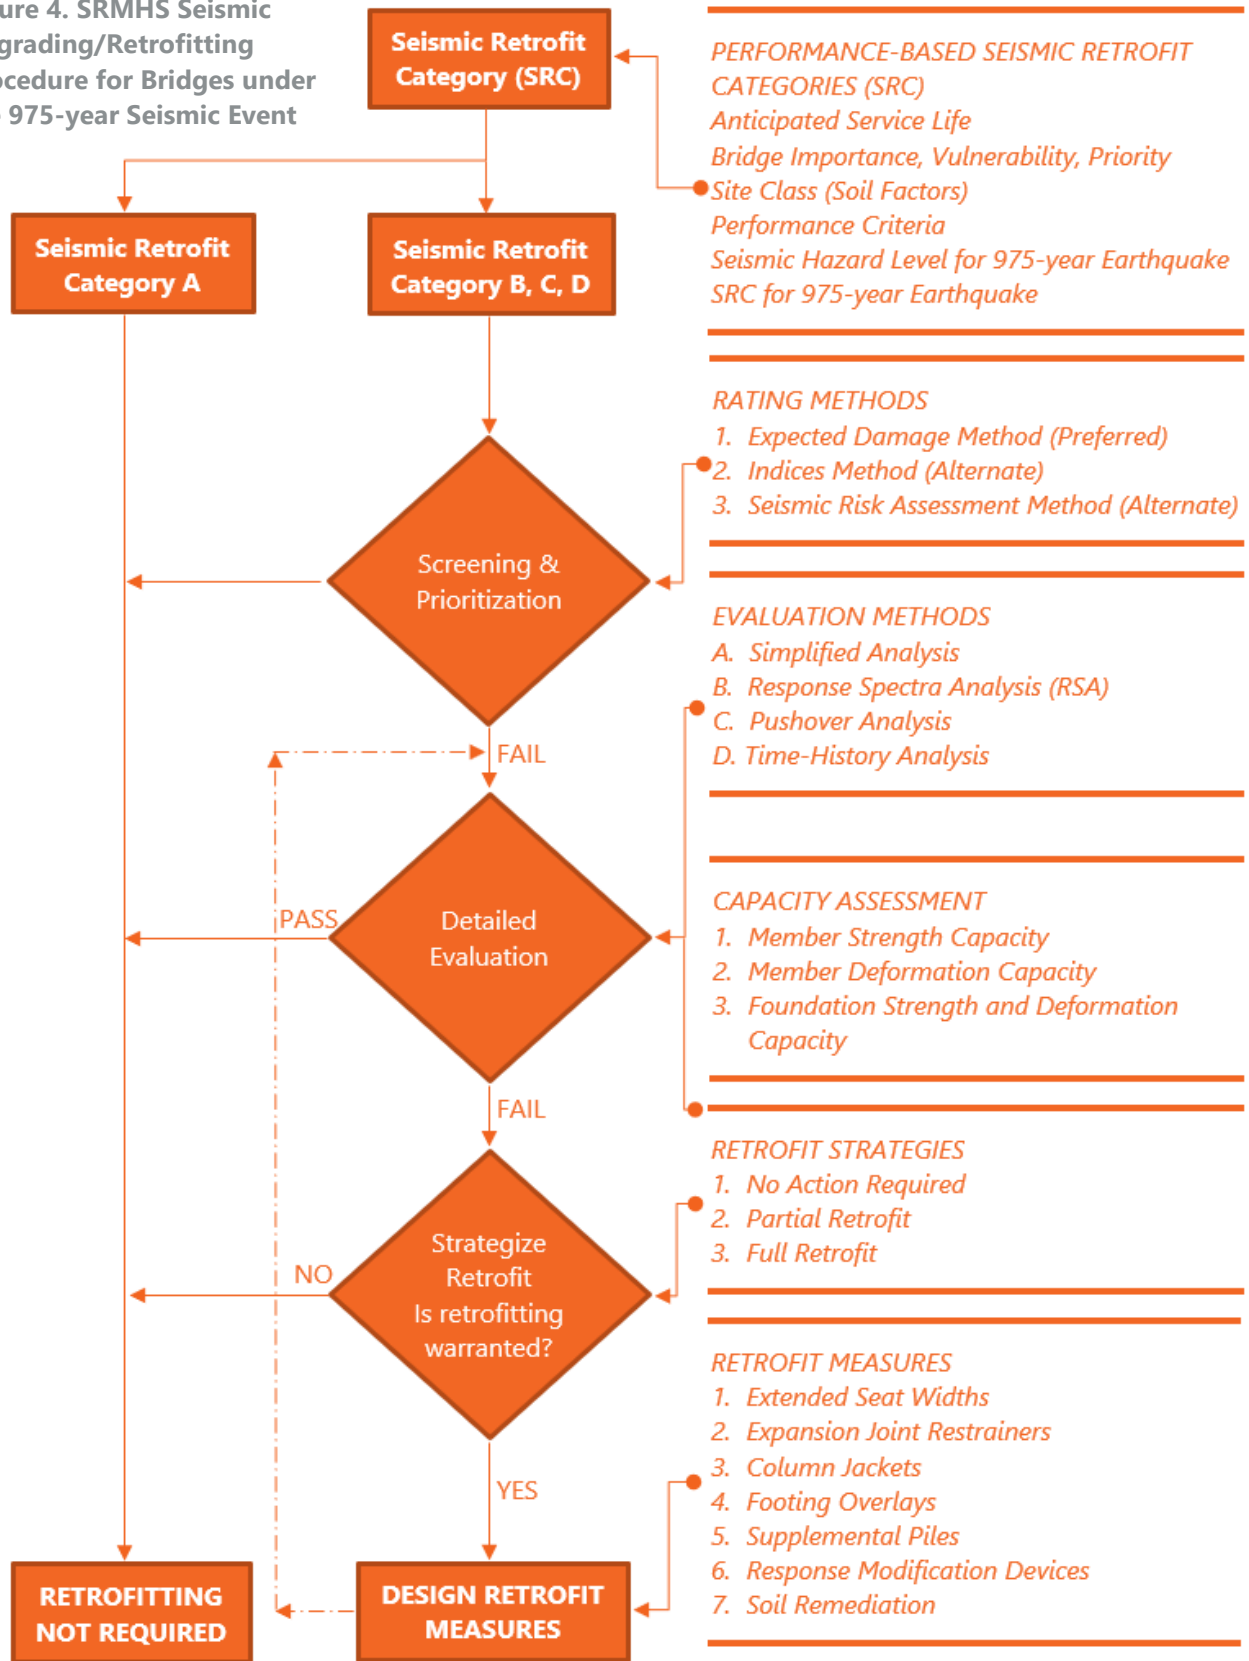
3.2.1 Performance Level

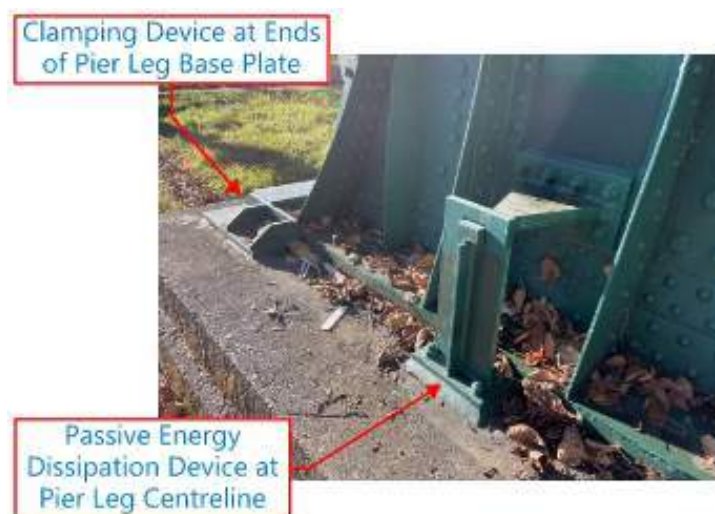
Figure 5. Typical Rocking Connection Components on the Lions Gate Bridge Approach Spans

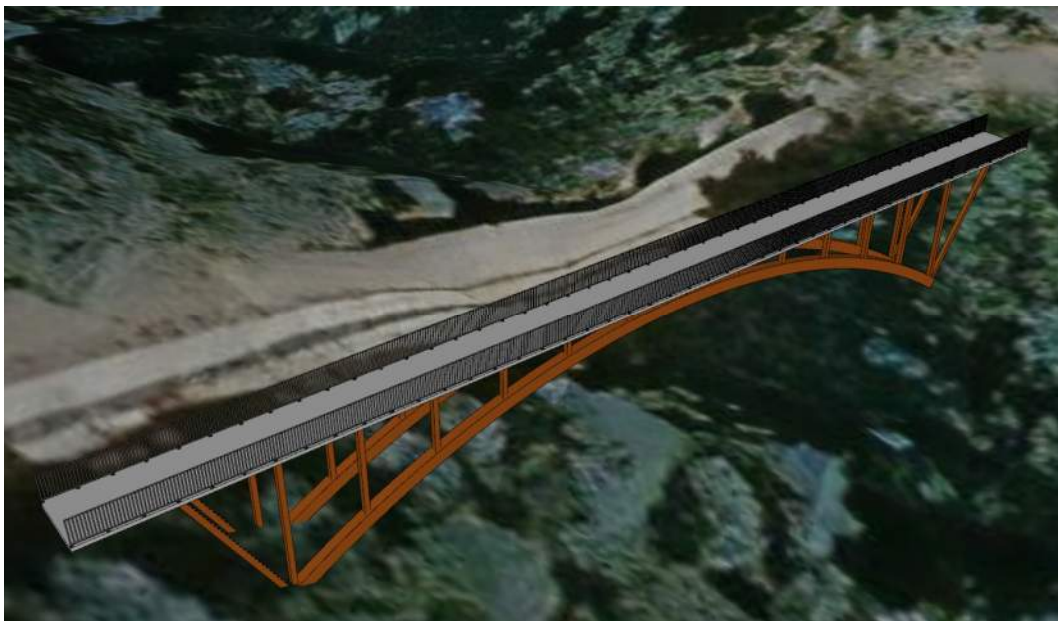
Figure 6. Arch Bridge Alternative Bridge Replacement Option

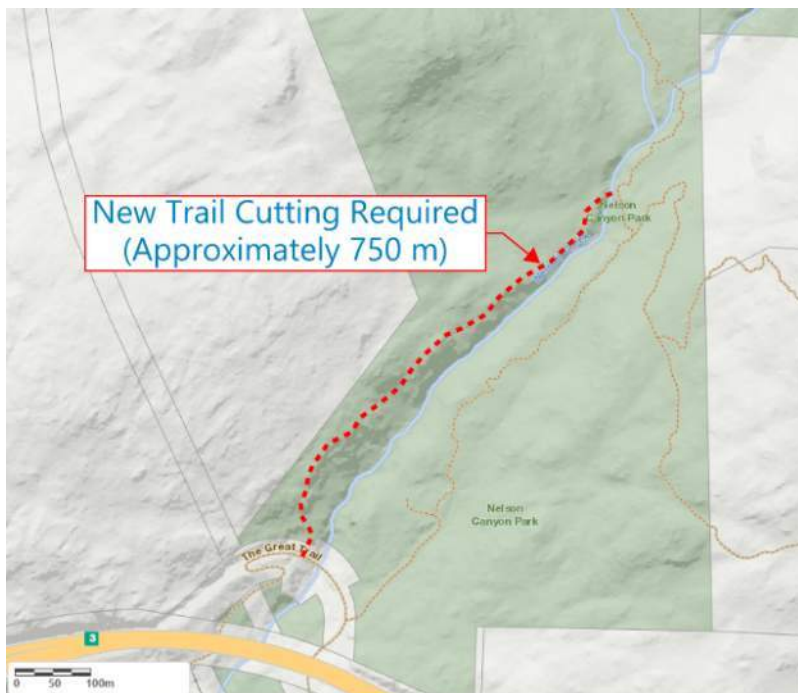
Figure 7. Pipeline-Only Alternative Bridge Replacement Option's Trail-Cutting Requirements
(Credit: Map source from WestMap by the District of West Vancouver)

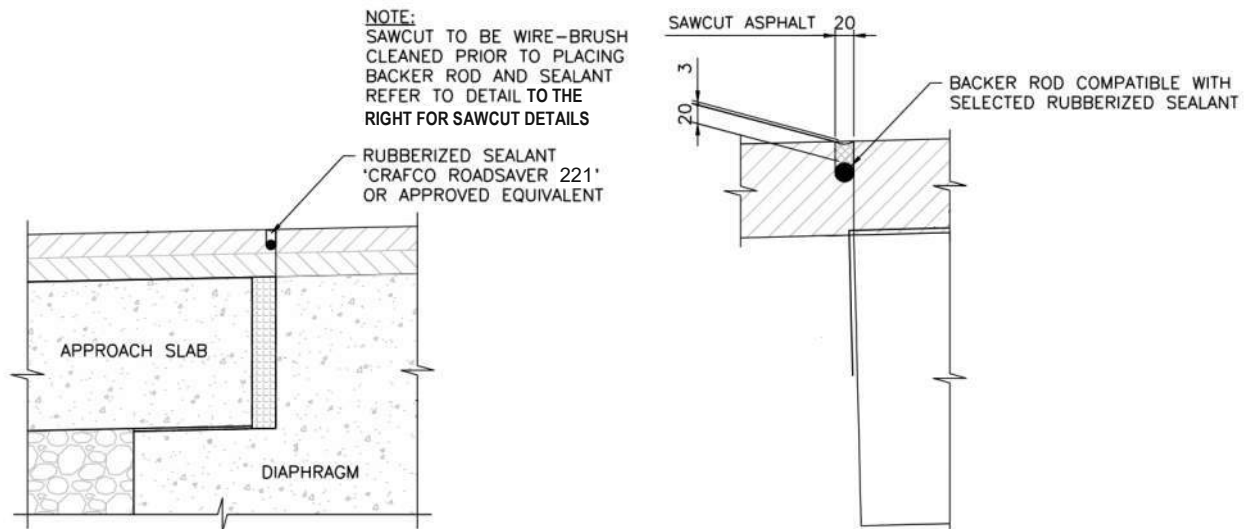
Figure 8. Proposed Alternative Strategy to Resealing Asphalt Deck Joints on Integral and Semi-Integral Bridges

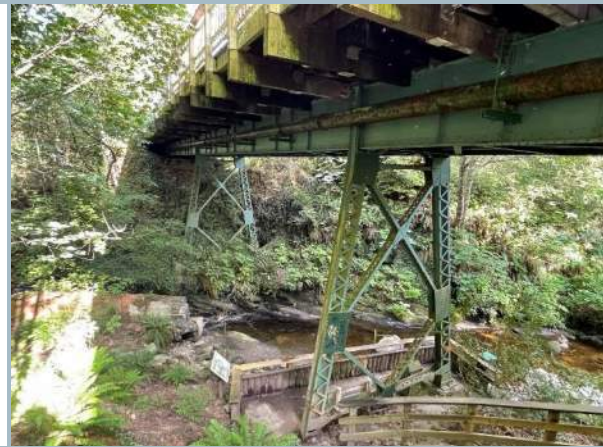
016. Watermain Utility along North Elevation (Note: Surface Corrosion of Pipe)

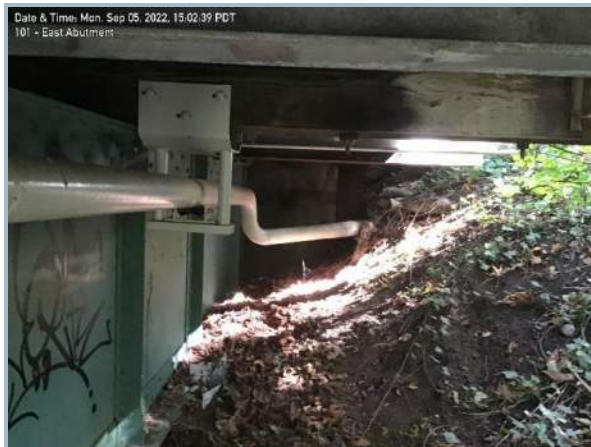
017. Gas Utility at Southeast Section of East Abutment

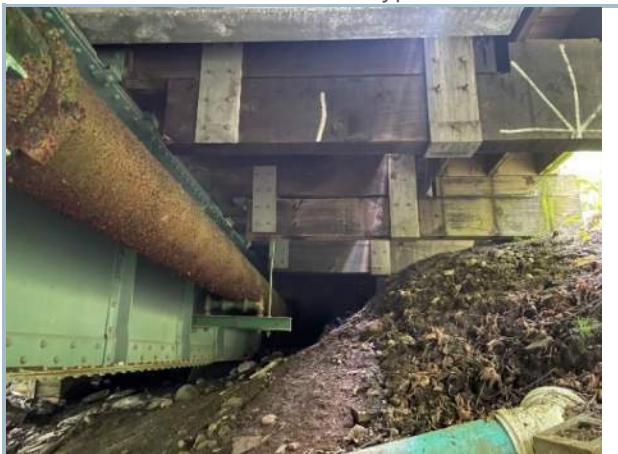
023. Bolted Connection of Transverse Timber Elements

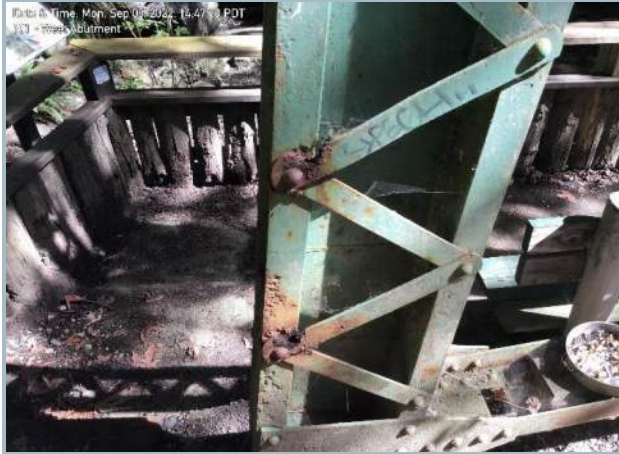
024. Pitting and Crevice Corrosion at West Pier Lattice, Typ.

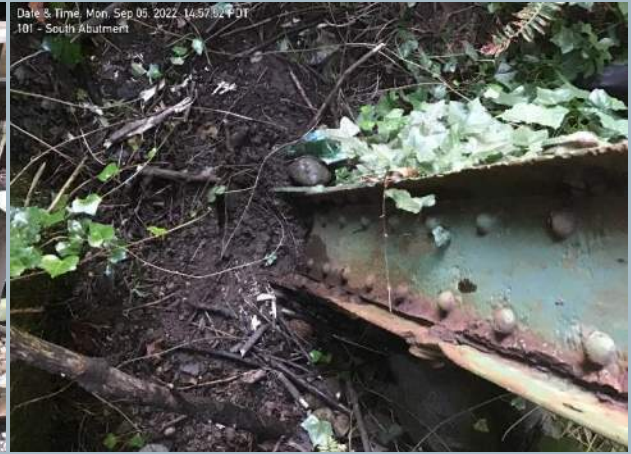
025. Buried Southeast Pier Footing (Note Corrosion-led steel delamination)

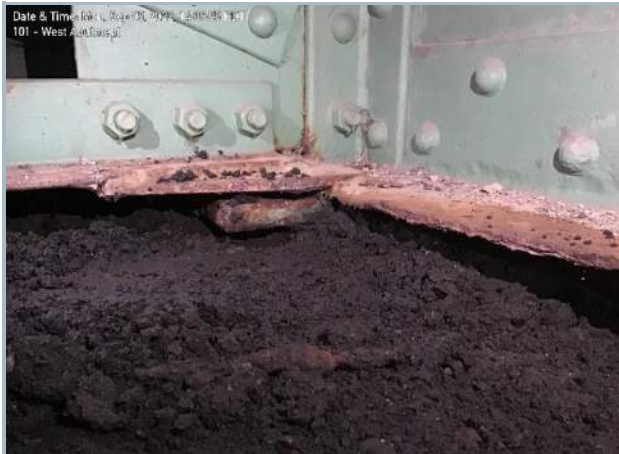
026. Buried Bearing Plate at East Abutment

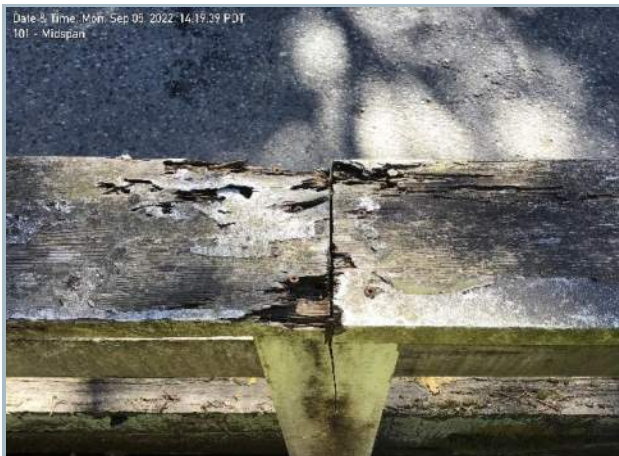
028. Decaying Timber Rail and Curb Components

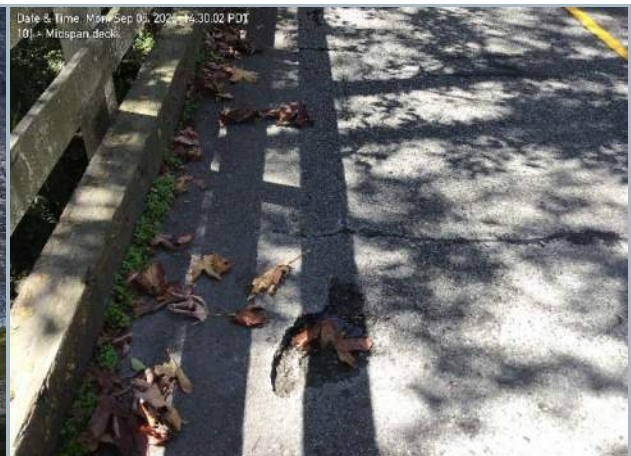
029. Cracking on Asphalt Wearing Surface, Typ.

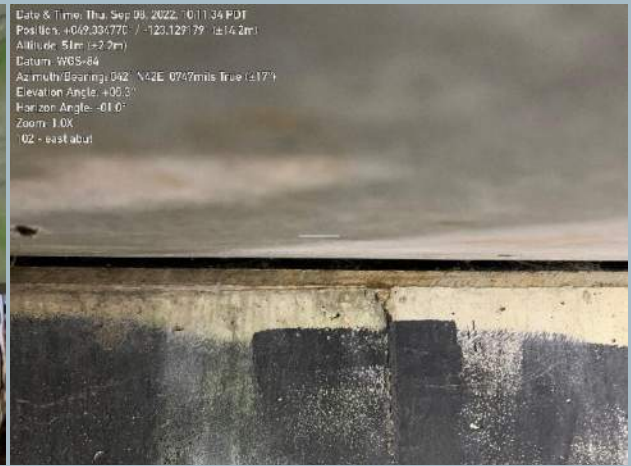
019. Elastomer Bearing at Abutment, Typ.

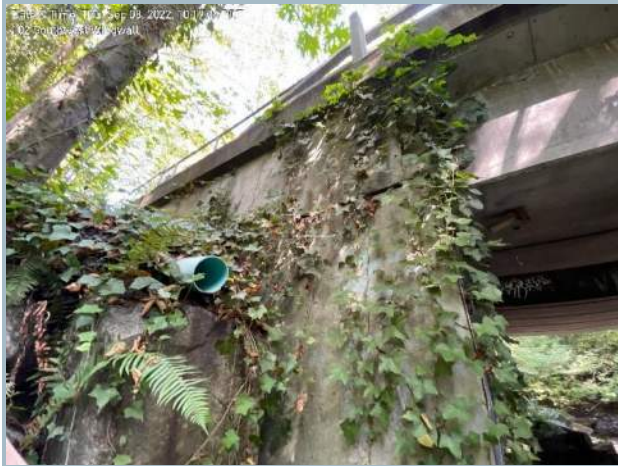
NOTABLE DEFICIENCIES

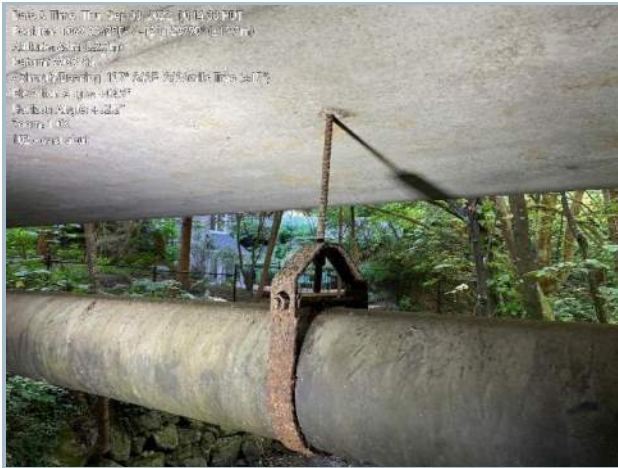
027. Corroding Pipe Hanger Support, Typ.

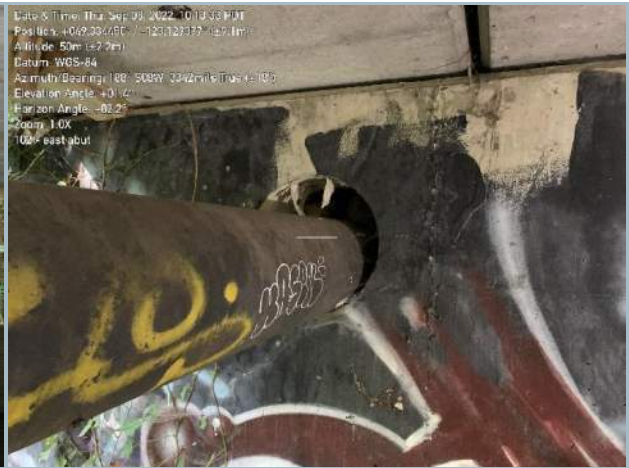
028. Void around Watermain Utility at West Abutment
(Note: Utility Pipe Directly bearing on Backwall)

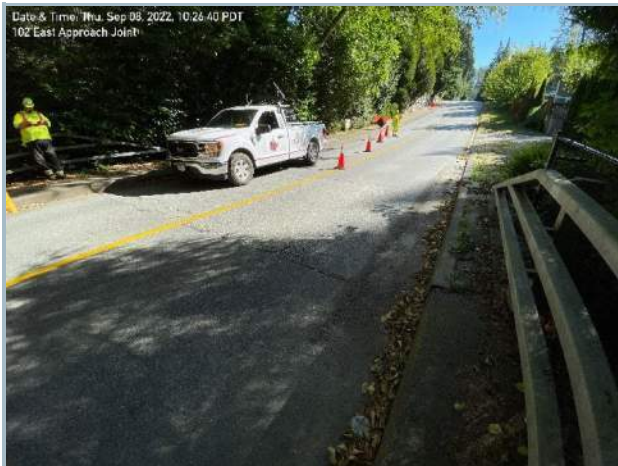
029. Cracking of Asphalt Wearing on East Approach
Indicating Probable Settlement

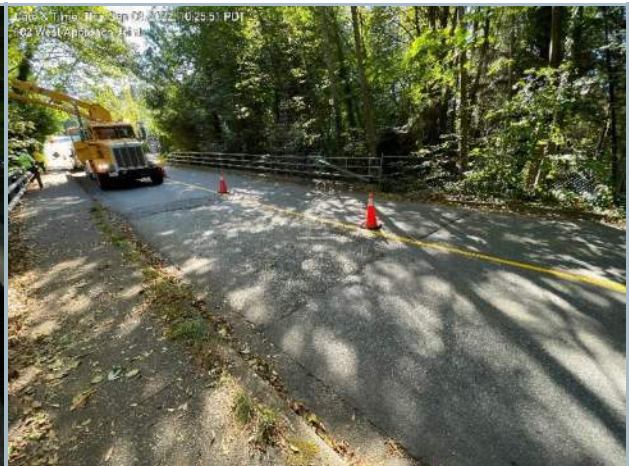
030. Cracking of Asphalt Wearing on West Approach
Indicating Probable Settlement

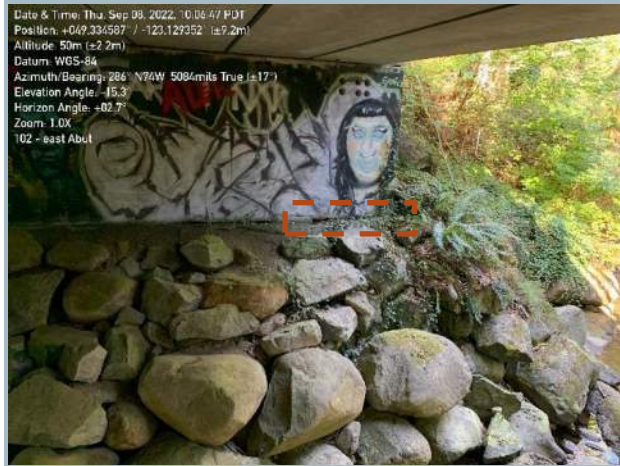
031. Undermining at Northwest Section of West Abutment

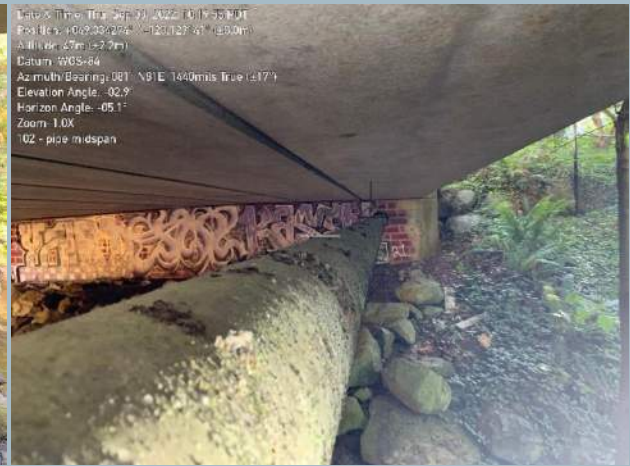
032. Vegetation Growth and Localized Corrosion of Watermain Utility

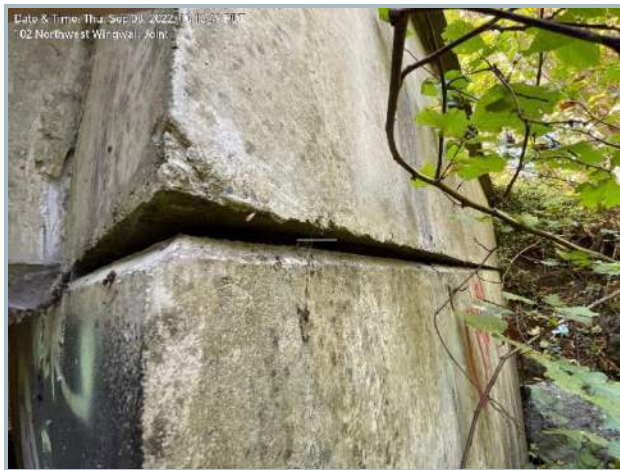
033. Notable Separation at Wingwall, Typ.

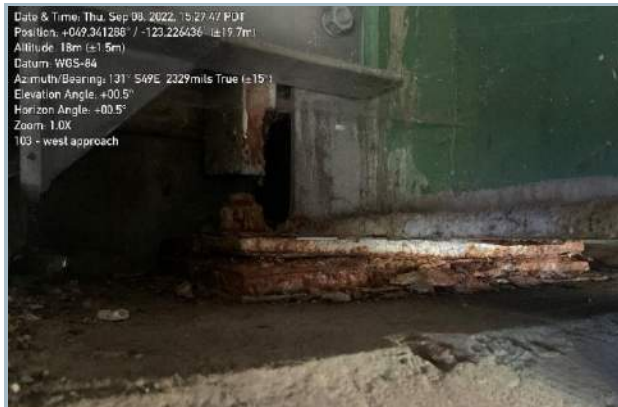
023. Corrosion-led Delamination of Steel Bearing Plate, Typ.

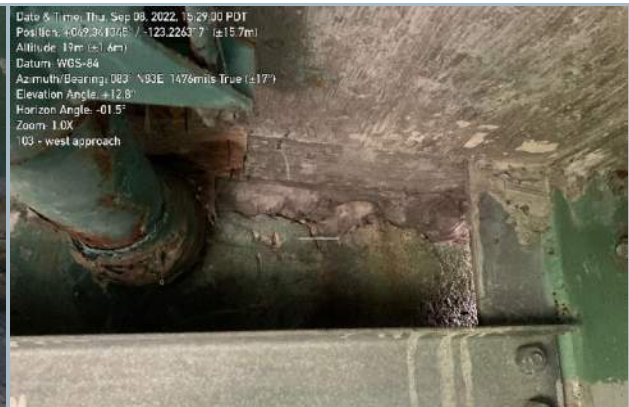
024. Concrete Delamination & Cracking Adjacent to Pipe Connection at West Abutment (Note: Bolted Lateral Restraint Connection)

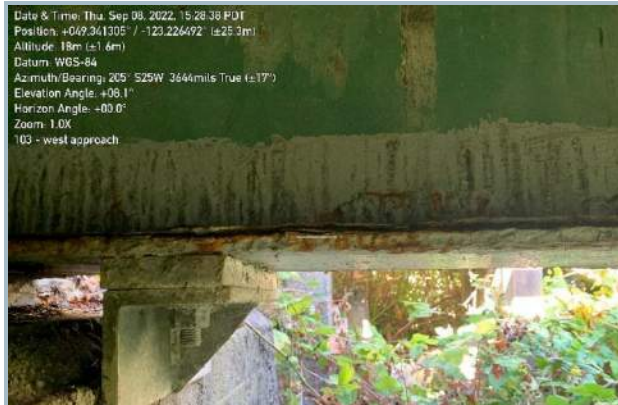
025. Bottom Flange Surface Corrosion and Deposit Attack at Abutment, Typ.

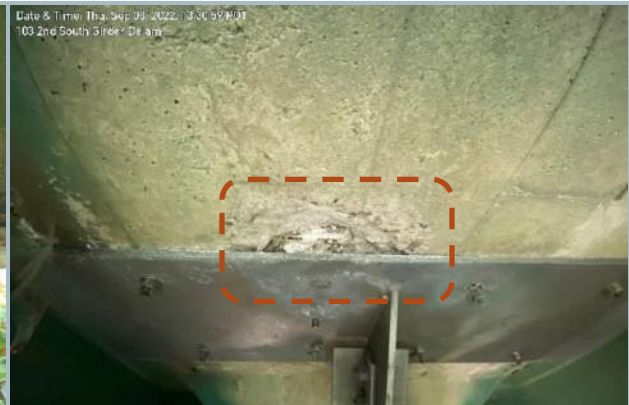
026. Spalling above East Pier Brace

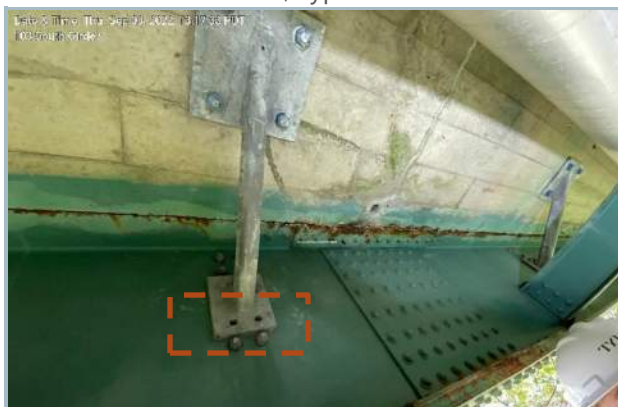
027. Railing Support Connection Bolts Missing Along South Profile, Typ. (Note Continuous Top Flange Corrosion, Typ.)

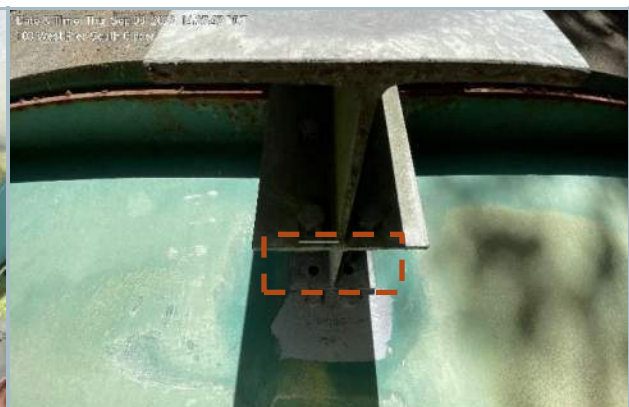
028. Railing Support Connection Bolts Missing Along South Profile, Typ.

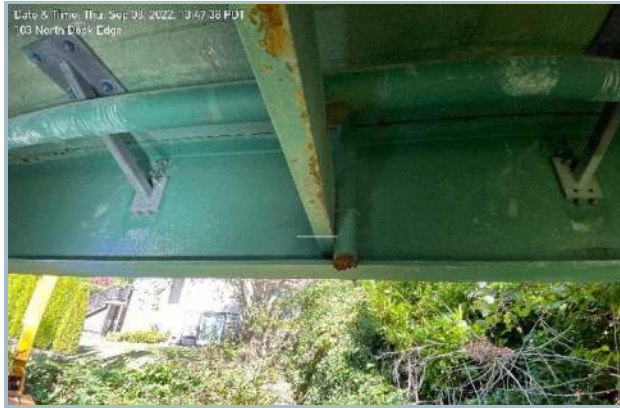
029. Corroding Drainpipe Outlets

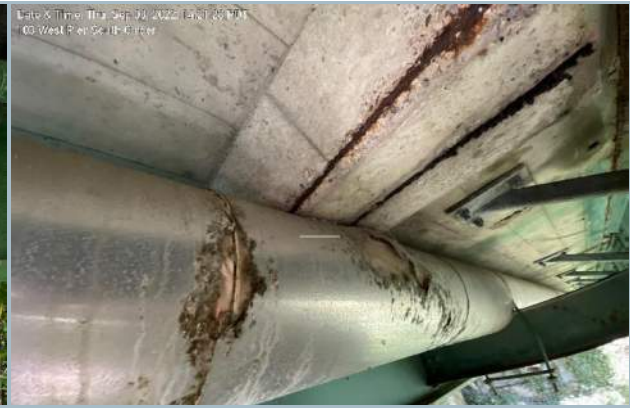
030. Exposed Reinforcing on Concrete Soffit
(Note Localized Deterioration of Pipe Surface)

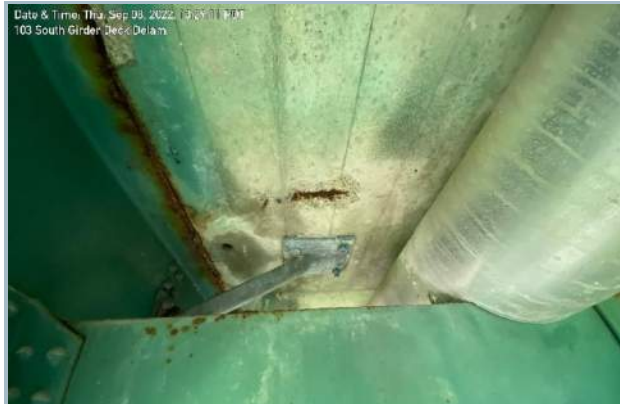
031. Exposed Reinforcing on Concrete Soffit at
Midspan along Second Girder from South Profile
(Note: Efflorescence and Cracking around
Previous Deck Drain)

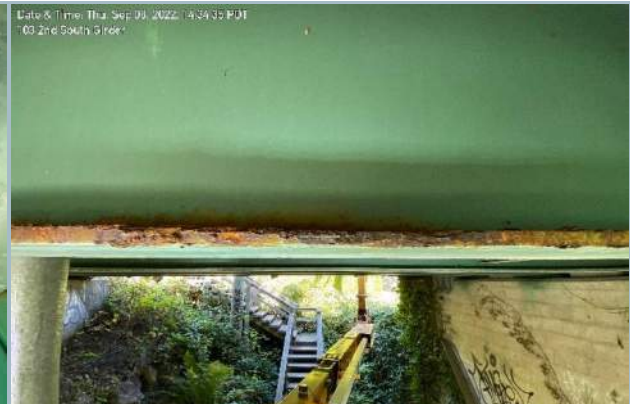
032. Localized Corrosion-led Deterioration of Bottom
Flange at West Pier, Typ.

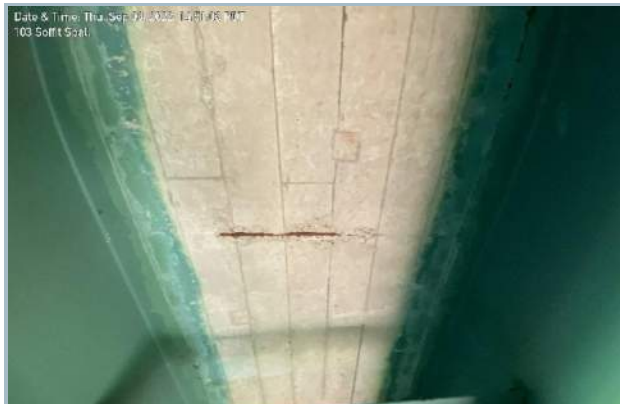
033. Exposed Reinforcing on Concrete Soffit at
Midspan along South Profile

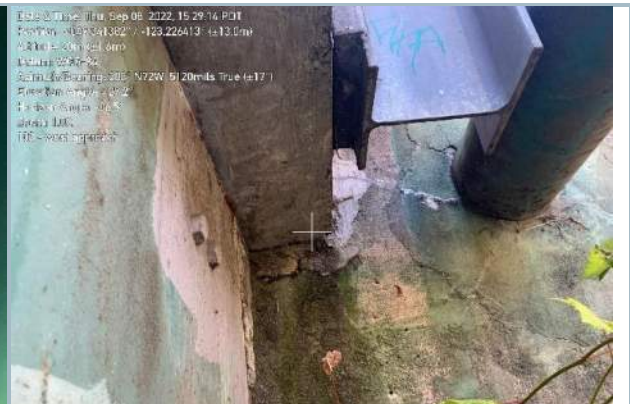
034. Cracking of Backwall around Sanitary Utility and
Concrete Repair at West Abutment

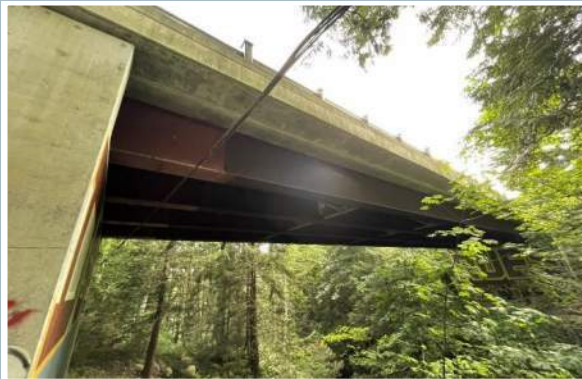
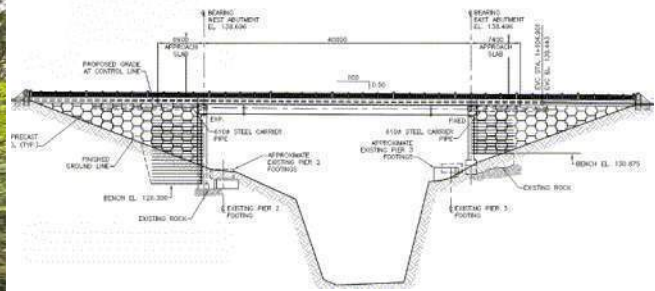
CONSTRUCTION DATE:	2008	
BRIDGE ORIENTATION:	East-West	
FEATURE SUPPORTED:	Almondel Road	
FEATURE CROSSED:	Cypress Creek	
SUBSTRUCTURE:	Abutments – semi-integral reinforced concrete abutments on bedrock with MSE retaining walls	
SUPERSTRUCTURE:	Welded steel plate girders with cast-in-place composite concrete deck	
WEARING SURFACE:	Asphalt, 2-Lane composite concrete deck	
APPROACHES:	Approaches are curved onto the straight-aligned bridge	
GENERAL:	SPANS:	1-span: 40.0m
	TOTAL LENGTH:	41.4m
	DECK AREA:	448m ²
	BEARINGS:	Elastomeric
	BANK/PIER PROTECTION:	Bedrock-walled canyon
	GUARDRAIL:	Steel on concrete upstand
	CURB:	Concrete
	UTILITIES	Gas; Watermain; Telecommunication line
	CLEARANCE:	23m
	ROADWAY CLASS:	Local
SIGNAGE:	Delineators; Fish-bearing Stream	
SEISMIC ASSESSMENT:	None	
DIAGNOSTIC TESTING/STUDY:	None	
PAST REHABILITATION WORKS:	None

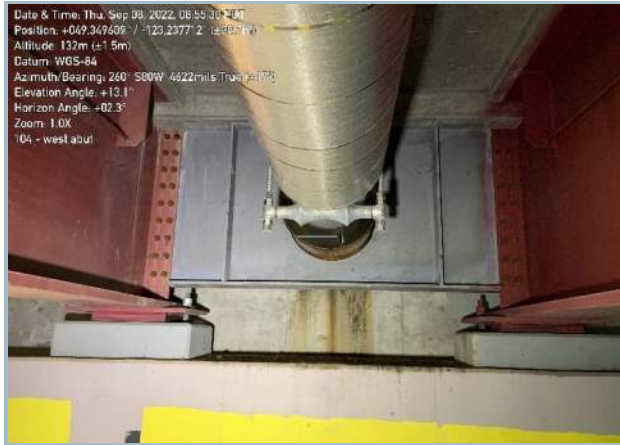
011. Central Waterman Utility
 (Note Staining of Backwall)

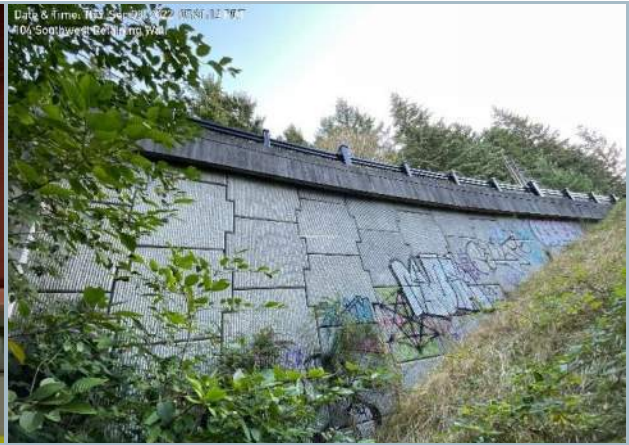
012. MSE Retaining Wall Along Southeast Section,
 Typ.

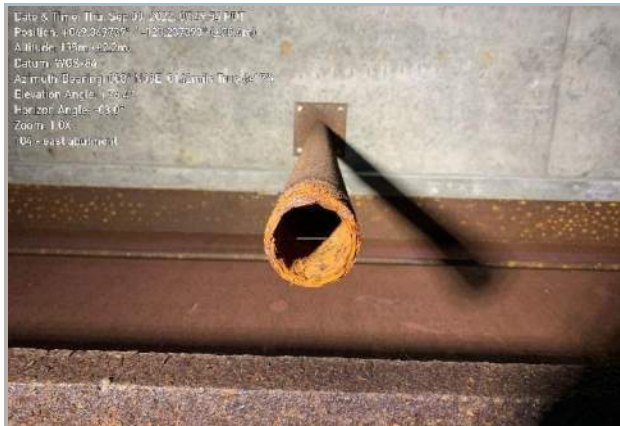
013. Corroding Weeping Drain Outlet, Typ.

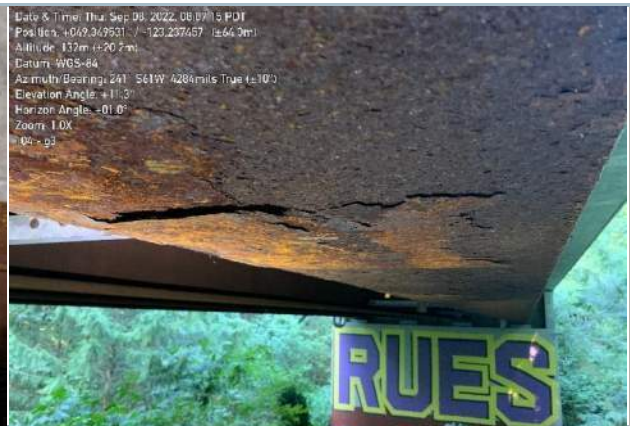
014. Localized Mill Scale Flaking on Bottom Flange of Weathering Steel (Expected Behavior)

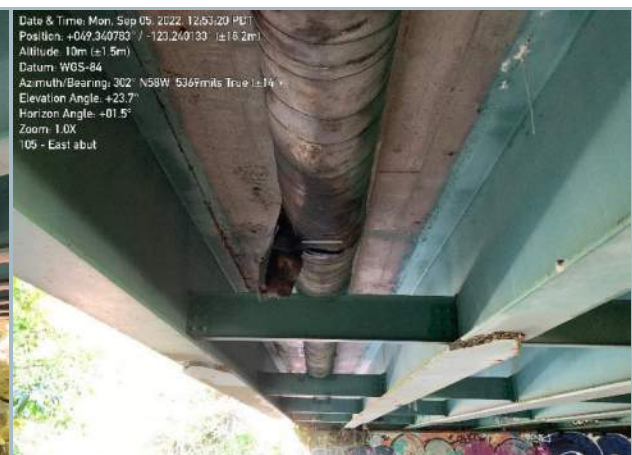
017. Watermain Utility Along South Profile (Note: Deterioration of Pipe Surface at Midspan)

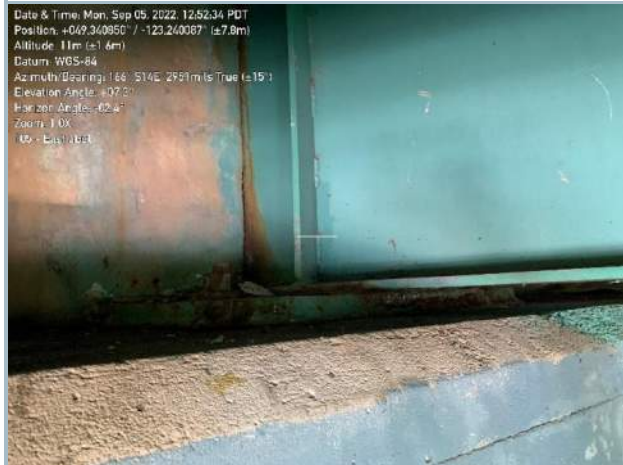
020. Anchored Steel Bearing Plate, Typ.
 (Note Surface Corrosion)

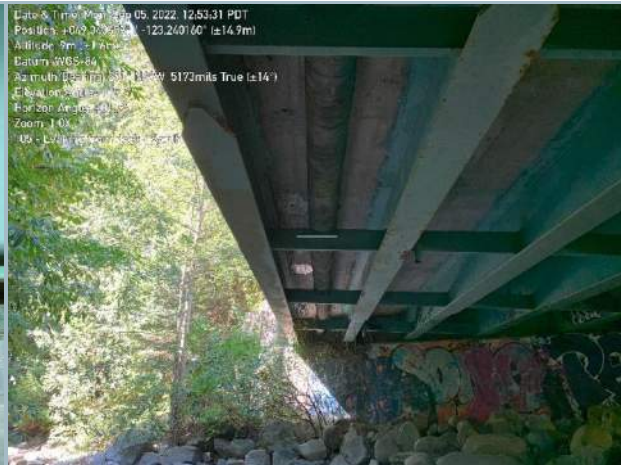
021. Lateral Bracing Elements at Equivalent Spacing, Typ.

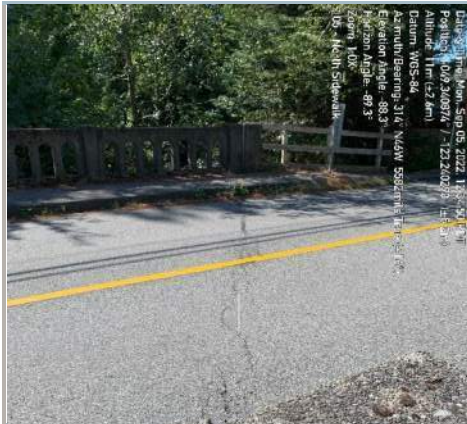
022. Cracking in Asphalt Wearing Surface of West Approach Slab

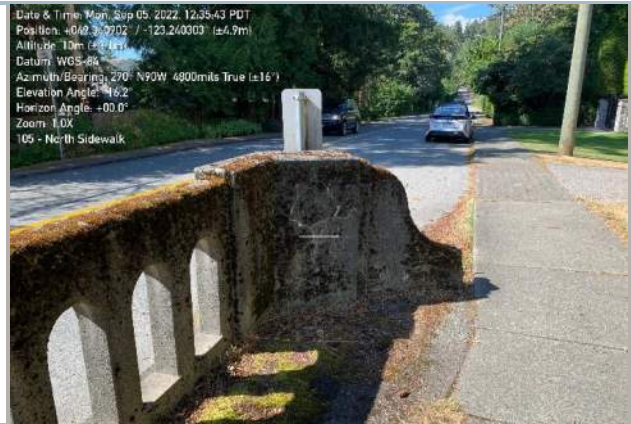
023. Efflorescence and Cracking Northwest Section of Parapet

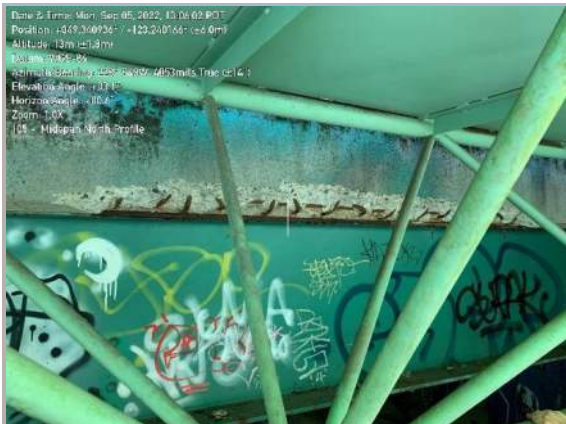
024. Exposed Section of Reinforcing at North Profile, Typ.

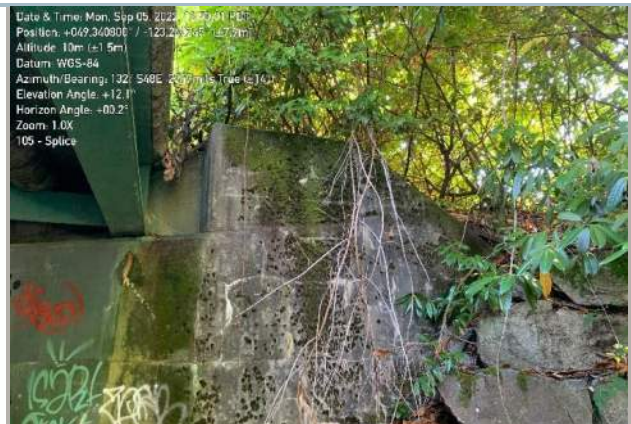
025. Efflorescence and Cracking at Southeast Wingwall

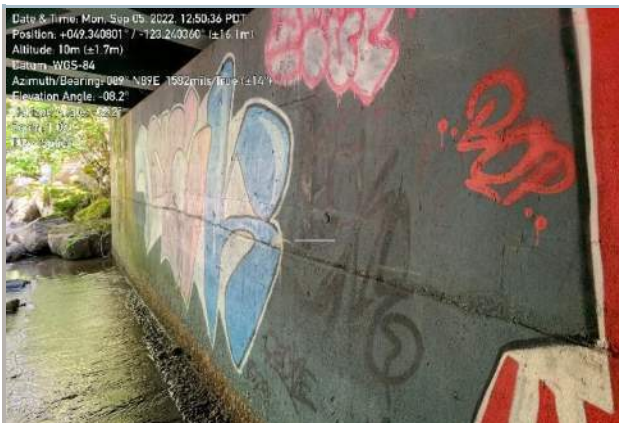
026. Longitudinal Cold-joint Separation at East Abutment Front Wall

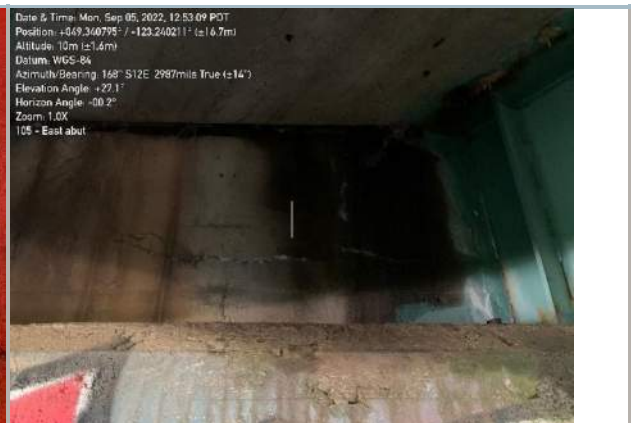
027. Efflorescence and Cracking at East Abutment Back Wall, Typ.

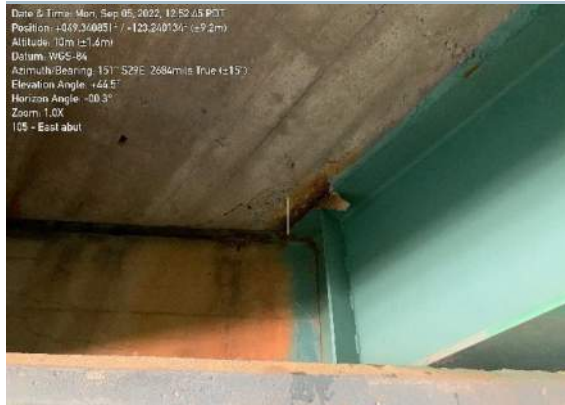
028. Top Flange Corrosion and Concrete Delamination at Soffit, Typ.

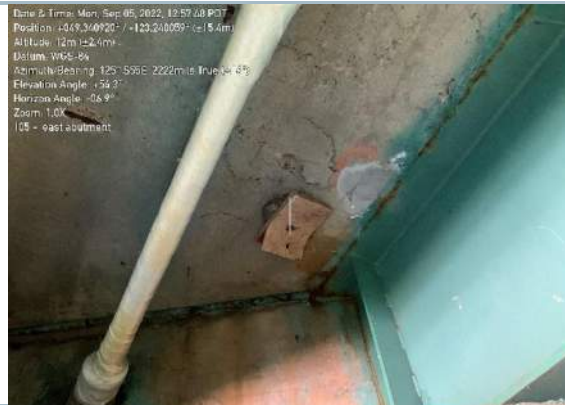
029. Localized Exposed Reinforcing at Soffit, Typ. (Note: Concrete Delamination at Northeast Section of East Abutment)

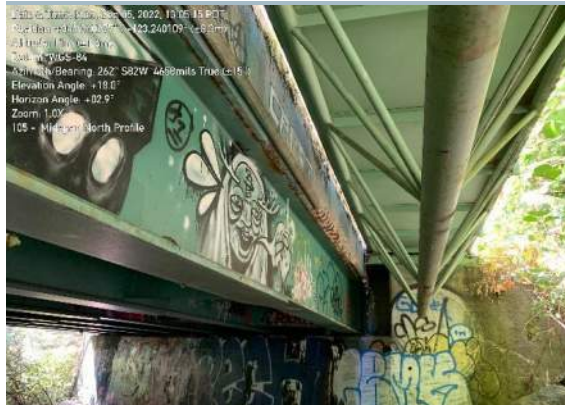
030. Continuous Top Flange Corrosion of North Stringer, Typ.

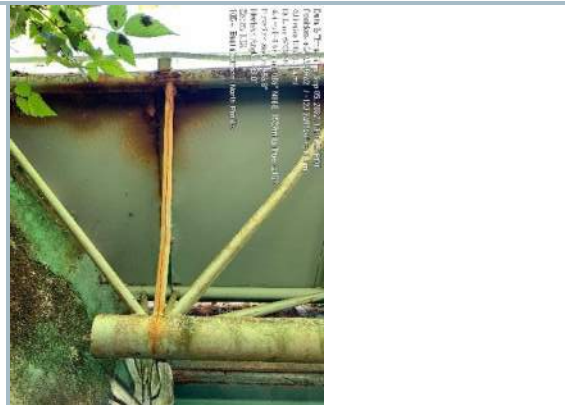
031. Bent Truss Strut Element and Corroding Walkway Soffit, Typ.

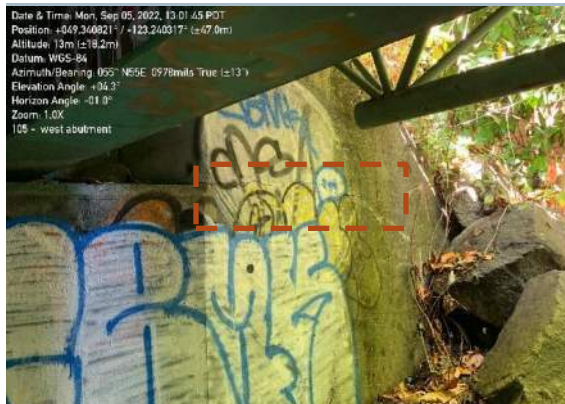
032. Cracking at Northwest Wingwall Section

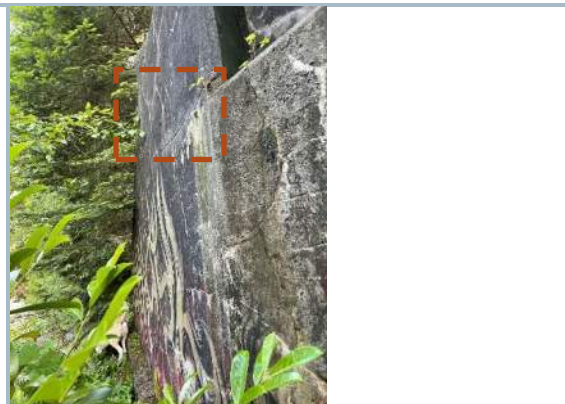
033. Wingwall Cracking at Southwest Side Wall

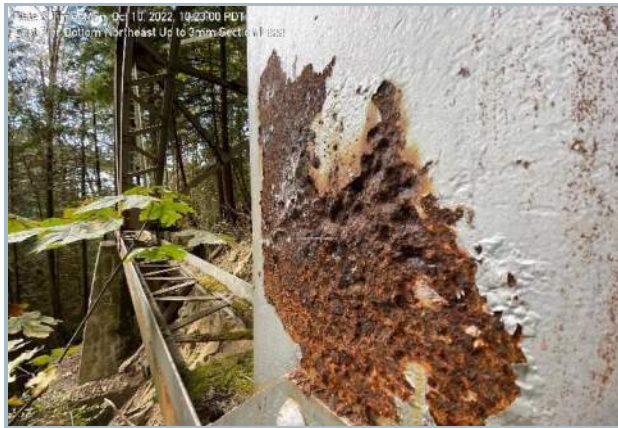
036. Pitting Corrosion with ~3mm Section Loss at Bottom of Northeast Pier

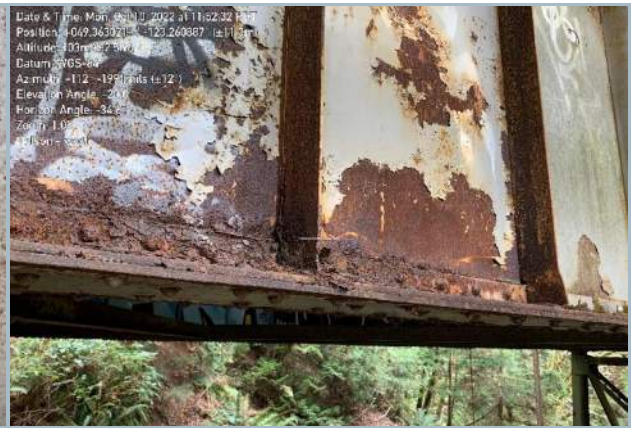
037. Deposit Attack and Accumulation on Bottom Flange of South Girder, Typ. (Note: Deterioration of Rivets)

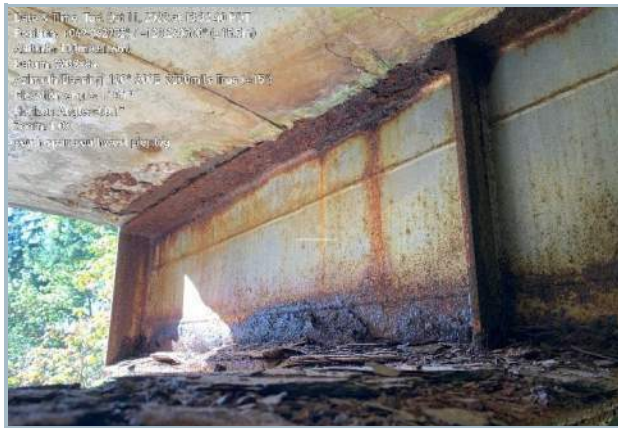
038. Accelerated Uniform Corrosion at Bottom Flange of Floor Beam 5

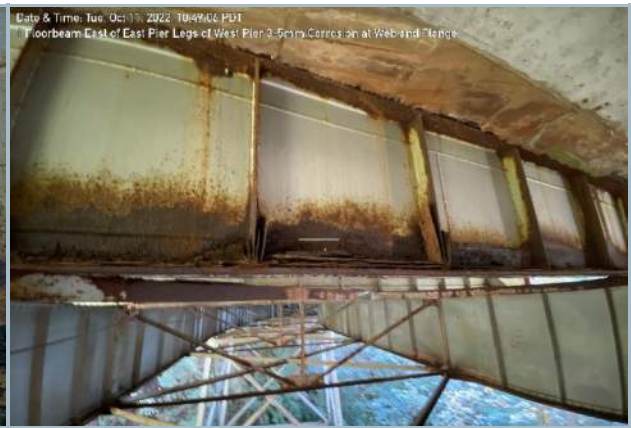
039. 3-5mm Section Loss on Bottom Flange of Floor Beam 9 (Note: Top Flange Corrosion, Typ.)

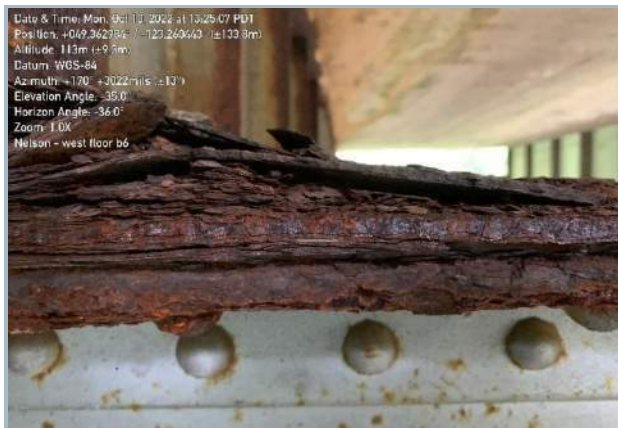
040. Accelerated Uniform Corrosion on Top Flange of Floor Beam 5, Typ.

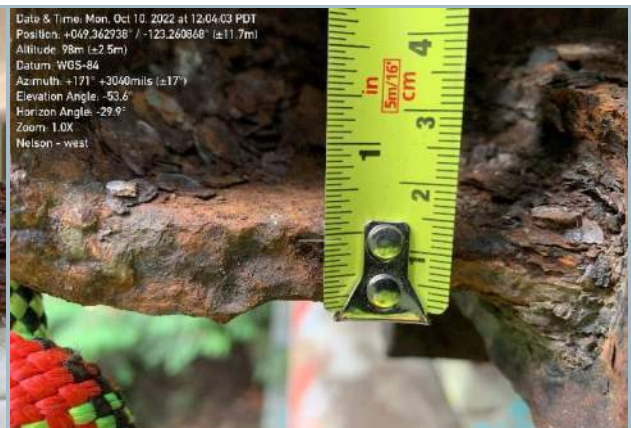
041. 3-5 Section Loss at Bottom Flange of Floor Beam 5 Below Expansion Joint

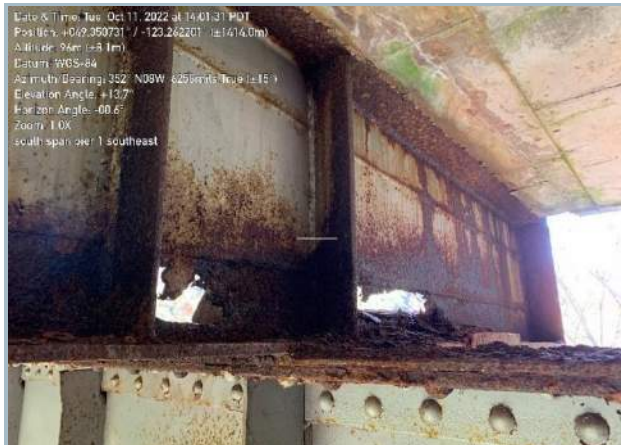
042. Complete Section Loss at Floor Beam 7

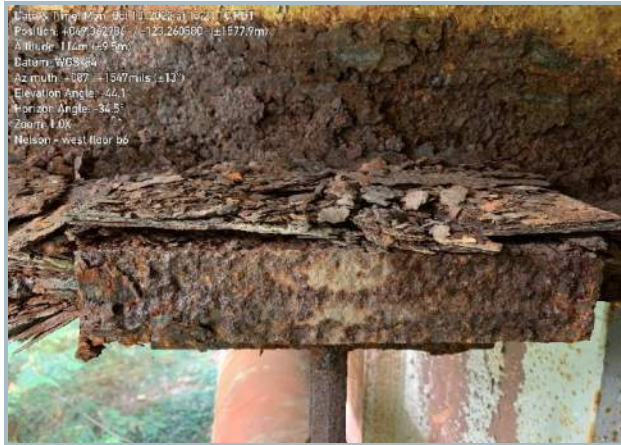
044. Accelerated Uniform Corrosion at Bottom Flange of Floor Beam 6

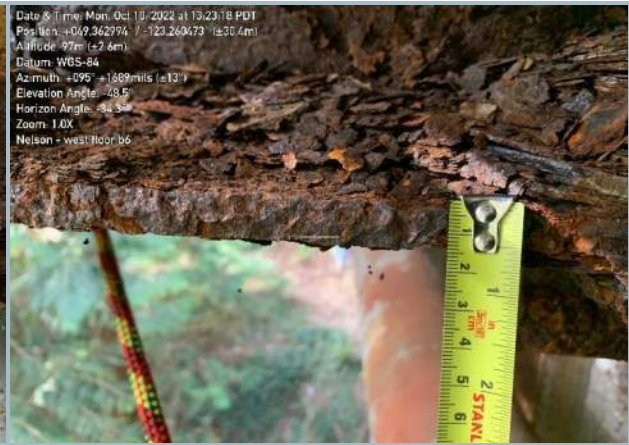
045. 3-5mm Section Loss at Bottom Flange of Floor Beam 6

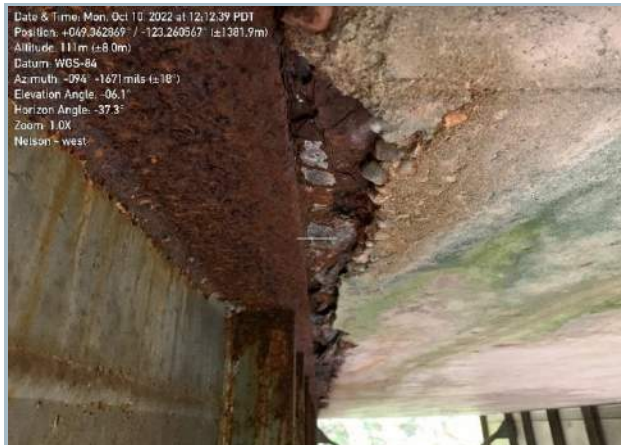
046. Top Flange Corrosion and Spalling of Deck Soffit at Floor Beam 14
