DISTRICT OF WEST VANCOUVER
750 17TH STREET, WEST VANCOUVER BC V7V 3T3

COUNCIL REPORT

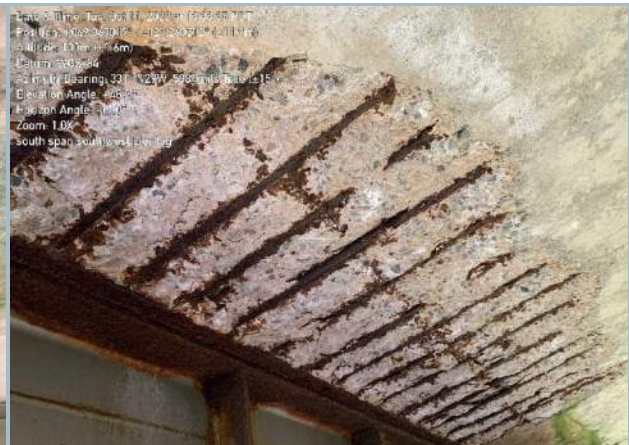
047. Exposed Reinforcing Section of Deck Soffit at Floor Beam 15

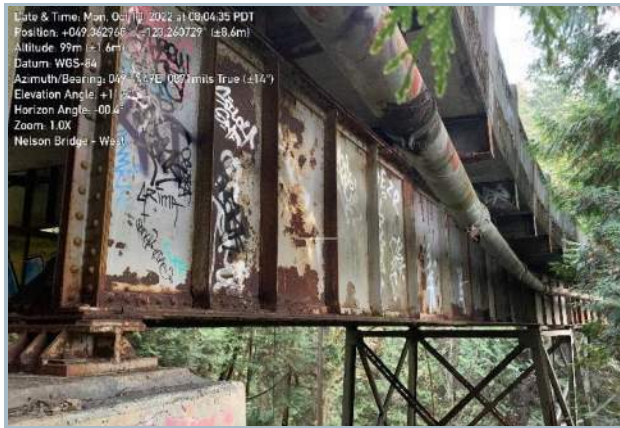
048. South Girder Bottom Flange Corrosion, Typ.

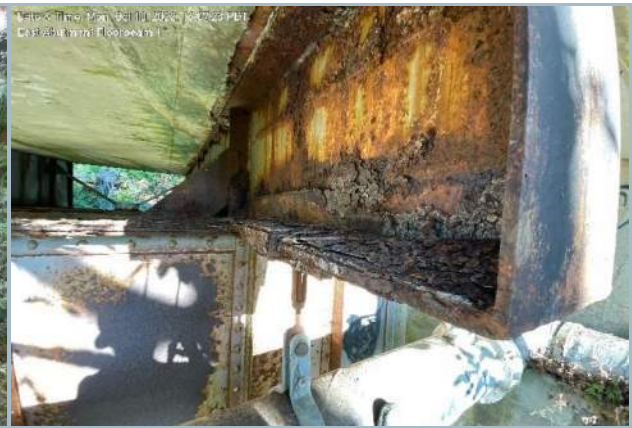
049. Accelerated Corrosion and Deposit Attack on Floor Beam 2

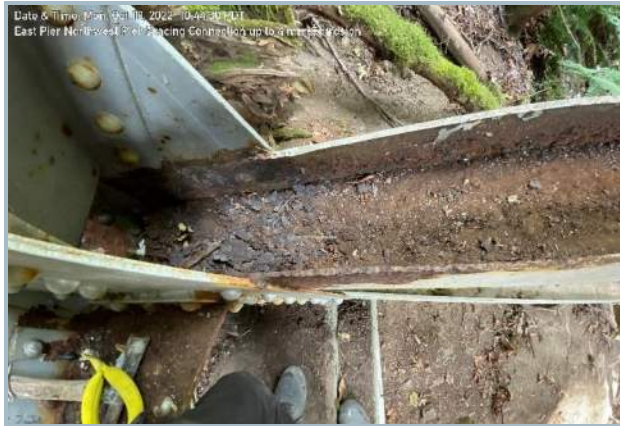
050. 4mm Section Loss at Northwest Base of West Pier

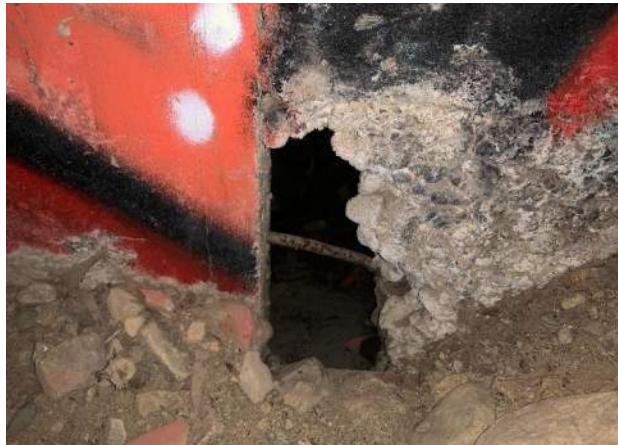
054. Concrete Void at West Abutment South Side Wall

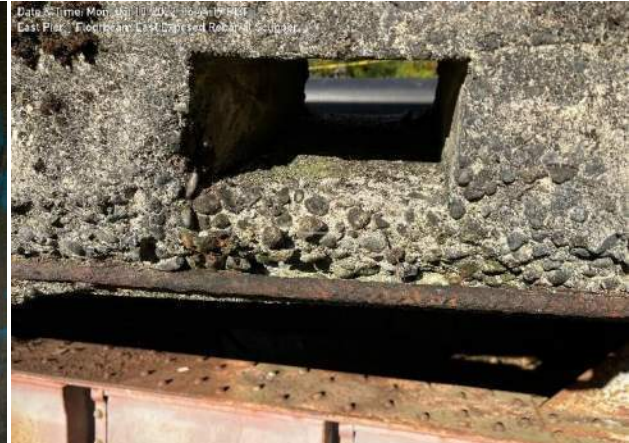
057. Concrete Spall and Exposed Reinforcing at Midspan of South Girder Profile

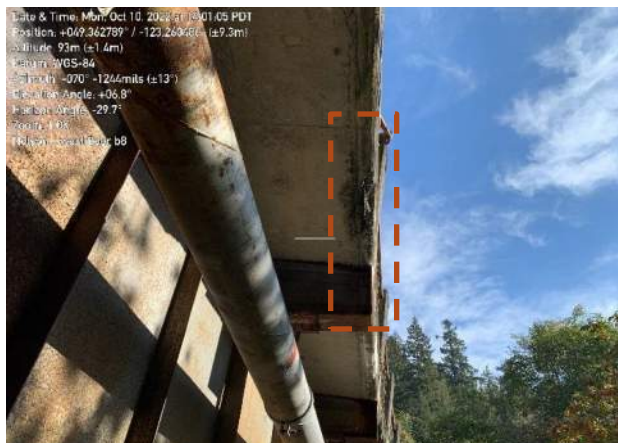
058. Localized Sections of Exposed Reinforcing at Midspan along South Profile, Typ.

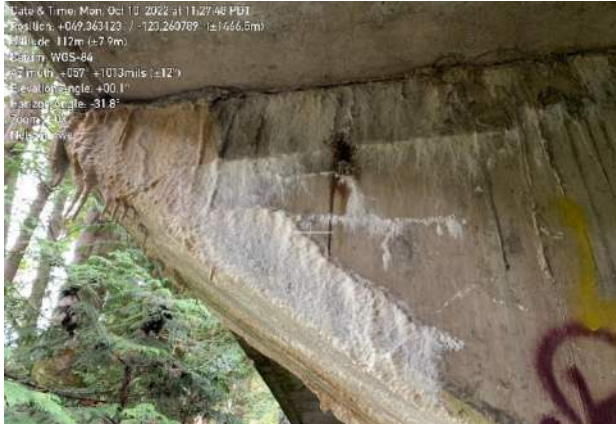
060. Efflorescence on Deck Soffit of West Abutment

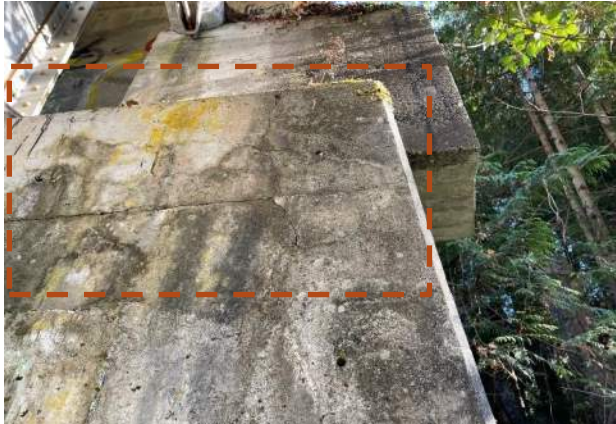
062. Extensive Cracking at East Abutment Side Wall

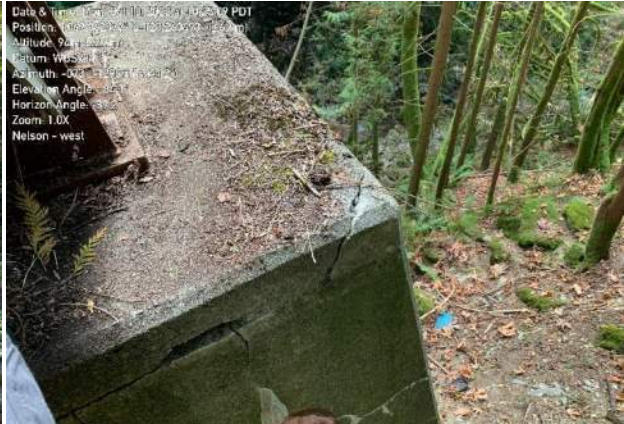
063. Cracking and Separation at Southeast Pedestal of West Pier, Typ.

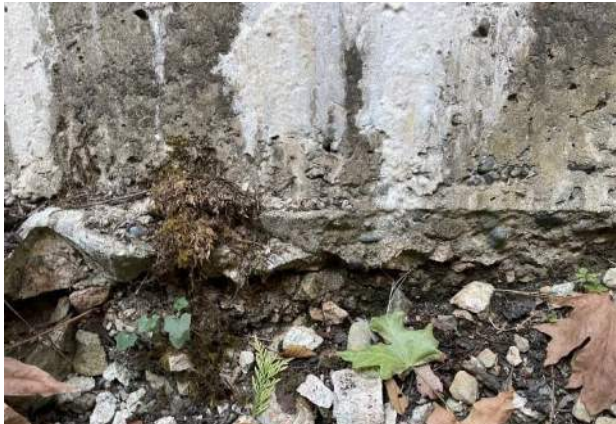
064. Undermining and Aggregate Exposure East Abutment Wing Wall

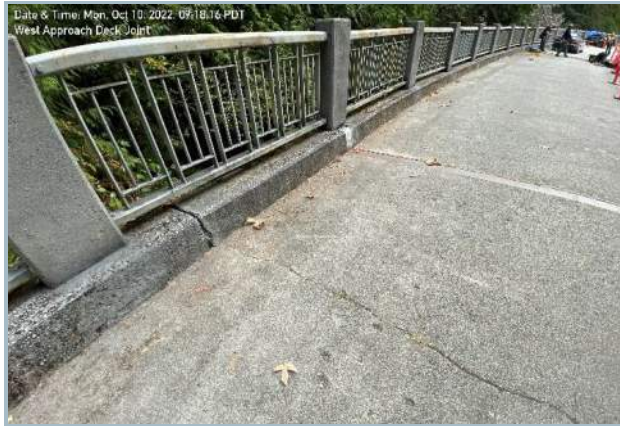
066. Cracking on Asphalt Wearing Surface at West Approach Deck Joint, Typ.

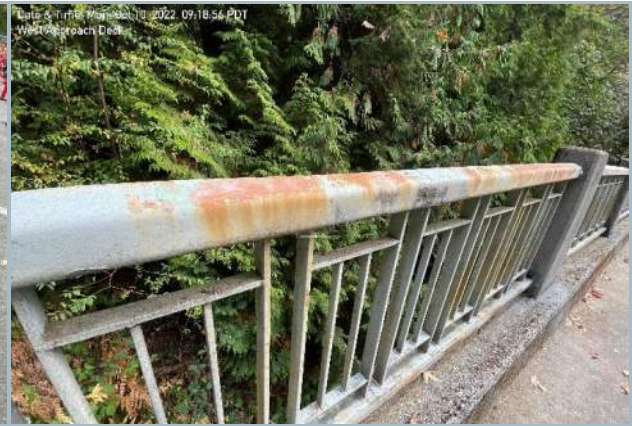
067. Localized Inconsequential Surface Corrosion on Northwest Railing, Typ.

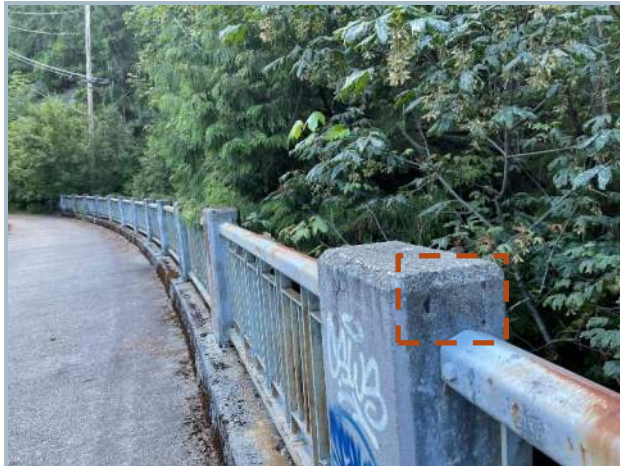
068. Localized Exposed Reinforcing on Deck Parapet at Midspan

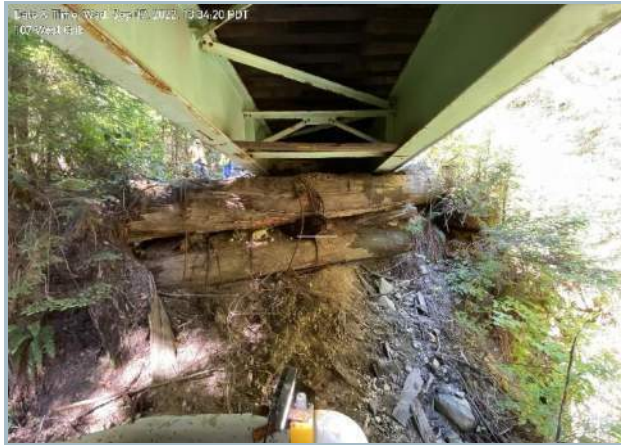
018. Unsecure Timber Crib at North Abutment

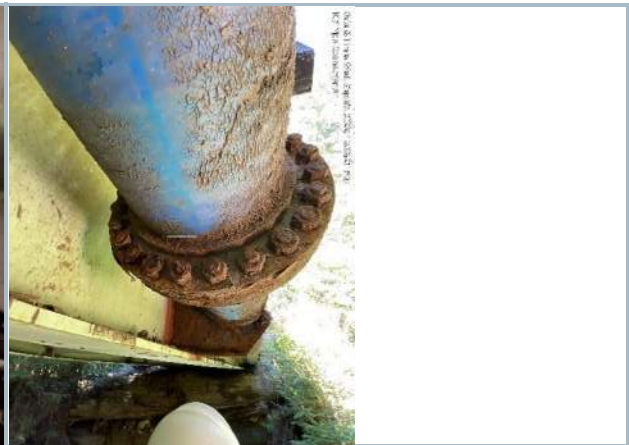
021. Corroding Utility Pipe Joint

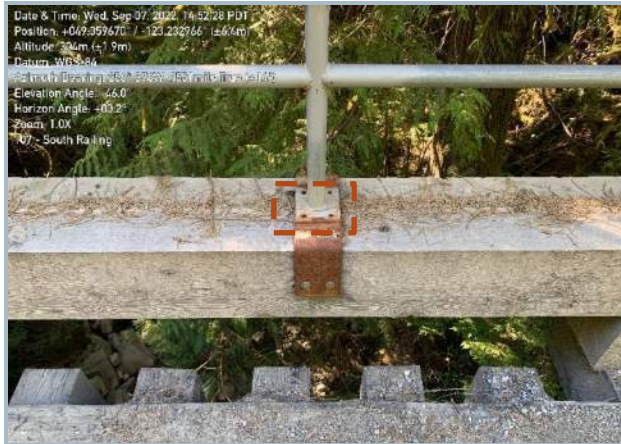
022. Anchor Bolts Not Installed at Rail Connection

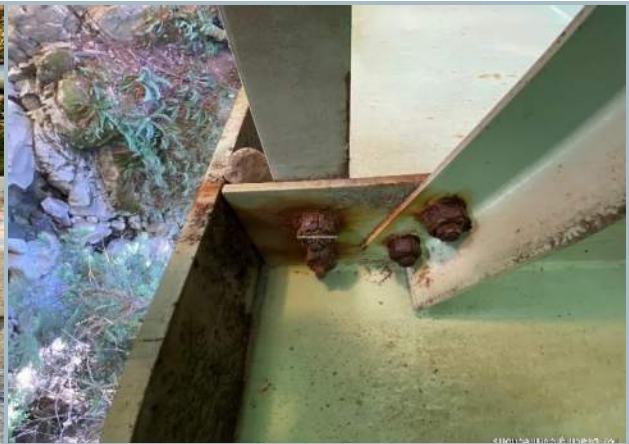
023. Degrading Bolts at Cross-brace Gusset Plate

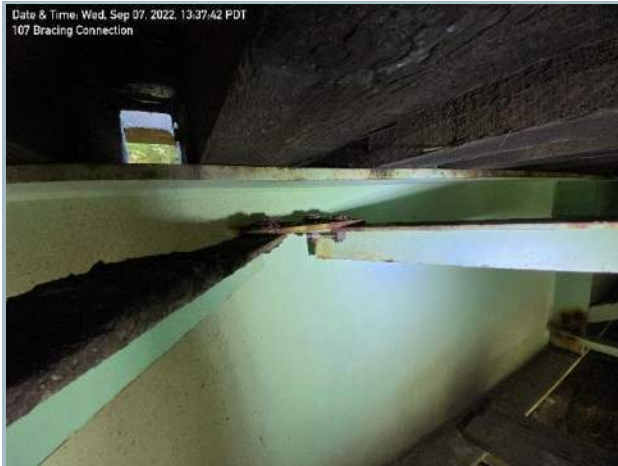
024. Degrading Bolts on Gusset Plate Connection
Subject to Crevice Corrosion

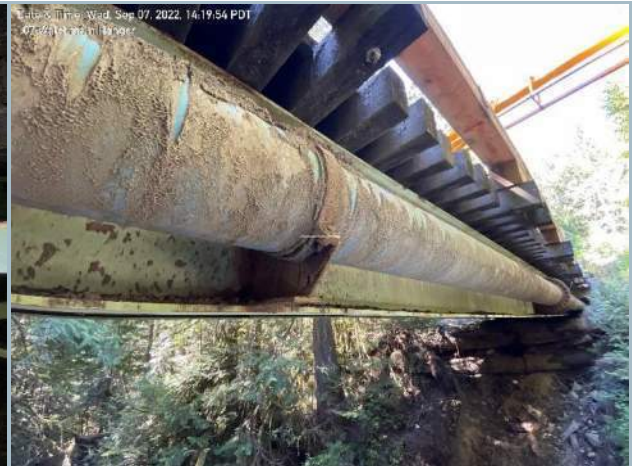
025. Corroding Pipe Hanger, Typ.

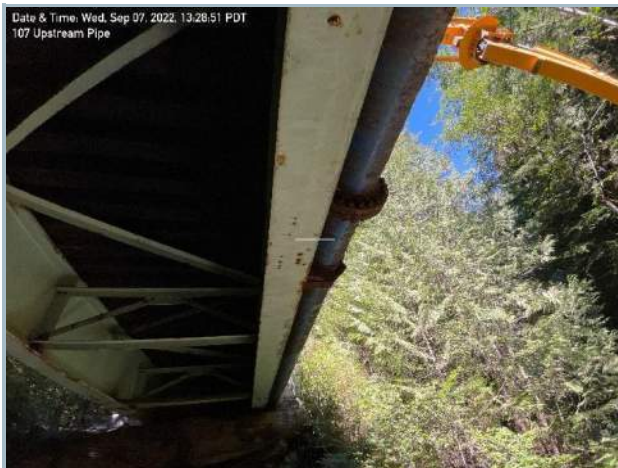
026. Intermittent Under Film Corrosion on Bottom
Flange of West Girder

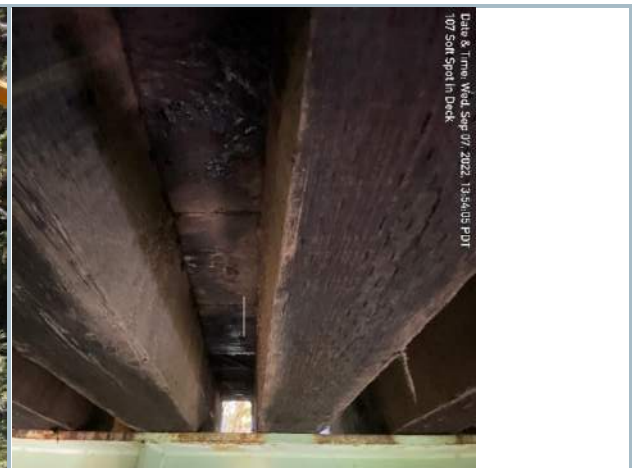
027. Rotting Timber Section at Midspan

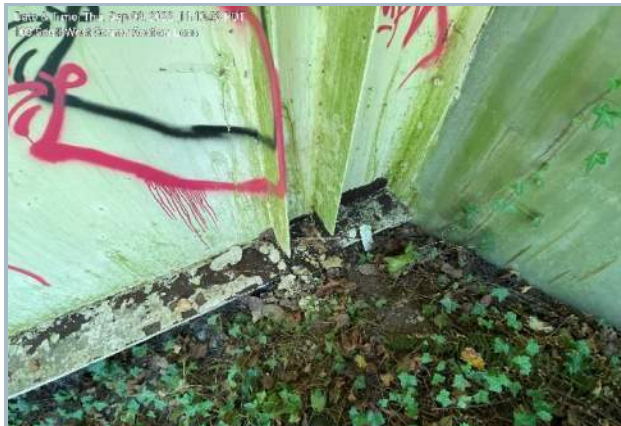
023. Coating Failure on Bottom Flange of Girder at Southwest Corner

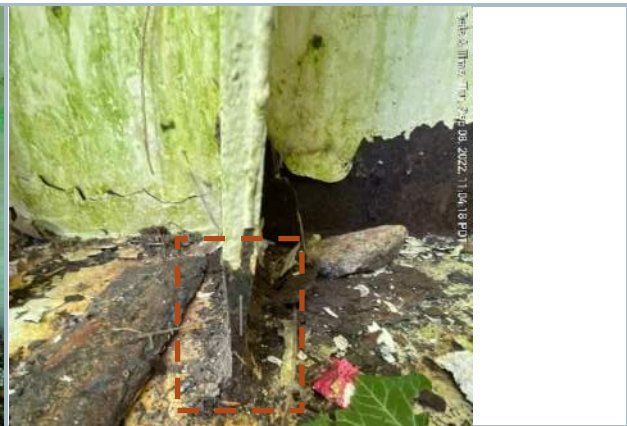
014. Stiffener Section Loss at Southwest Corner

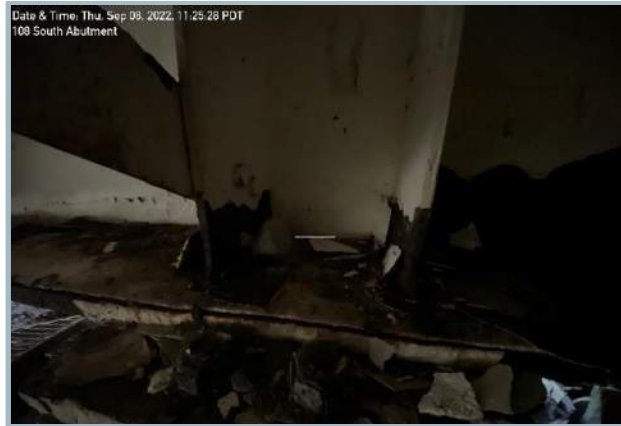
015. Coating Failure at Bearing Plate of South Abutment

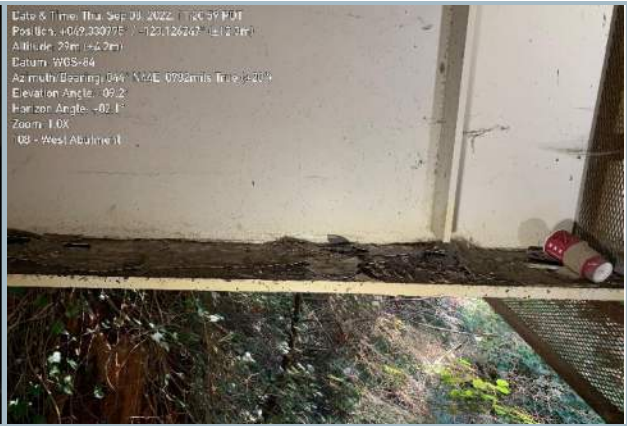
016. Localized Sections of Coating Failure at Bottom Flange of South Girder, Typ.

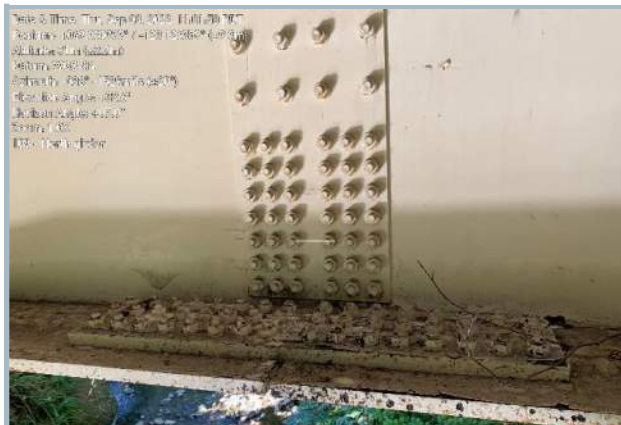
017. Localized Sections of Coating Failure at Splice Locations, Typ.

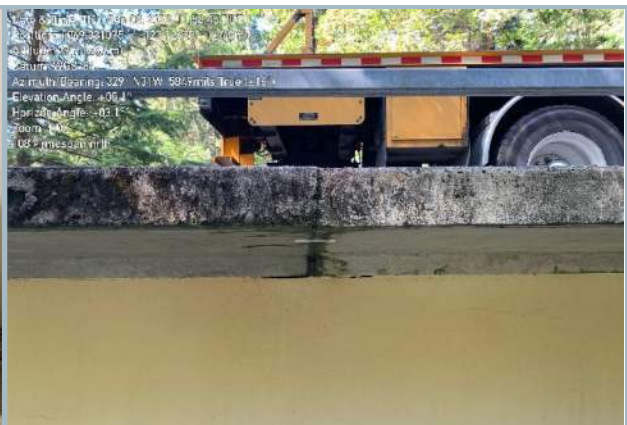
018. Separation in Concrete and Spalling Occurring at Deck Joints, Typ.

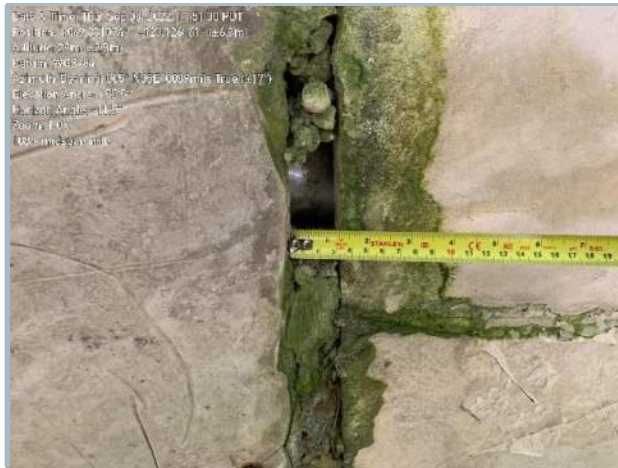
019. 1.25" Concrete Void at Deck Joint Viewed from Sidewalk Soffit

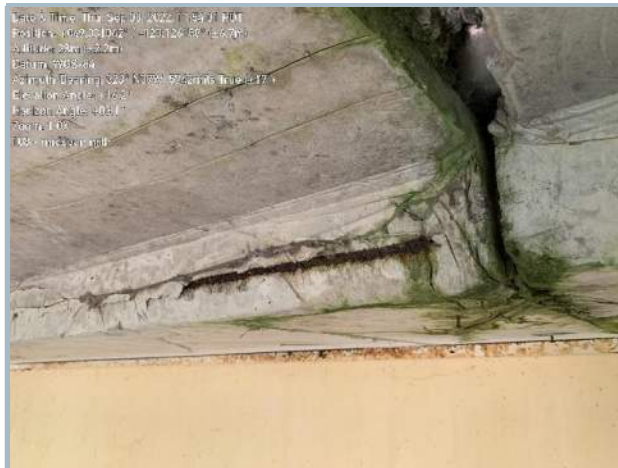
021. Exposed Reinforcing Adjacent to Deck Joint Separation (Note Extensive Cracking Emanating from Deck Joint)

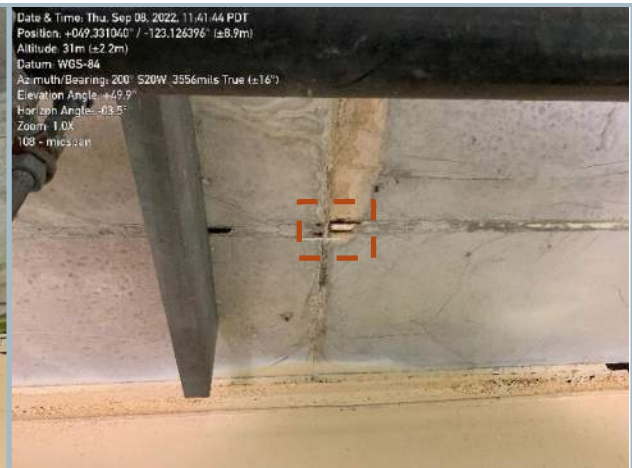
022. Localized Sections of Exposed Reinforcing along Deck Soffit

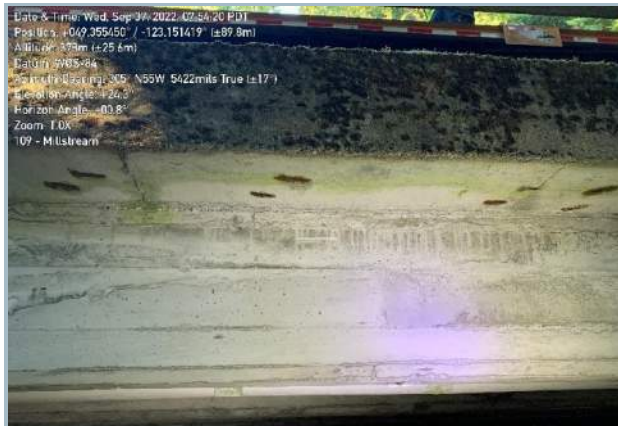
018. Exposed Reinforcing along Girder 5 Soffit (Southmost Girder)

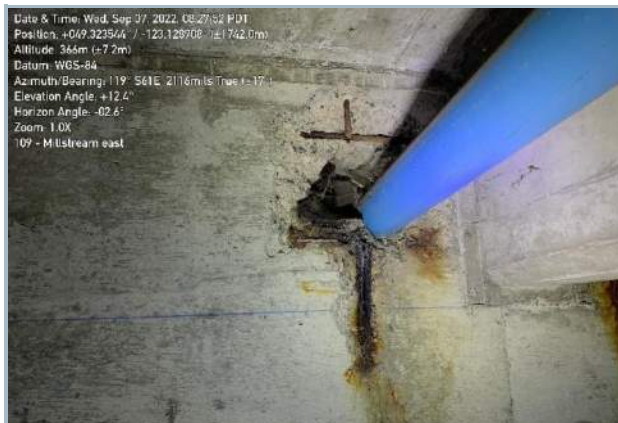
022. Concrete Spalling and Exposed Reinforcing at Utility Pipe Connection at East Abutment

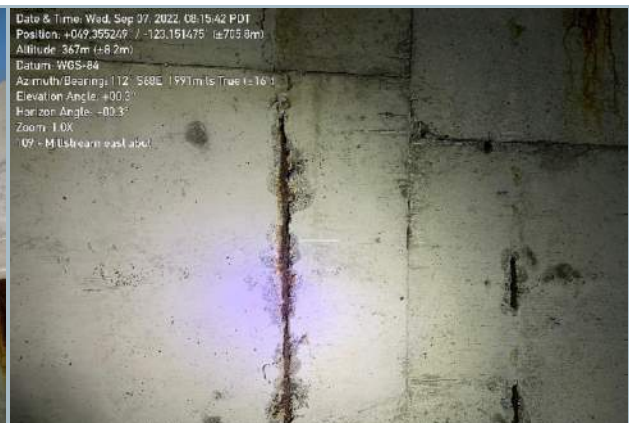
023. Exposed Reinforcing at East Abutment

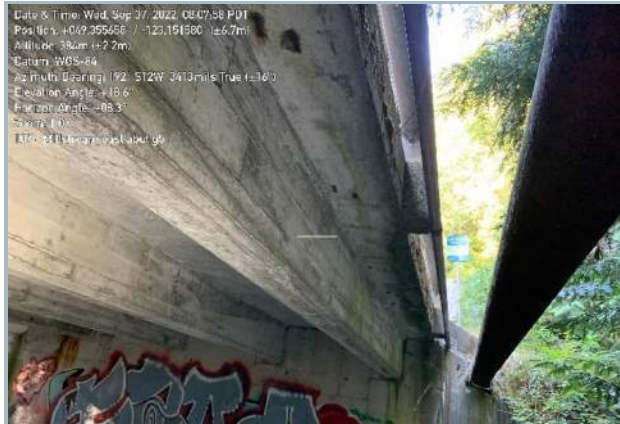
024. Staining of Deck Soffit at Southmost Girder

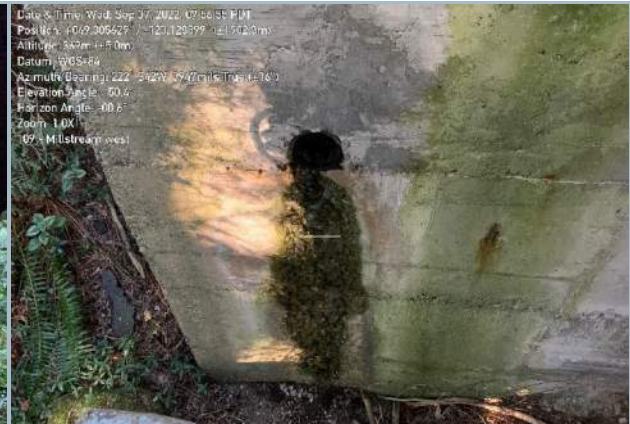
025. Spalling and Staining of Drain Outlet at West Abutment

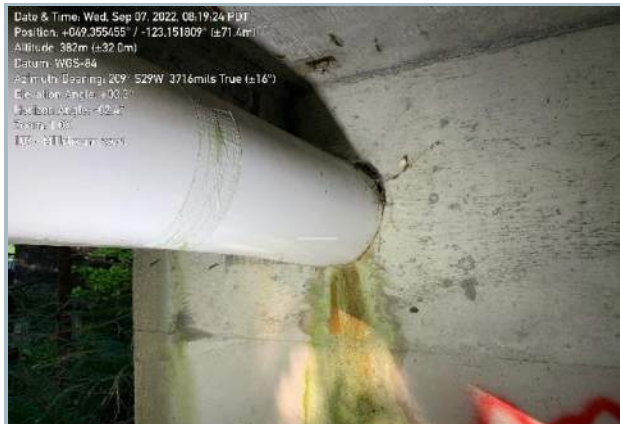
026. Staining of Utility Line at West Abutment

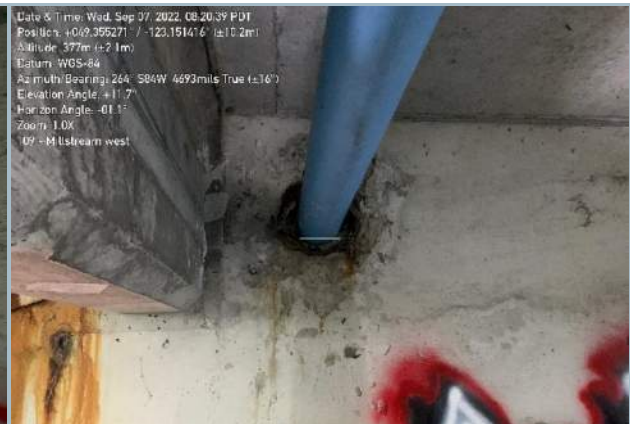
027. Spalling and Staining Around Gas Utility Line at West Abutment

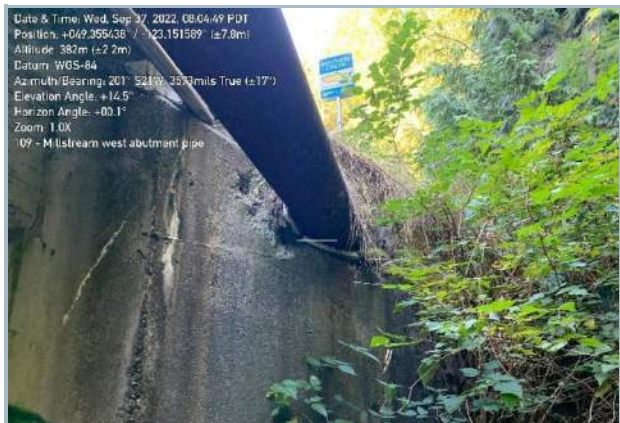
028. Spalling and Staining of Utility Line Connection at Northwest Wing Wall

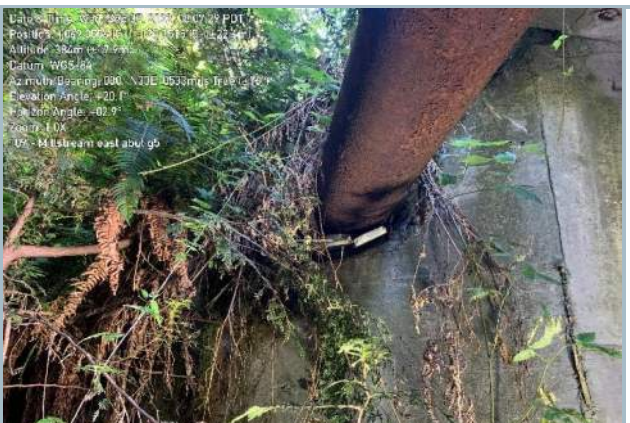
029. Spalling and Staining of Utility Line Connection at Northeast Wing Wall

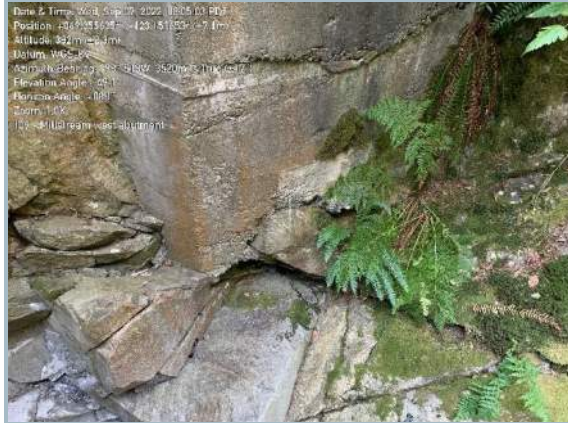
024. Undermining at South Section of West Abutment

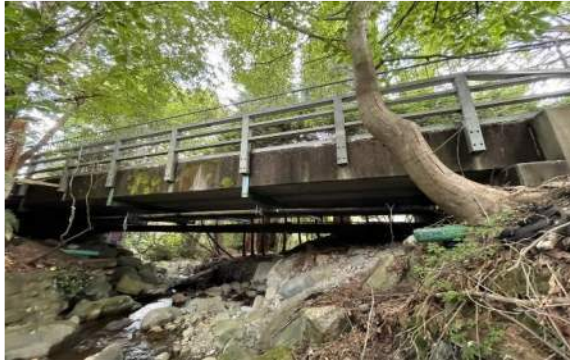
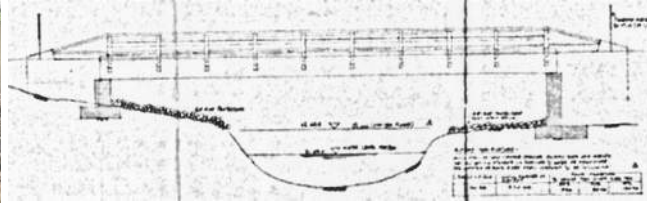
CONSTRUCTION DATE:	1995	
BRIDGE ORIENTATION:	East-West	
FEATURE SUPPORTED:	Sinclair Court	
FEATURE CROSSED:	Lawson Creek	
SUBSTRUCTURE:	Abutments – semi-integral reinforced concrete on spread footings	
SUPERSTRUCTURE:	Prestressed concrete box girders	
WEARING SURFACE:	Unsurfaced	
APPROACHES:	Asphalt roadway is in straight-alignment with bridge	
GENERAL:	SPANS:	1-span: 18m
	TOTAL LENGTH:	18m
	DECK AREA:	133m ²
	BEARINGS:	Neoprene
	BANK/PIER PROTECTION:	Concrete wingwalls, rip-rapped
	GUARDRAIL:	Steel
	CURB:	Concrete
	UTILITIES:	Gas; Watermain; Electrical ducts
	CLEARANCE:	N/A
	ROADWAY CLASS:	Local
	SIGNAGE:	Delineators; Gas Pipeline
SEISMIC ASSESSMENT:	None	
DIAGNOSTIC TESTING/STUDY:	None	
PAST REHABILITATION WORKS:	None

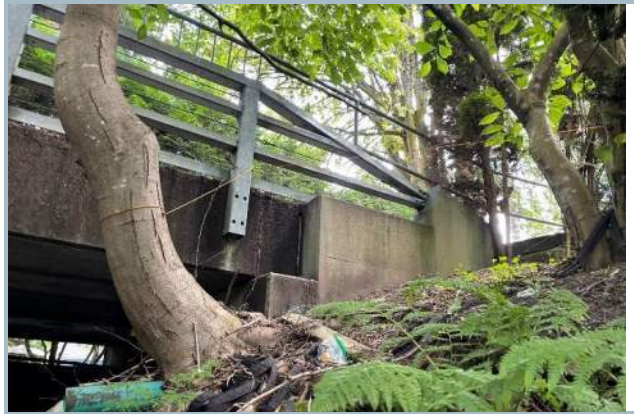
015. Prestressed Box Girders Bearing on Semi-Integral Abutment

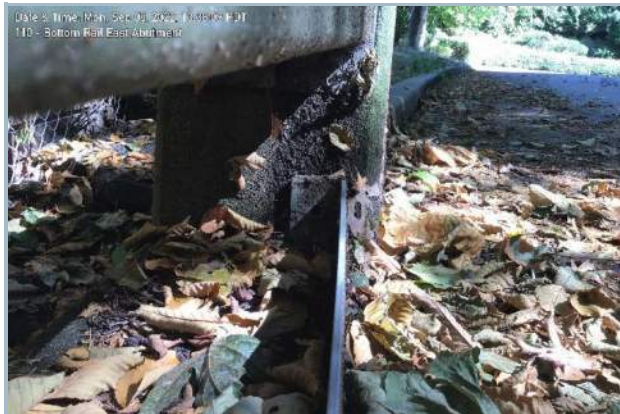
016. Dislodged Bottom Rail at Southeast Corner

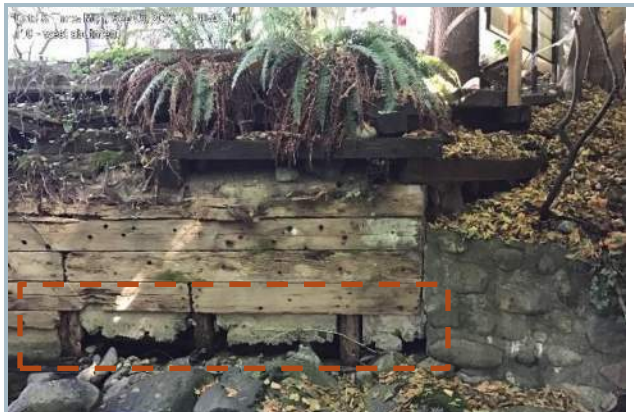
018. Degrading Timber Retaining Wall at Northeast Corner

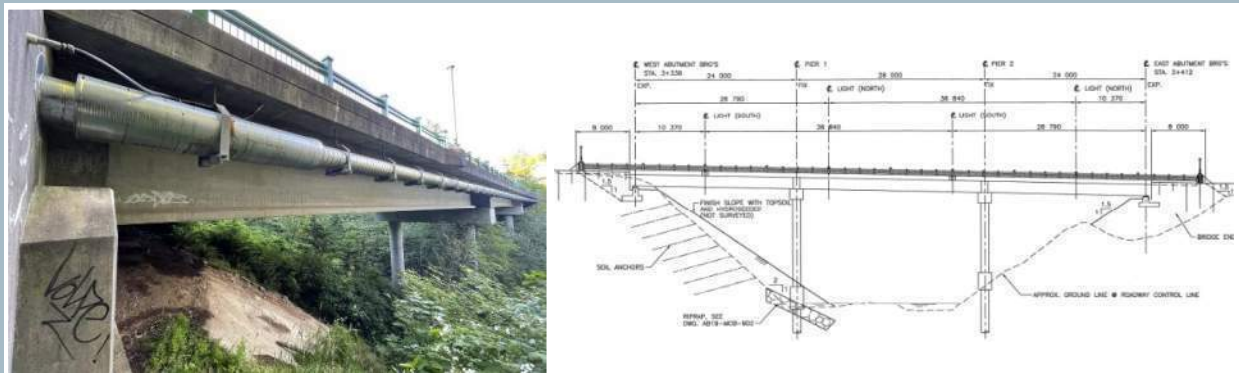
CONSTRUCTION DATE:	2002	
BRIDGE ORIENTATION:	East-West	
FEATURE SUPPORTED:	Chippendale Road	
FEATURE CROSSED:	McDonald Creek Main Branch	
SUBSTRUCTURE:	Abutments - Reinforced concrete on spread footings Piers - Concrete piers and columns supported by concrete pile cap and piles	
SUPERSTRUCTURE:	Prestressed concrete I-girders composite with a cast-in-place concrete deck	
WEARING SURFACE:	Asphalt	
APPROACHES:	Asphalt roadway is in straight-alignment with bridge	
GENERAL:	SPANS:	3-span; 25.9m-25.9m-25.9m
	TOTAL LENGTH:	77.6m
	DECK AREA:	871m ²
	BEARINGS:	Elastomeric
	BANK/PIER PROTECTION:	None
	GUARDRAIL:	Steel
	CURB:	Concrete
	UTILITIES:	Gas; Storm Sewer; Watermain
	CLEARANCE:	17m
	ROADWAY CLASS:	Local
	SIGNAGE:	Delineators; Fish-Bearing Stream
SEISMIC ASSESSMENT:	None	
DIAGNOSTIC TESTING/STUDY:	None	
PAST REHABILITATION WORKS:	None

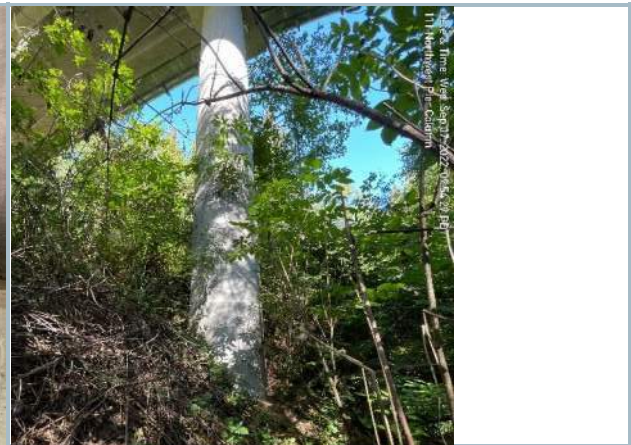
106. Deep Foundation, Typ.

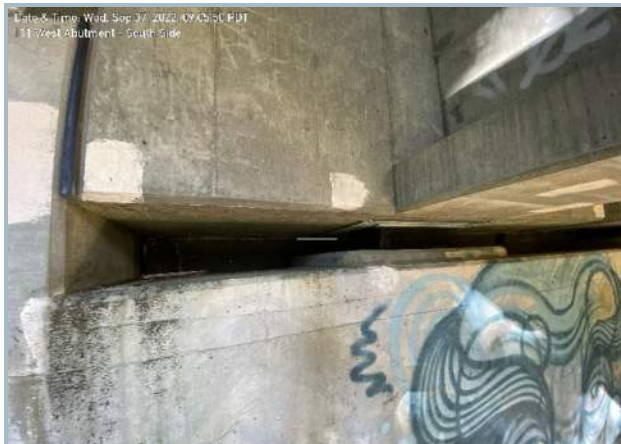
107. Elastomeric Bearing at South Section of West Abutment (Note: Elastomeric Pad on Short Side Wall Restraint)

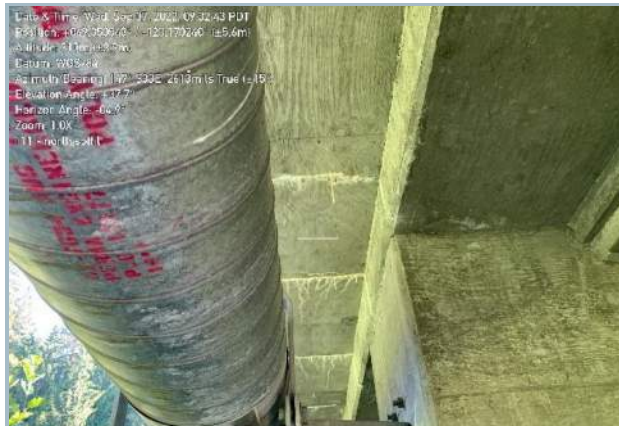
023. Intermitting Efflorescence along Overhang Soffit of North Profile

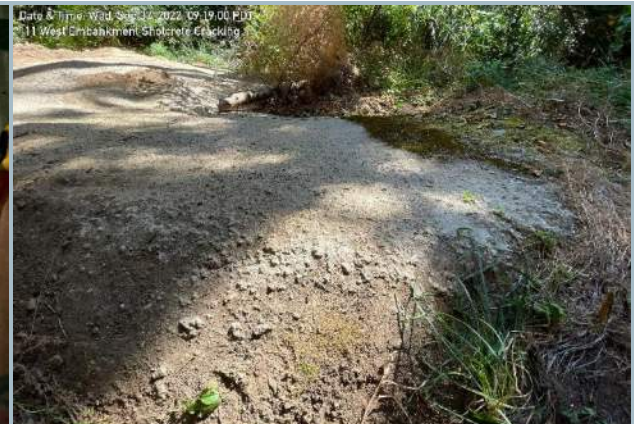
026. Cracking of Shotcrete on West Embankment

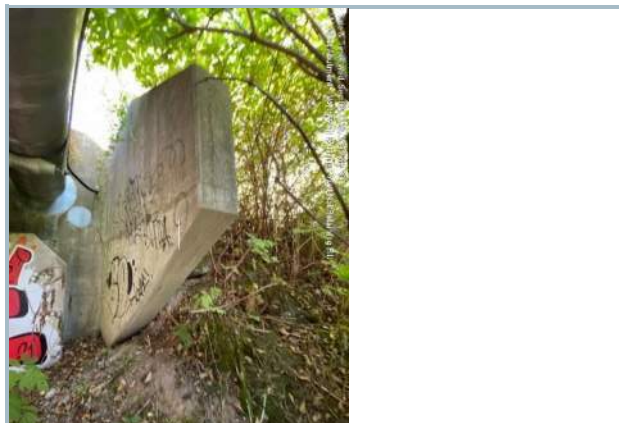
027. Wing Wall at Northwest Section Not Retaining Fill

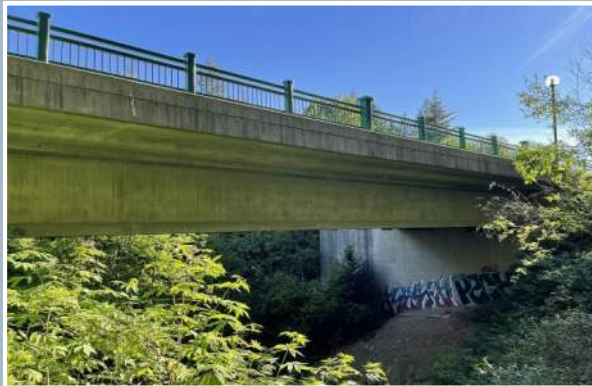
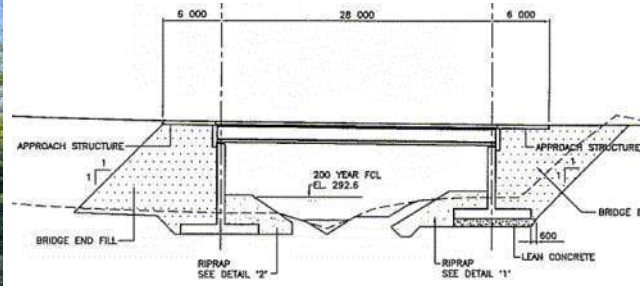
CONSTRUCTION DATE:	2004	
BRIDGE ORIENTATION:	East-West	
FEATURE SUPPORTED:	Chippendale Road	
FEATURE CROSSED:	Marr Creek	
SUBSTRUCTURE:	Abutments - Reinforced concrete on spread footings with MSE wingwalls	
SUPERSTRUCTURE:	3-Prestressed concrete I-girders composite with a cast-in-place concrete deck	
WEARING SURFACE:	Asphalt	
APPROACHES:	Asphalt roadway is in straight-alignment with bridge	
GENERAL:	SPANS:	1 -span
	TOTAL LENGTH:	28m
	DECK AREA:	314m ²
	BEARINGS:	Neoprene
	BANK/PIER PROTECTION:	None
	GUARDRAIL:	Steel
	CURB:	Concrete
	UTILITIES:	Gas; Watermain
	CLEARANCE:	6m
ROADWAY CLASS:	Local	
SIGNAGE:	Fish-bearing Stream	
SEISMIC ASSESSMENT:	None	
DIAGNOSTIC TESTING/STUDY:	None	
PAST REHABILITATION WORKS:	None

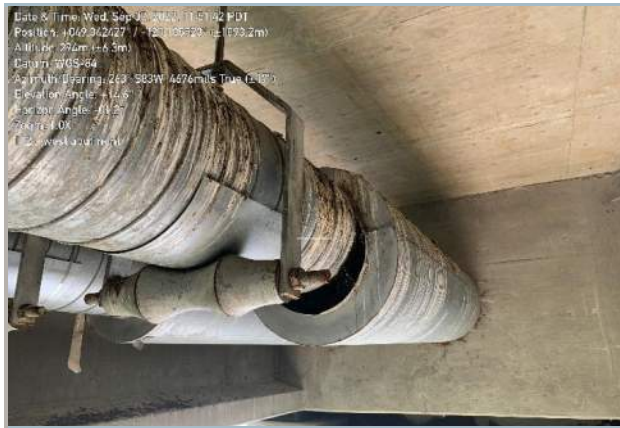
1016. Void at Utility Pipe Connection

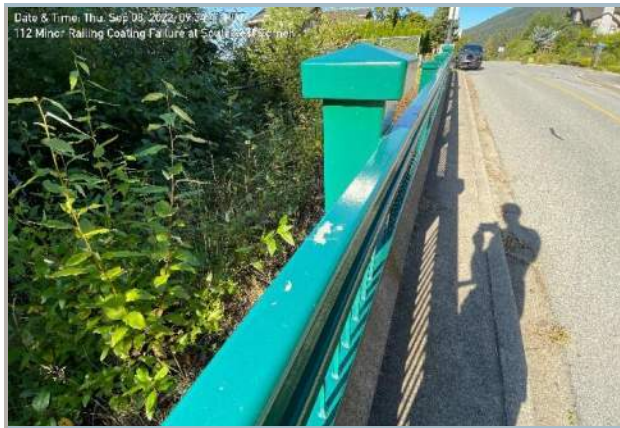
1018. Minor Coating Failure on South Railing

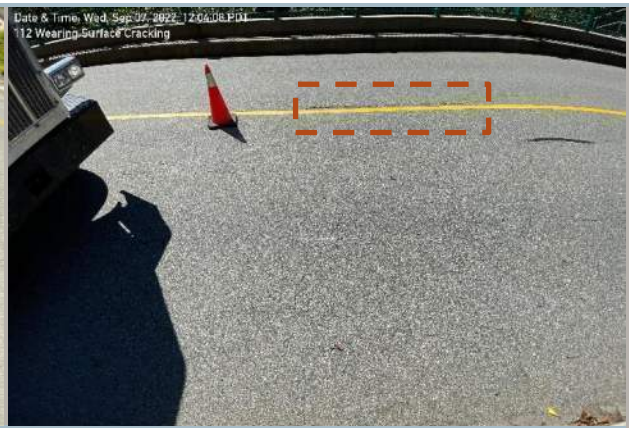
1019. Minor Cracking on Asphalt Wearing Surface at Midspan

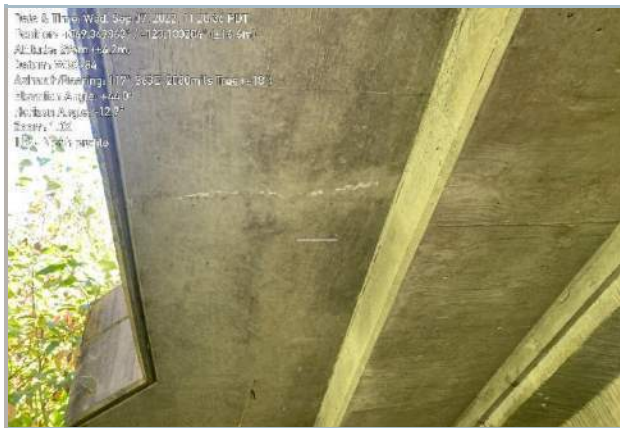
1020. Minor Efflorescence at North Profile

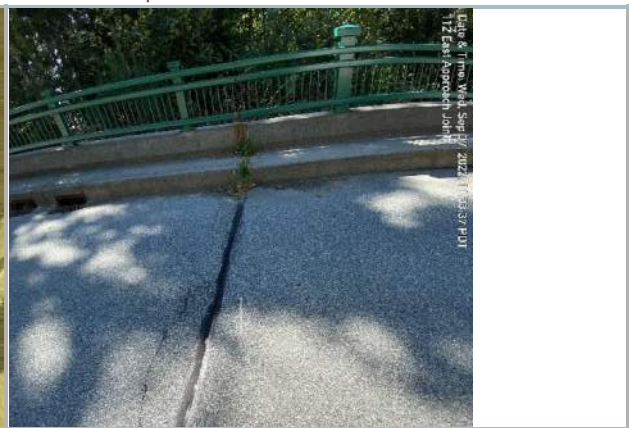
1021. Cracking of Asphalt Wearing Surface at East Approach Joint

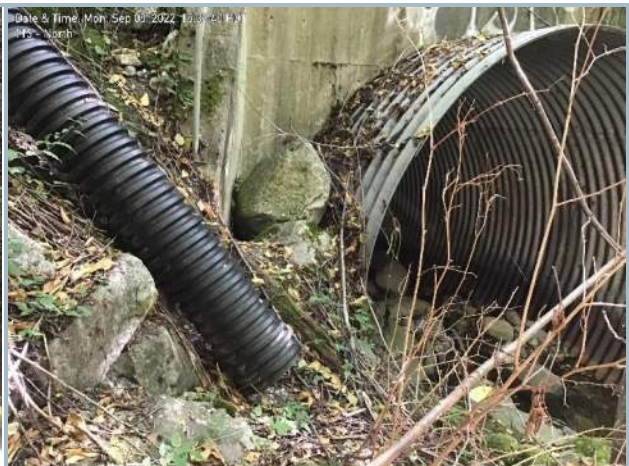
016. Stormwater Drainpipe East of Culvert Inlet

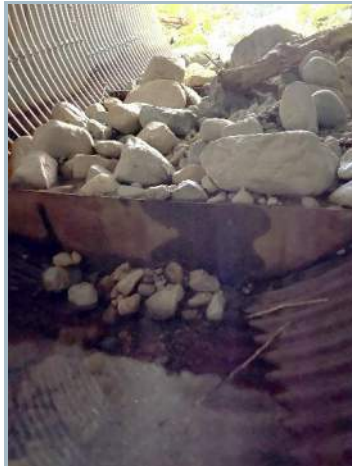
013. Obstructed Bulkheads, Typ.

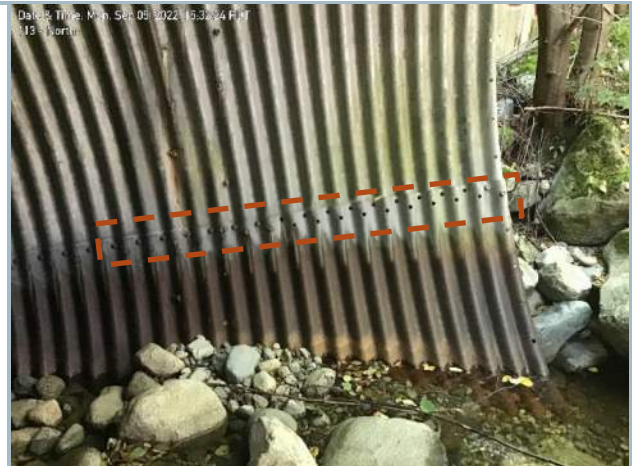
014. Missing Splice Bolts at Inlet

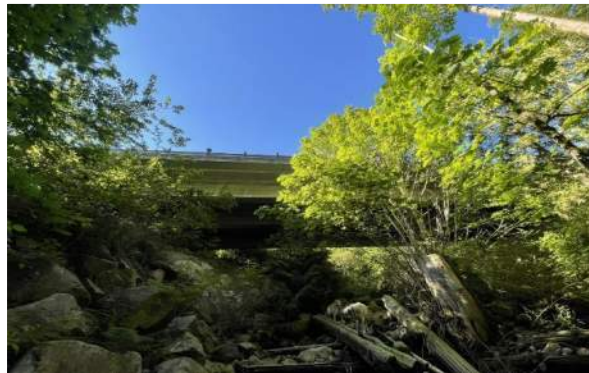
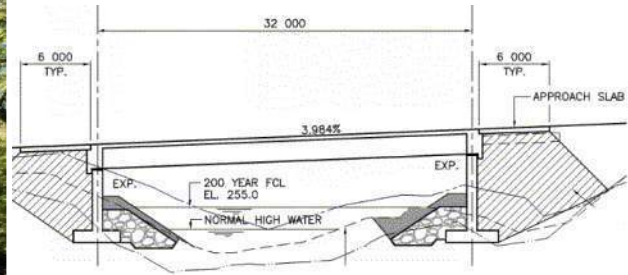
CONSTRUCTION DATE:	2010	
BRIDGE ORIENTATION:	East-West	
FEATURE SUPPORTED:	Chippendale Road	
FEATURE CROSSED:	Rogers Creek	
SUBSTRUCTURE:	Abutments – semi-integral reinforced concrete spread footings with MSE wingwalls	
SUPERSTRUCTURE:	Prestressed concrete I-girders, Composite with a cast-in-place concrete deck	
WEARING SURFACE:	Asphalt	
APPROACHES:	Asphalt roadway in a straight-alignment with bridge	
GENERAL:	SPANS:	1-span
	TOTAL LENGTH:	32.0m
	DECK AREA:	82m ²
	BEARINGS:	Elastomeric Bearing
	BANK/PIER PROTECTION	None
	GUARDRAIL:	Steel
	CURB:	Concrete
	UTILITIES:	Gas; Watermain
	CLEARANCE:	3m
	ROADWAY CLASS:	Local
	SIGNAGE:	Delineators; Pedestrian Crosswalk; Fish-bearing Stream
SEISMIC ASSESSMENT:	None	
DIAGNOSTIC TESTING/STUDY:	None	
PAST REHABILITATION WORKS:	None

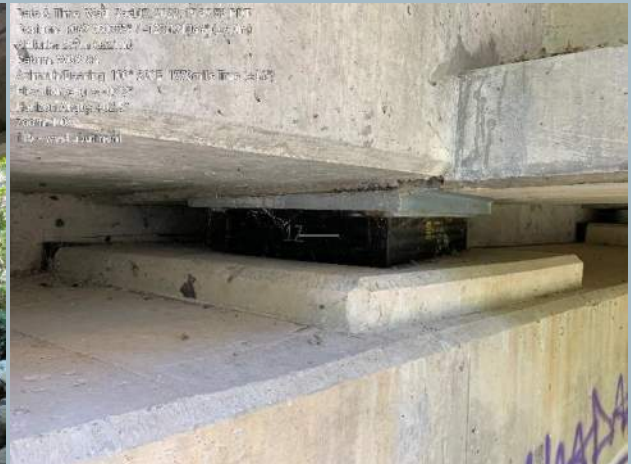
020. Elastomeric Bearing Pad
in Moderate Condition, Typ.

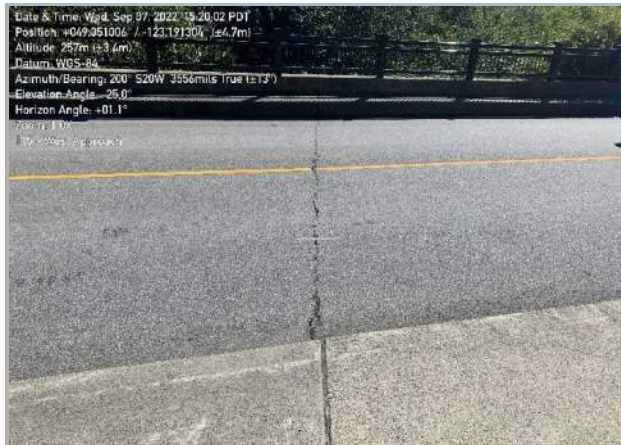
021. Cracking of Asphalt Wearing Surface at West Approach (Note Skewed Orientation)

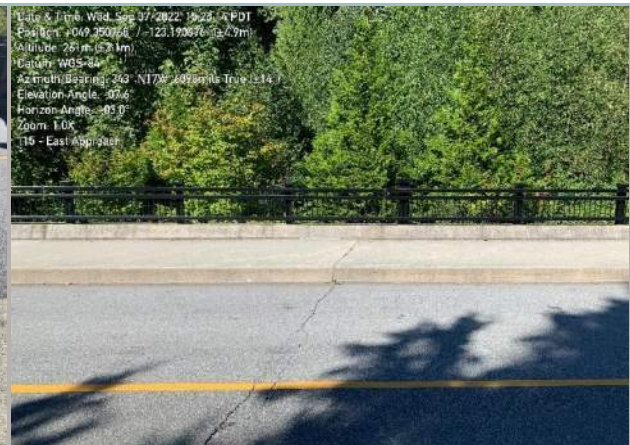
022. Cracking of Asphalt Wearing Surface at East Approach (Note Skewed Orientation)

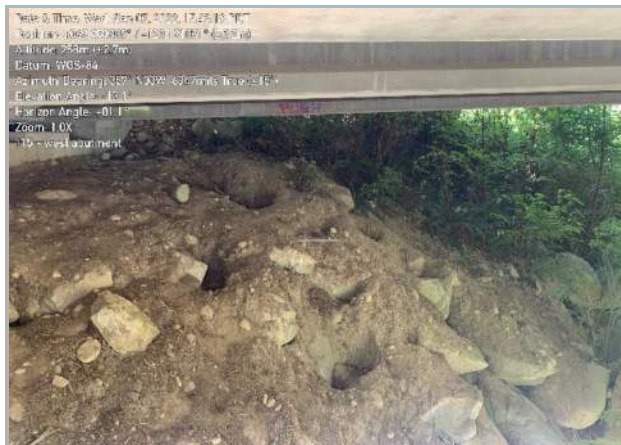
023. Scour Accumulation on West Embankment

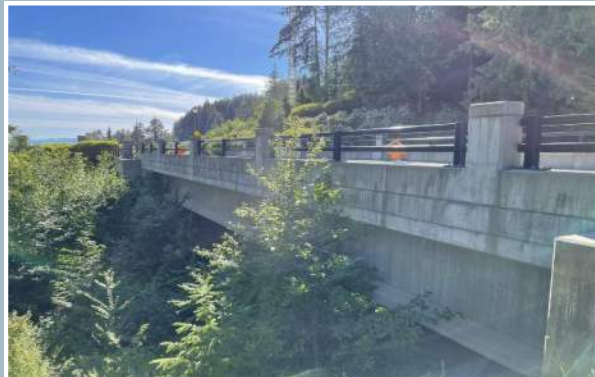
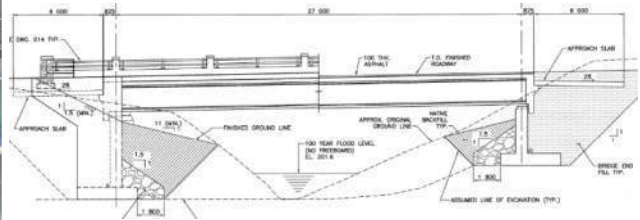
CONSTRUCTION DATE:	2014	
BRIDGE ORIENTATION:	East-West	
FEATURE SUPPORTED:	Single lane for Chippendale Road	
FEATURE CROSSED:	Pipe Creek	
SUBSTRUCTURE:	Abutments - Reinforced concrete on spread footings with MSE wall	
SUPERSTRUCTURE:	3 - Prestressed concrete I-girders, Composite with a precast concrete deck	
WEARING SURFACE:	Asphalt	
APPROACHES:	Asphalt roadway in straight-alignment with bridge	
GENERAL:	SPANS:	1-span: 27.0m
	TOTAL LENGTH:	27.0m
	DECK AREA:	108m ²
	BEARINGS:	Elastomeric Bearing
	BANK/PIER PROTECTION	None
	GUARDRAIL:	Steel
	CURB:	Concrete
	UTILITIES:	Watermain
	CLEARANCE:	9.5m
	ROADWAY CLASS:	Local
	SIGNAGE:	Stop and Yield signs to accommodate single-lane traffic
SEISMIC ASSESSMENT:	None	
DIAGNOSTIC TESTING/STUDY:	None	
PAST REHABILITATION WORKS:	None

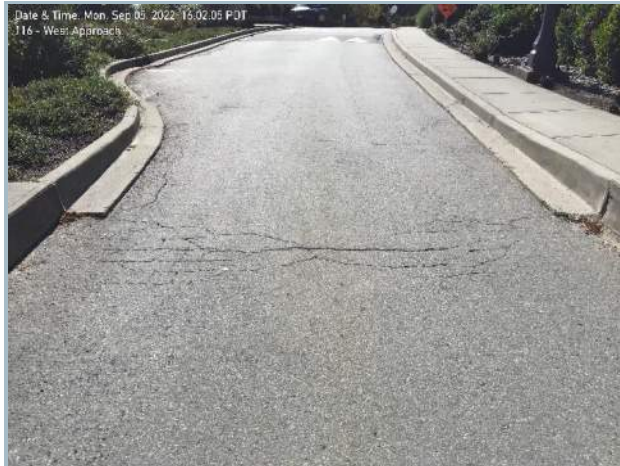
017. Cracking of Asphalt Wearing Surface Along Approach Slab, Typ.

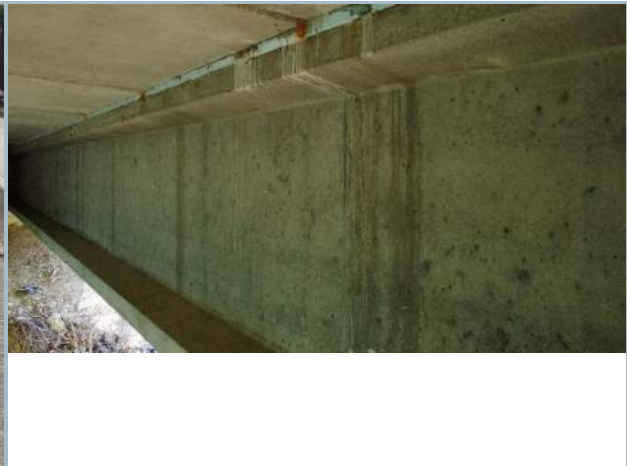
018. Moisture Ingress at Soffit Below Cracked Asphalt of Approach Slab

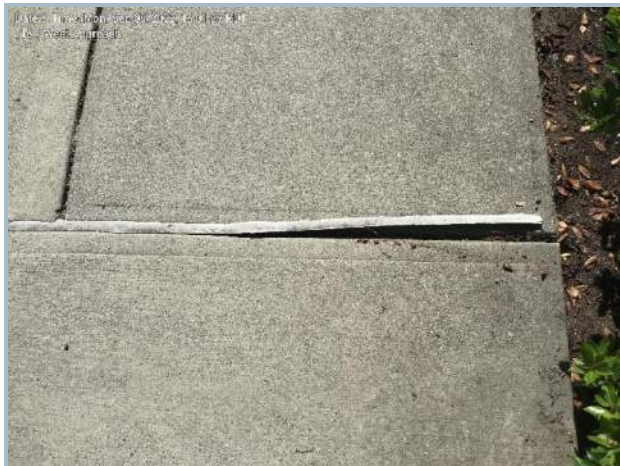
019. Expansion Joint Peel at Northeast Section of Sidewalk

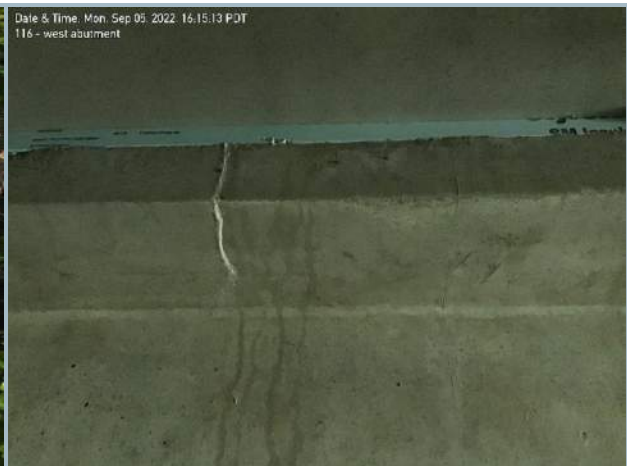
020. Minor Cracking & Efflorescence along Top Flange of Central Girder at West Abutment

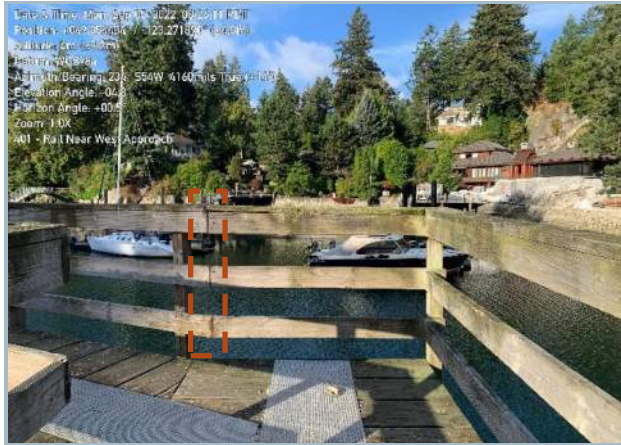
024. Vertically Unsupported Timber Splice at Bedrock Pier

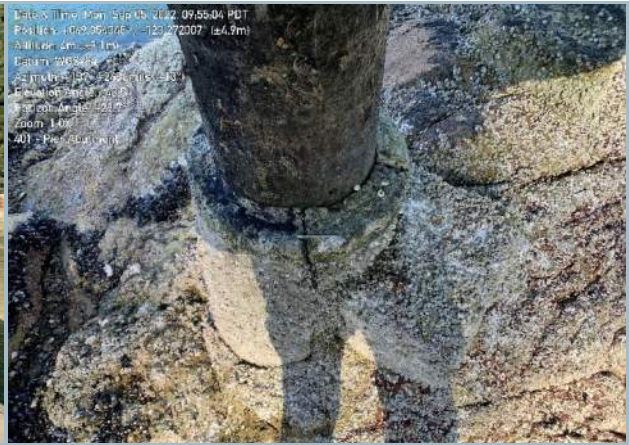
025. Cracked Concrete Pedestal at Bedrock Pier

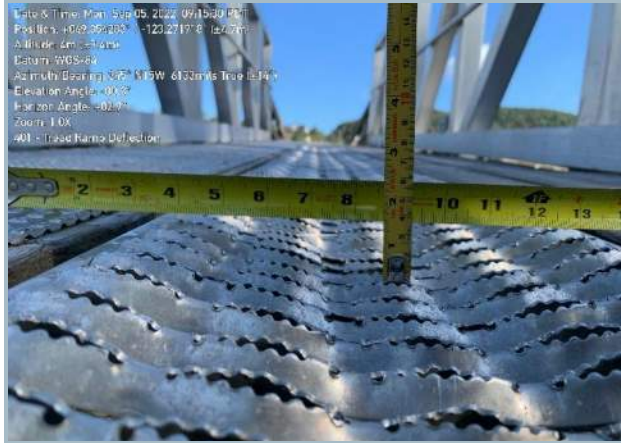
026. 1.5" Deflection of Unsupported Central Walkway Tread

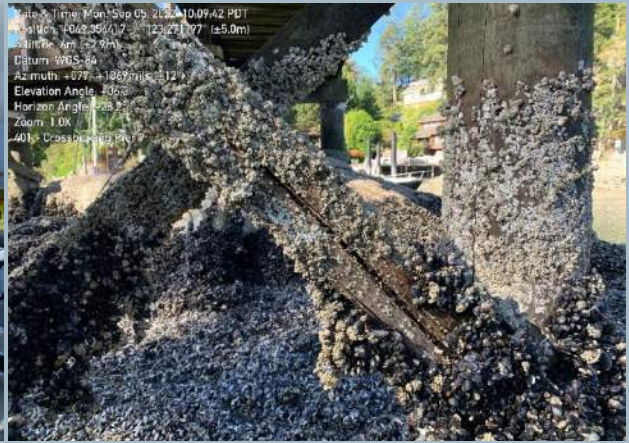
027. Decaying Timber Brace at Pier, Typ.
