DISTRICT OF WEST VANCOUVER
750 17TH STREET, WEST VANCOUVER BC V7V 3T3

COUNCIL REPORT

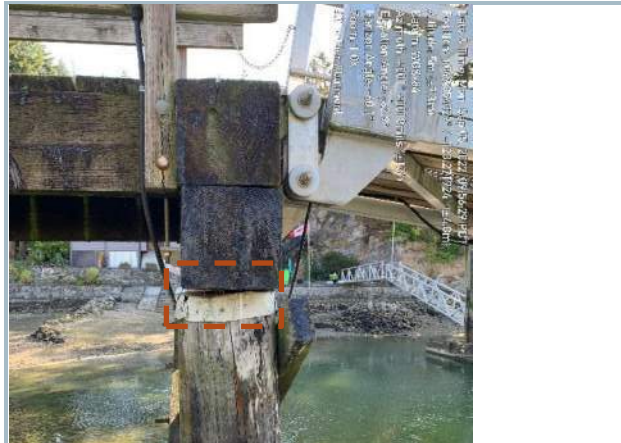
028. Non-bearing Pier Cap at Gangway Transition

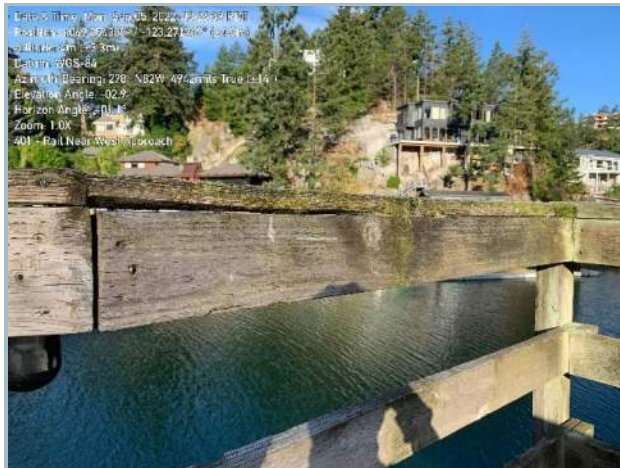
030. Localized Lifting of Decaying Top-rail, Typ.

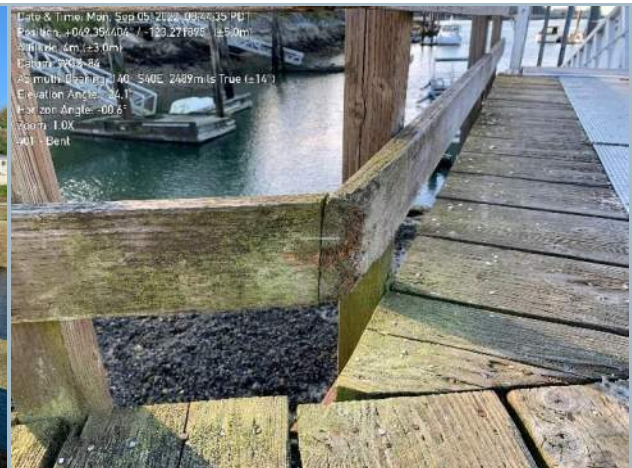
031. Unsecure Mid-rail at Pier Abutment

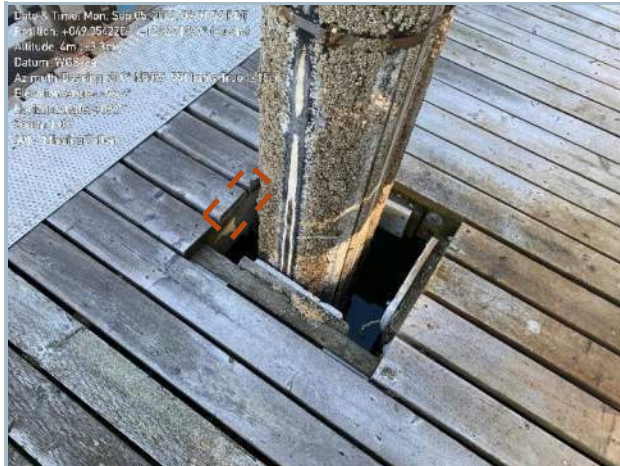
032. Timber Pier Dock Restraint Missing Teflon Bumper

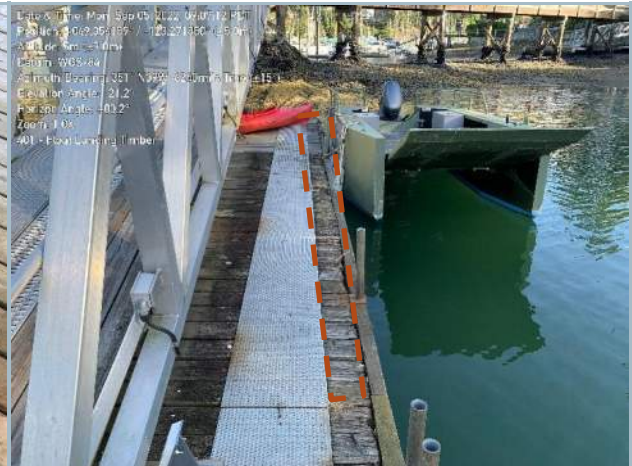
033. Decay Deck Members at East Profile of Dock

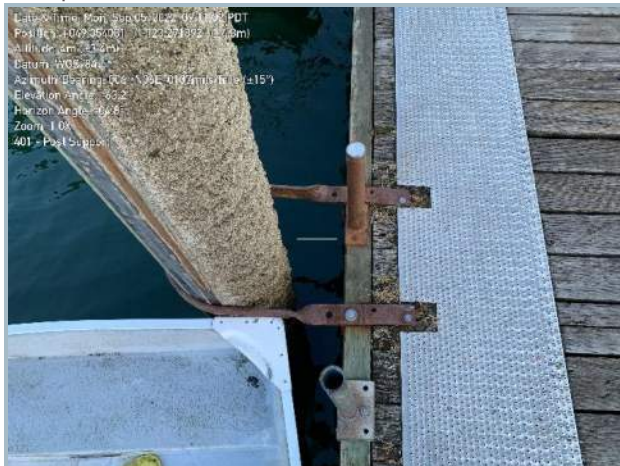
034. Dissimilar Timber Pile Restraint

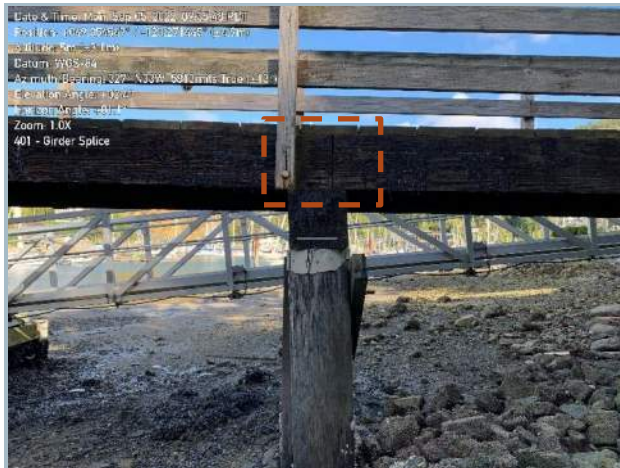
036. Unbalanced Longitudinal Beam Bearing Seat

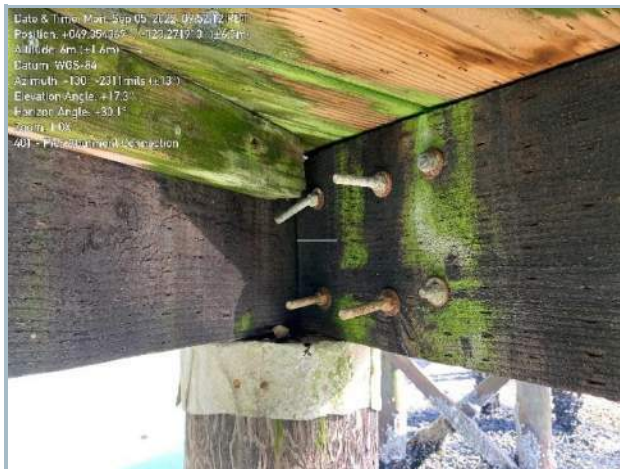
038. Inadequate Placement of Anchors at Bedrock Pier

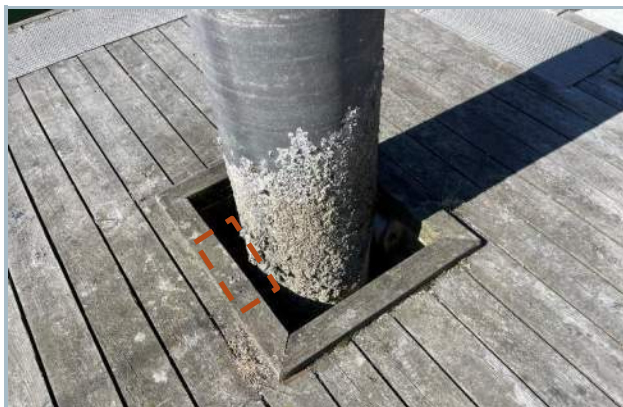
017. Timber Pile Dock Restraint System, Typ.
(Note: Missing Roller Support)

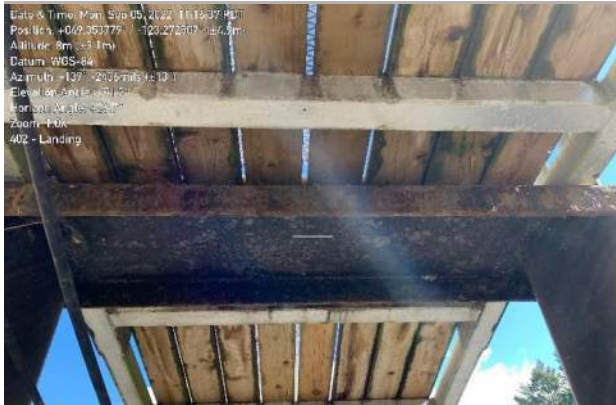
018. Minor Surface Corrosion of Pier Cap

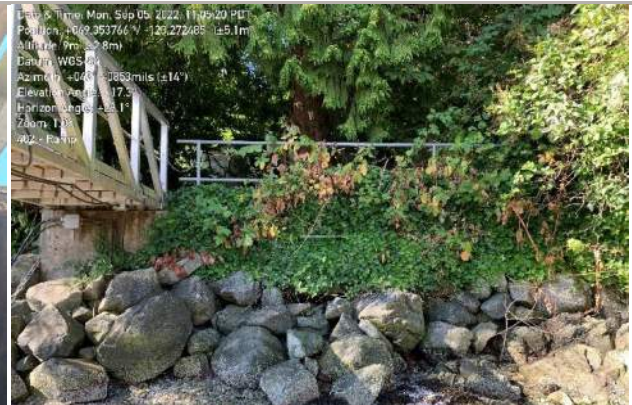
019. Minor Undermining at Northwest Section of West Backwall

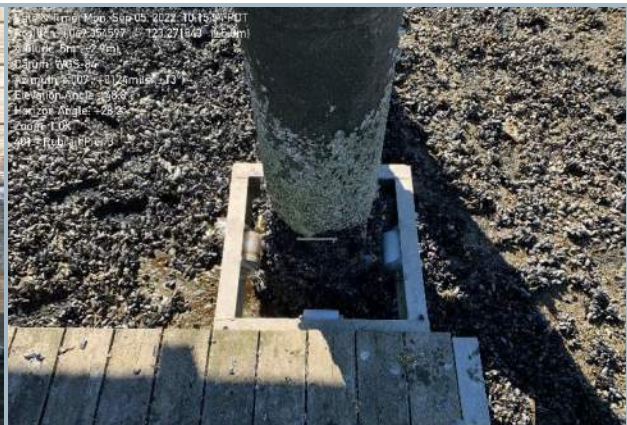
010. Dock Restraint Timber Pier Connection

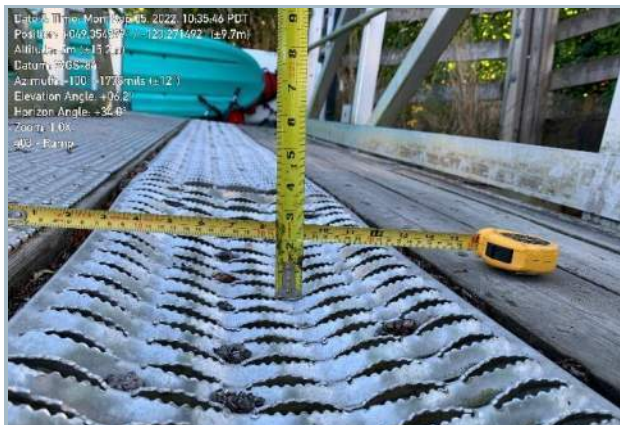
011. 2" Deflection of Unsupported Central Walkway Tread
