DISTRICT OF WEST VANCOUVER
750 17TH STREET, WEST VANCOUVER BC V7V 3T3

COUNCIL REPORT

Date:	May 12, 2024
From:	Jenn Moller, Director of Engineering & Transportation Services
Subject:	Eagle Island Access Infrastructure
File:	1700.09

STRUCTURE ID: 401 – MAINLAND DOCK

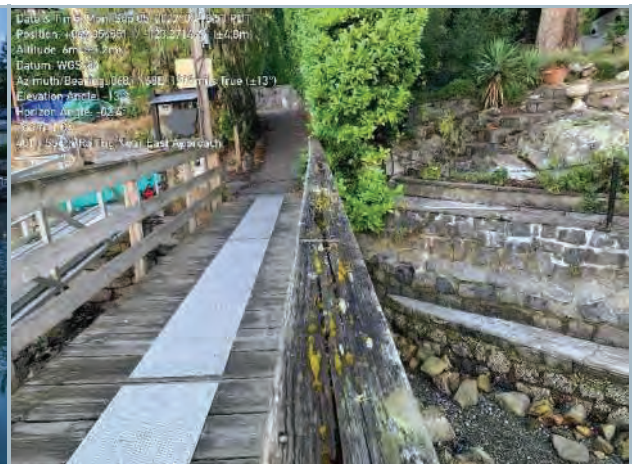
006. West Approach
(Note: Splitting and Warping of Top-rail)

Pier caps require straightening from their currently rotated orientation. Replace rub rails on pile connections. Tigthen loose connection on ramp joint leading down to float or replace the bearing pin. Monitor splitting on hand rails and mid rails. Monitor longitudinal crack in Span 1 of west girder. Blackout paint on deck lights needs to be reapplied.

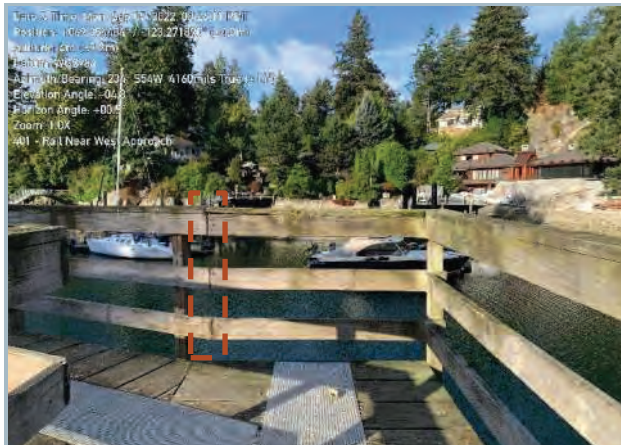
024. Vertically Unsupported Timber Splice at Bedrock Pier

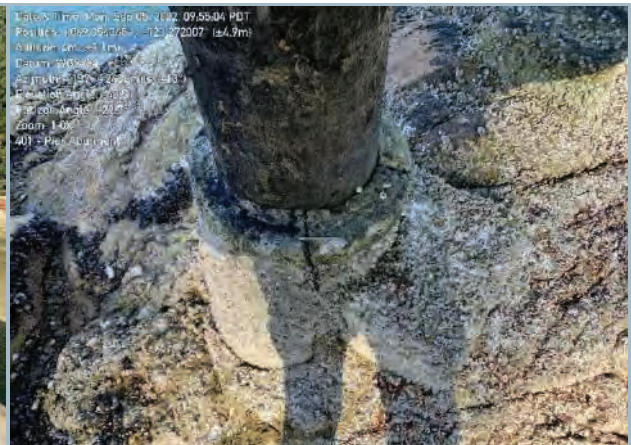
025. Cracked Concrete Pedestal at Bedrock Pier

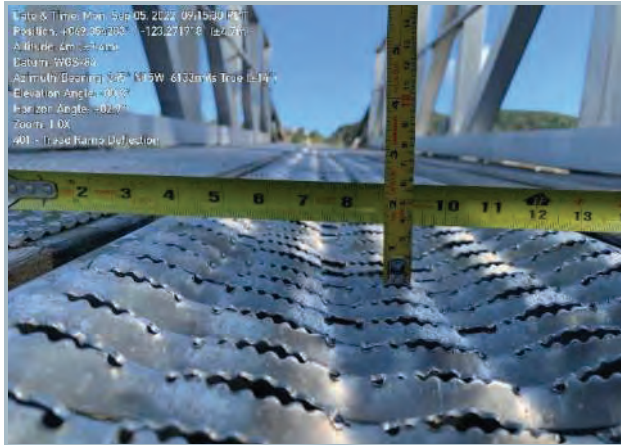
Mostly good condition aside from surface wearing and centre ramp panel.
 Float planks good to very poor. Severe deflection in middle tread of ramp.
 Deck panel joints on ramps heavily deformed, replacement/strengthening required.
 No kick plates except on the aluminum ramp.

026. 1.5" Deflection of Unsupported Central Walkway Tread

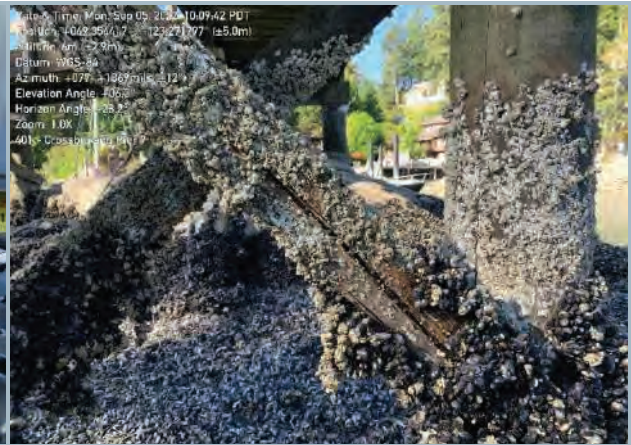
The cross-bracing on the piers is in poor condition and almost completely failed on some piers. The seismic demands are likely low due to the low seismic mass (the structure is entirely timber or aluminum), but the structure does not have a reliable seismic force resisting system, and therefore is likely moderately vulnerable to seismic loading.

027. Decaying Timber Brace at Pier, Typ.

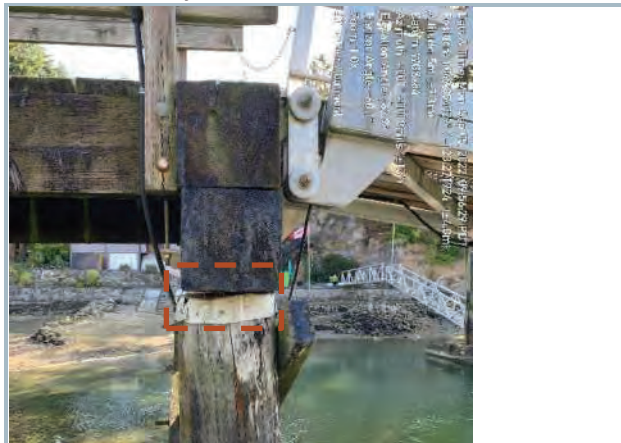
028. Non-bearing Pier Cap at Gangway Transition

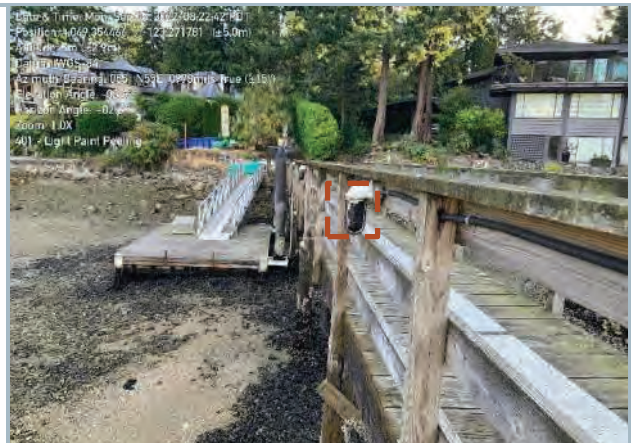
029. Diminishing Black Paint on Light Fixtures, Typ.

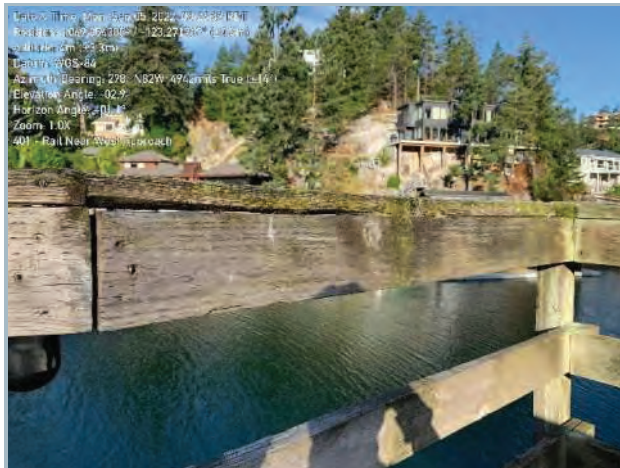
030. Localized Lifting of Decaying Top-rail, Typ.

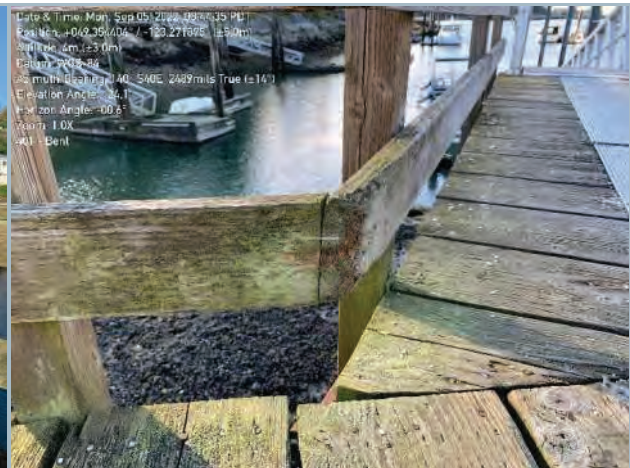
031. Unsecure Mid-rail at Pier Abutment

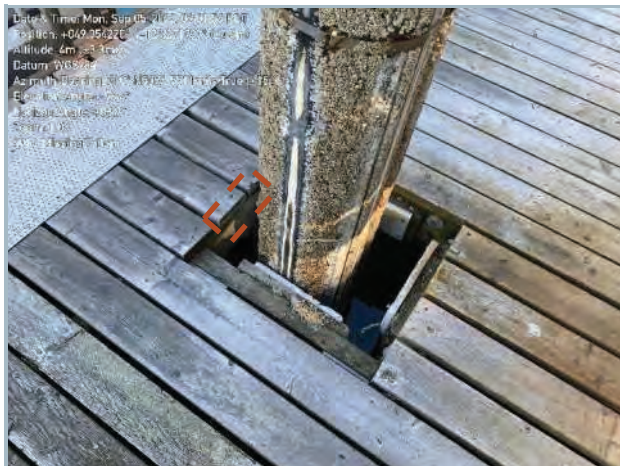
032. Timber Pier Dock Restraint Missing Teflon Bumper

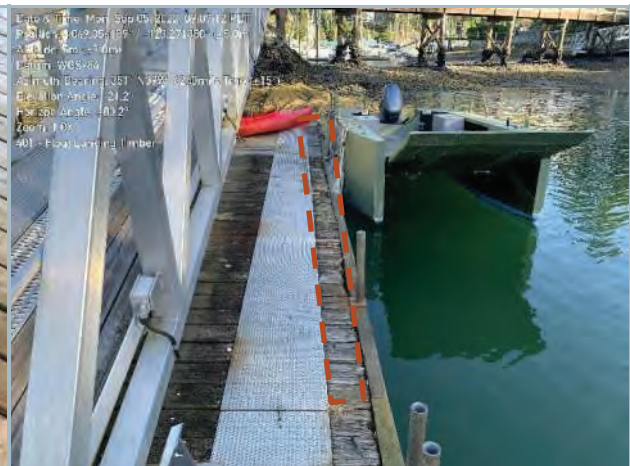
033. Decay Deck Members at East Profile of Dock

Pier 4 is rotated approximately 4 degrees and should be straightened to plumb. Large portions of float, particularly on north side of ramp on the float section closest to the pier has suffered from moderate to severe decay and should be redecked within 4 years. Regrout pile bars on piers 8 and 9, which are founded on the bedrock outcrop at the southern end of the pier. Almost all of the pier cross-bracing members require replacement within 4 years. Replace pile sliders/rub rails that have detached on floats. While likely not needed at this time, erosion protection to the piers not founded on bedrock is recommended in the future to mitigate the high erosion potential of those piers.

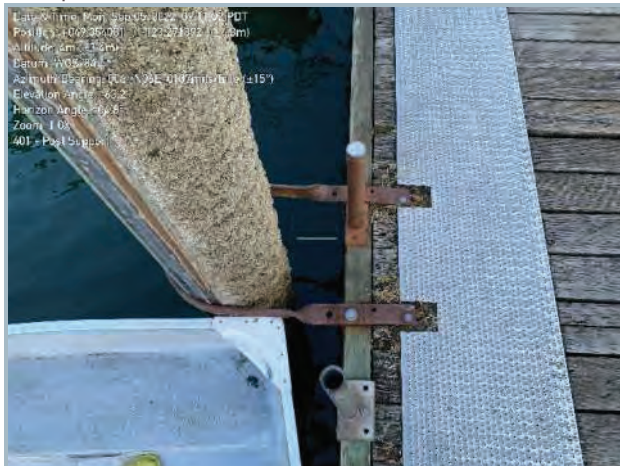
034. Dissimilar Timber Pile Restraint

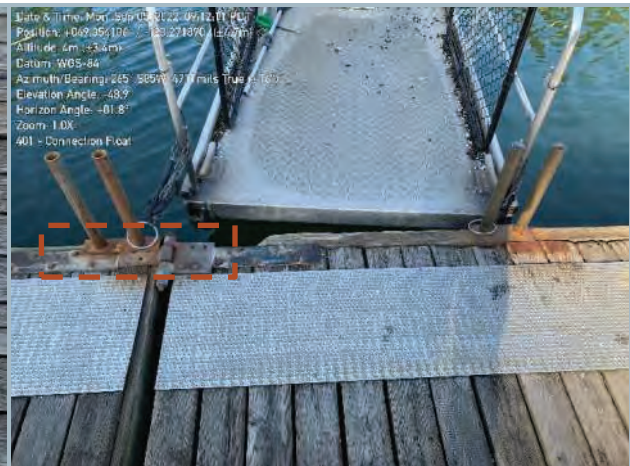
035. Overlapping Plates at Dock Connection

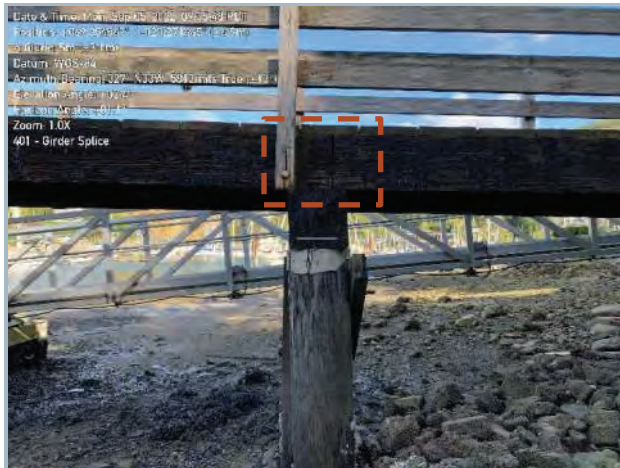
036. Unbalanced Longitudinal Beam Bearing Seat

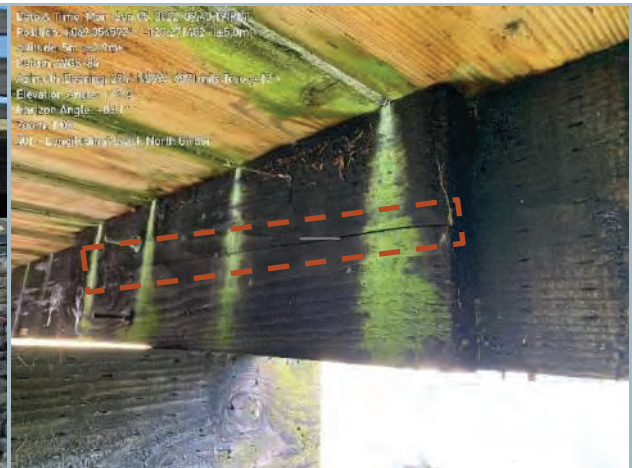
037. Full Longitudinal Splitting of Timber Splice

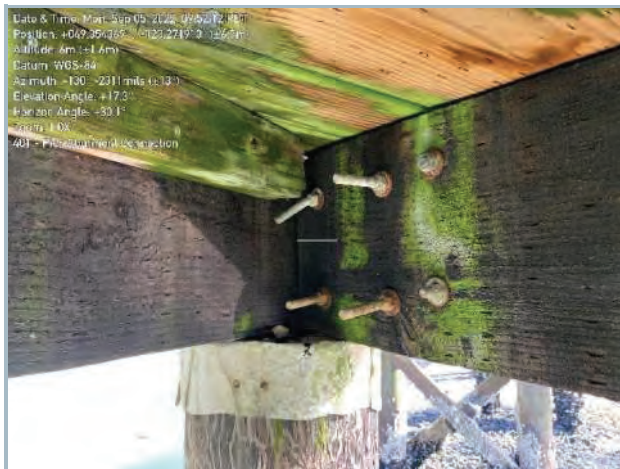
038. Inadequate Placement of Anchors at Bedrock Pier

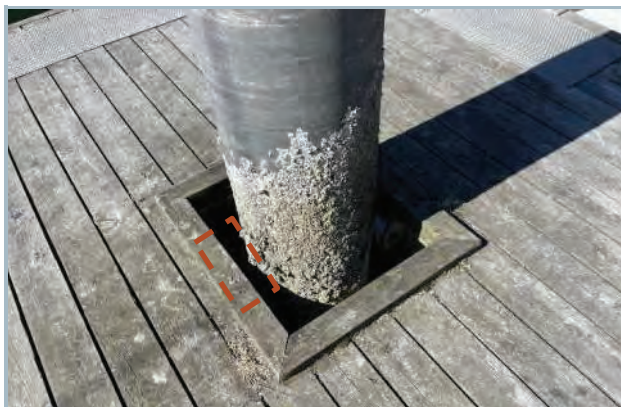
017. Timber Pile Dock Restraint System, Typ.
(Note: Missing Roller Support)

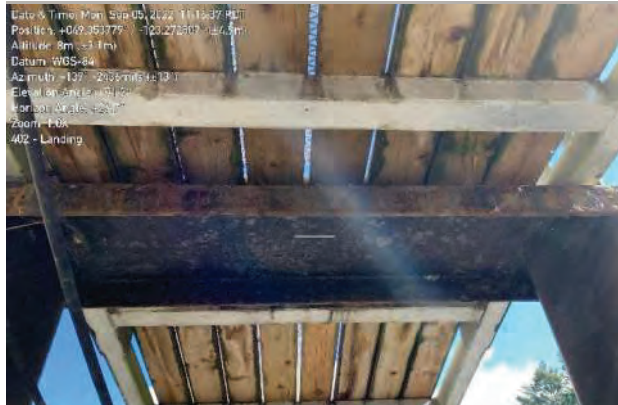
018. Minor Surface Corrosion of Pier Cap

Remove excess corrosion on piles supporting pier and coat with an approved product or add anodes to inhibit further corrosion.

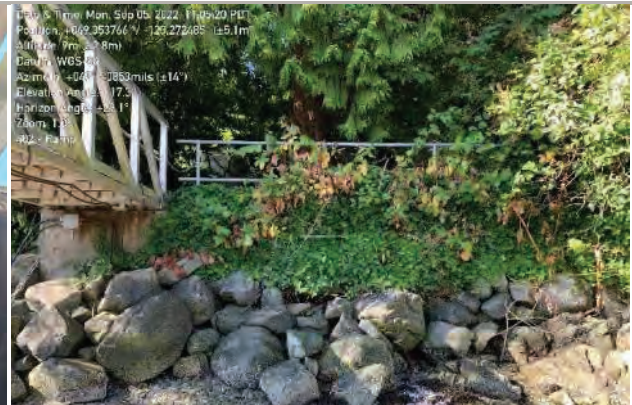
019. Minor Undermining at Northwest Section of West Backwall

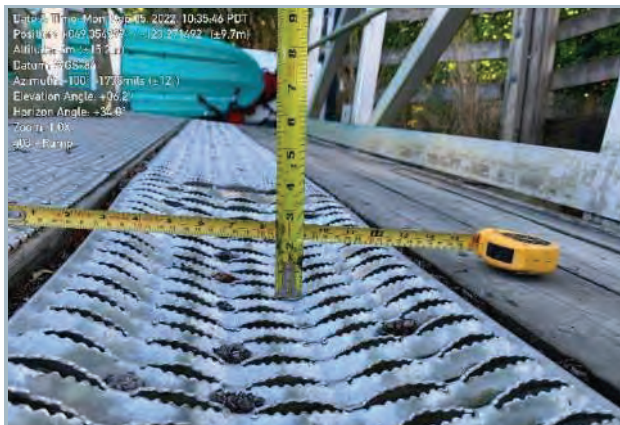
Mostly good condition aside from surface wearing and centre ramp panel.
 Float planks good to very poor. Severe deflection in middle tread of ramp.
 Deck panel joints on ramps heavily deformed, replacement/strengthening required.
 Aluminum kick plates in generally good condition.

011. 2" Deflection of Unsupported Central Walkway Tread

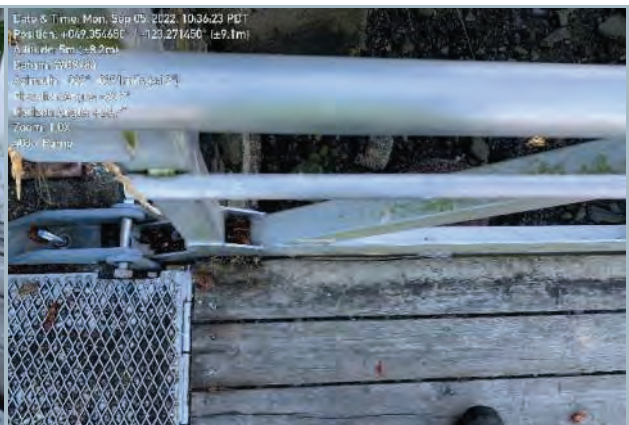
012. Debris Accumulation at Rail Truss Base
