# SYKES RESIDENCE

5616 WESTPORT PLACE, WEST VANCOUVER  
CONSERVATION PLAN

NOVEMBER 2014

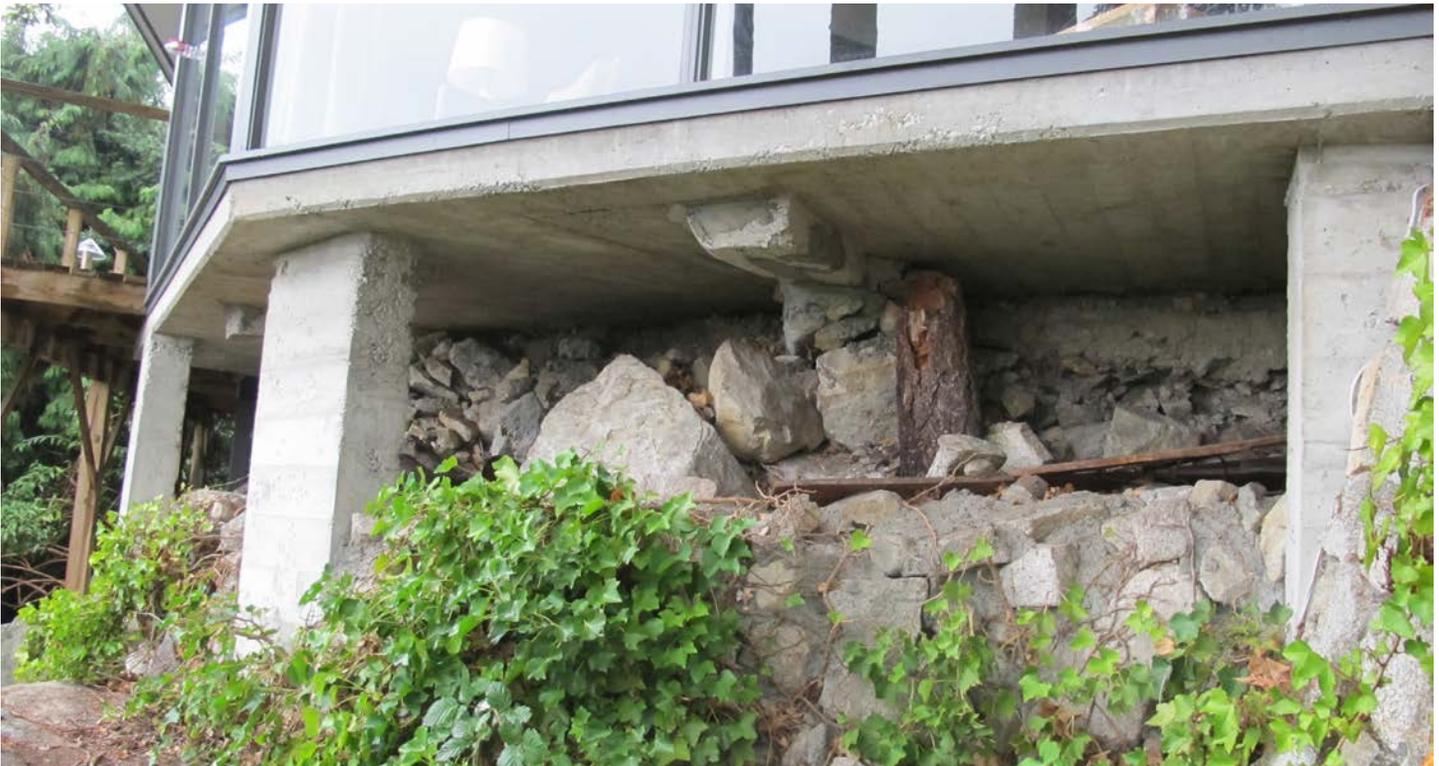
The Sykes Residence is built into the cliffside and the bedrock is incorporated into the poured-in-place concrete foundation along with the stone retaining walls on the south side that support the cantilevered house. The concrete foundation appears to be in good condition and subsidence was not observed during the visual review. In localized areas signs of efflorescence were noted on concrete surfaces, particular where material changes between concrete foundation walls and bedrock occur. It appears these are merely of aesthetic and not of structural concerns, but a structural review may be carried out. The cantilevered concrete slab of the lower floor is supported by structural concrete pillars, while the retaining wall below the carport was constructed with granite blocks. The granite retaining wall on the south side is covered with ivy, which is well adopted for living in woodlands and thrives well where light levels are low. It has its feeding roots anchored in the ground and climbs up trees or walls with strong adhesive to rough surfaces. This can lead to ivy stems penetrating the mortar of masonry walls and breaking up the structure. Ivy removal should be carefully undertaken without further structural damage to the mortar joints or waterproofing problems.

Concrete pillars support the cantilevered floor slab of the living room

- Preserve the historic foundation walls, concrete pillars and stone retaining walls.
- Carefully remove ivy from the stone retaining wall. Rake loose mortar and repoint with suitable mortar of lower compressive strength than the existing granite blocks. Mortar colour to match existing.
- If future seismic upgrades or structural interventions are contemplated, the work should not diminish character-defining elements and the design should be sympathetic to the historic character of the house.

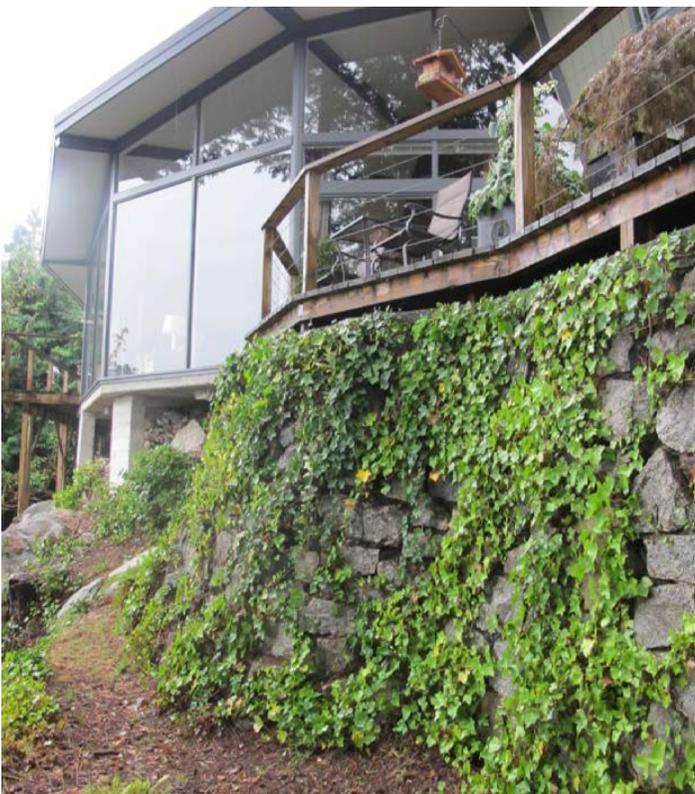
Granite retaining wall covered with ivy

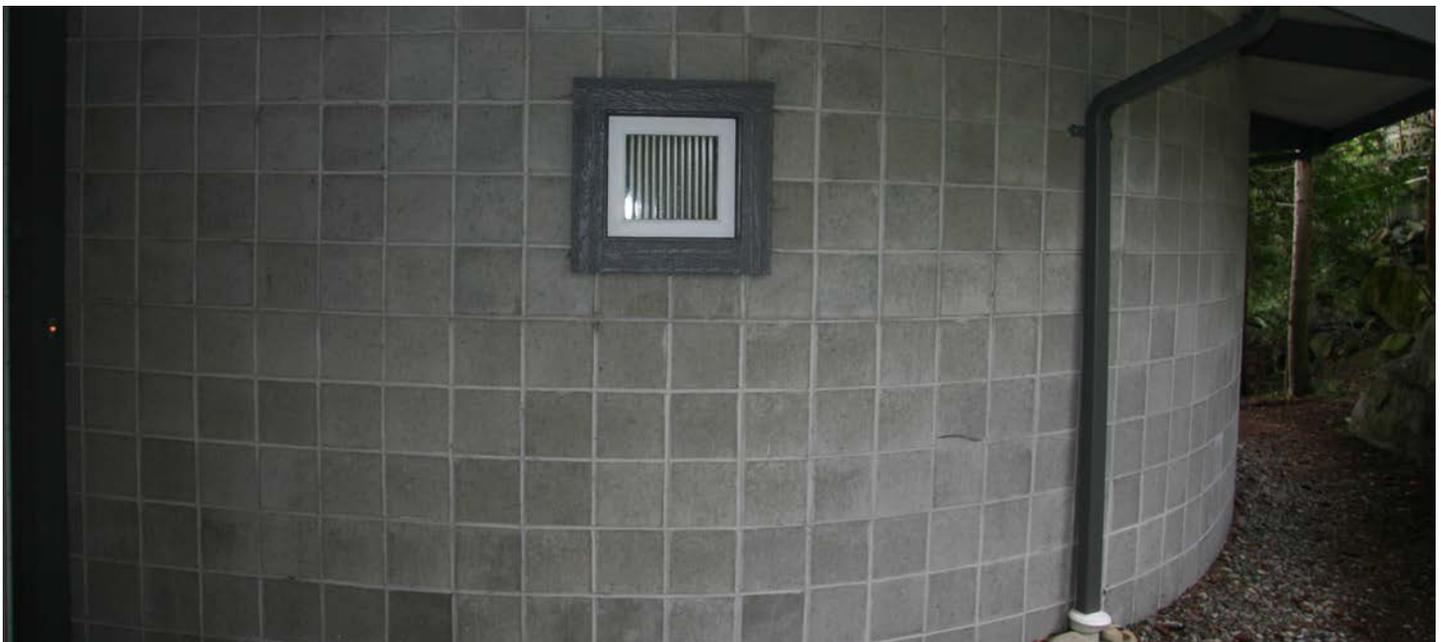
A significant architectural feature of the Sykes Residence is a curved cinder concrete block wall on the north side of the house and identified as 'Denstone' blocks on the original architectural drawings. The square shaped concrete blocks in medium grey colour and smooth surface are laid in stack bond pattern. The mortar joints feature a lighter grey colour and are almost flush with the concrete blocks. The curved concrete block wall and mortar joints are in good condition and signs of cracking, spalling, or other damage was not observed. The curved cinder block wall should be preserved as a character-defining element.

Original 'Denstone' block wall

- Preserve the curved concrete block wall.
- Cleaning should only be carried out only if necessary and with the mildest cleaning method possible, starting with a mild water rinse. High-pressure power washing, abrasive cleaning or sandblasting should not be allowed under any circumstances on any original building materials of the house.
- Repointing should only be undertaken if existing mortar shows signs of deterioration. New mortar to match existing in composition, colour and joint profile.

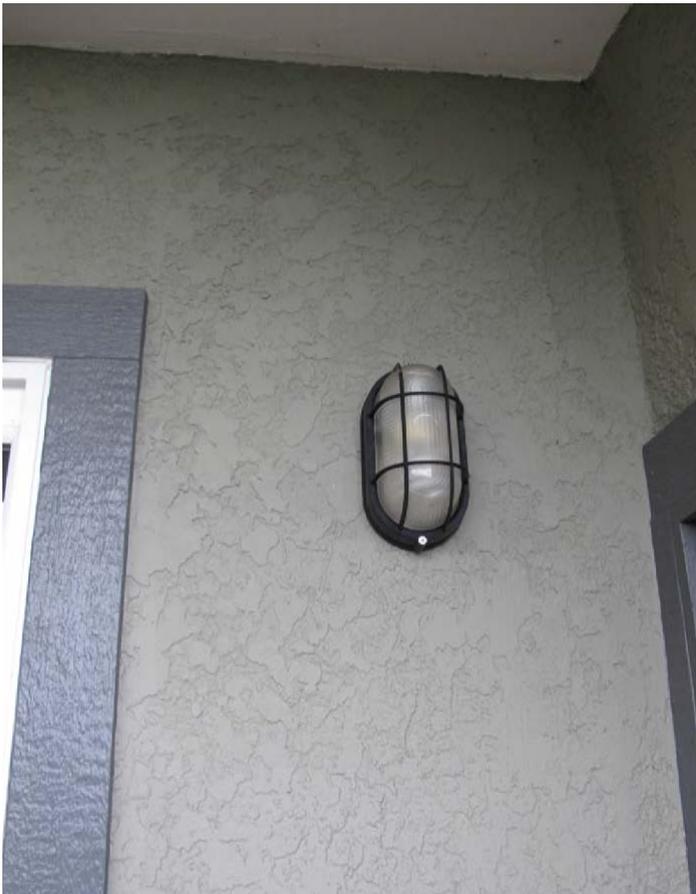
Originally sections of the exterior walls were finished with California stucco. Areas featuring the original finish are still extant on the southwest elevation of the upper floor. The render is in good condition and should be preserved as an important architectural feature.

Original stucco finish

- Sections with original California stucco finish are in good condition and should be preserved. If future repair work is required, appropriate repair materials matching the original in material and surface finish should be used.
- Later shingle siding is not original to the house and if renewal is required in the future, remove the shingles and reinstate the California stucco finish to match original.

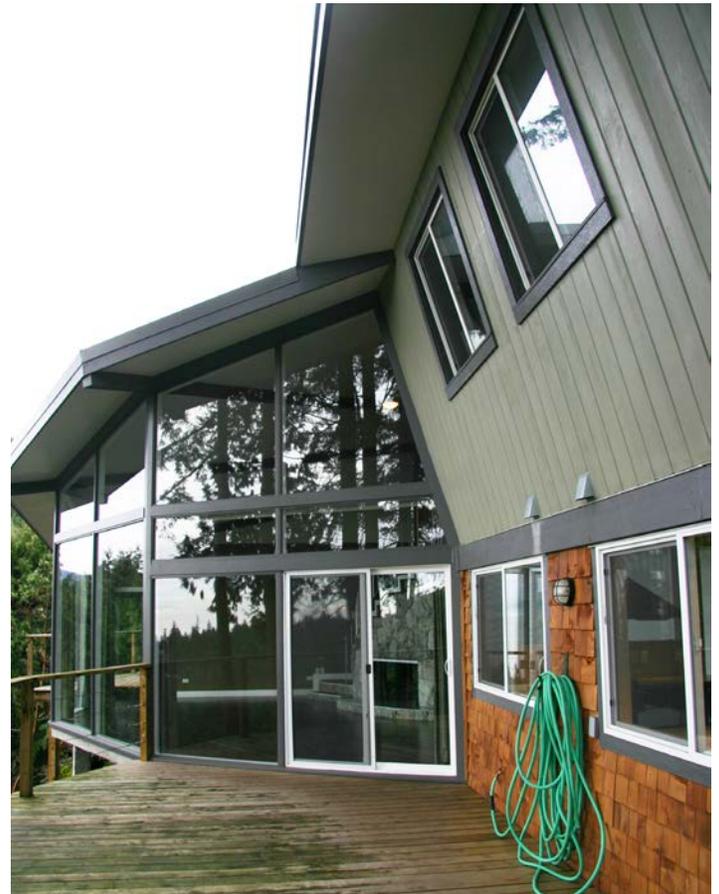
In locations where prolonged water ingress severely damaged the original stucco render, for example at the southeast elevation near the kitchen, the original cladding was removed and replaced with cedar shingles. This substitute material is not original to the architectural design and if replacement is required in the future, the original California stucco finish should be reinstated.

The Sykes Residence features vertical V-jointed cedar siding on the angled upper bedroom floor, which is original to the house and an important architectural feature. Based on a visual review the original siding appears to be in good condition and is well protected by a wide roof overhang. The vertical cedar siding is also installed on the interior walls of the open carport and the staircase walls leading to the lower floor.

Angled upper wall with original wood siding, lower level with new cedar shingles

- Original vertical cedar siding should be preserved as a character-defining element.
- If deterioration will be detected in the future, damaged material should be restored in place. Only severely damaged or deteriorated panels should be replaced with new siding to match original in material, size, profile and thickness.

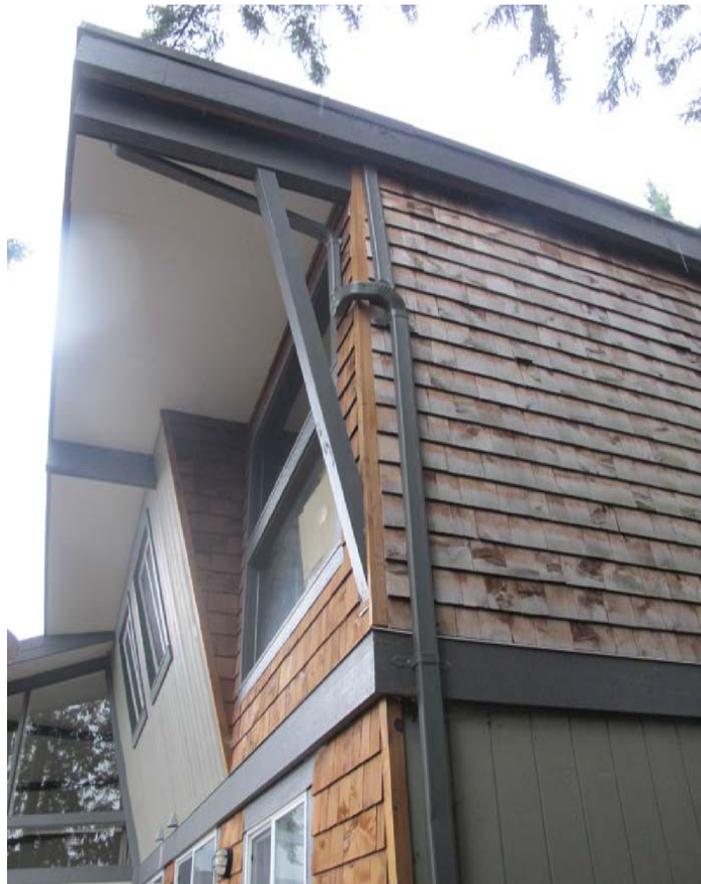
East-facing carport wall now closed with shingle-clad wall to prevent water ingress

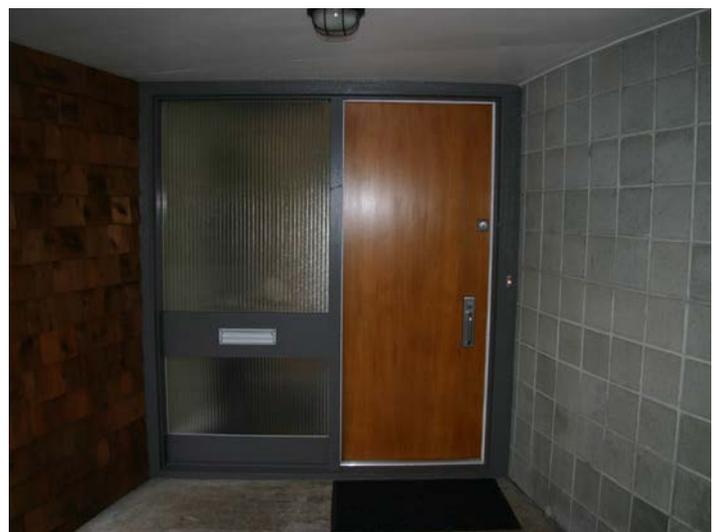
The original solid wood front door with reeded glass sidelights in original wood frames are extant. The assembly is a character-defining element of the Sykes Residence. The recessed entry door is well protected from the environment and in very good condition.

Original front door assembly with reeded sidelights

- The front door assembly with reeded glass sidelights is a character-defining element and should be preserved in situ.
- The original secondary door at the lower should be retained, if possible.
- Repairs should only be carried out if necessary and with appropriate conservation methods.

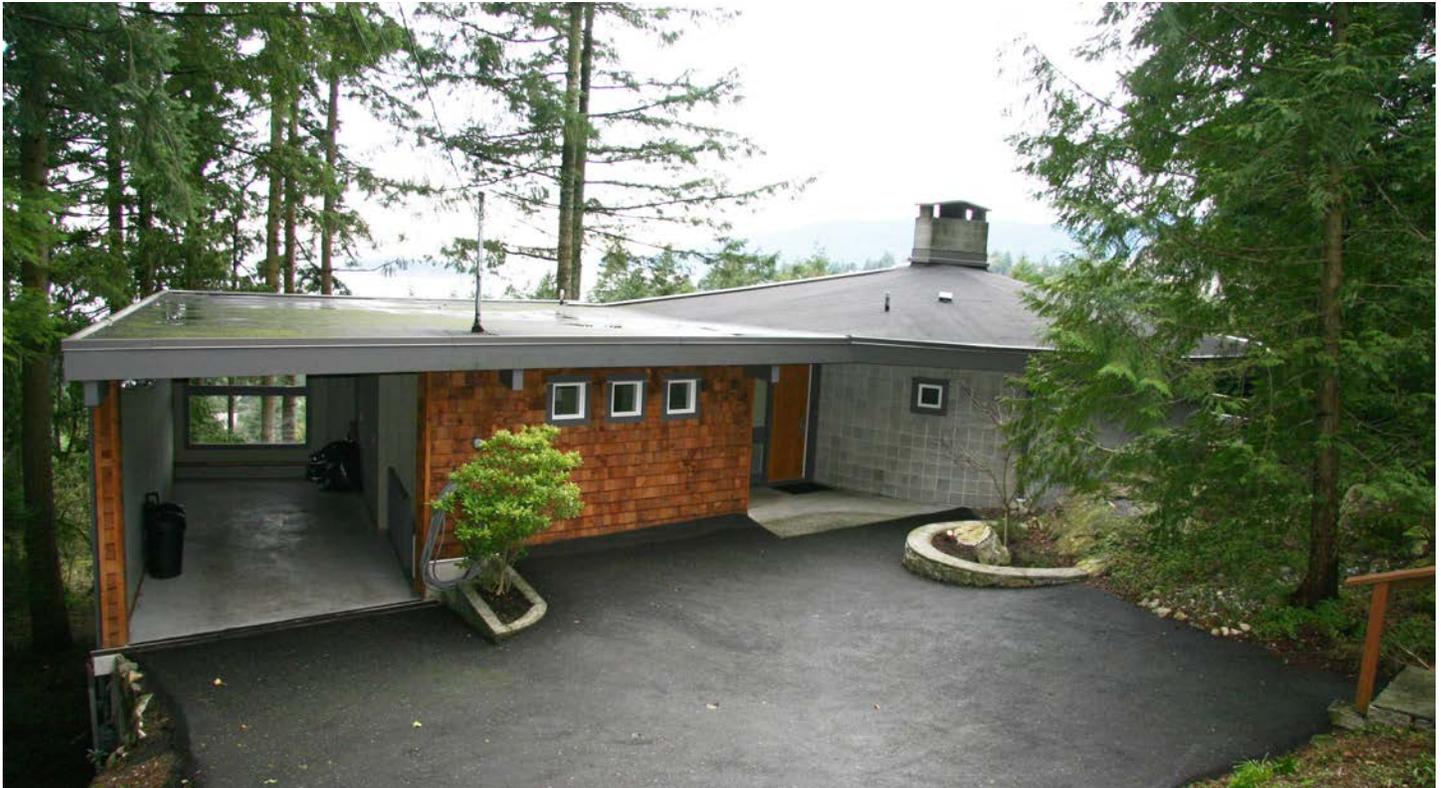
The Sykes Residence features a 'spiral-helix' roof above the main body of the house and a flat roof over the carport. The roof structure is an expression of the innovative design typical for West Coast Style homes. The wide-flaring eaves are important features and protect the envelope from direct rainwater. The roofing materials and membranes were repaired with torch down roof in recent years that provides good waterproofing capabilities to the flat and sloped roofs. Additional metal flashings assist in shedding rainwater from the roof and protecting the envelope. New rainwater leaders and downspouts drain the water away from the building. During the recent site visit some standing water and accumulated organic debris on the flat carport roof was noted.

Flat roof above carport and office

Regular inspections to detect damage of the roof membrane and removal of build-up debris and cleaning of clogged downspouts ensure that rainwater drains freely and prevents water penetration and material deterioration.

- The original 'spiral-helix' roof, flat roof and cinder block chimney will be preserved as character-defining elements.
- Regular inspection and cleaning of the roof and flashings should be carried out and repairs undertaken where necessary. If roof elements are deteriorated beyond repair, replace with new material that is physically and visually compatible.
- Investigate condition of cinder blocks and mortar joints. If required, masonry may be repointed and cleaned using a natural bristle brush and clean water rinse.
- The rainwater disposal system should be adequately designed and regularly maintained to ensure drainage from the site.
- Trimming of trees in close proximity to the house will help to reduce organic debris accumulating on the roof.

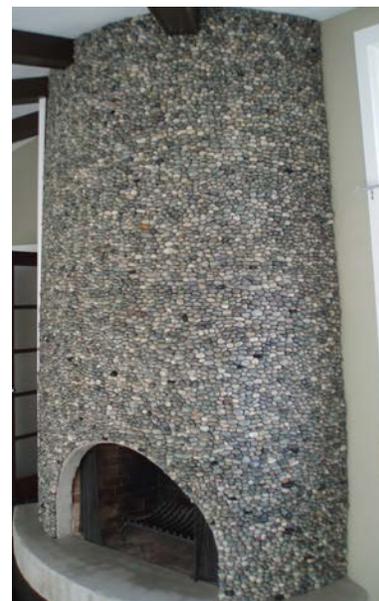
Original concrete block fireplace.  
Decorative pebbles are a later intervention.
