TERRANE
GEOTECHNICAL GROUP

March 3rd, 2022
Project #7591

**Re: PRELIMINARY SLOPE HAZARD ASSESSMENT
PROPOSED NEW INFILL DEVELOPMENT
6155 EAGLERIDGE PLACE, WEST VANCOUVER, B.C.**

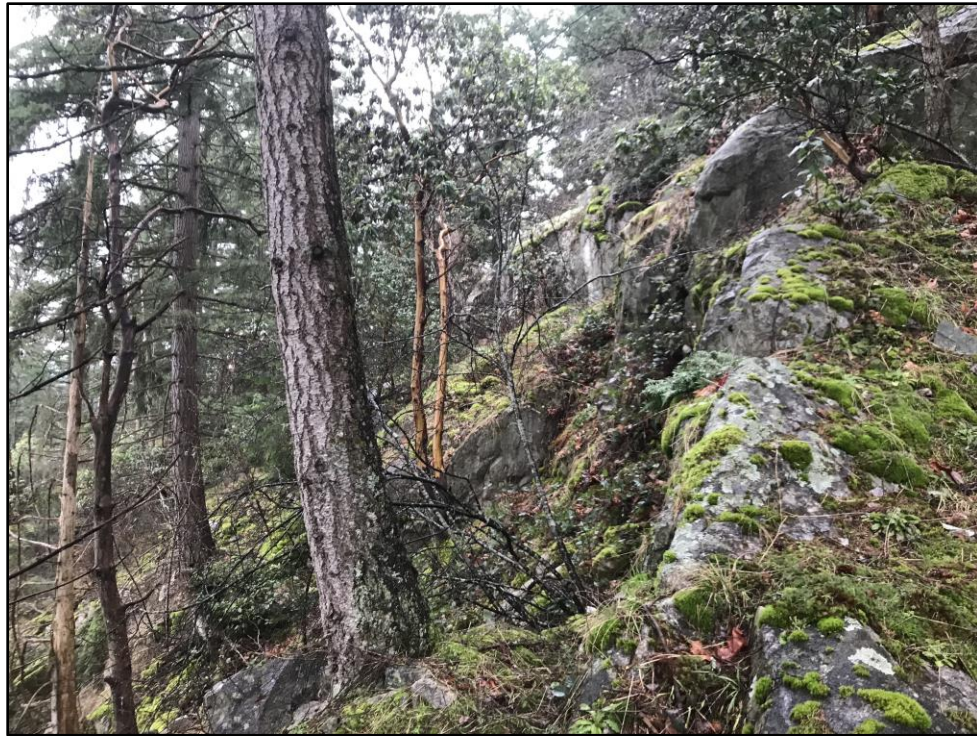
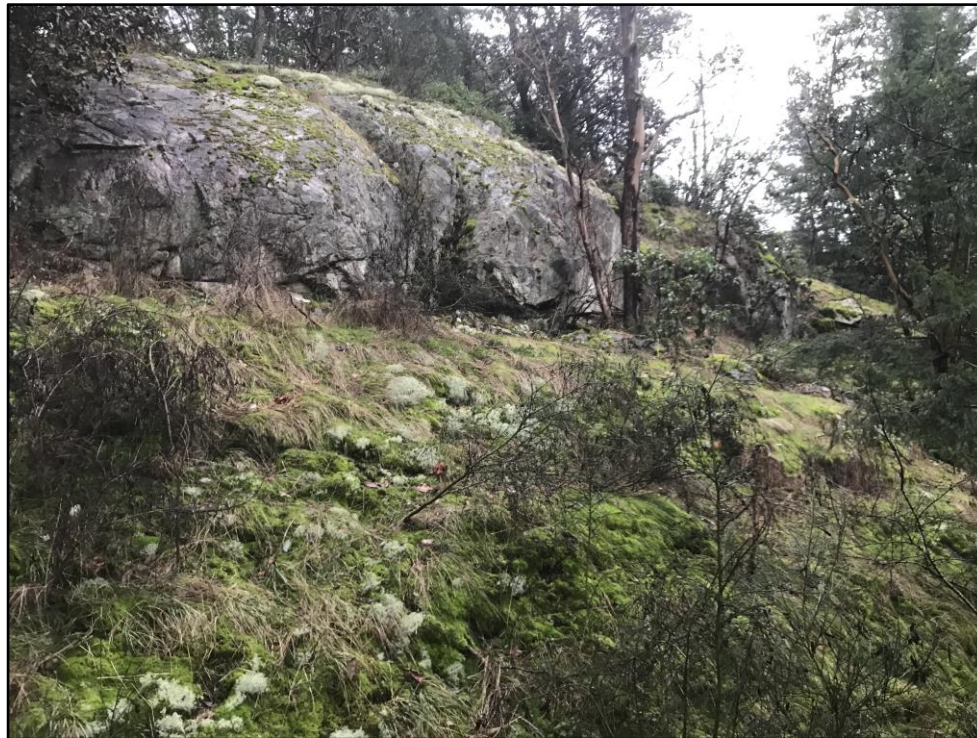
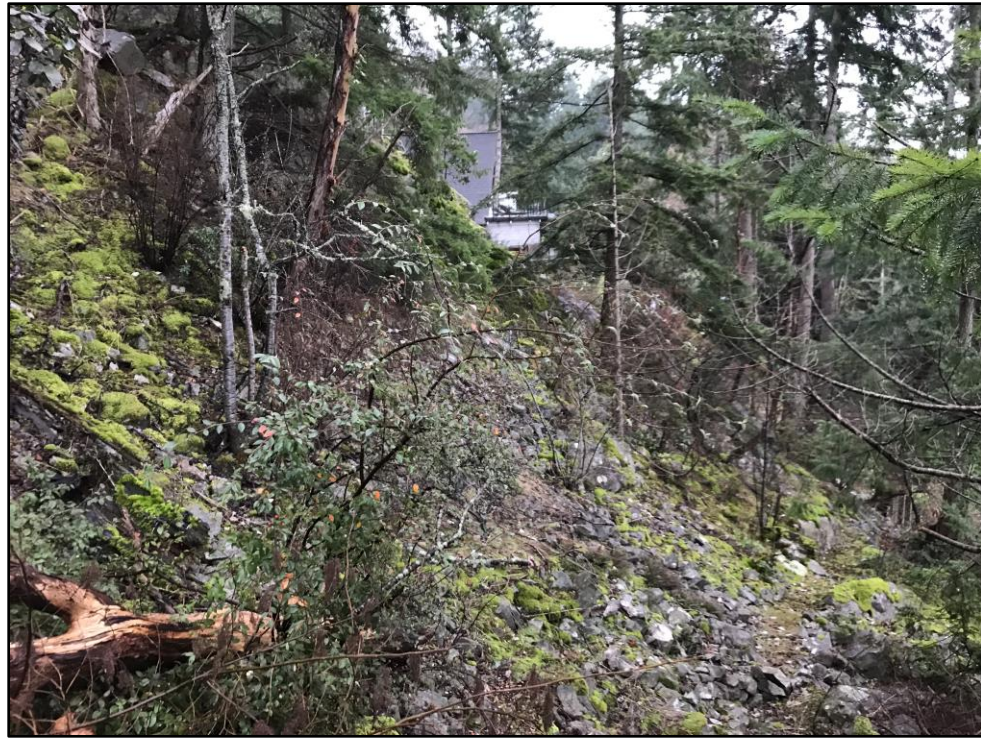
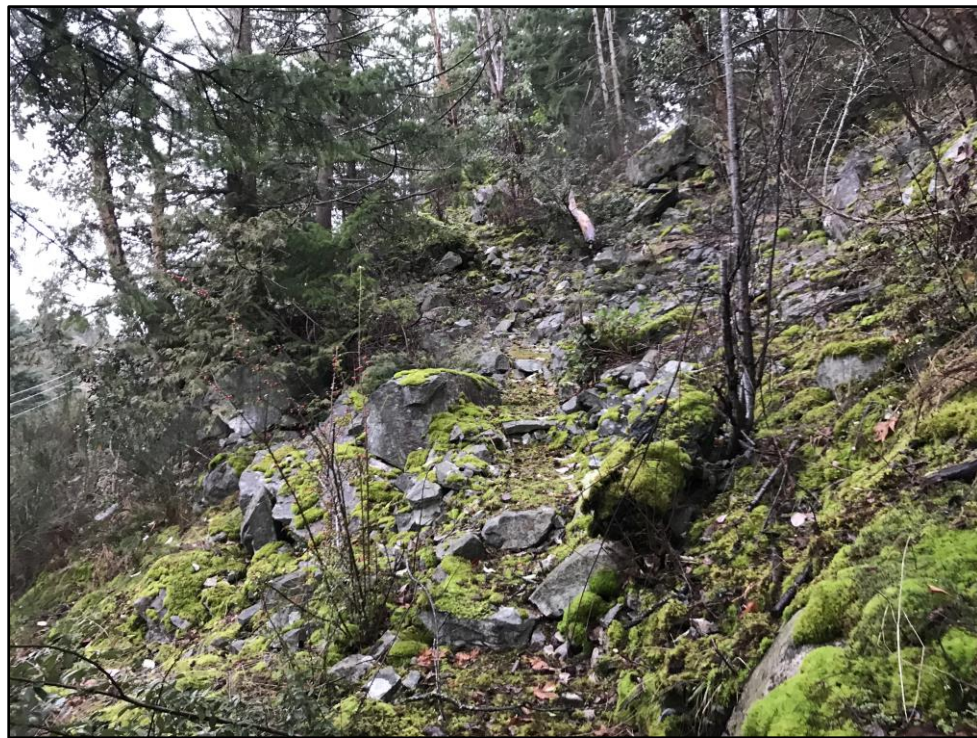
Granodioritic bedrock is extensively exposed throughout the site area. Where it is not exposed, it is covered with a thin mantle of colluvium or forest litter. The site area is generally moderately vegetated with coniferous and deciduous trees with trunk diameters of up to 0.8 m as well as shrubs/bushes and moss cover. Photos 1 to 4 show the topography and vegetation cover in the central portion of the site.

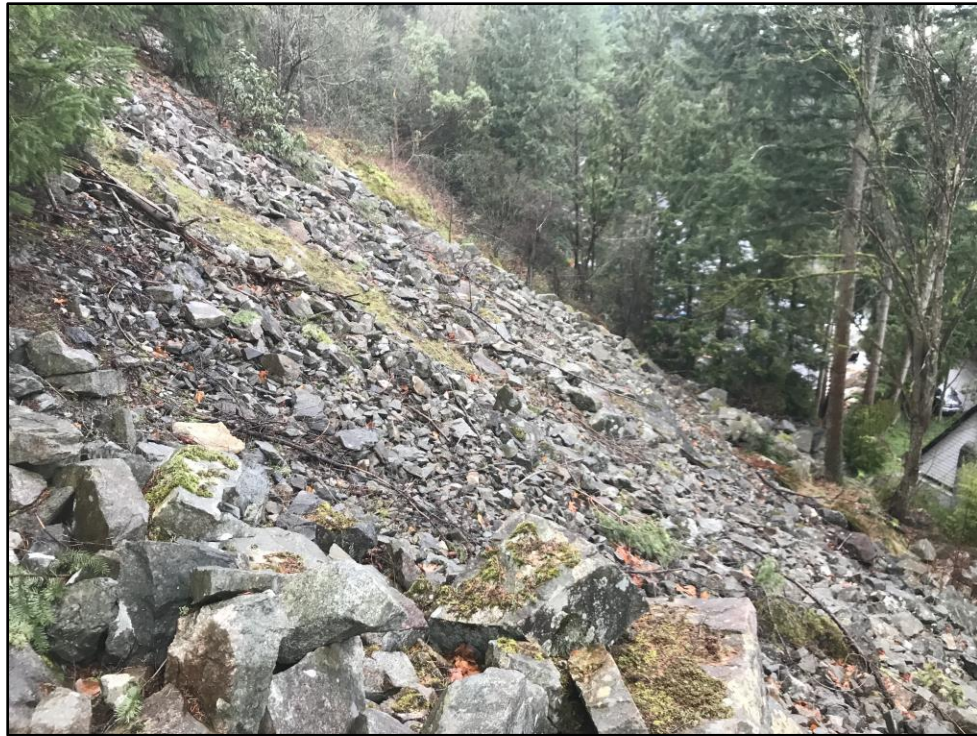
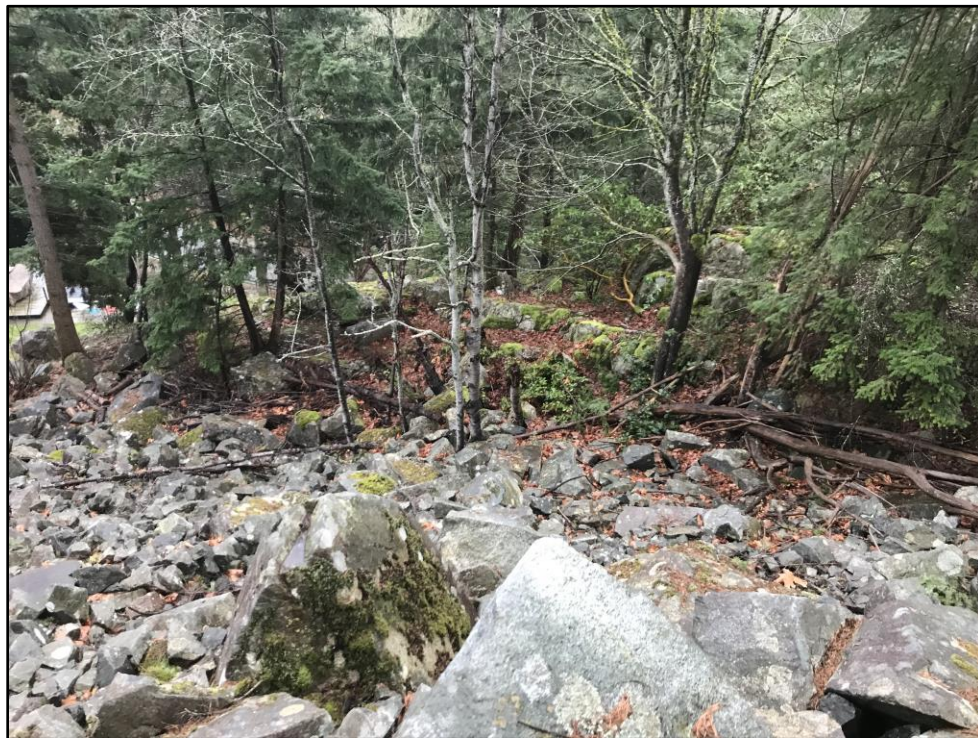
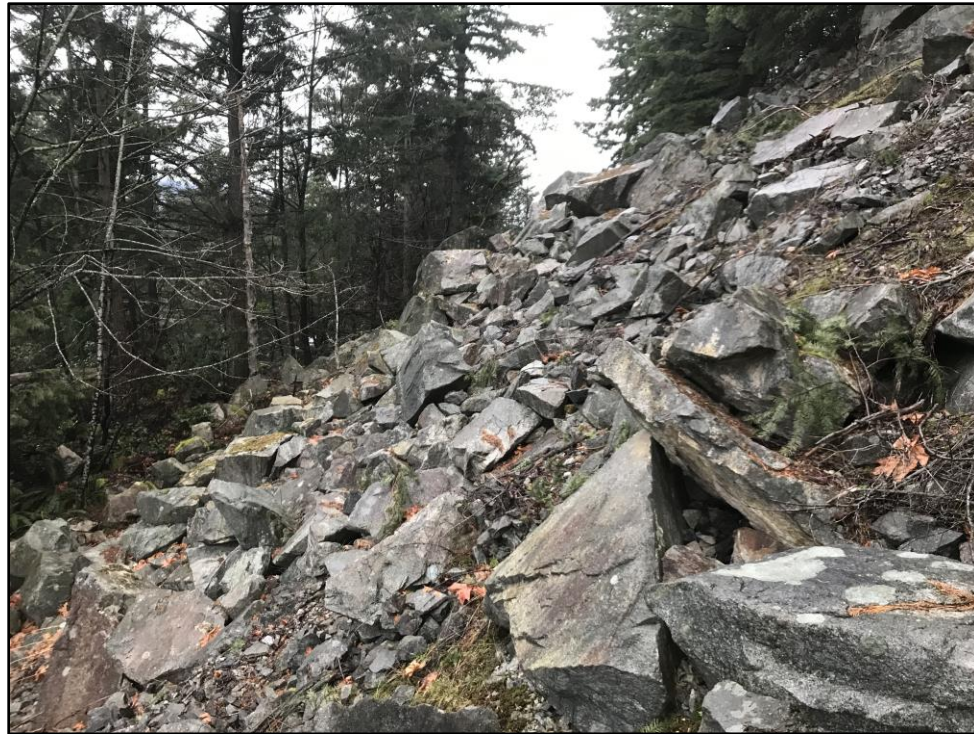
There is a talus rock slope on the adjacent site uphill to the east. The top of the talus rock slope is along the west side of Highway 1 and with toe area terminating close to the eastern uphill boundary of the site. Some of the talus rock is located within the site. It is understood that the talus rock is actually blast rock that was pushed over onto the original rock slope during construction of Highway 1 above the site as there is no visible source zone for the talus rock slope. The talus rock slope varies in overall height from 30 m at the south end to about 12 m at the north end and has a measured angle of 38°. This is the typical angle of repose for an angular rock (talus) slope. The rock blocks in the slope have a dimension of up to 3 m but the median size is about 0.6 m. The largest rocks are typically located in the toe area of the talus rock slope. Some bedrock outcrops are visible within the talus rock slope. No soil exposures were observed in the talus except perhaps some localized areas with colluvium. No trees were growing within the talus and no tree stumps were identified protruding from the talus. It is estimated that the talus rock slope is

not more than about 2.5 m thick and is underlain by competent bedrock. Photos 5 to 7 show the talus rock slope.

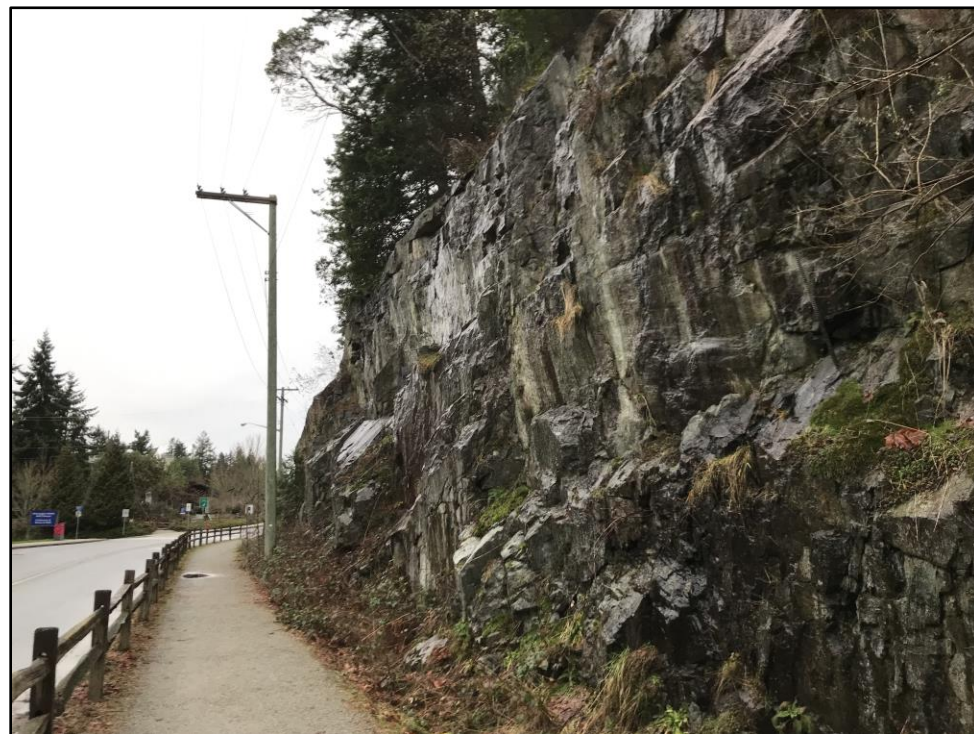
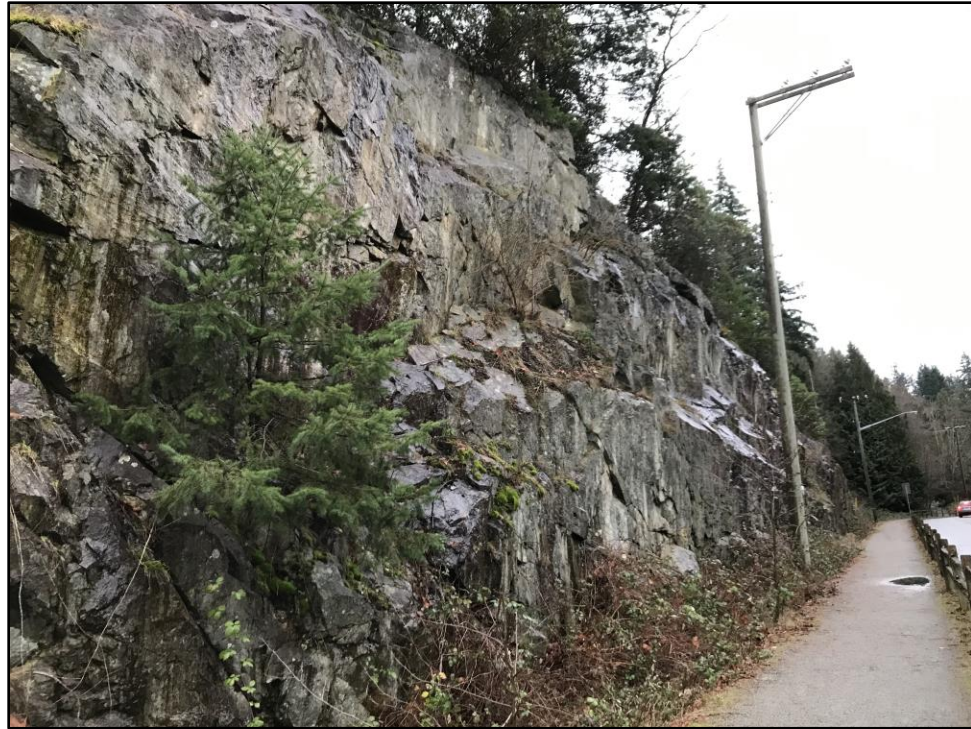
The northern half of the western site boundary is located along the crest of a steep rock cut on the east side of Marine Drive. The cut is oriented approximately north/south (parallel to Marine Drive). The rock cut varies in height from about 5 m at the south end to about 10 m at the north end. The rock cut is sloped at between 65° and 90°. There are a number of spot rock bolts and dowels visible on the rock cut which were likely installed to stabilize loose or potentially loose blocks following blasting. Photos 8 & 9 show the rock cut. Photo 10 shows typical rock bolts/dowels on the cut face.

2. Controlled blasting techniques should be employed where blasting is required to accommodate installation of the foundations of Proposed Units 12 through 18 to limit (minimize) blast damage to the rock cut and rock slope adjacent to Marine Drive; A blasting engineer should be retained to review blast designs.

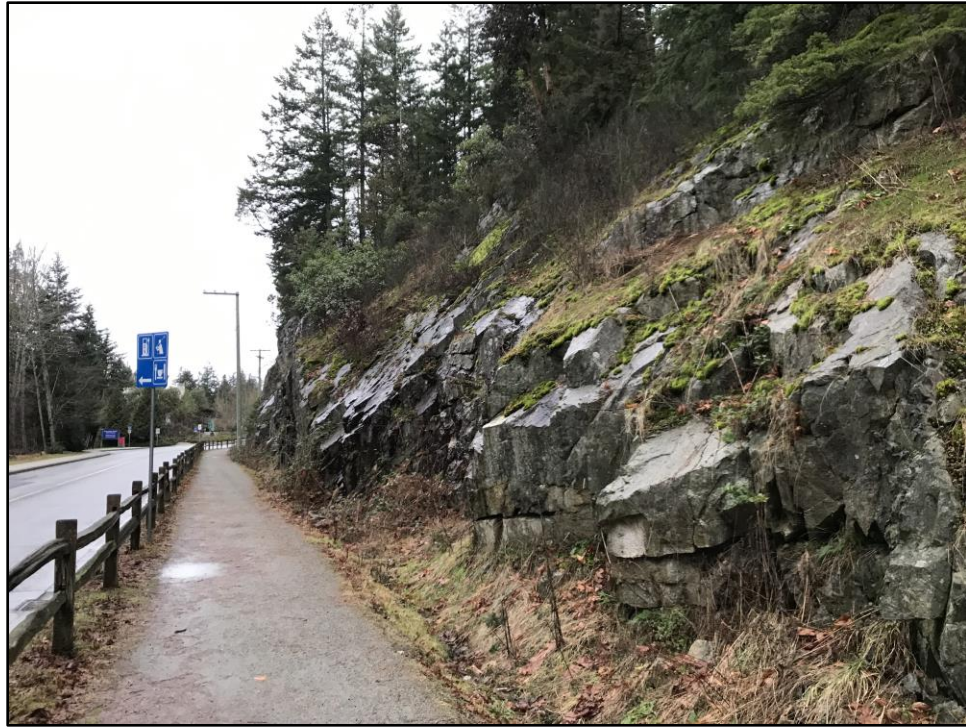
Photo 11

South of the rock cut described above, competent bedrock sloping to the west is exposed. The major north/south oriented joint set that dips downward to the west at between 40° and 50° is visible (Photo 11). The overall slope reduces to some 35° close to the southwest property corner.

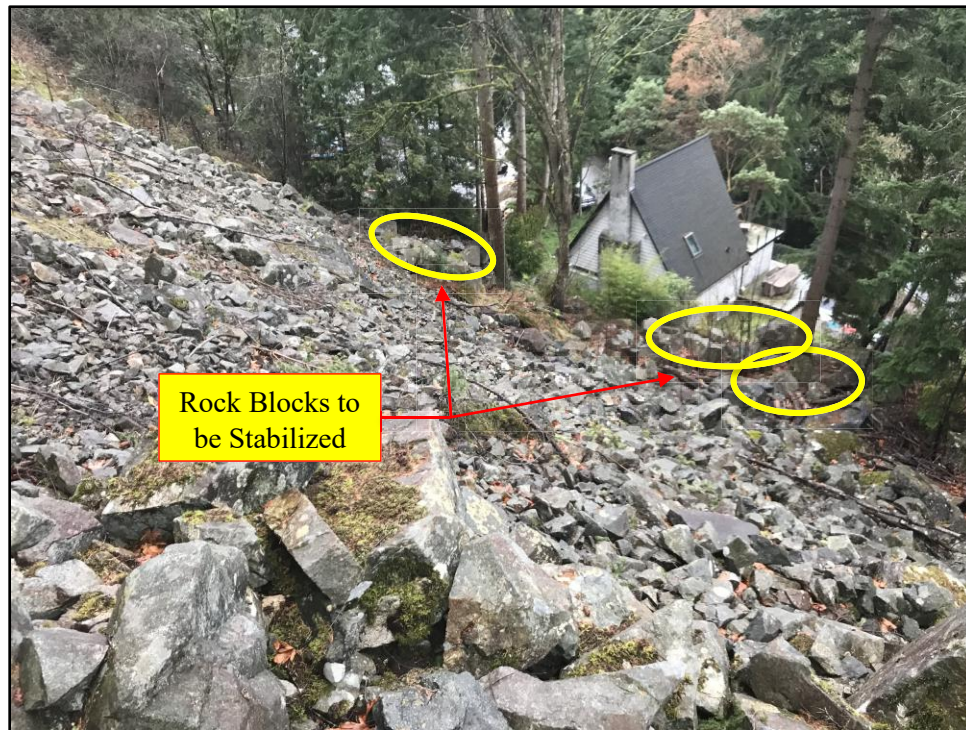
Photo 12

A talus rock slope is present on the adjacent site uphill to the east. The toe of the talus rock slope typically extends a short distance into the site area. As there is no source area for the talus rock, there is no rock fall hazard that will impact the site from uphill to the east. There are a few large rock blocks at the toe of the talus rock slope in the southern end of the site that are judged to be only marginally stable (Photo 12). These rocks should be repositioned (stabilized) during site development.

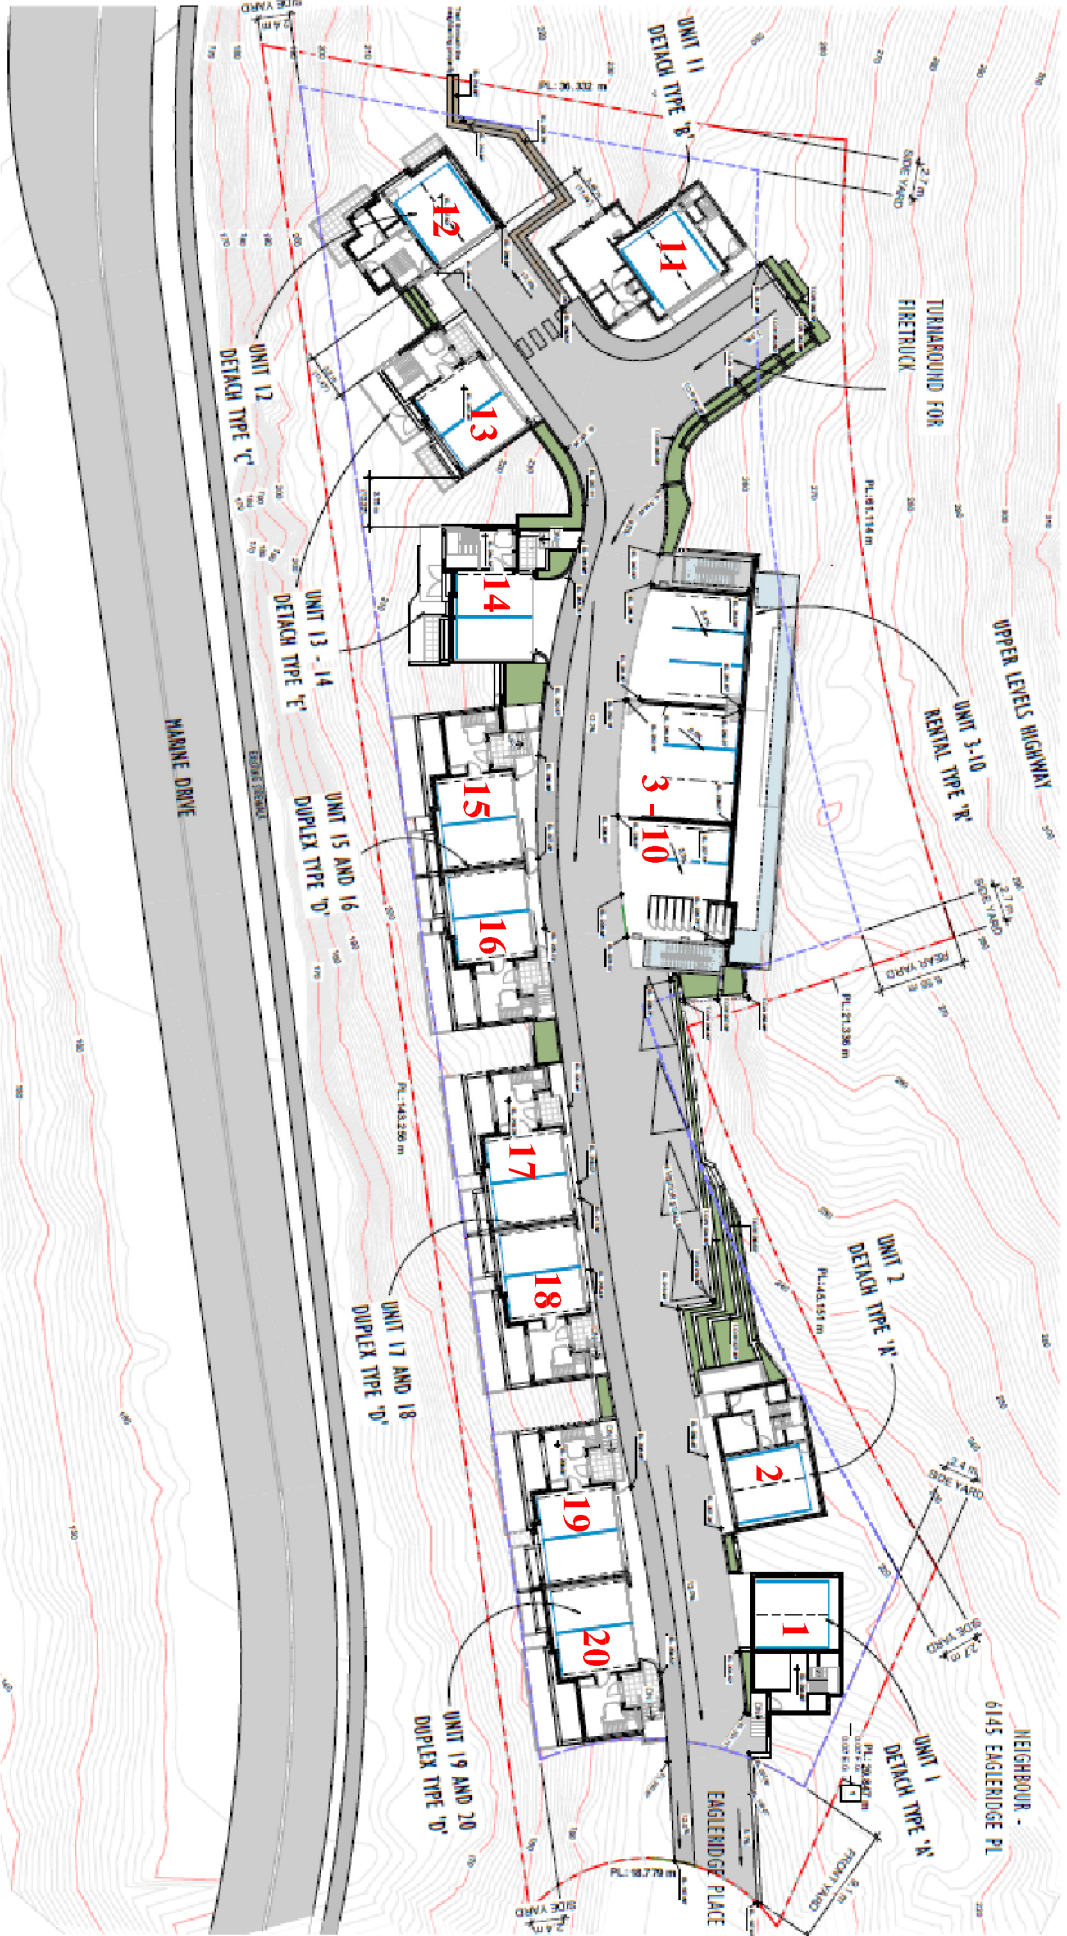
FIGURE 2

It is proposed to construct 10 multilevel detached infill housing structures, including a driveway with turnaround, on the site as illustrated on Figure 2.
