Diamond Head Consulting Ltd. Arborist Report

4701 South Piccadilly Road
West Vancouver, BC

July 23, 2015

To be submitted with Tree Protection Plan

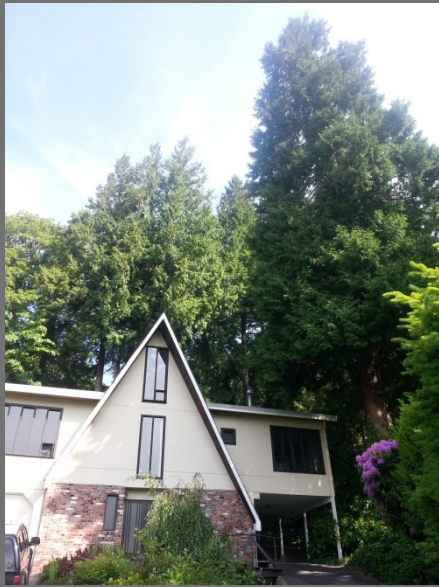
Photo 1. Showing the existing house and the grove of trees located in the back yard.

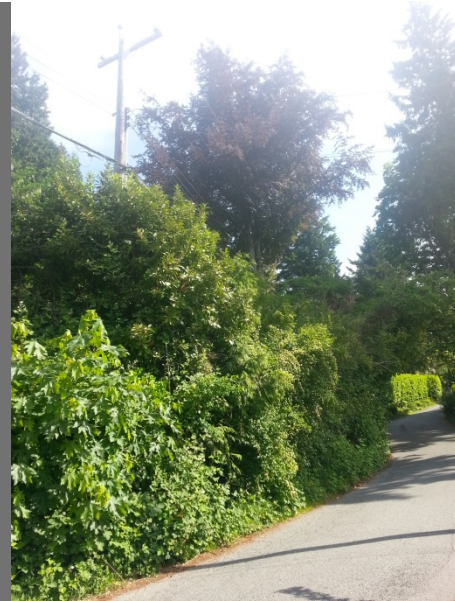
Photo 2. Showing the frontage of the subject site and the overgrown laurel hedge.

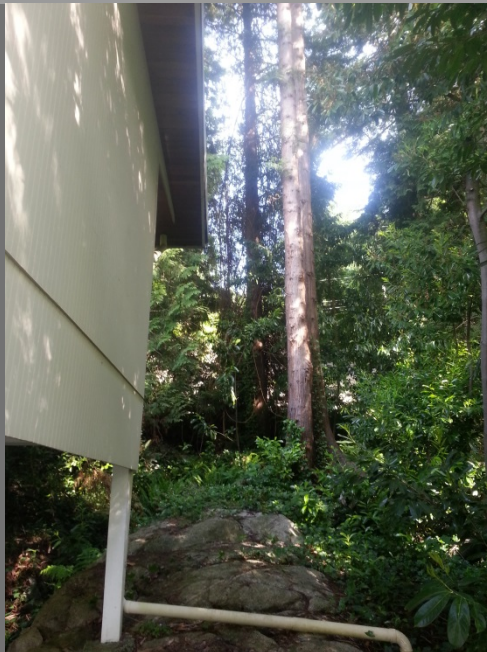
Photo 3. Tree # 109, is growing on the rock outcrop and may become unstable during the rock removal.

- **Tree # 109:** is growing on top of a rock outcrop, and it's my understanding that portions of the rock or the entire rock will be removed to accommodate the new building foundation. Since the main anchoring roots are wrapped around the rock, disturbance of this rock will most likely cause the tree to become unstable making it prone to root plate failure (via toppling). This tree will then become a higher risk for failure potential and should be removed to mitigate future safety risk to the site.

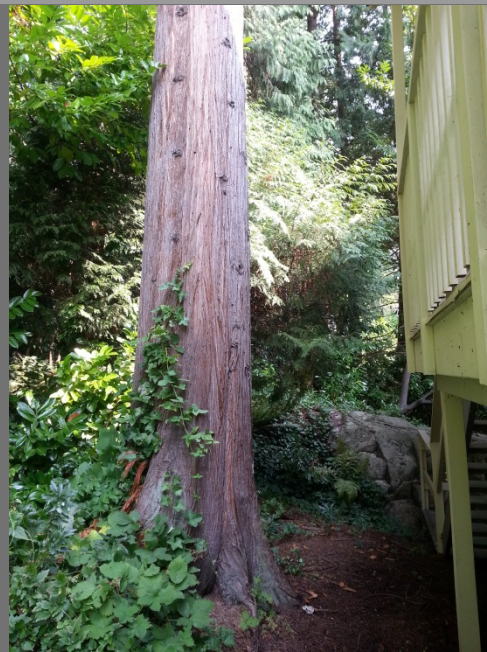
Photo 4. Several trees are growing within the existing building's envelope. Note these trees should be removed before house demo.
