**Tree Inventory for the
Proposed Development at
Kiwanis Seniors Housing Society
West Vancouver, BC**

January 2011

Civic address: **2105 Haywood Ave, West Vancouver, BC**
Client name: **Kiwanis Seniors Housing Society**
Date of site visit: October 4, 2010

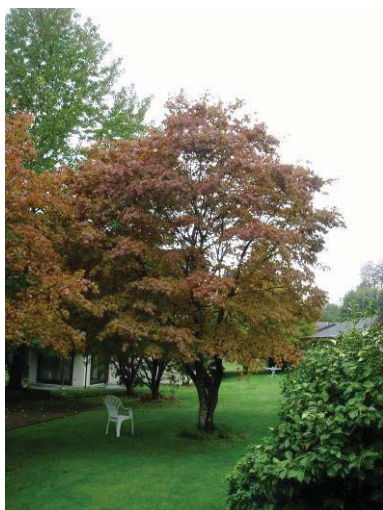
Photo 1. Tree 5719 - Japanese Maple typical of those found on and adjacent to this site

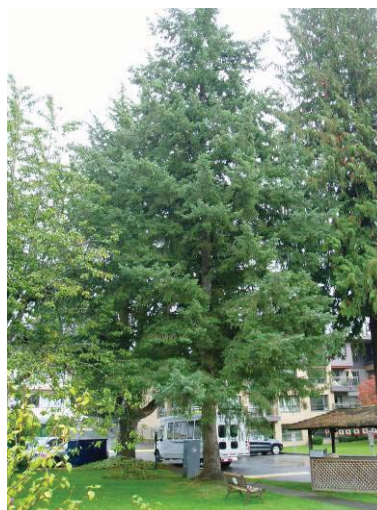
Photo 2. Tree 5721 – Mature Douglas-fir

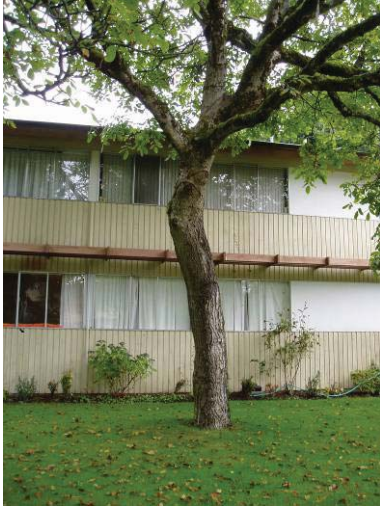
Photo 3. Tree 5707 is a mature English Walnut

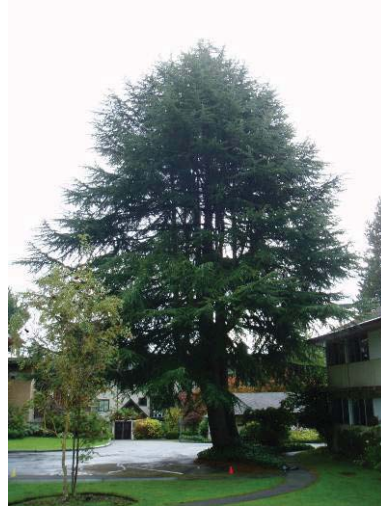
Photo 4. Trees 5727 and 5728 are mature Deodar cedar with roots that are in conflict with the existing road and sidewalk.

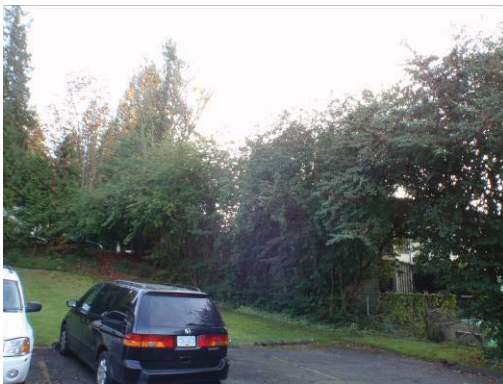
Photo 5. Trees 5767 to 5697 are a row of hawthorn growing on the northern property line.

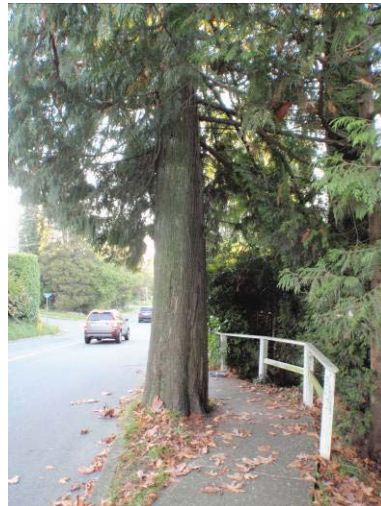
Photo 6. Tree 5675 is an off site mature western redcedar that is in conflict with 21st St and the sidewalk.
