October 21, 2020

**Re: Structural Condition Assessment Report  
Klee Wyck House  
200 Keith Road, West Vancouver**

**WHM # 19143**

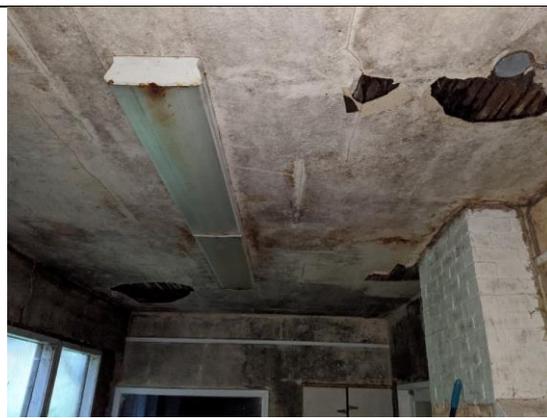
Photo 4: Upper floor ceiling showing significant water ingress

As seen in the above photos, large amounts of mold are present throughout the upper floor. Due to large amounts of water ingress, many of the interior finishes are peeling away to reveal wet structural elements.

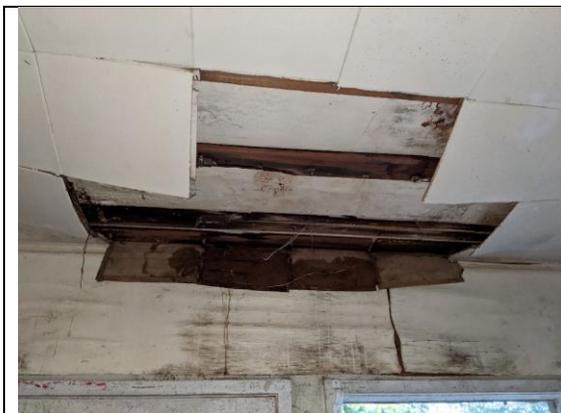
Photo 5: Exposed ceiling strapping on the upper floor.

Water ingress was present throughout the upper floor. Ceiling tiles and ceiling finishes have fallen off in a number of areas, exposing the framing above. Puddles were also present on the upper level floor.

- The roof sheathing is expected to be in very poor condition due to the large amount of water ingress.
- Roof rafters will have experienced a lot of moisture over the past few years and rot is expected, especially where water can collect, such as at supports and along the ceiling.
- Water ingress is also apparent along the walls and rot is expected in the existing wall framing.
- The water damage to the structural elements will have reduced their load-carrying capacity.

- The roof framing is expected to be compromised by the amount of water ingress that is present. The building should not be accessed while there is loading on the roof (i.e. snow, high winds).

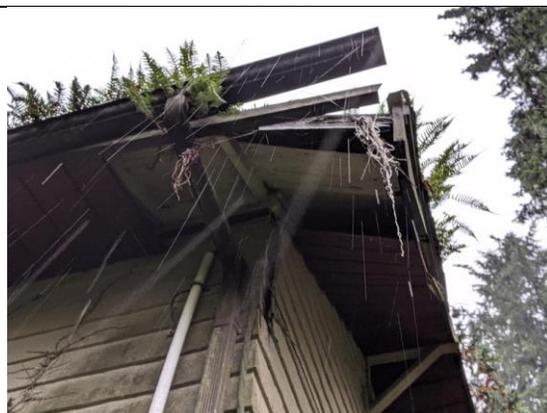
Photo 6: Damaged roof overhang at northwest corner of the building.

In addition to the above assumed damages, the northwest corner of the roof has also been damaged (Photo 6).

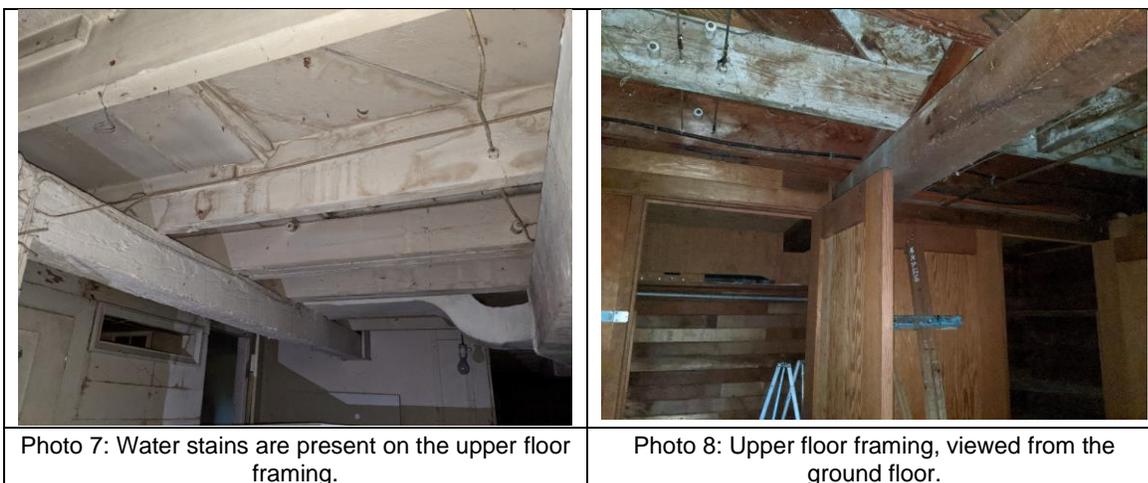
On the ground floor, WHM was able to review a larger portion of the existing framing. At the time of WHM's review, the framing appeared generally dry, however some signs of previous moisture were present.

While the general condition of the framing viewed from the ground floor was good, the large amount of water ingress on the upper level will impact the condition of the ground floor framing over time. The presence of puddles in some areas are also a concern since those areas may have localised rot on the floor framing.

- While the general condition of the floor framing may be in acceptable condition, the presence of puddles on the floor may have caused localised rot to the framing in areas which could not be observed during WHM's visit. If access to the building is desired by the client, a thorough, intrusive review of the condition of the floor framing would be required to identify unsafe areas.

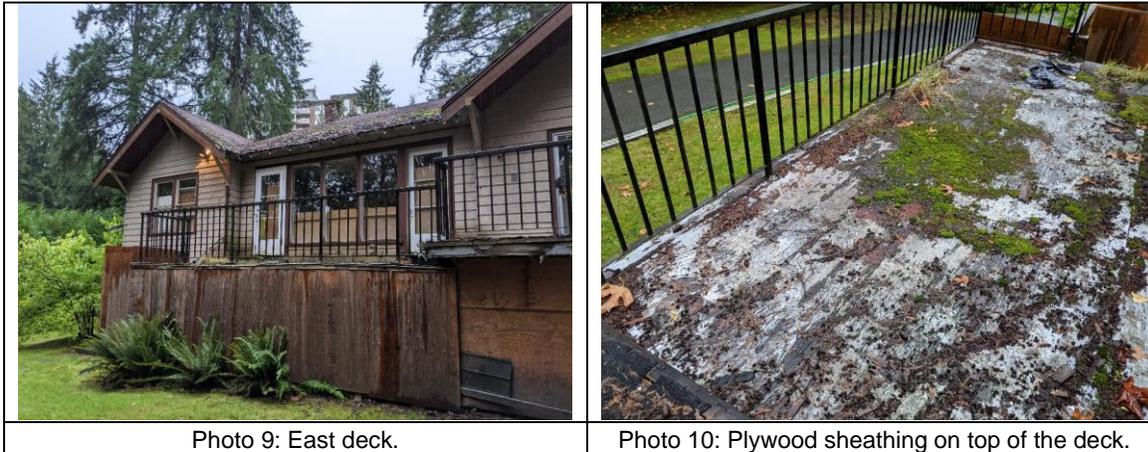
The east side of the building has a large deck which is accessed from the second floor. Access was not available to the area below the deck to review the framing but the condition from above suggests that it is in very poor condition.

The plywood decking was very soft and the joists supporting the deck are expected to be rotting.

- Due to the amount of mold present throughout, appropriate precautionary measures should be taken by any personnel accessing the building.
- The east deck of the building should not be accessed.
