DISTRICT OF WEST VANCOUVER
750 17TH STREET, WEST VANCOUVER BC V7V 3T3

COUNCIL REPORT

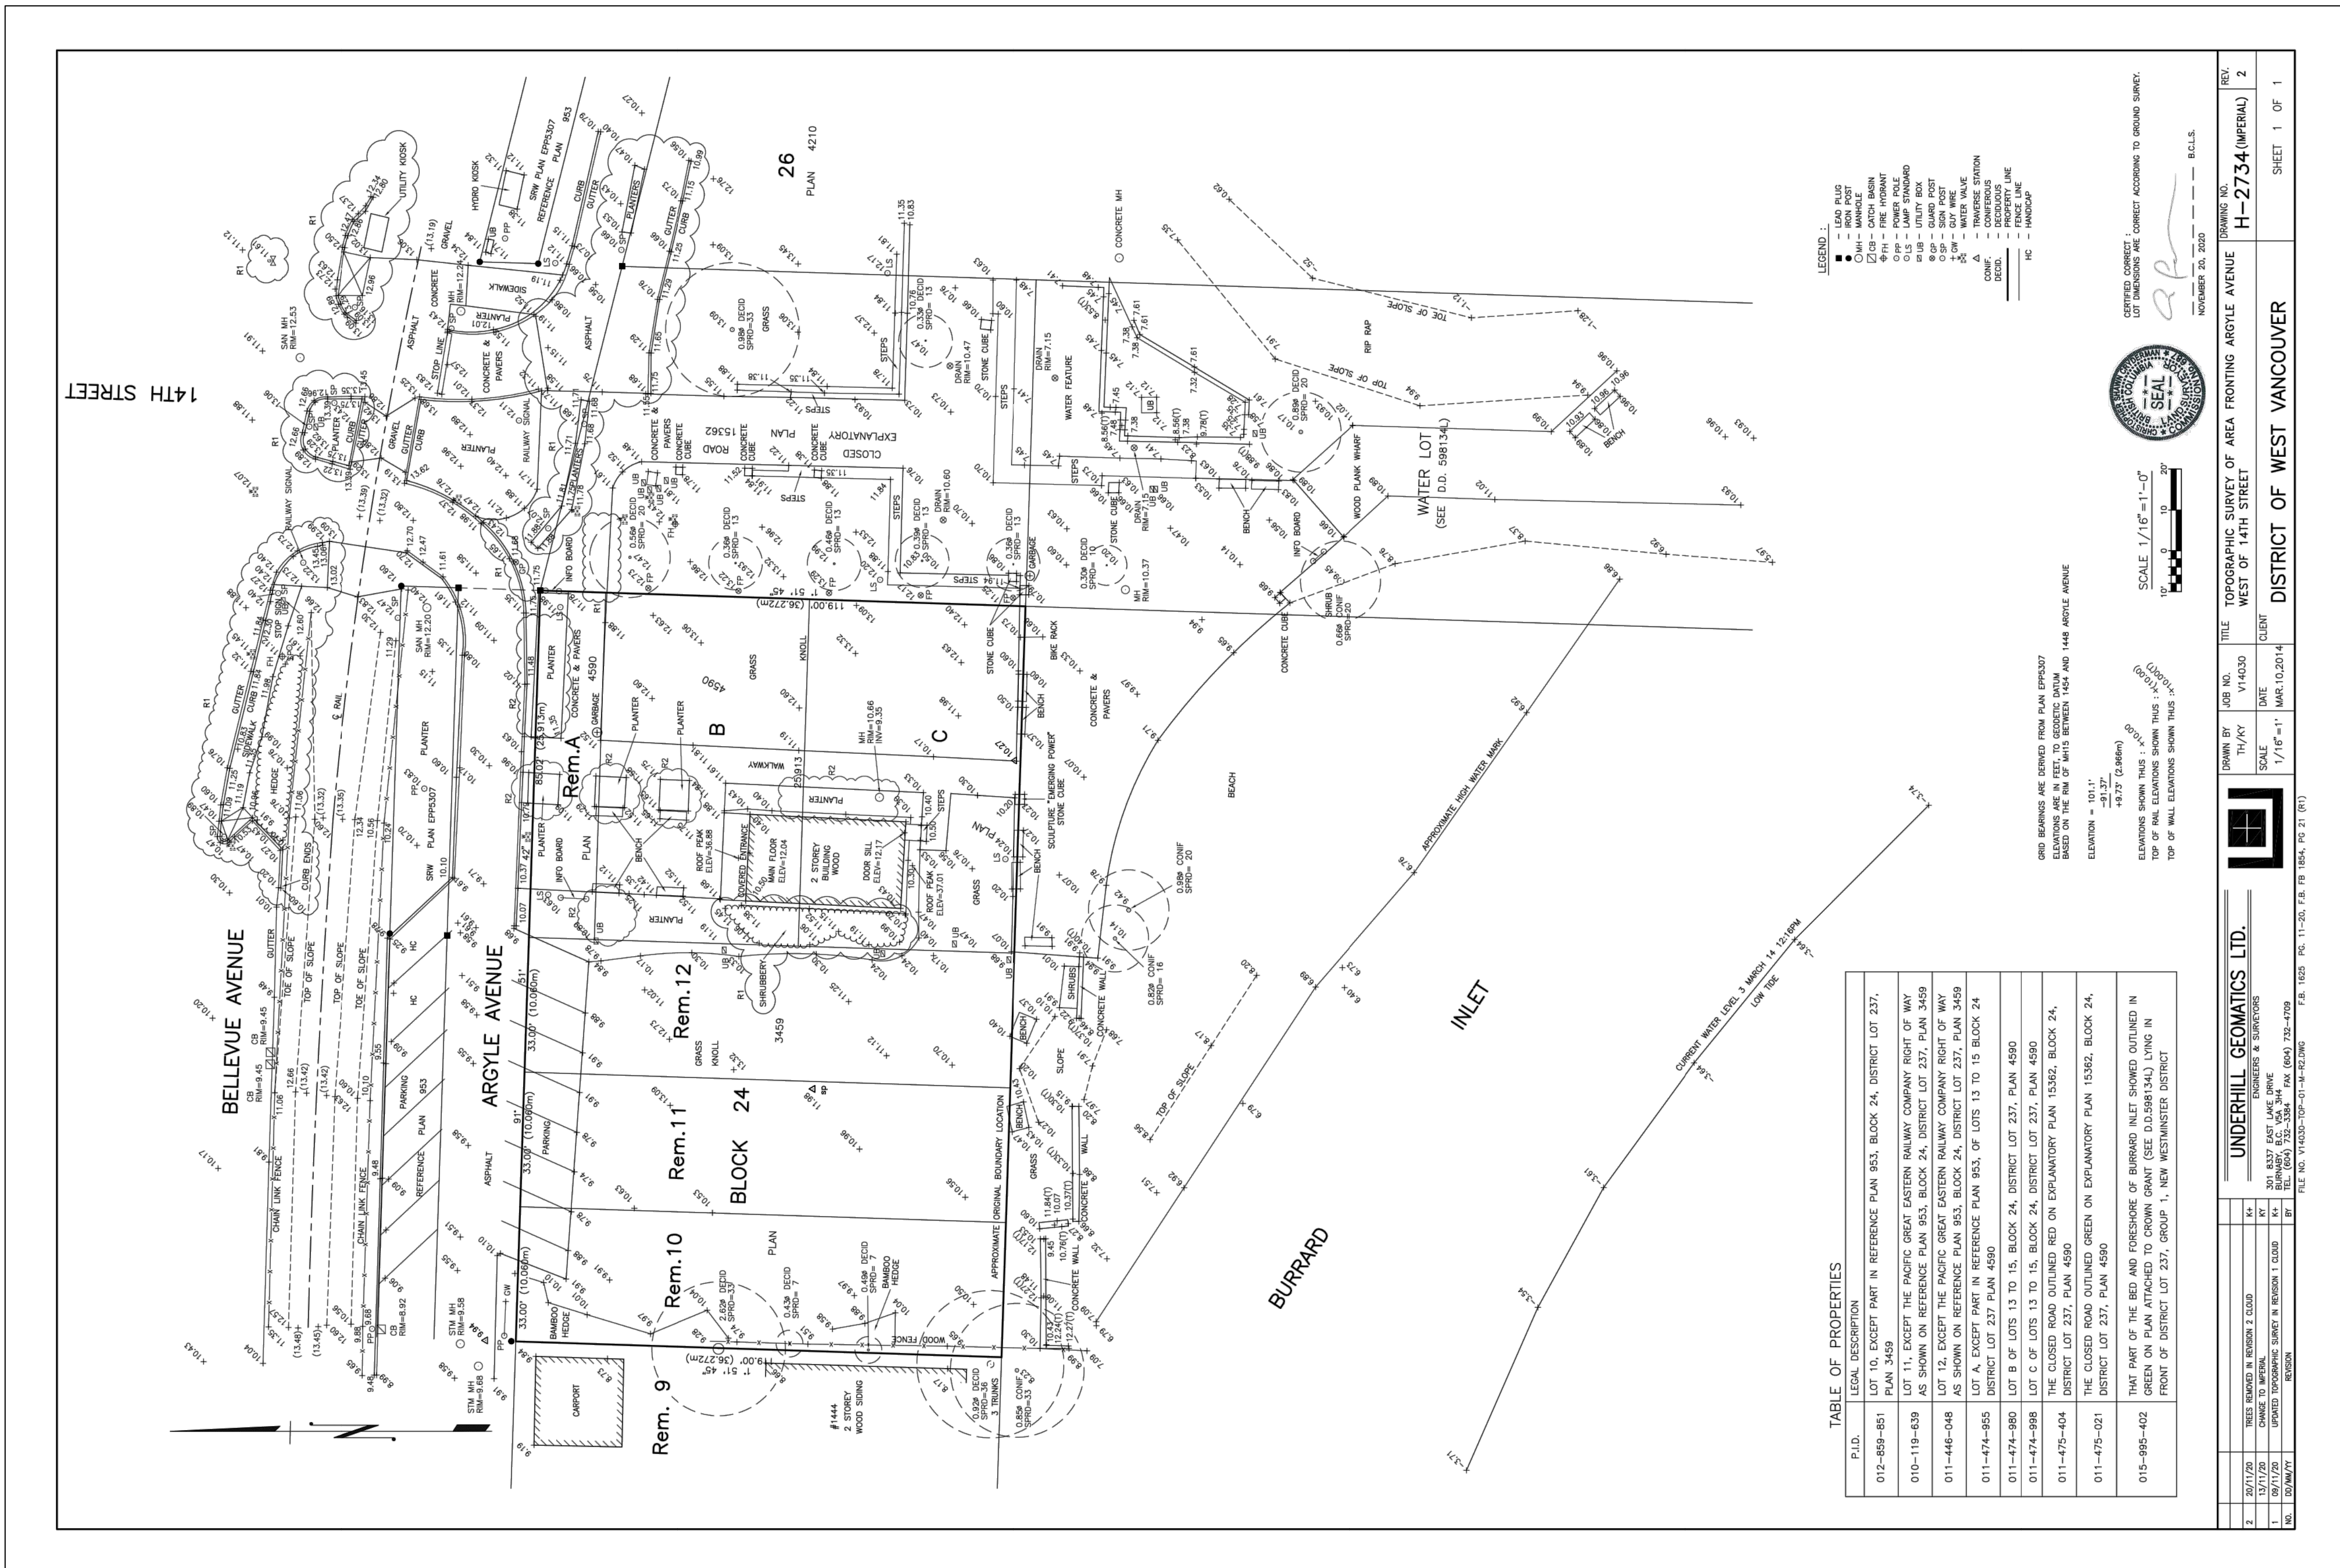
- LEGEND:
- IRON PIPE
 - MANHOLE
 - CATCH BASIN
 - POWER POLE
 - LAMP STANDARD
 - GUANO POST
 - WATER VALVE
 - TRANSVERSE STATION
 - CONCRETE
 - PROPERTY LINE
 - HANDCUP

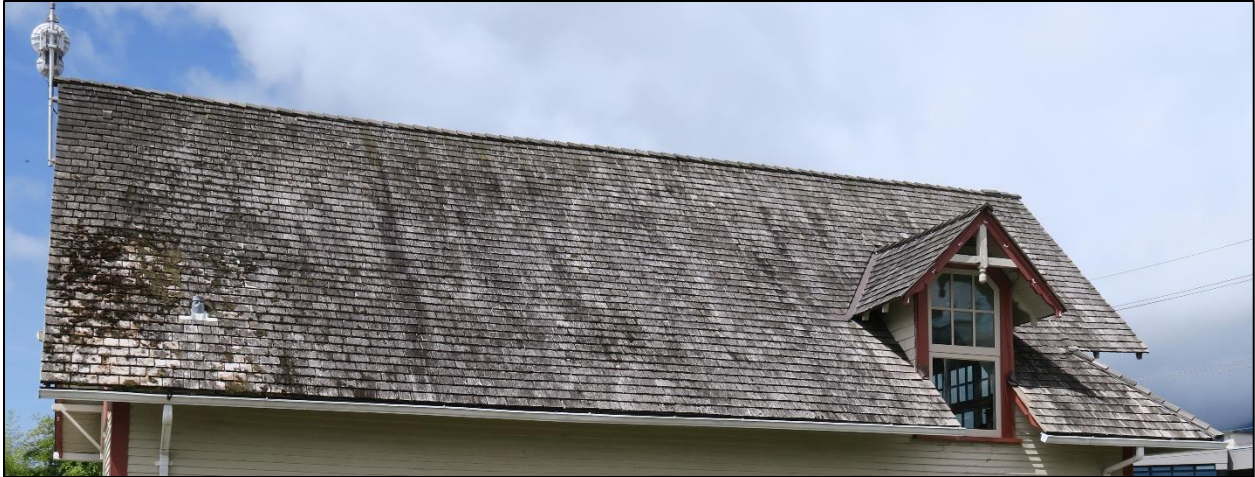
Fig. 17: Eastern side view of the Ferry Building Gallery, 2020, illustrating the current state of the roofing. (Source: Ehman)

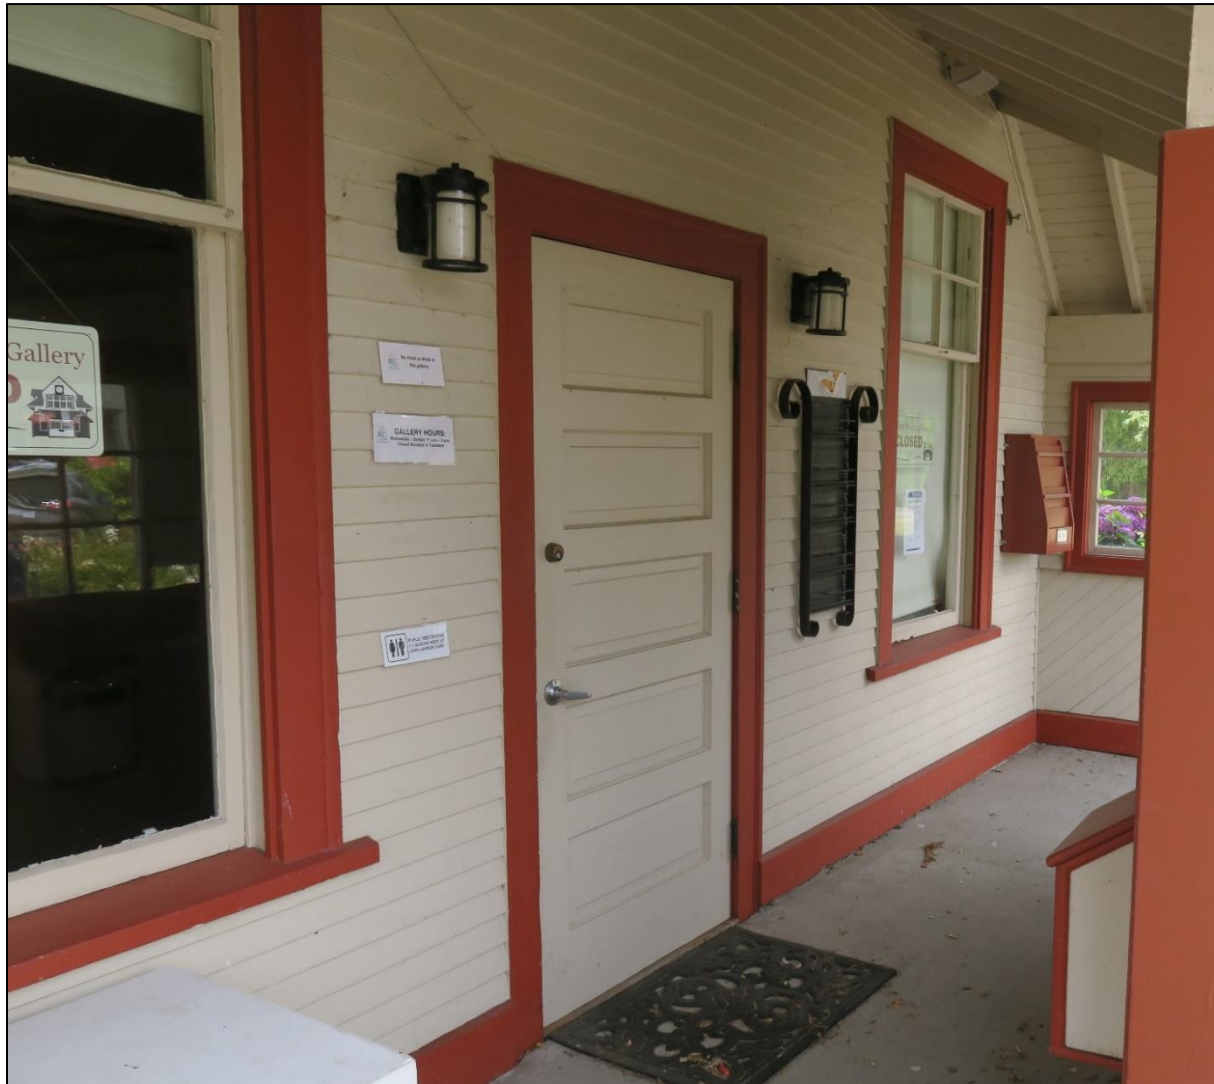
Fig. 20: The front entrance of the Ferry Building Gallery, 2020, illustrating the largely good condition of its front door, windowsills and trims. Note also the more appropriate lighting, compared to the back of the property, as visible in Fig. 21 below. (Source: Ehman)

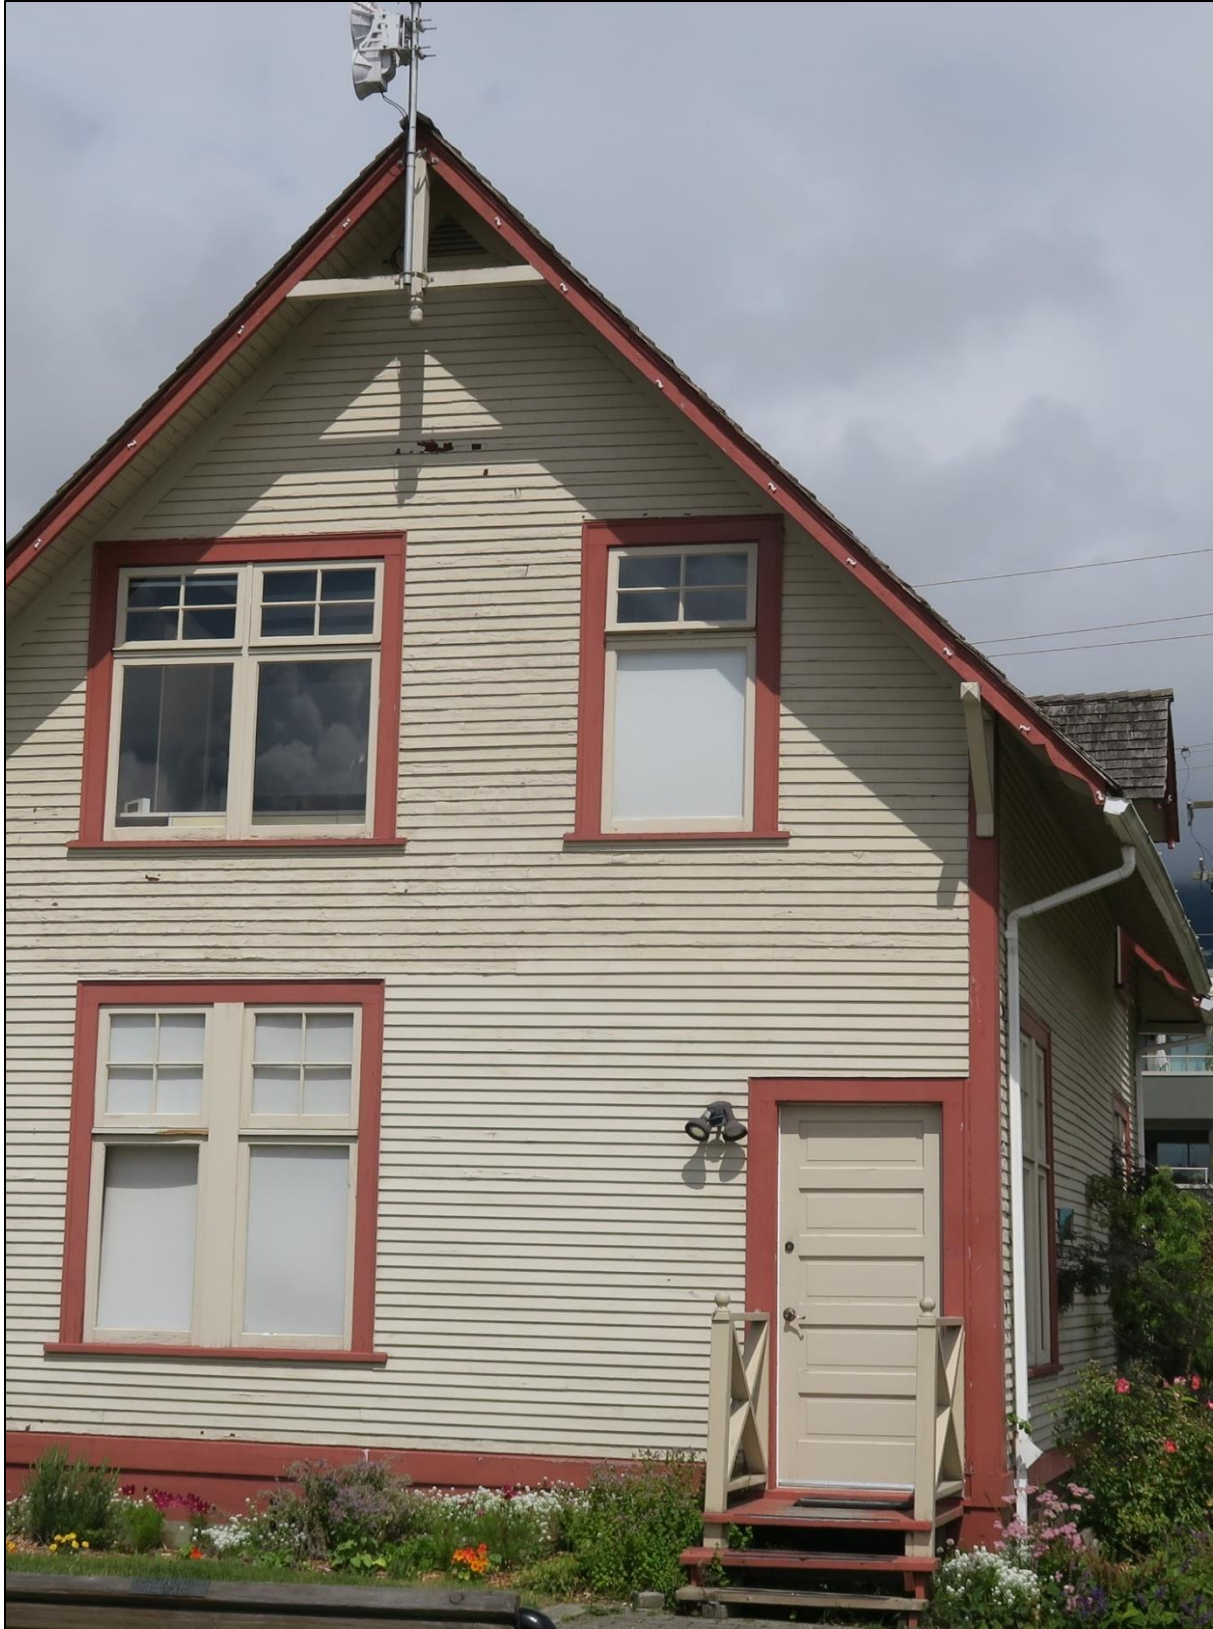
Fig. 21: The back entrance of the Ferry Building Gallery, 2020, illustrating the largely good condition of its back door and windows. Note the less appropriate lighting and the antennae that should be removed. (Source: Ehman)

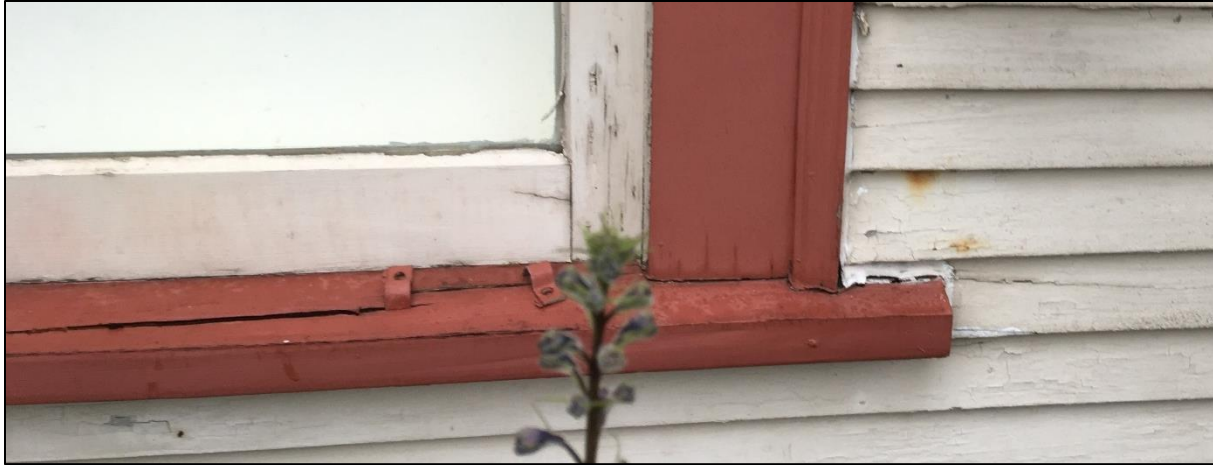
Fig. 22: Detail shot of one of the eastern windowsills and trims, showing signs of deterioration, including a large crack in its sill. (Source: Ehman)

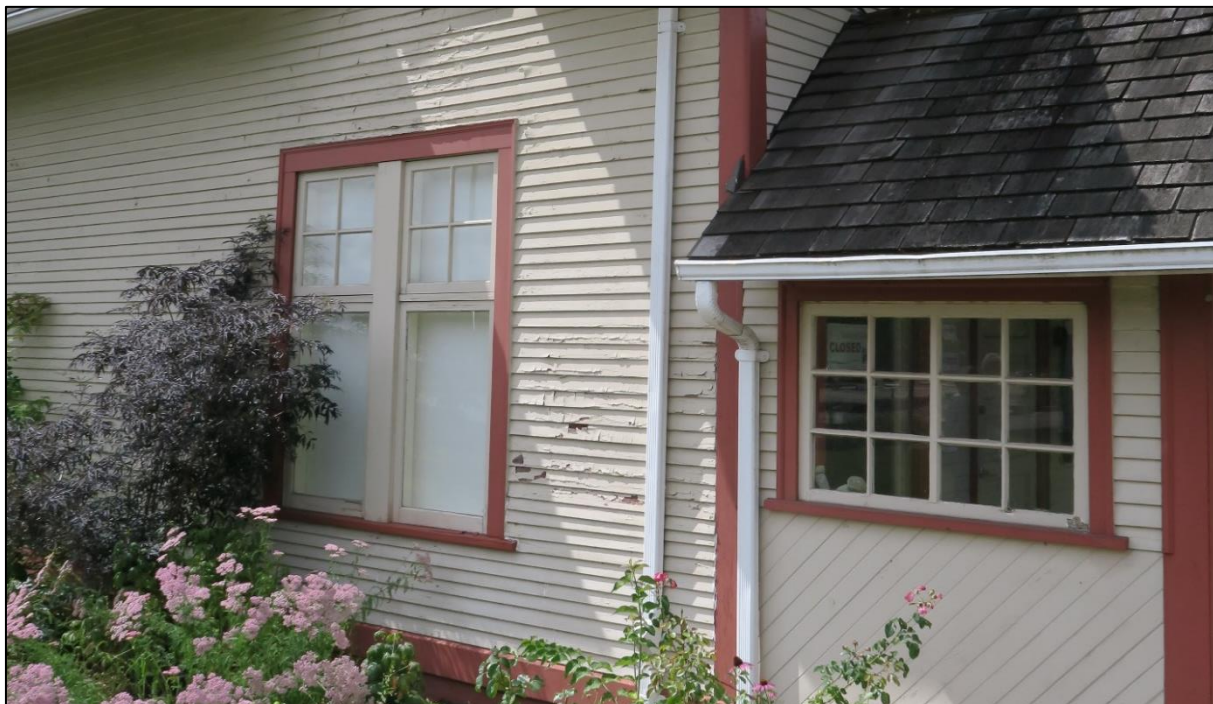
Fig. 23a: The eastern side of the Ferry Building Gallery, 2020, illustrating the condition of the siding, in particular showing areas with peeling paint (a detail shot of which is shown in Fig. 23b below). (Source: Ehman)

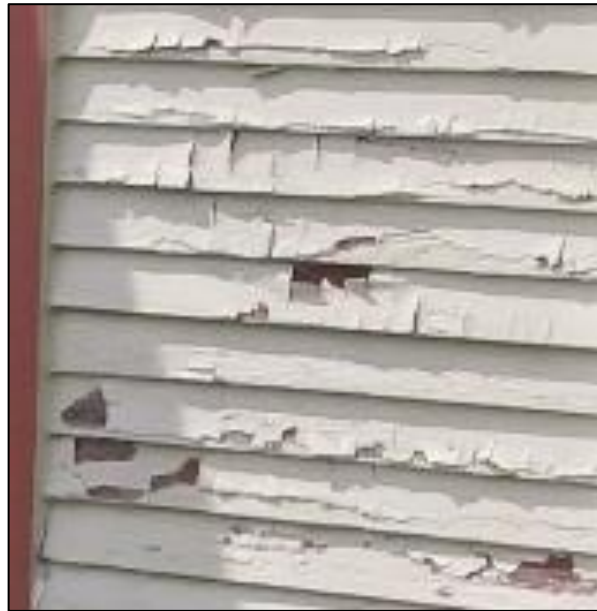
Fig. 23b: Detail shot of the eastern side of the Ferry Building Gallery, 2020, illustrating the areas of peeling paint. Note this also reveals the earlier, inverse paint scheme with a darker red for the main body colour. (Source: Ehman)

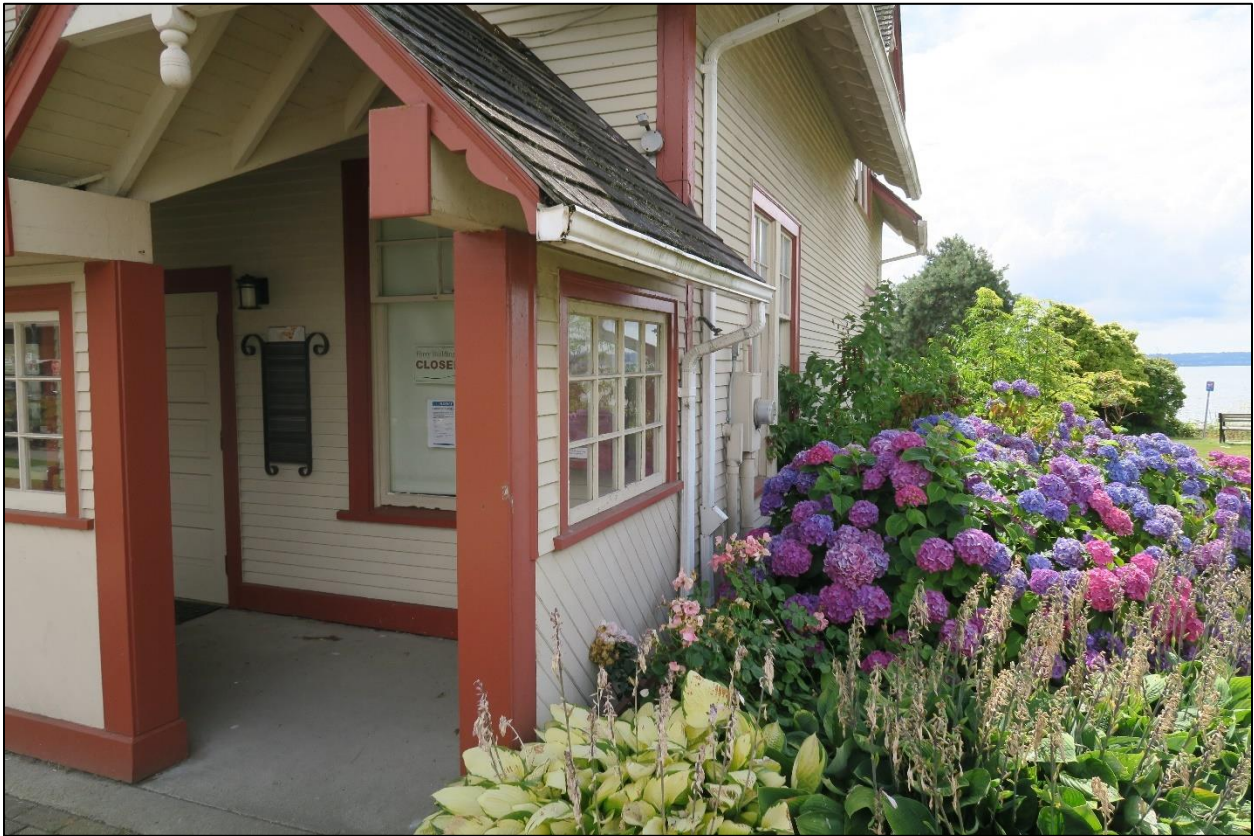
Fig. 25: View from the northwest corner, showing some of the landscaping growing very close to the heritage building. (Source: Ehman)

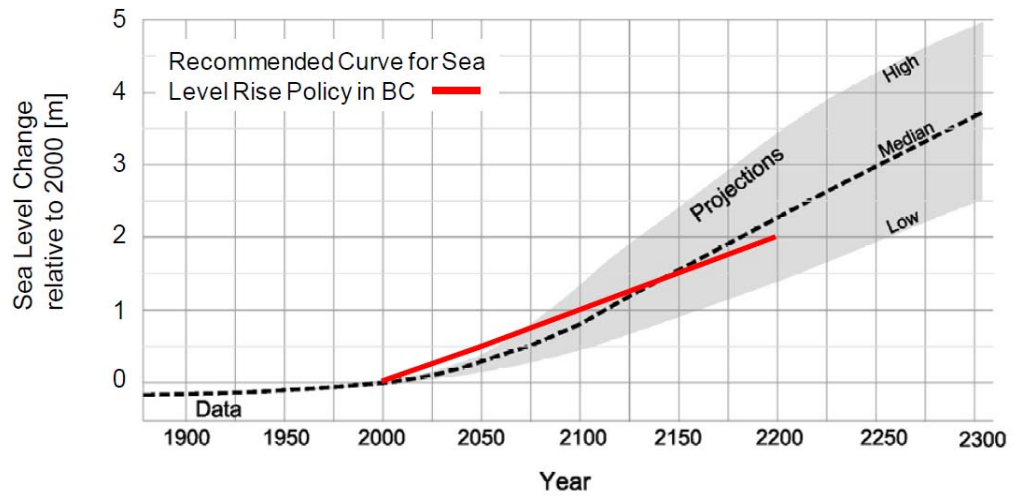
Figure 6 Recommended Global Sea Level Rise Curve for Planning and Design in BC (Ausenco Sandwell, 2011)

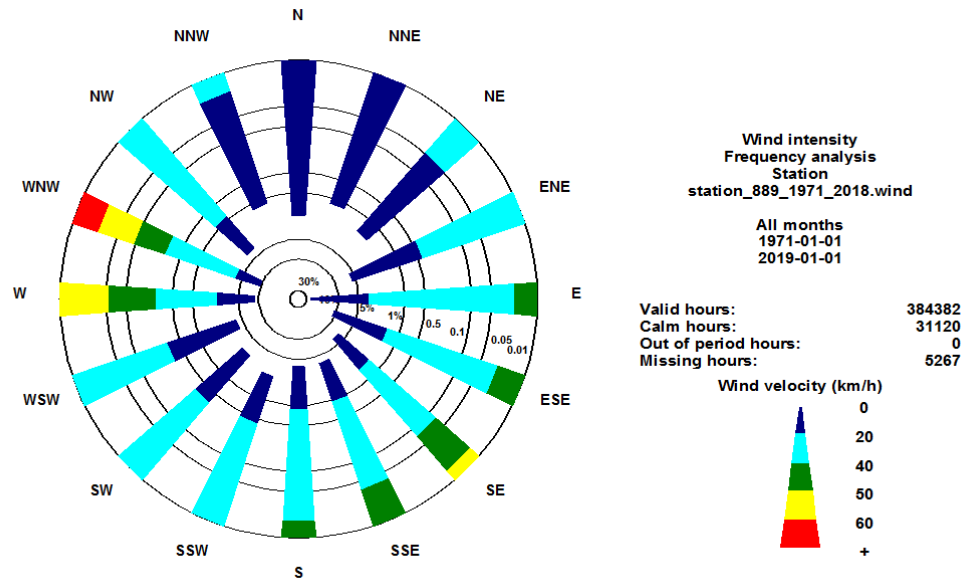
Figure 7 Wind Rose at Vancouver Airport Climate Station

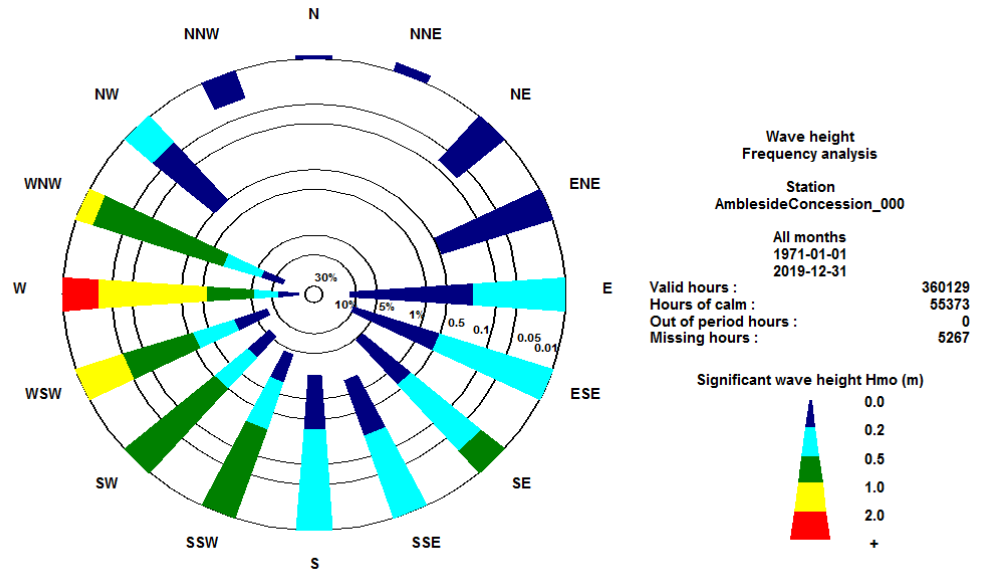
Figure 8 Offshore Wave Height Rose

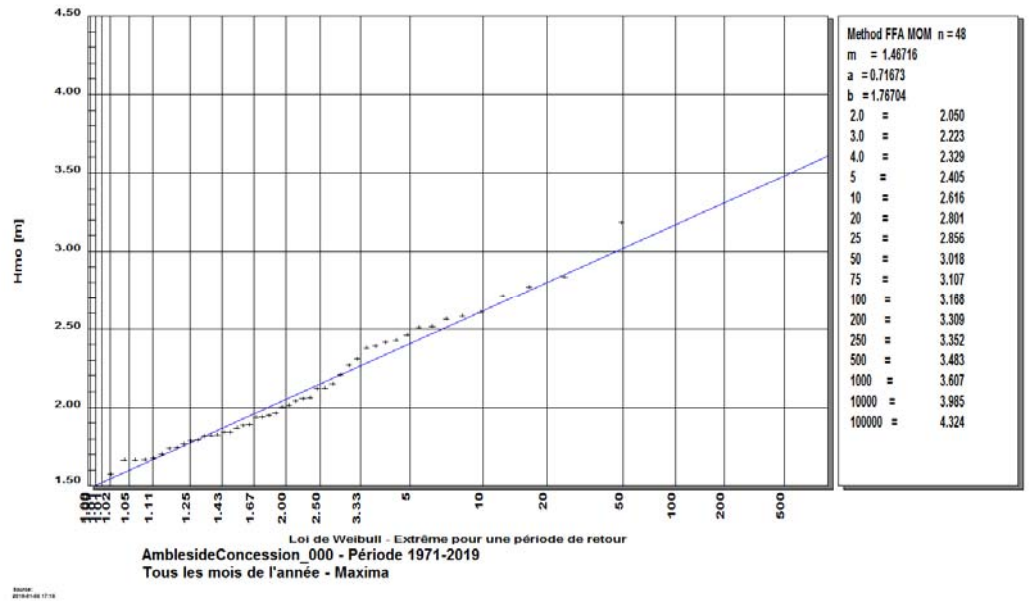
Figure 9 Wave Height Frequency
