TREE INSPECTION REPORT

Date: **September 26, 2019** Rev 0: **ACL File: 19214**
 Attn: **Katie Hlynsky** Prepared by: **Nick McMahon**
Hlynsky Architects
 2439 Bellevue Avenue
 West Vancouver, BC V7V 1E1
 Senior Project Arborist
 Project: **BP Application for a Single-Family Home**
4358 Ross Crescent
 Re: **Aerial inspection and Detailed Decay Testing**

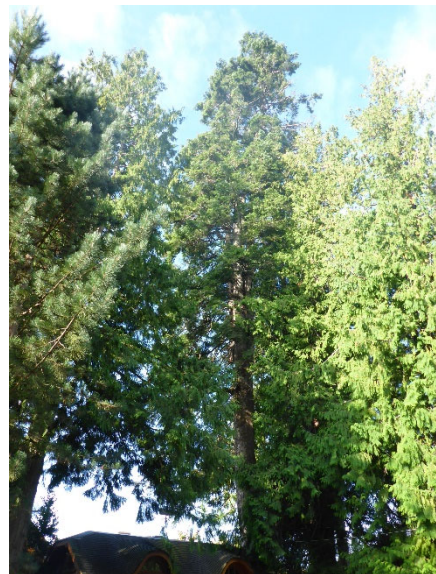
Photo 1.
Tree A

Tag or ID:	<i>Dbh (cm):</i> 138	<i>Species:</i> Grand fir (<i>Abies grandis</i>)
A	<i>Spread Rad (m):</i> 6.0	<i>Struc Class:</i> Open <i>Health:</i> Good
	<i>Height (m):</i> 50	<i>Age Class:</i> Mature <i>Ownership:</i> On-site

- An existing derelict garage is located within the subject site and within the root zone to the west.
- A concrete retaining wall has been installed in alignment with the east property line appears to end approximately 2.5m southeast of the stem.
- An off-site garage has been historically built in close proximity to the east property line directly adjacent to the subject tree. We did not undertake root mapping to this stage of review and root impacts – if any, from the construction of the off-site structure have not been observed.

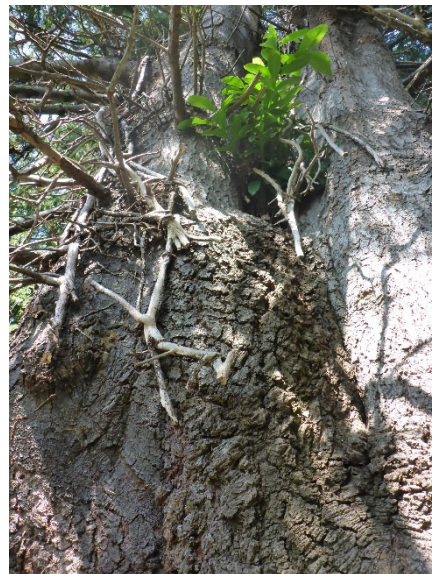
Photo 2.
Leader Attachments

- Multiple co-dominant leaders narrowly attach at a height of 15m above grade with a bark inclusion and well limb-tied in the crown.
- Over-extended co-dominant scaffold branches on the west side of the crown with a marm form (double-candelabra). This defect is considered most likely for failure and considered a moderate risk.
- Lower crown suppressed on the north and south sides due to proximity and shading from adjacent (secondary canopy) trees.
- Sounding suggested significant internal defect in the stem at 5.0m above grade. Resistograph testing undertaken at this height indicated normal growth patterns and sound wood.

- Aerial resistograph testing was undertaken at a height of 25m above grade – 20cm below the attachment of multiple co-dominant leaders. No signs of actively cracking stems were observed.
- Testing results have been analyzed and found to indicate normal growth patterns and sound wood at multiple test sites at the specified height.

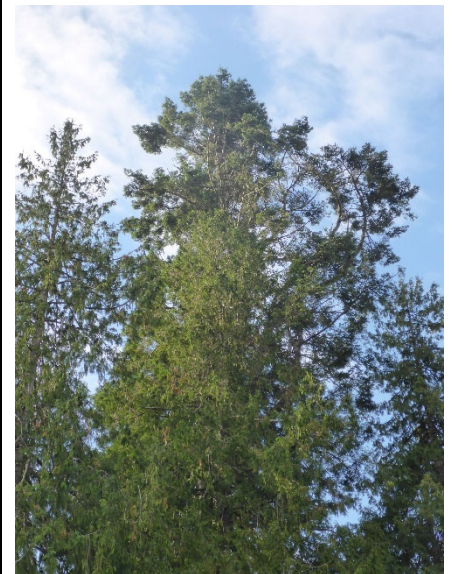
Photo 3.
Over-Extended Branches

- Over-extended scaffold branches are prone to torsional failure via wind loading.

- Pruning to remove or reduce the length of over-extended branches and thinning to reduce wind resistance is expected to reduce the likelihood of branch failure.
