## **Heritage Designation Bylaw No. 5459, 2026**

A bylaw to designate 1768 Argyle Avenue as protected heritage property.

# NAVY JACK HOUSE

1768 ARGYLE AVENUE, WEST VANCOUVER, BC

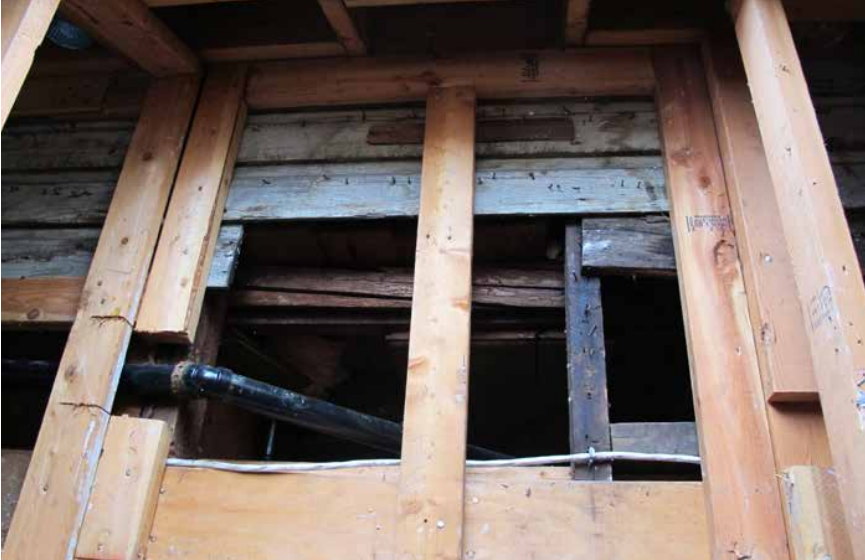
*Siding behind later construction, Ground Floor East Side*

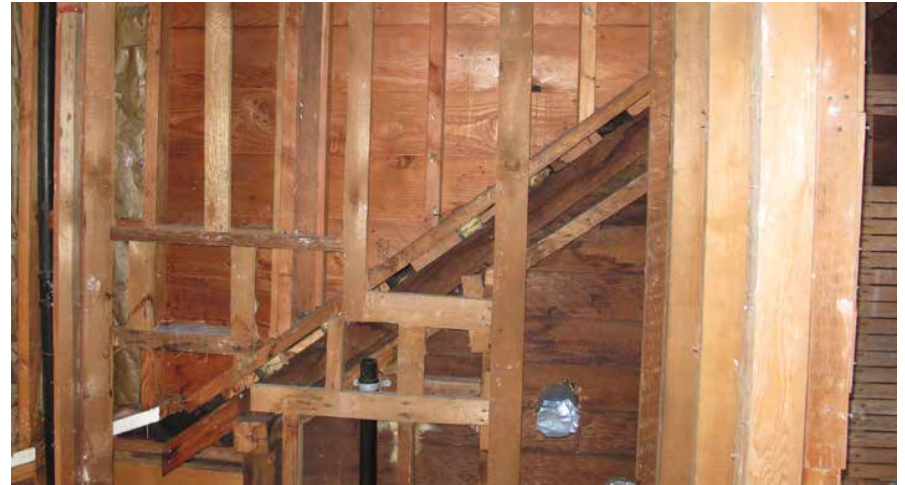
Although the roof framing has been cut out in several locations, virtually all of the planking that formed the exterior soffits were left in place, and can be traced on the east and west sides of the house.

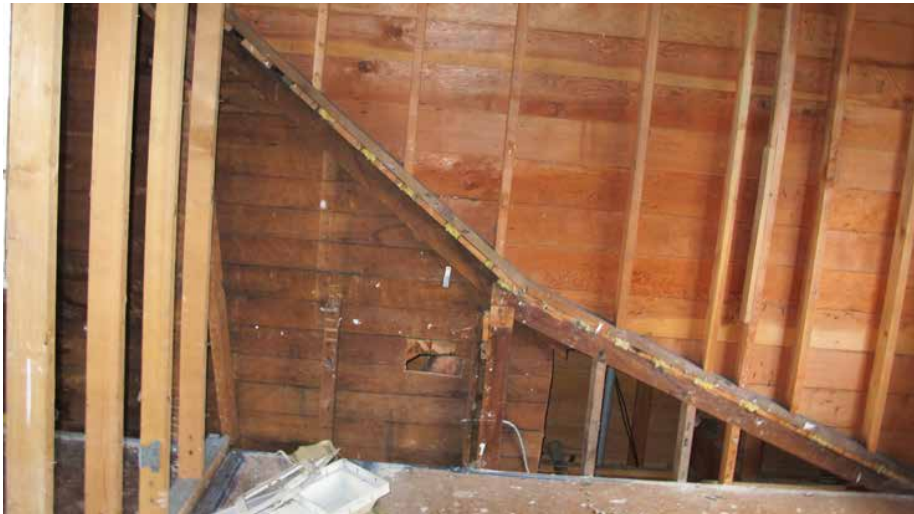
Siding behind later construction, Ground Floor East Side

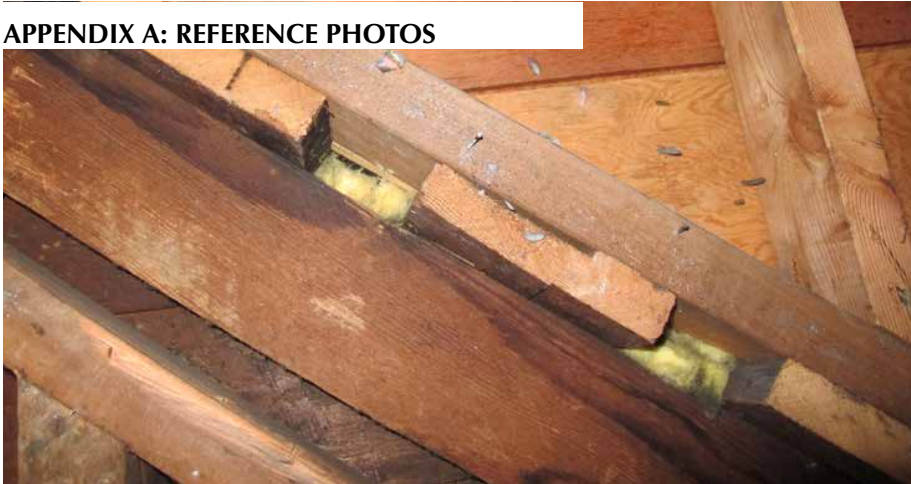
*Cut-through roof structure showing original nailing strips.*

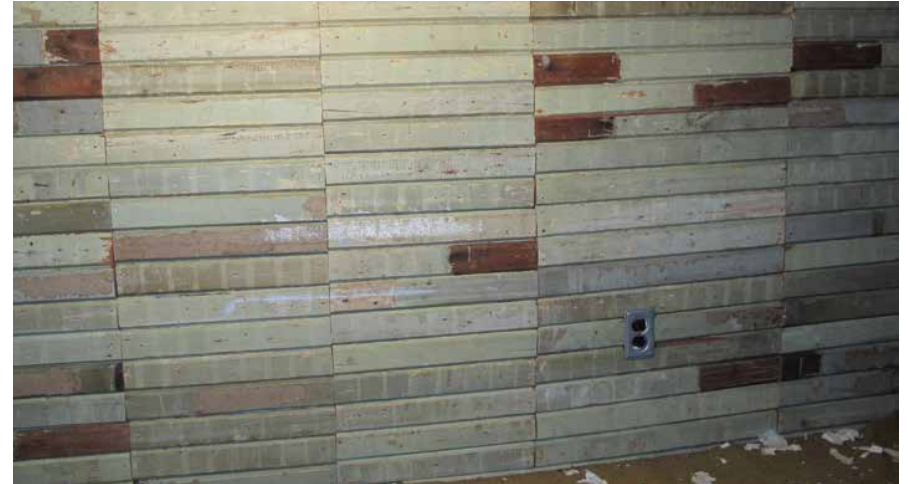
*Basement Level wood sidings repurposed as cladding*

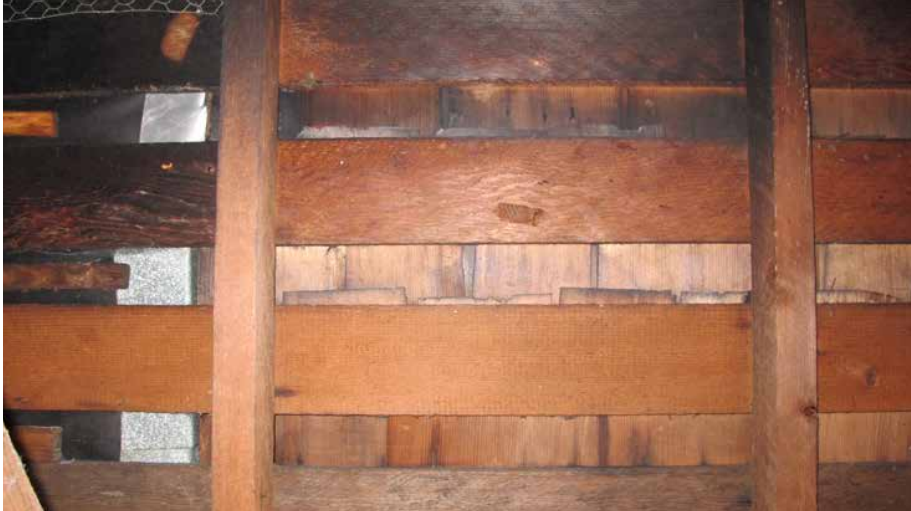
*Underside of intact cedar shingle roofing*

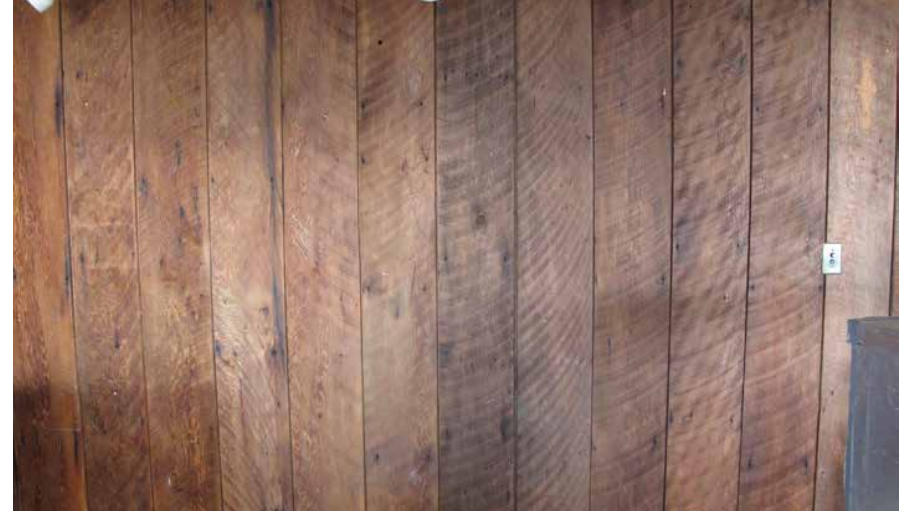
*Living Room Sawn Lumber repurposed by homeowners*
