## **Arborist Report Rev 1.1 for:**

## 6544 Royal Ave, 6388 & 6390 Douglas Street West Vancouver, BC

Published Date: March 22, 2024

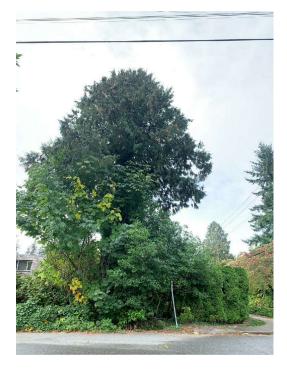
a) Large diameter cedar that will be retained.

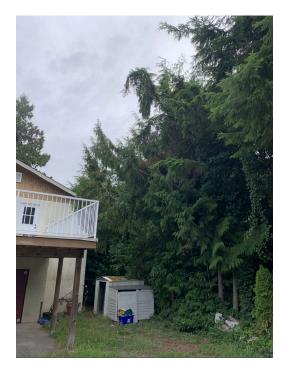
c) Topped trees bordering the Property.

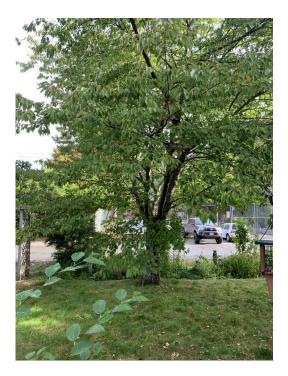
b) Municipal Cherry tree which will be retained (Tree 11).

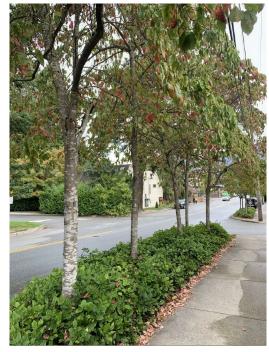
d) Row of boulevard Dogwoods that must be protected.

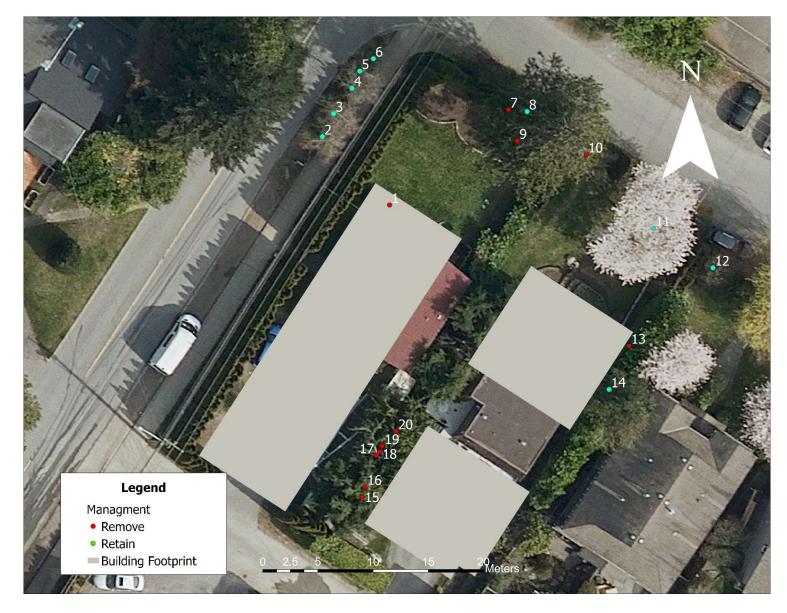
*Figure 4:* Overview map of surveyed trees and respective management decisions within the Development Area.

During the field assessment, the arborist measured 20 trees identified by the Professional Surveyor on or directly adjacent to the Development Area which were greater than 10 cm DBH. Of these, nine trees are fully on the property, and eleven were off-property municipal trees. Municipal trees are protected by the Boulevard Bylaw. On-property Trees 15-20 are conifers that have all been topped to create a hedge row between the two properties. The trees have poor growth form and some chlorosis and rot caused by the stress of previous pruning. Tree 8 is a large diameter (136 cm DBH) red cedar that needs

to be removed to allow for sidewalk construction. Trees 1 and 13 are laurel hedges which are considered invasive under Schedule A and therefore should be removed. Additionally, there is a significant amount of English ivy, and Himalayan blackberry On-Property which should be removed as per Schedule A invasive species guidance.

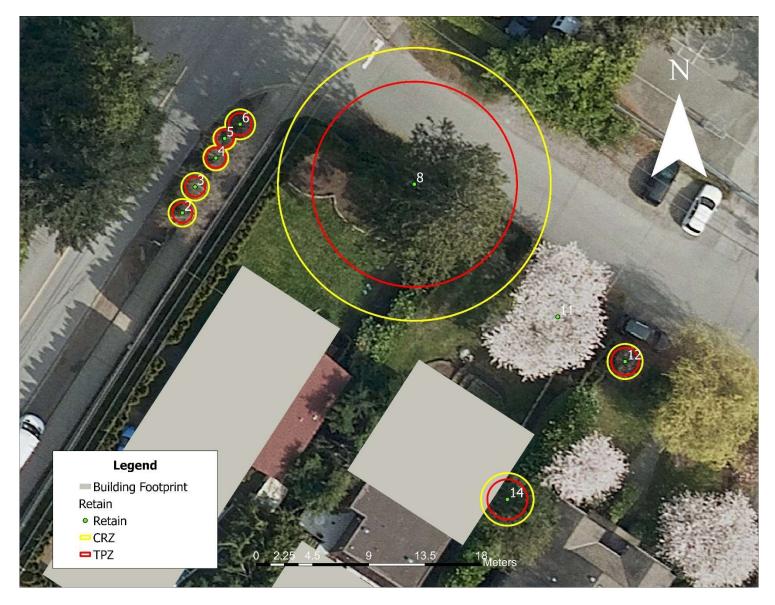
Figure 5 Retained trees and their respective TPZs.

Tree 2, 3, 4, 5, 6, 8, 11, & 12 must have tree protection zones installed. These trees are protected by the Boulevard Bylaw and therefore **require** protection.

Due to impact to CRZs, seven trees will require fence barrier installation before the commencement of any of the proposed land development works. Fence barriers shall be erected at the distance stated in the TPZ column found in *Table 1* (see also Figure 4). These trees include:
