RATHBURN ARBORIST CONSULTING INC.

TREE RETENTION ASSESSMENT:

Civic address:	2968 Mathers Crescent West Vancouver "Binning House"
Project No.:	unknown
Client name:	Jesse Saniuk-Vice-President-Four Sails Realty Inc
Date of site visit:	March 28, 2017
Weather during visit:	Heavy Rain

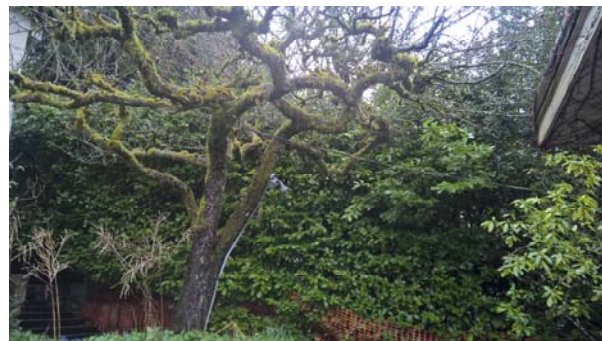
Showing the apple tree to be restored

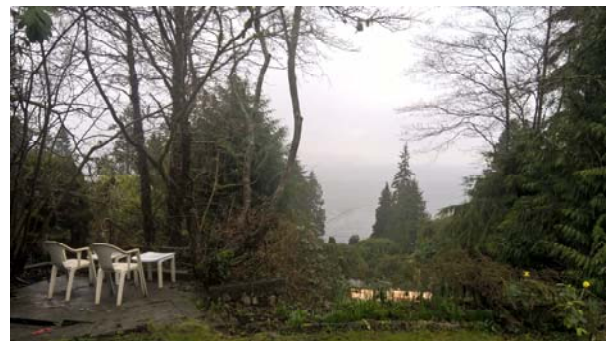
Showing the Japanese maple growing within the retaining wall.

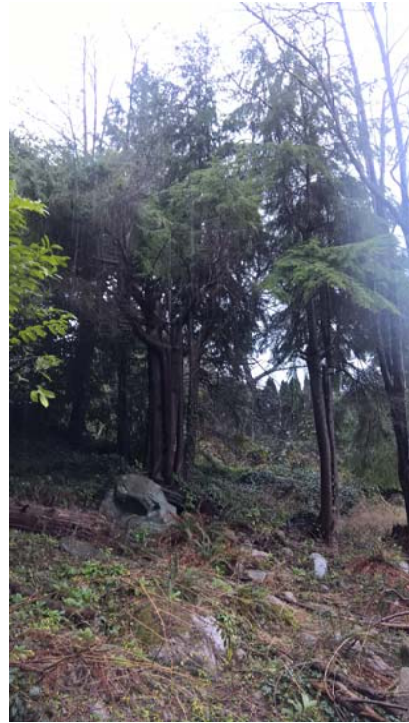
Showing the topped on-site conifers

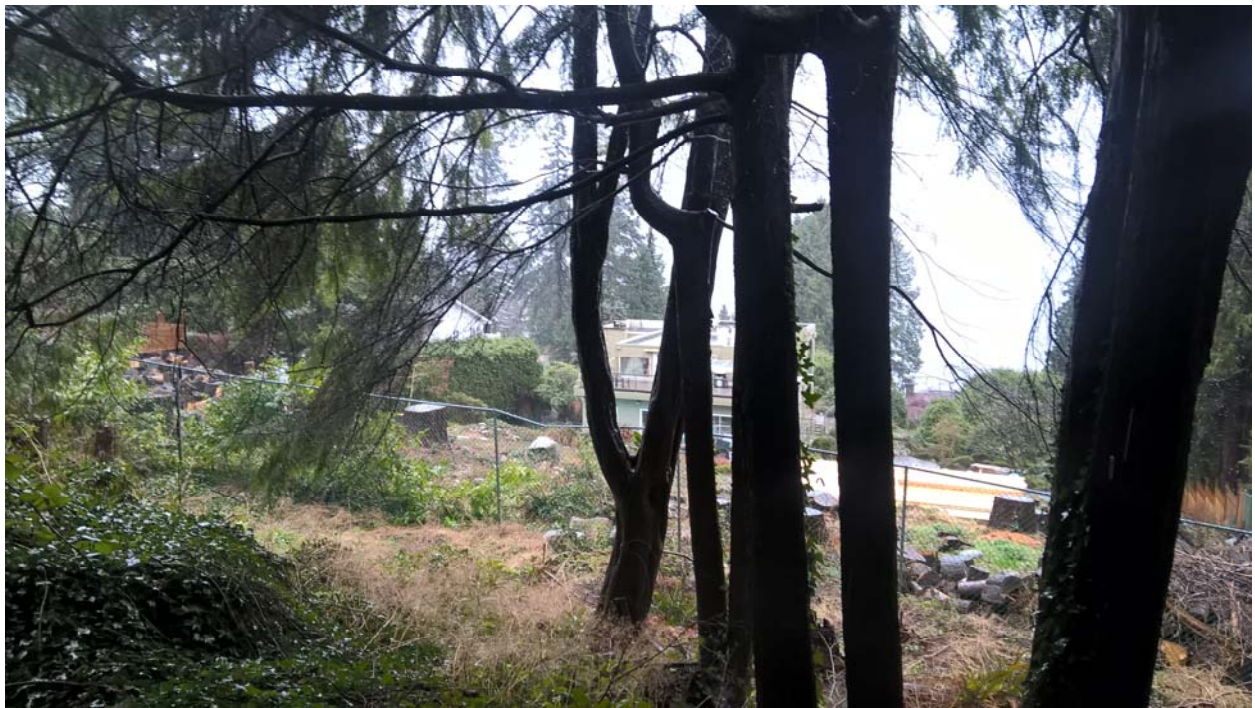
Showing the off-site tree stumps (south of chainlink fence)
