Arboricultural Inventory and Report

1768 Argyle Avenue
West Vancouver, BC

Date: August 20, 2024

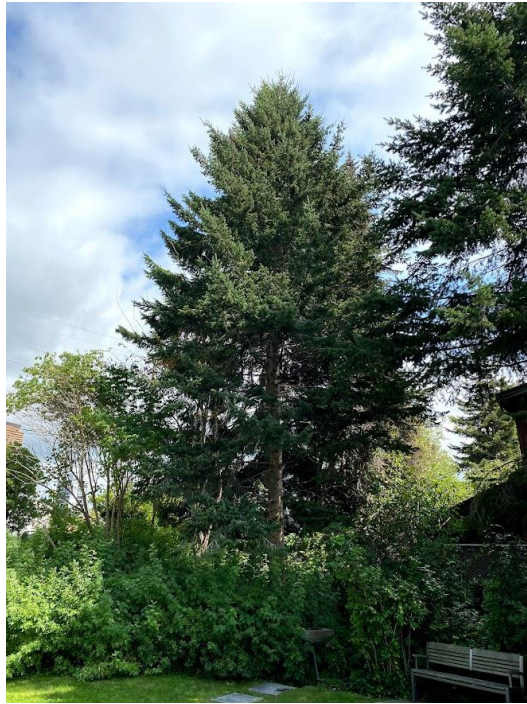
Trees #8 and #9 lie between the Navy Jack House and a proposed walkway at the west edge of the site. An ISA Certified Arborist should supervise works for the proposed pathway immediately west adjacent of the CRZ of tree #8, as well any planting done between the new addition on the Navy Jack House and the south end of the CRZ of tree #8.

Photo 1. #Tree 8, as seen from west of the site.

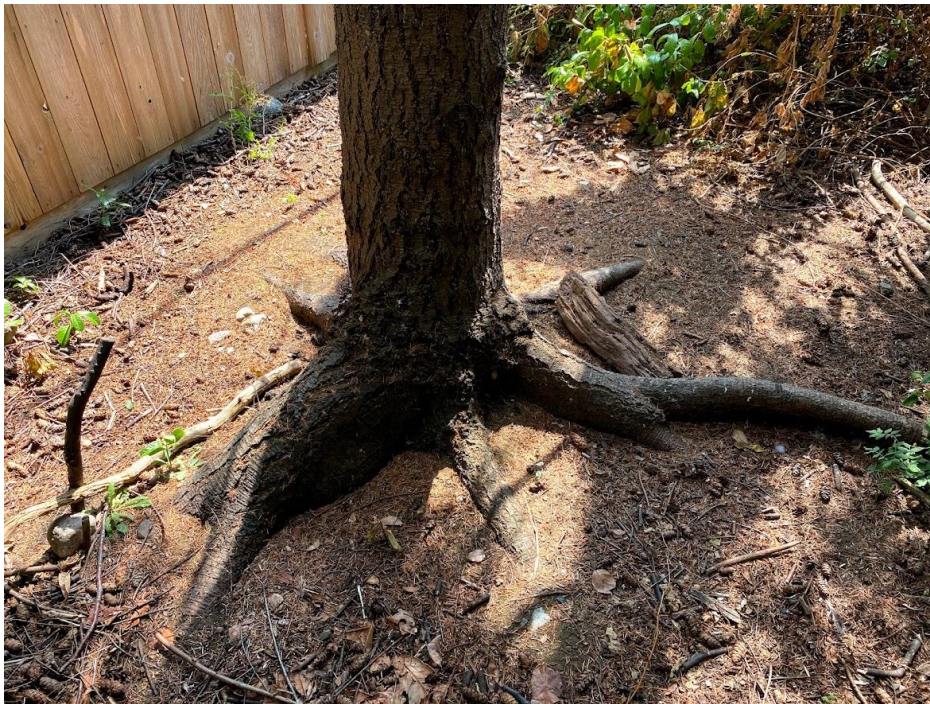
Yes	14	City	Douglas-Fir	<i>Pseudotsuga menziesii</i>	37	18	60-79%	5	Moderate	Growing next to property line for Navy Jack House. Single straight stem with an above ground root flare. Crown extends to touch Navy Jack House.	Medium	Remove	Tree location conflicts with proposed building additions.	3.7

Photo 2. Tree #14, showing exposed roots.

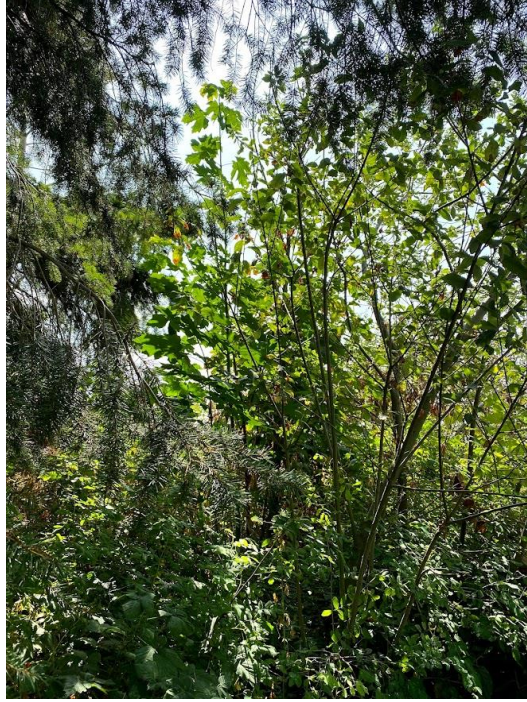
Photo 3. Tree #15, growing under canopy of adjacent trees.

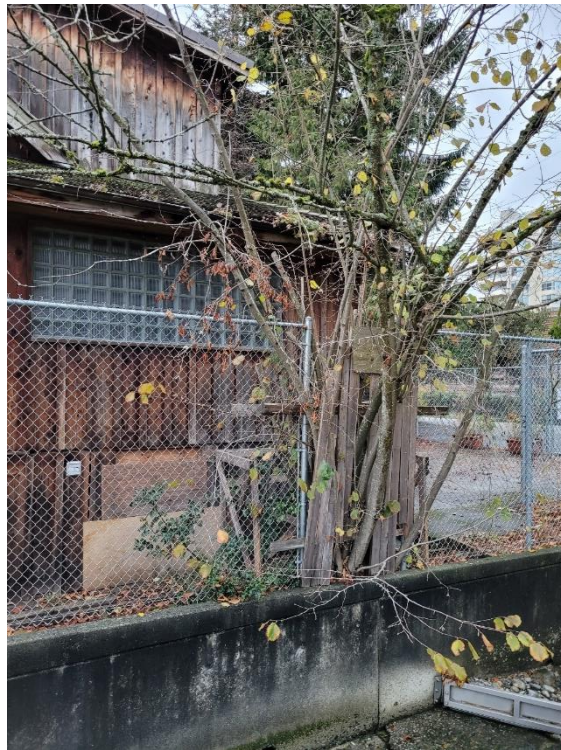
No	38	City	Common Hazelnut	<i>Corylus avellana</i>	17	5		3	Poor	Multiple stems embedded in chainlink fence. Rooted in retaining wall. Identified as missing tree #6 in A. Banks email Nov 30, 2022.	Low	Retain	Protect and retain as required. TPZ has been reduced to allow for pedestrian passage on the east side of the house.	2
No	39	City	Golden chain tree	<i>Laburnum x watereri</i>	42	6		2	Poor	Roted in retaining wall. Identified as missing tree #7 in A. Banks email Nov 30, 2022	Low	Retain	Protect and retain as required.	4.2

Photo 4. Tree #38, growing in retaining wall.

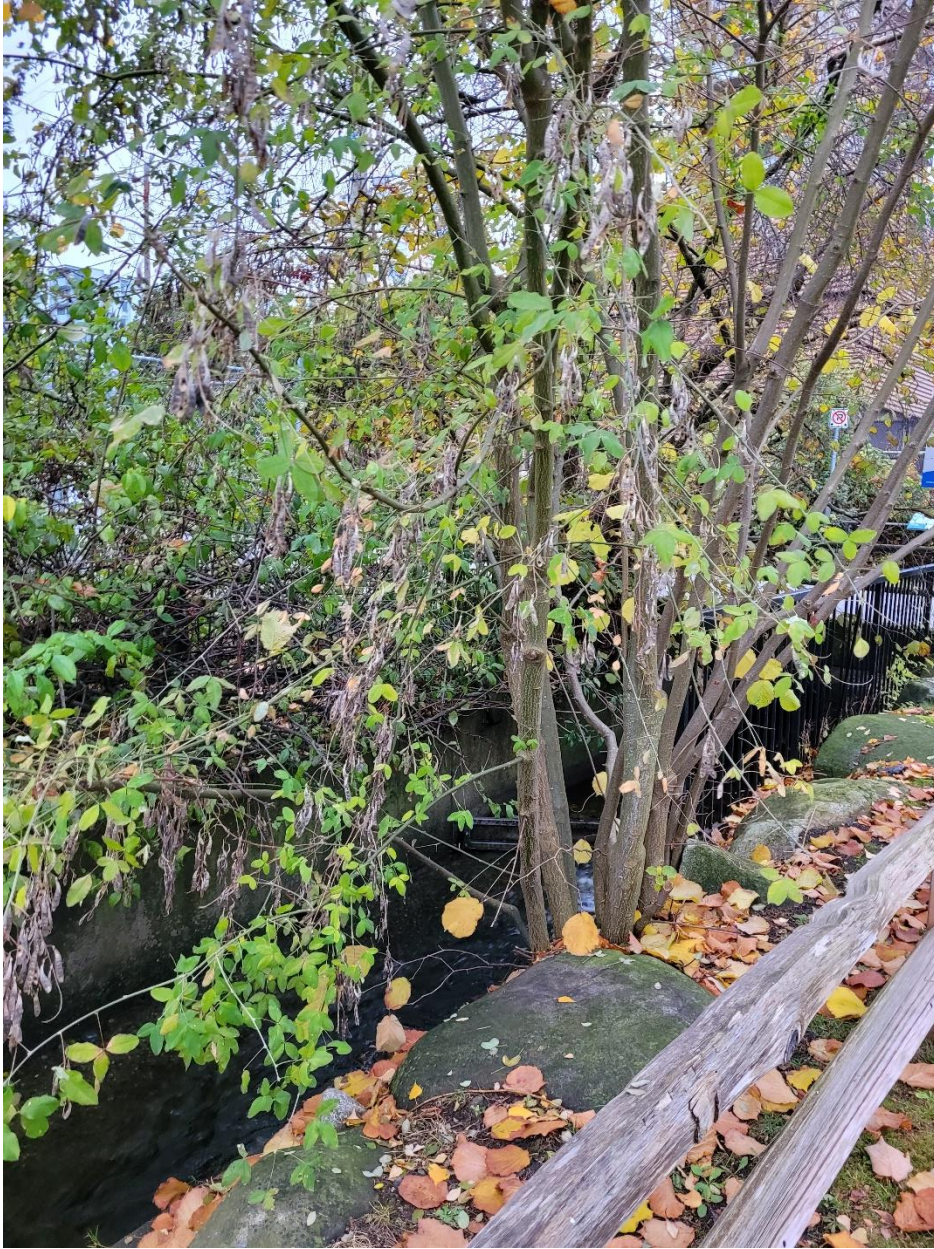
Photo 5. Tree #39, growing in retaining wall along Lawson Creek.
