# THE STEWART - LOUGH RESIDENCE

5768 Larson Place, West Vancouver, British Columbia

STATEMENT OF SIGNIFICANCE & BACKGROUND  
APRIL 2022  
CONSERVATION PLAN  
NOVEMBER 2022

### I. Condition Survey

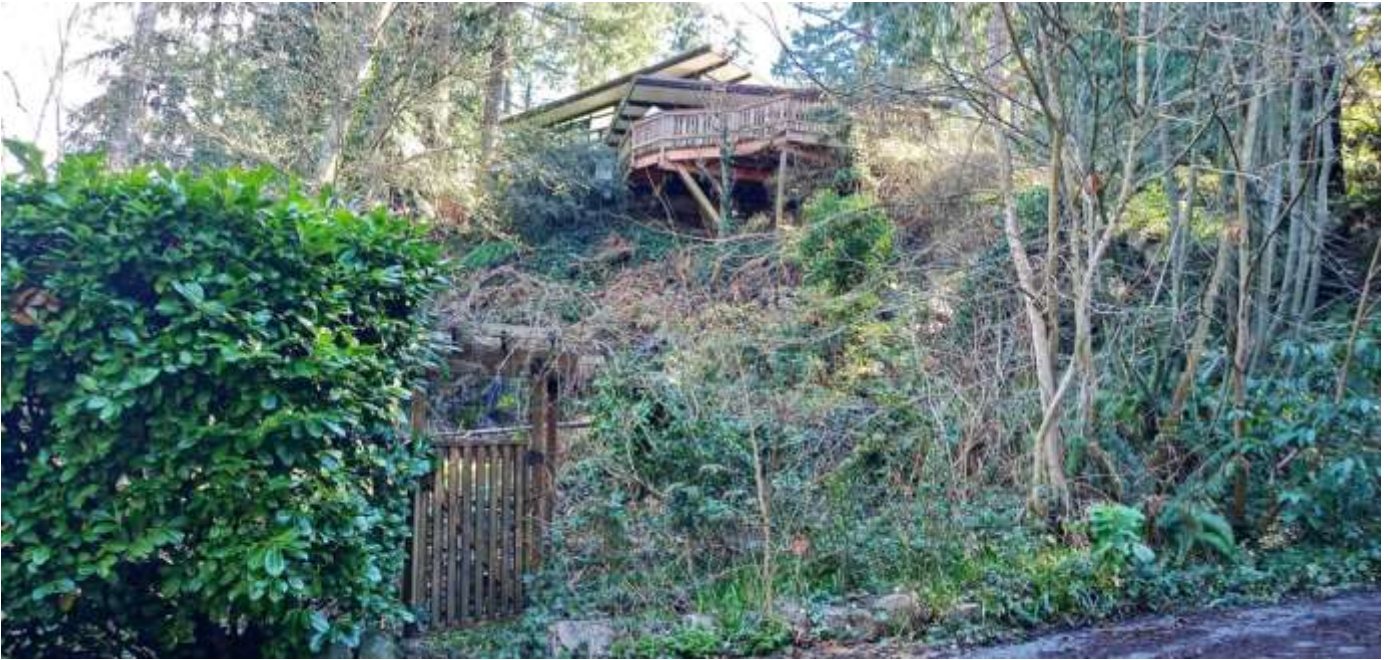
The lower slope of the current property is steep and deprived of major trees, typically found in the area. A neglected wooden gate stands at the lower Larson Place's Street frontage. The pathway up to the house has not been maintained and there are no visible traces of the original driveway. The view of the house from lower Larson Place is compromised by the deck extension and its heavy wooden balustrade, which is incongruous to the original structure. The play of the skewed roof geometry, however, is still visible above the deck.

Figure 69: The Stewart-Lough Residence seen from lower Larson Place with gate

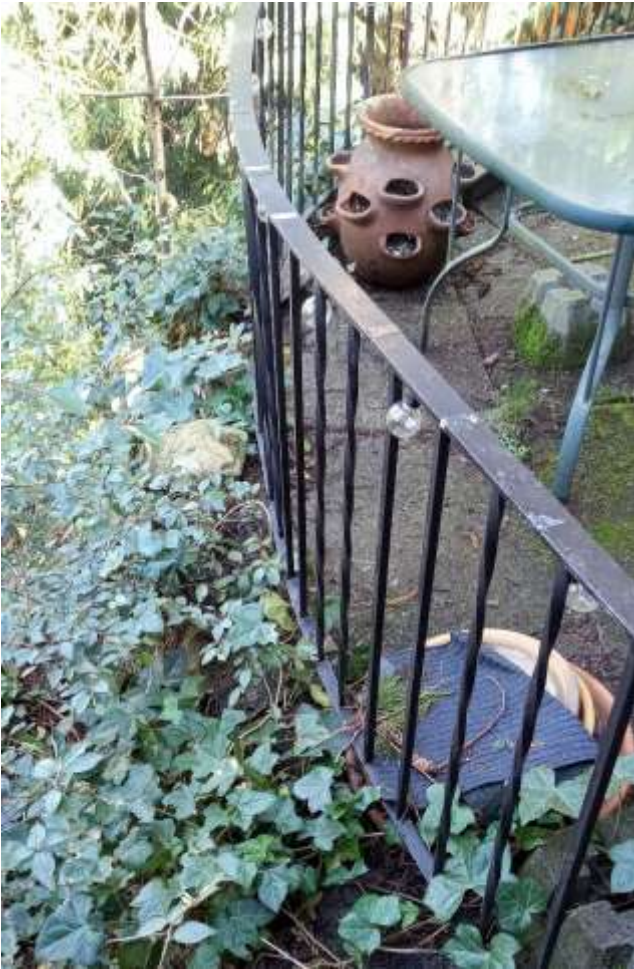
Figure 82: Original steel railing around north side terrace

The circular metal railing on the north side of the house should be maintained and refurbished; the rust should be removed, the surfaces cleaned, the railing stabilized and refinished in matching colour. Flag stone surfaces on the north side of the house should be extended to the entire space defined by the circular metal railing. The wood deck structure should be reviewed by a qualified engineer, especially the 1970’s deck extension; the removal of the 1970’s deck extension should be considered. The deck floor should be reviewed and repaired where required with matching material, in kind, size and profile. Replacing the existing wood railing with a lighter metal one should also be considered. The concrete walkway from the deck to the entrance, and street should be kept and the existing lawn maintained. Loose and cracked concrete should be repaired if possible or replaced in parts with matching material. Steps from the walkway to the wooden deck, and the street should be maintained. The stone steps to the street should be rehabilitated with matching material. Stone walls and stair features should be rehabilitated with matching material, in size and design. Outdoor spaces should be clear of debris, extraneous tools and furniture.

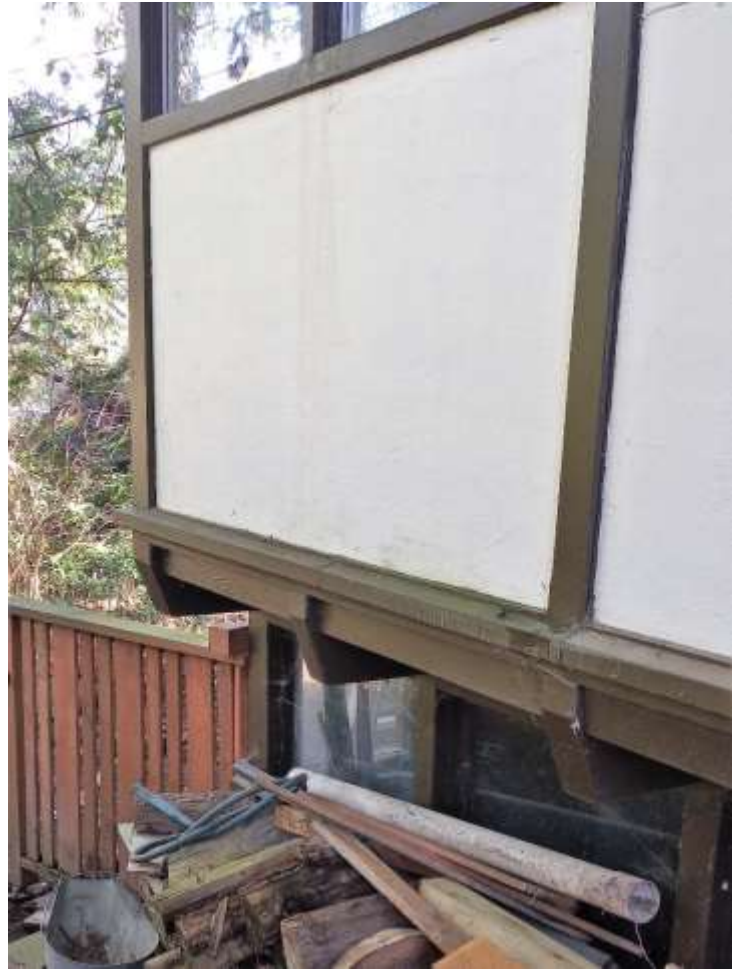
Figure 83: Crawl space under the east side of the house

10. **Crawl space; Rehabilitation:** The hovering of the house over the land is manifested by the open crawl spaces at the northeastern corner of the structure. The crawl space should be free of debris and should not be used for storage. Posts and beams supporting the house should be visible where possible. The tail ends of the main floor beams should be preserved and repaired if damaged with matching material and profile. The ground under the house should be kept dry. The drainage system around the footings should be reviewed and improved if deficient.

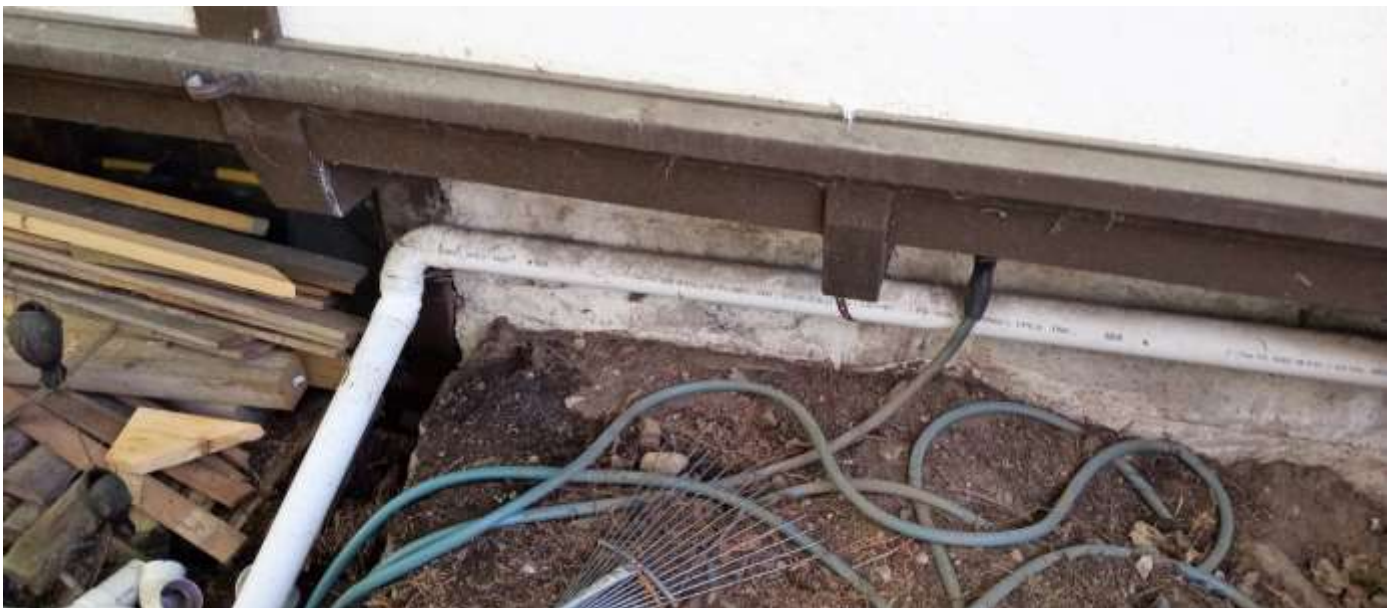
Figure 84: Concrete footing and drain pipe

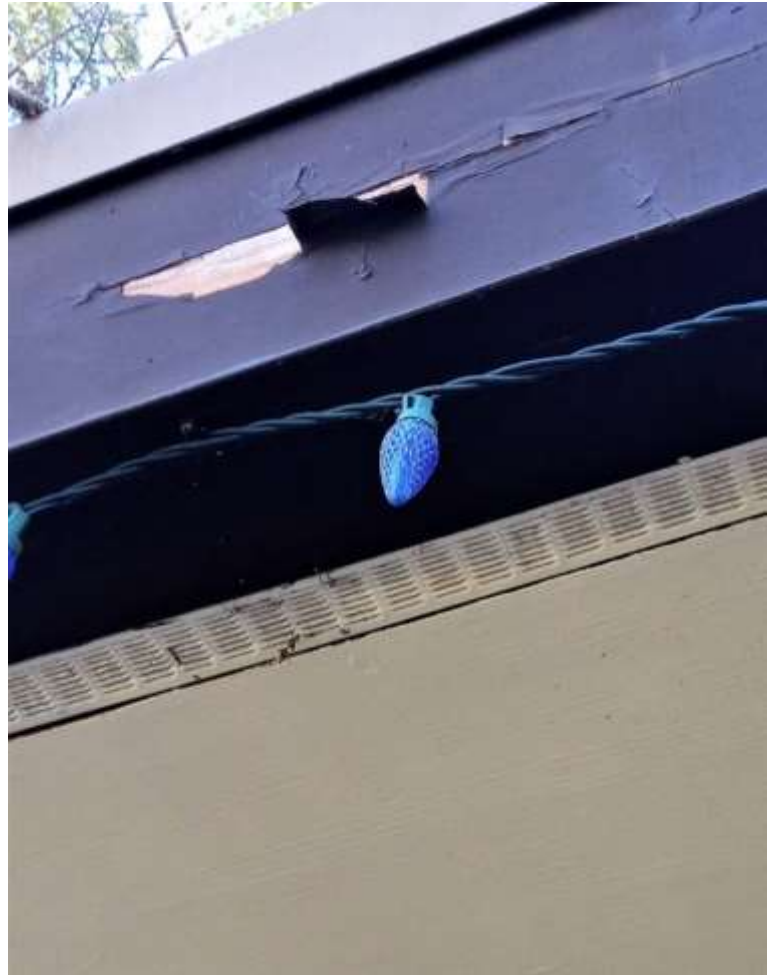
Figure 95: Roof soffit vents and paint peeling at fascia

5. **Soffits; Rehabilitation:** The roof overhang plastered fiber board soffits should be reviewed for their stability, moisture content, and content of hazardous material. The effectiveness of the punched metal vents should also be reviewed. The metal vents should be removed, cleaned, stripped and refinished. Damaged metal vents should be replaced with matching material.

6. **Fascia boards; Rehabilitation/preservation:** The roof fascia boards should be refinished since paint is peeling and chipping at several locations. Paint colour should match the existing. Damaged boards should be replaced with matching material, in kind, size and profile; entire lengths should be provided; patching is not acceptable.

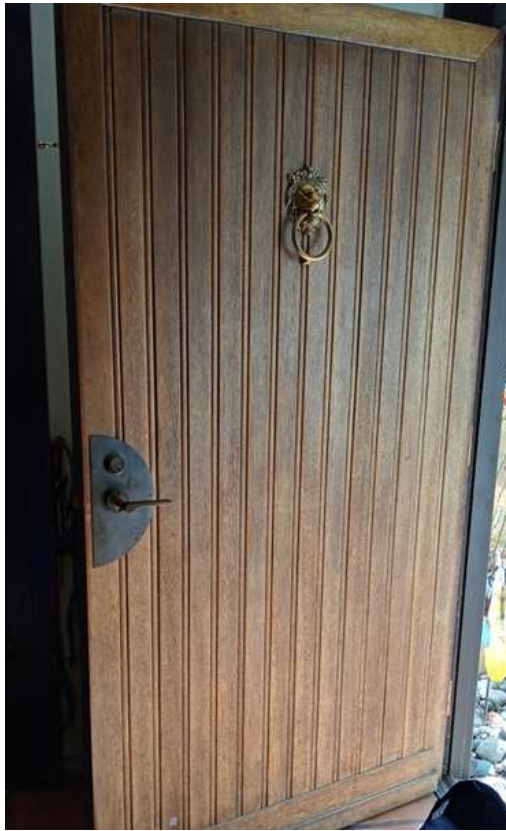
Exterior doors are significant in this house for giving access to the three outdoor spaces. The front has a solid wood door with a distinctive scored pattern, original hardware, and a transom lite. The dining room has a double door fully glazed with transom and side lites. The storage door on the east side is half glazed with side windows. The second-floor bedroom and hall doors are solid wood doors with side windows. All the doors are in good condition, especially the front door.

Figure 108: Front door

15. **Exterior doors; Preservation:** The front door should be preserved including its finish and hardware. The transom lite should be maintained as found. Other exterior doors should be maintained and refinished if required. Smooth operation of doors should be reviewed and rehabilitated where needed. Location and type of exterior doors should remain the same as existing.

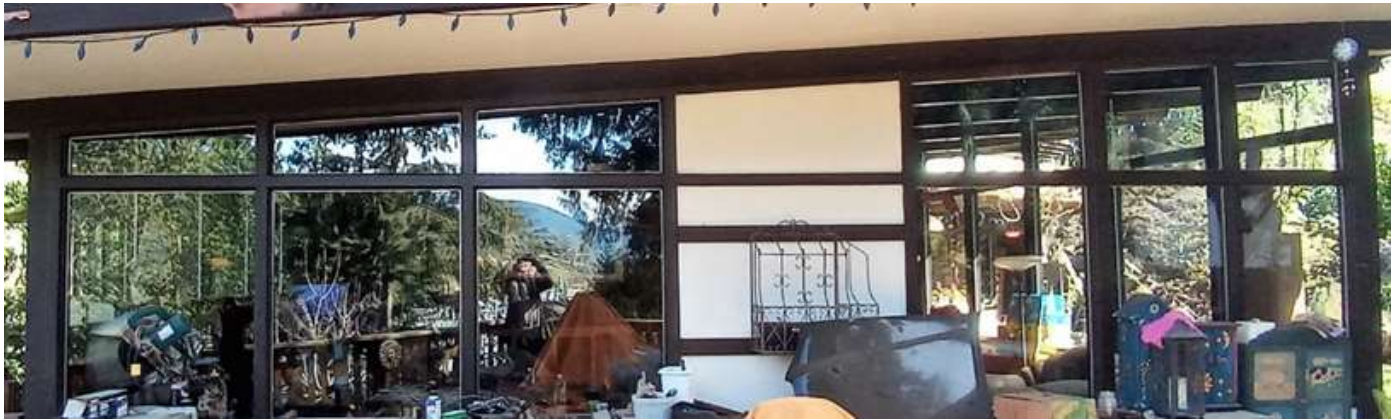
Most of the windows at the Stewart-Lough House are fixed with double glazed with sealed units. Casement windows are strategically located for cross ventilation. The top of windows are generally lining up leaving the transom lites to mediate the slope of the roof. The windows are framed with posts and rails; there are minimum sills and no casing, inside or outside. The windows are in good condition throughout the house.

Figure 115: West side windows with transom WW 01 – WW 06

14. **Windows; Preservation/rehabilitation:** Windows and transom lites should be reviewed by a qualified window specialist. Leaking sealed units should be replaced and replacement installed in the same manner as existing. Window sill, and casings should remain the same as existing. The location and number of casement windows should be maintained. Casement windows should be reviewed and their smooth operation rehabilitated if required. Window frames should be refinished where needed, matching existing lustre and colour.
