NAVY JACK HOUSE

1768 ARGYLE AVENUE, WEST VANCOUVER, BC

HERITAGE CONSERVATION PLAN

MARCH 2024 (REVISED JULY 2024)

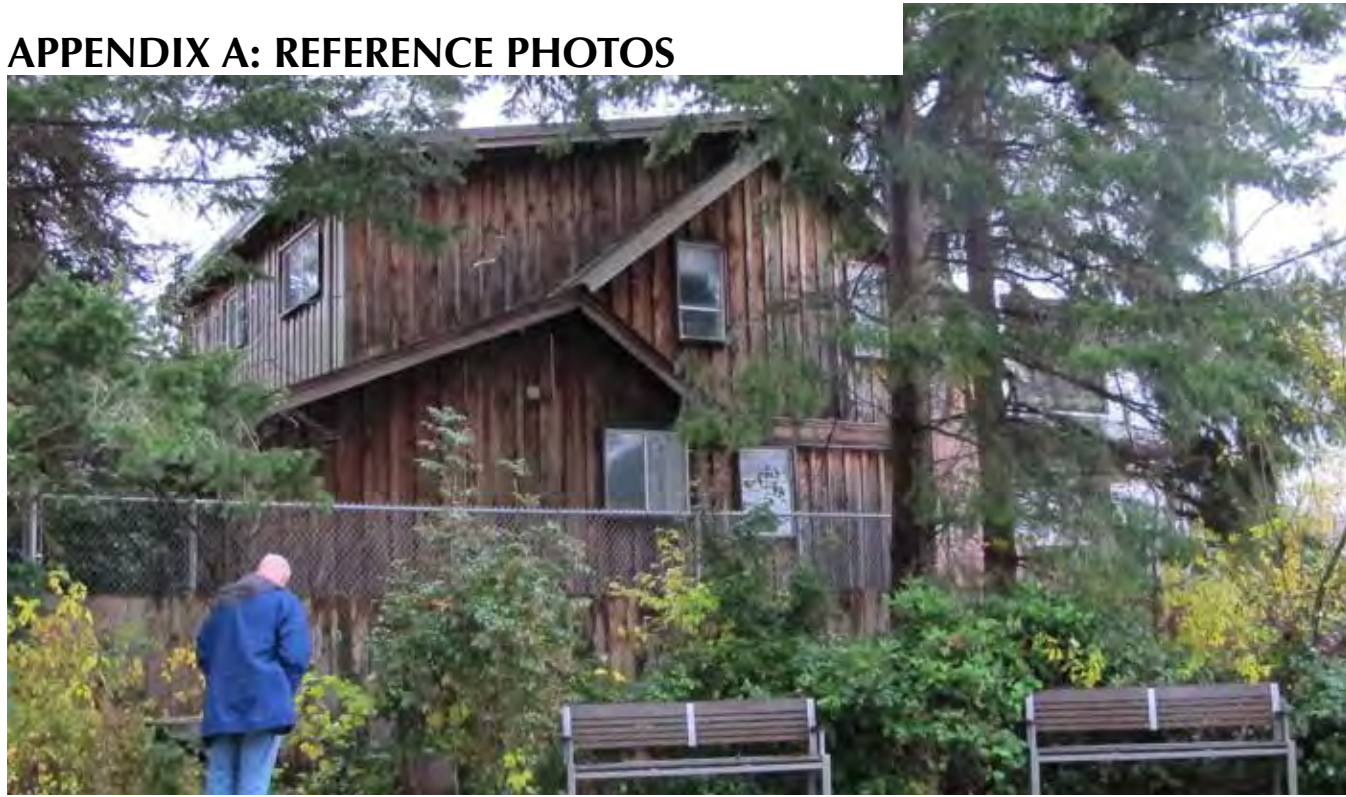
Existing West Elevation. November 2020

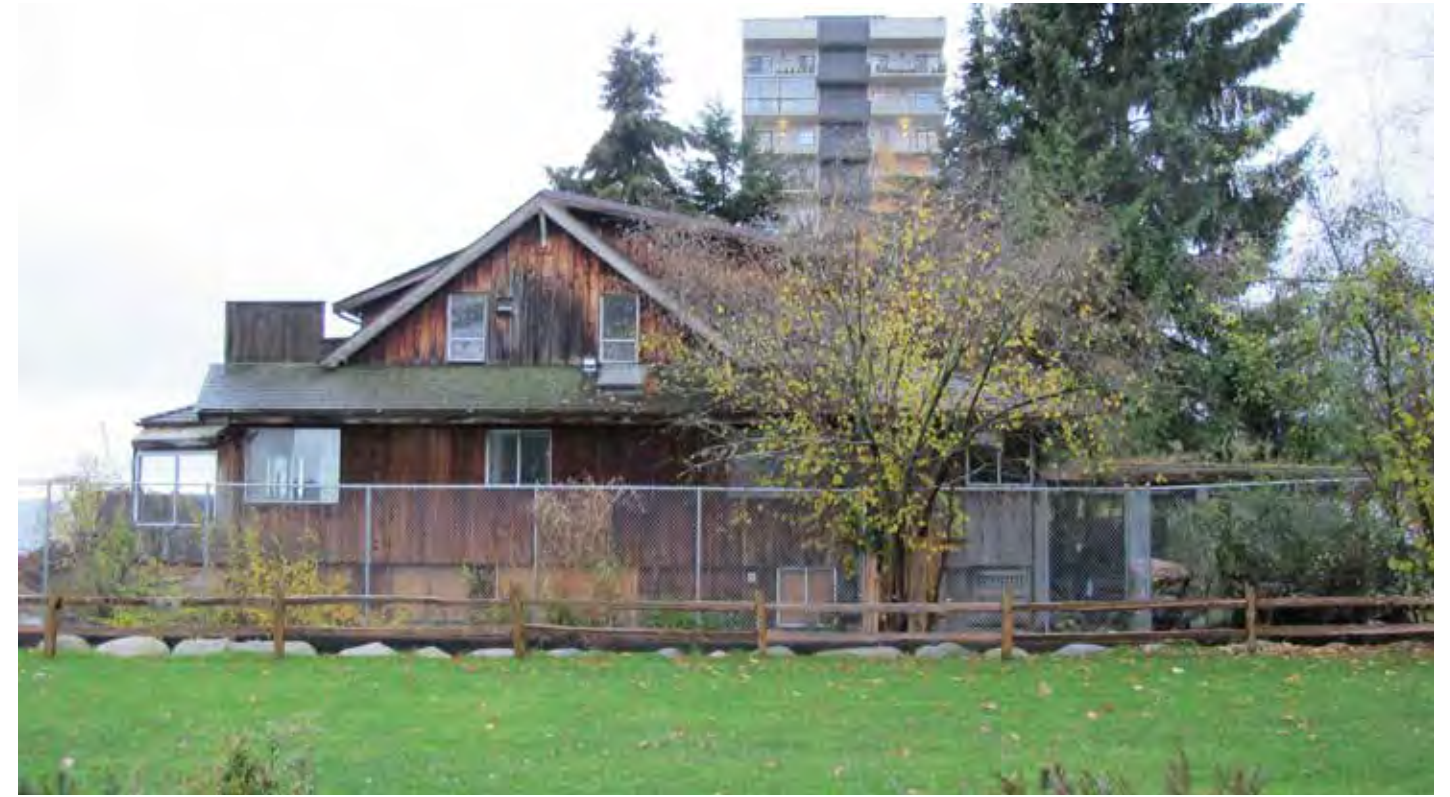
Existing East Elevation. November 2020

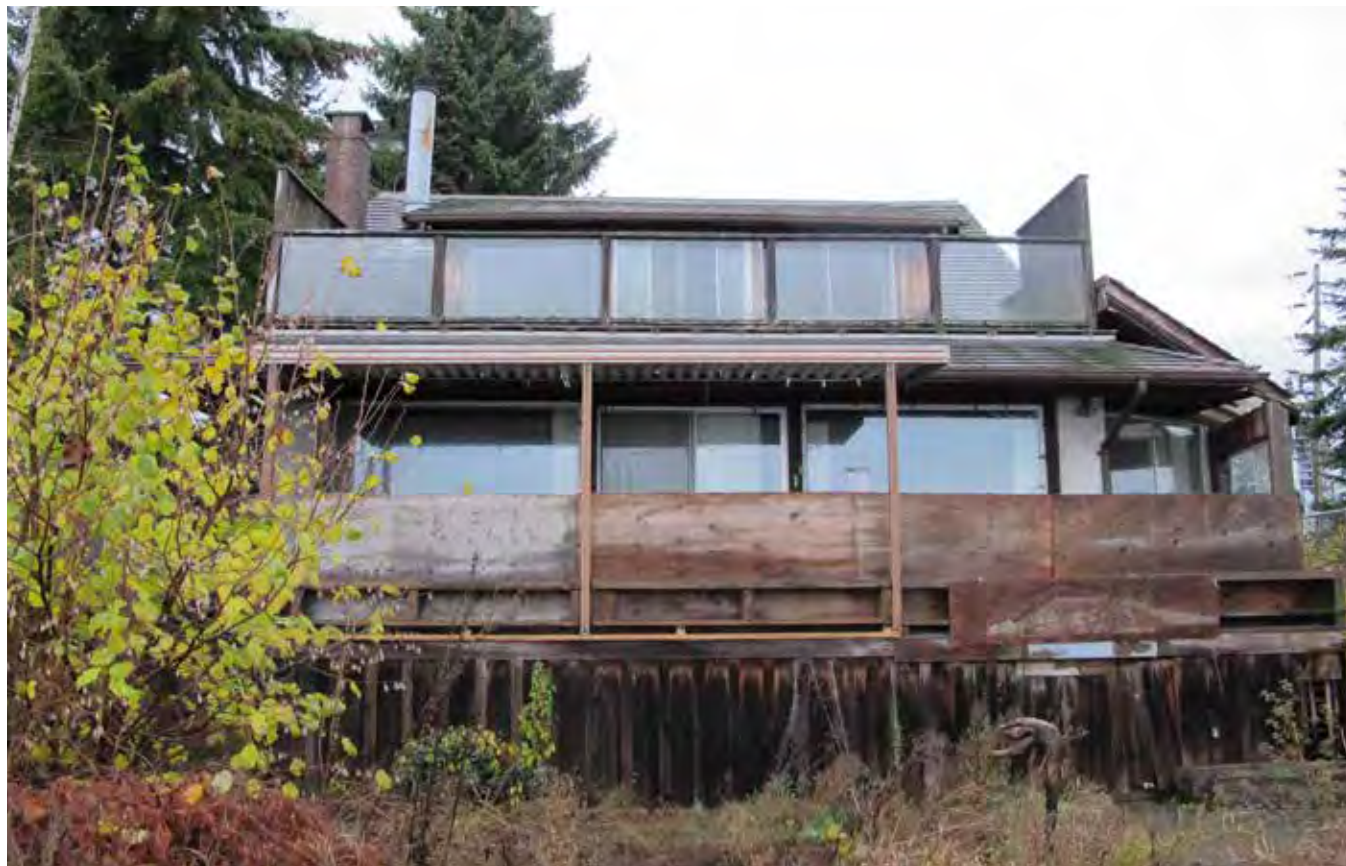
Existing South Elevation. November 2020

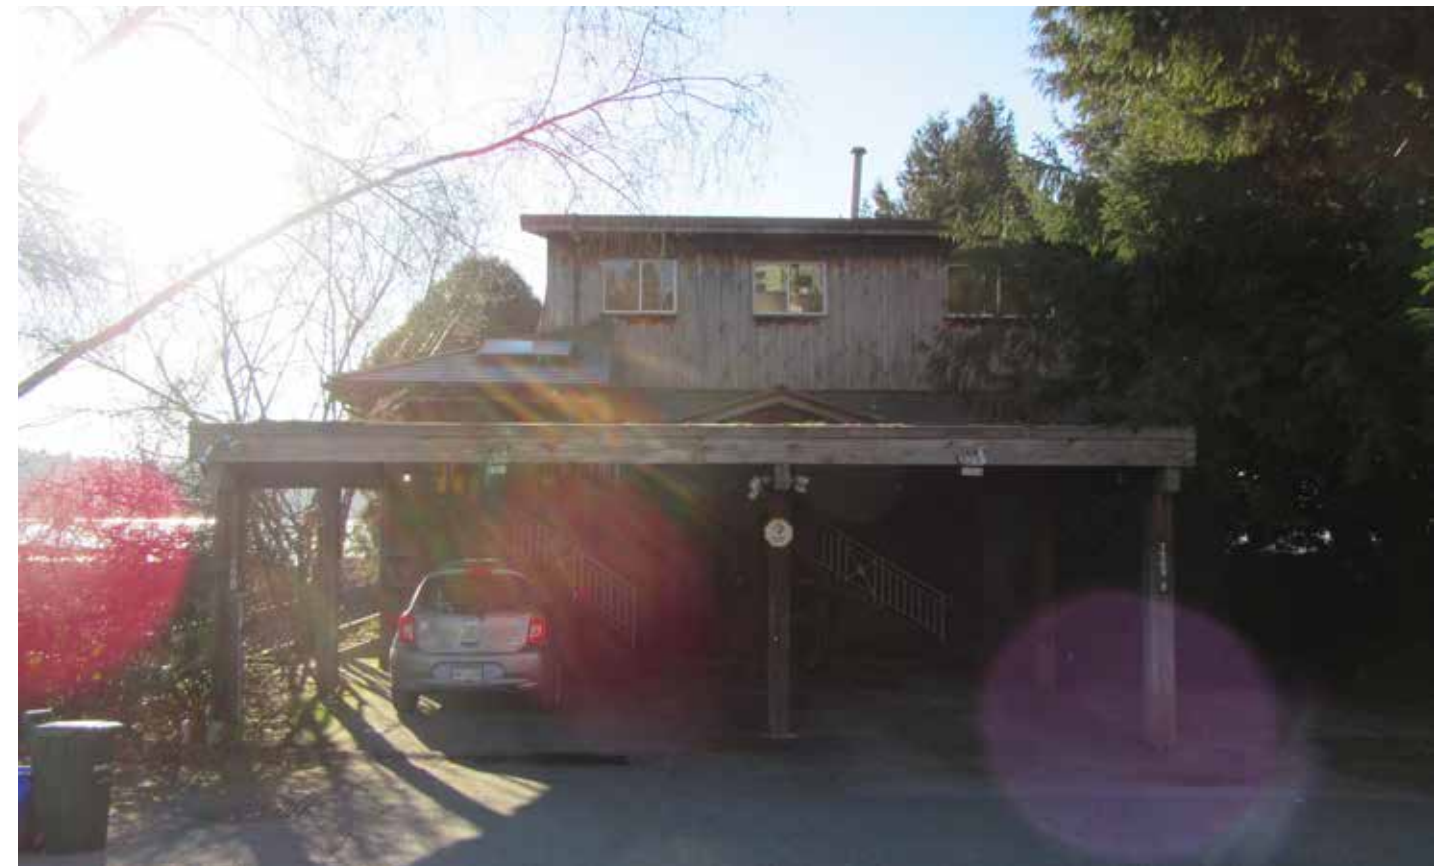
Existing North Elevation. January 2017

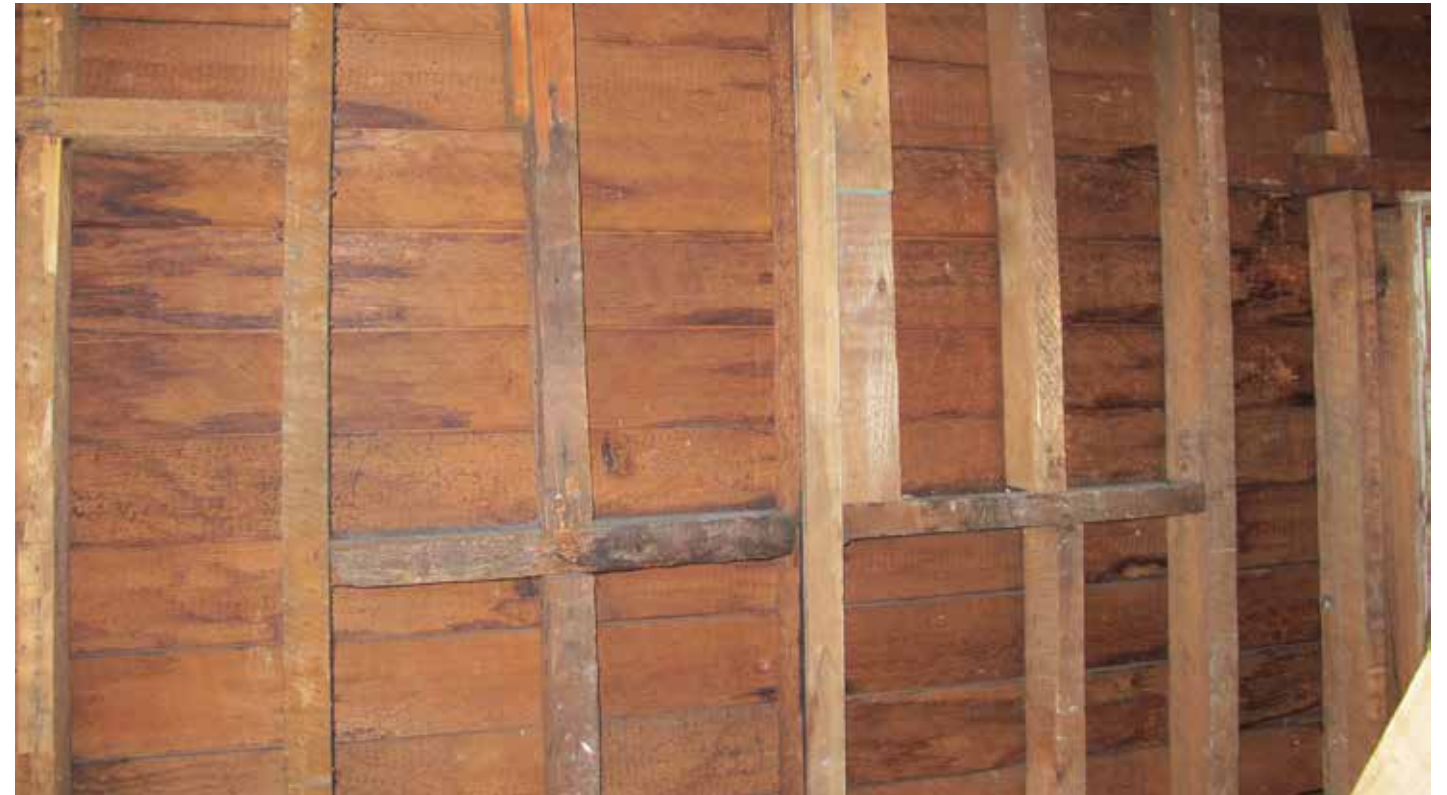
Backside of exterior cladding.

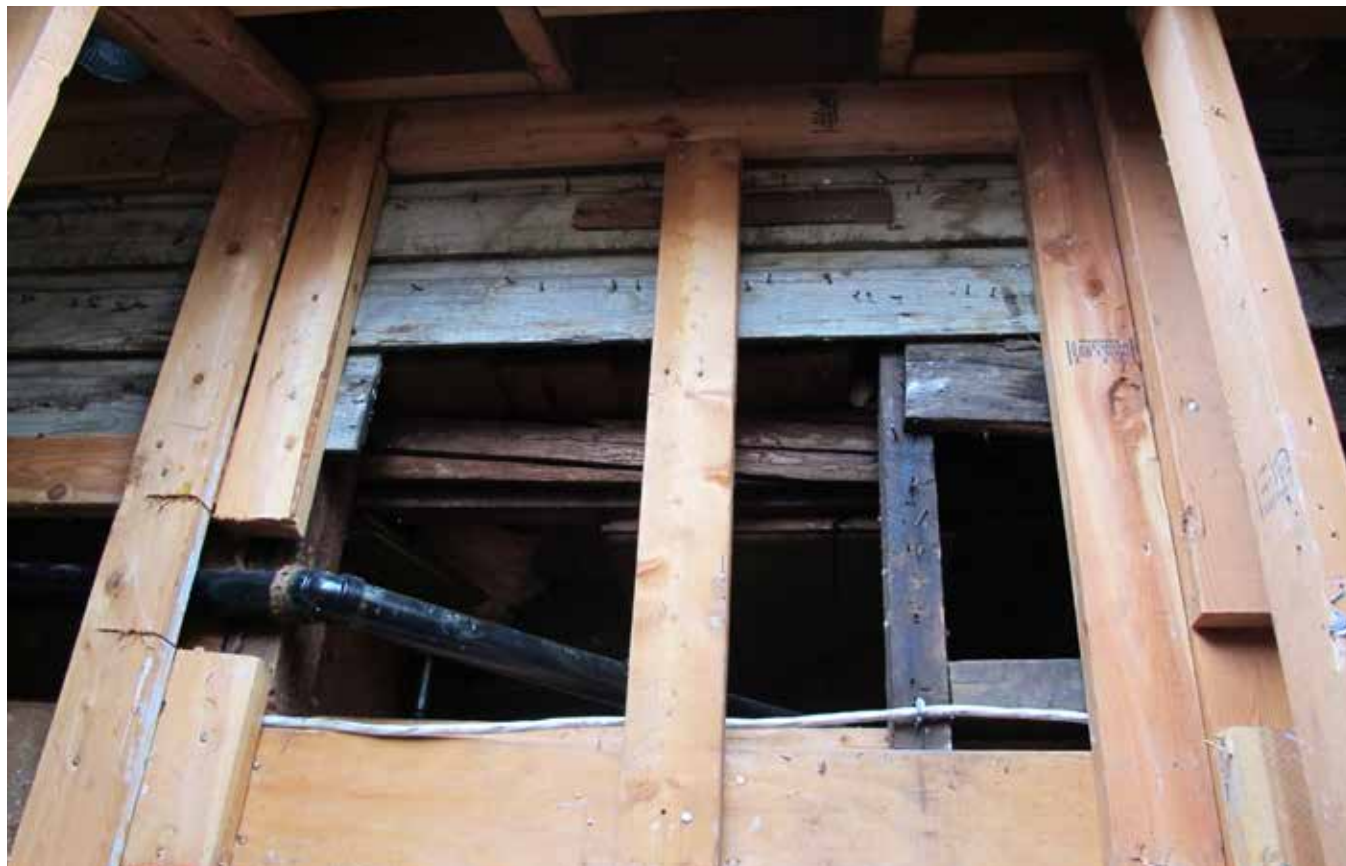
Siding behind later construction, Ground Floor East Side

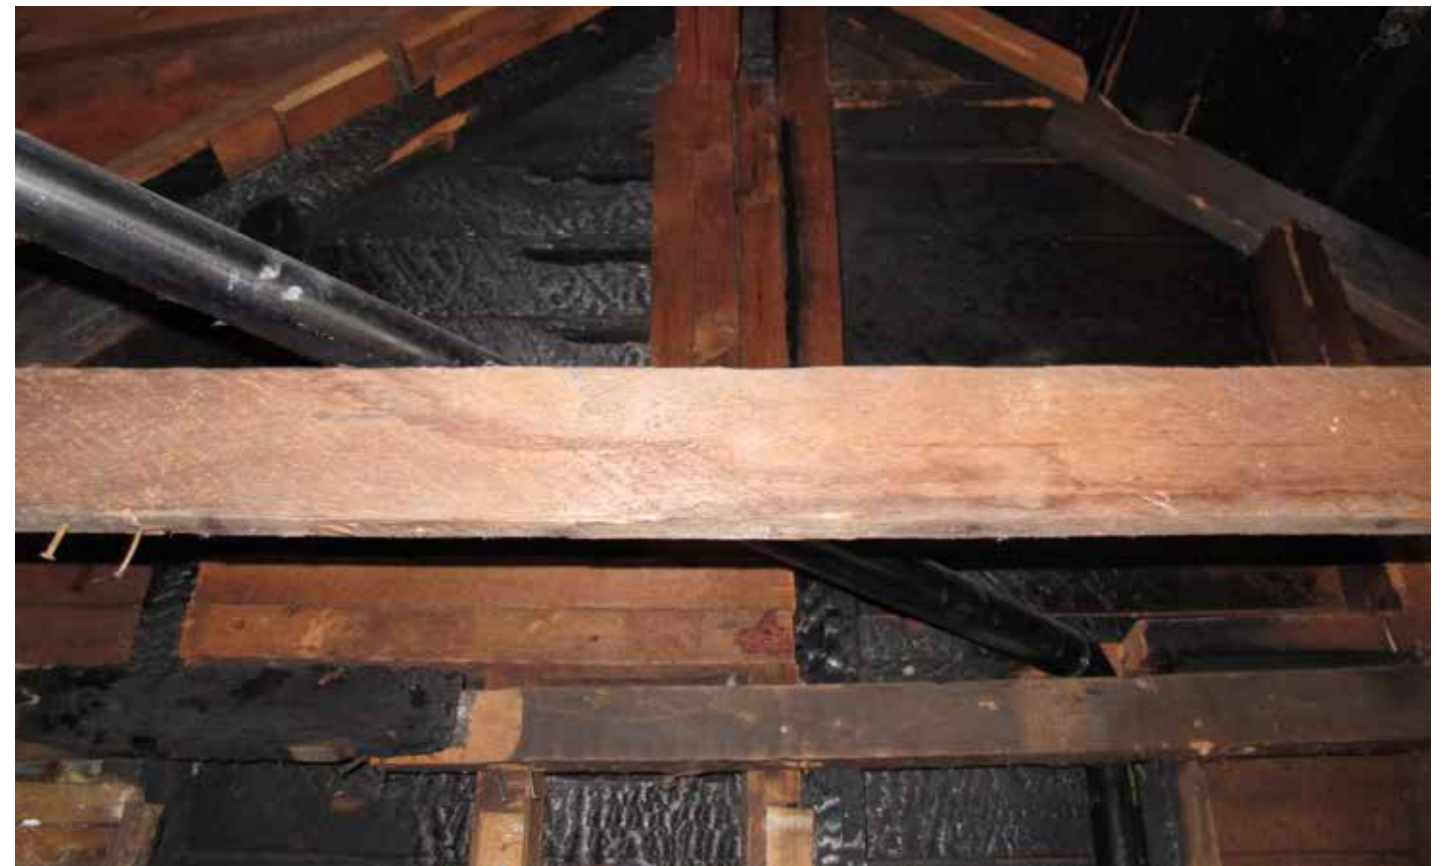
Evidence of chimney fire in the East Gables.

EXISTING ELEMENTS (CDE = CHARACTER DEFINING ELEMENT)	PRELIMINARY CONDITION ASSESSMENT	CONSERVATION TREATMENT	CONSERVATION RECOMMENDATION
5.8	CHIMNEYS <ul style="list-style-type: none"> Two later added chimneys circa 1909 	DISTURBED (DEMOLISHED) <ul style="list-style-type: none"> West chimney appears to be intact. East chimney has been removed. 	Restoration	28. Using archival images, reconstruct both east and west chimneys limited to above the roofline, which were added on in the 1909 period when the property was acquired by the Lawson family and instituted additions.

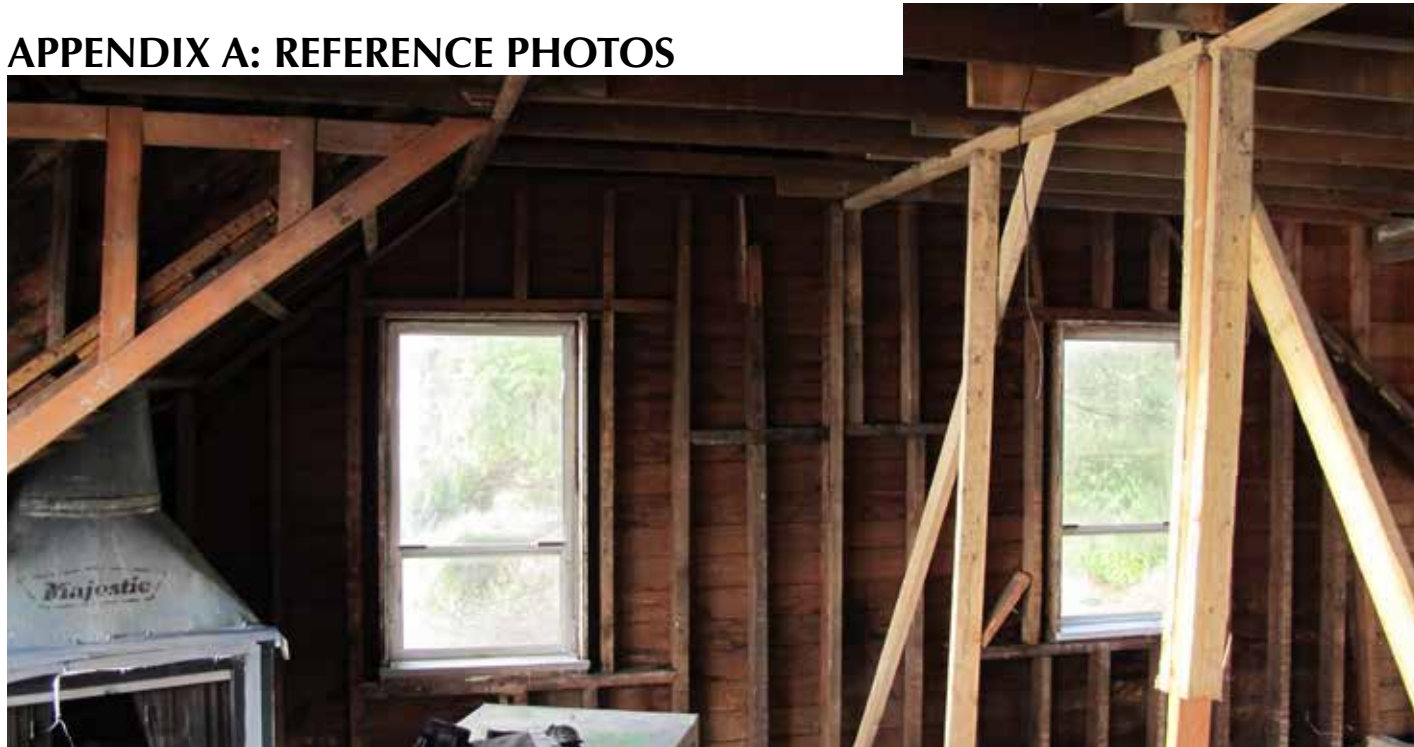
None of the window frames or assemblies have survived, but the window openings are clearly evident on the second floor and provide measurements for how the windows can be restored. Original double-hung configuration as per archival photos.

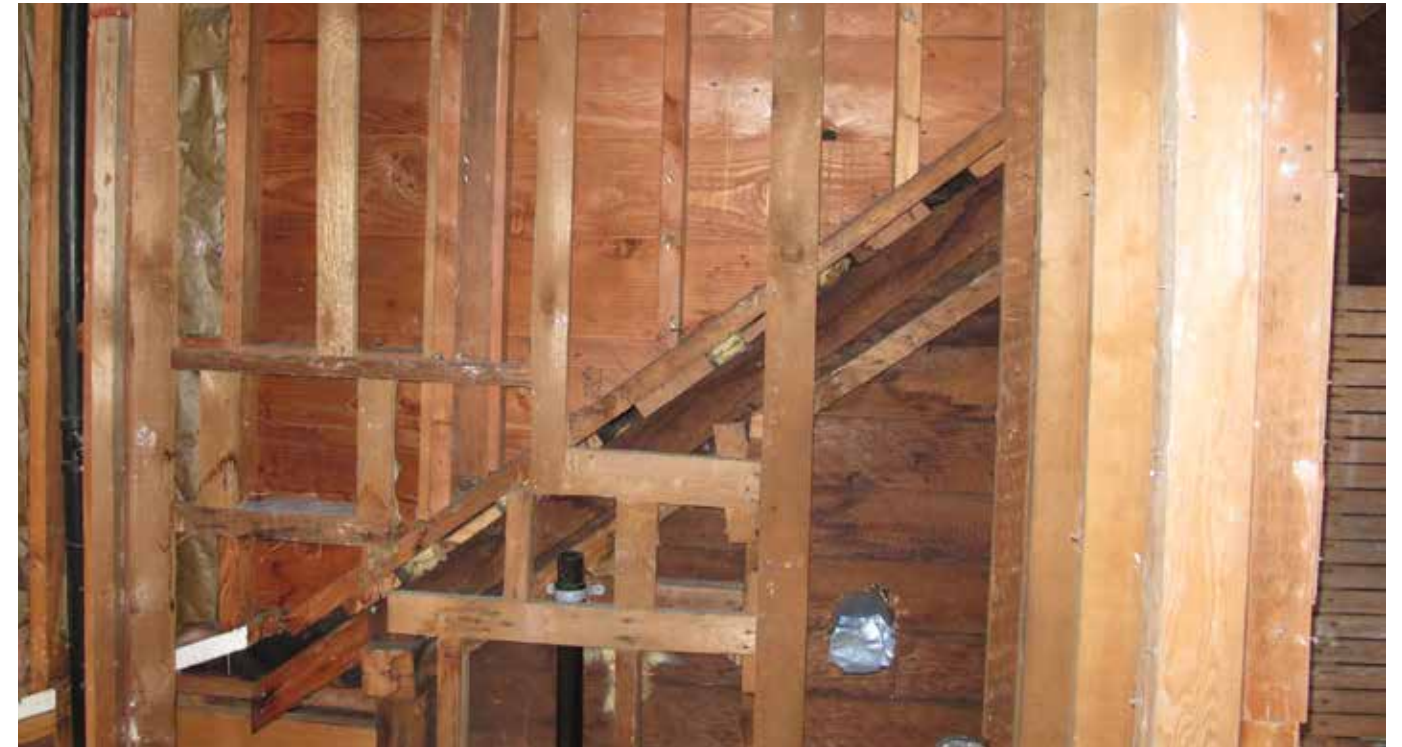
Although the roof framing has been cut out in several locations, virtually all of the planking that formed the exterior soffits were left in place, and can be traced on the east and west sides of the house.

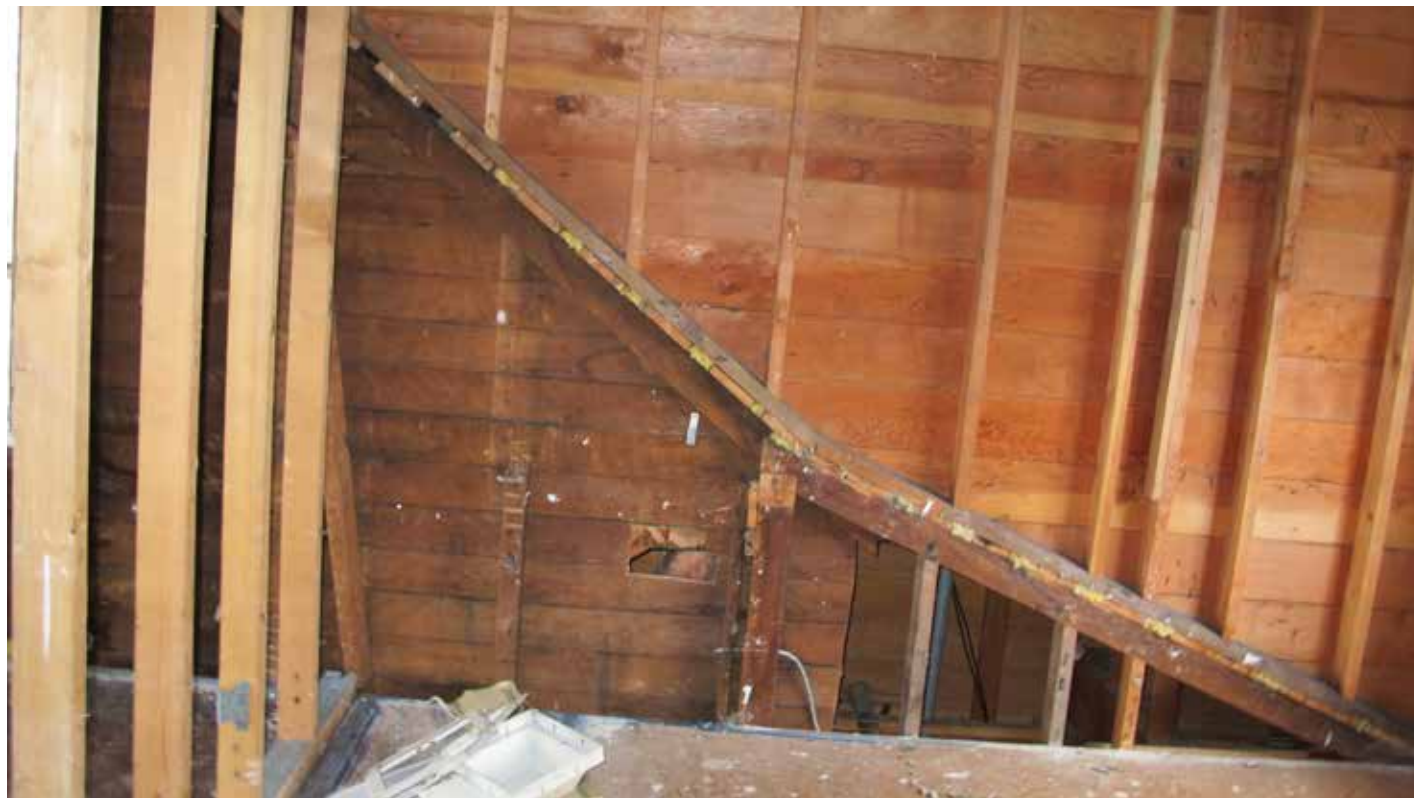
Siding behind later construction, Ground Floor East Side

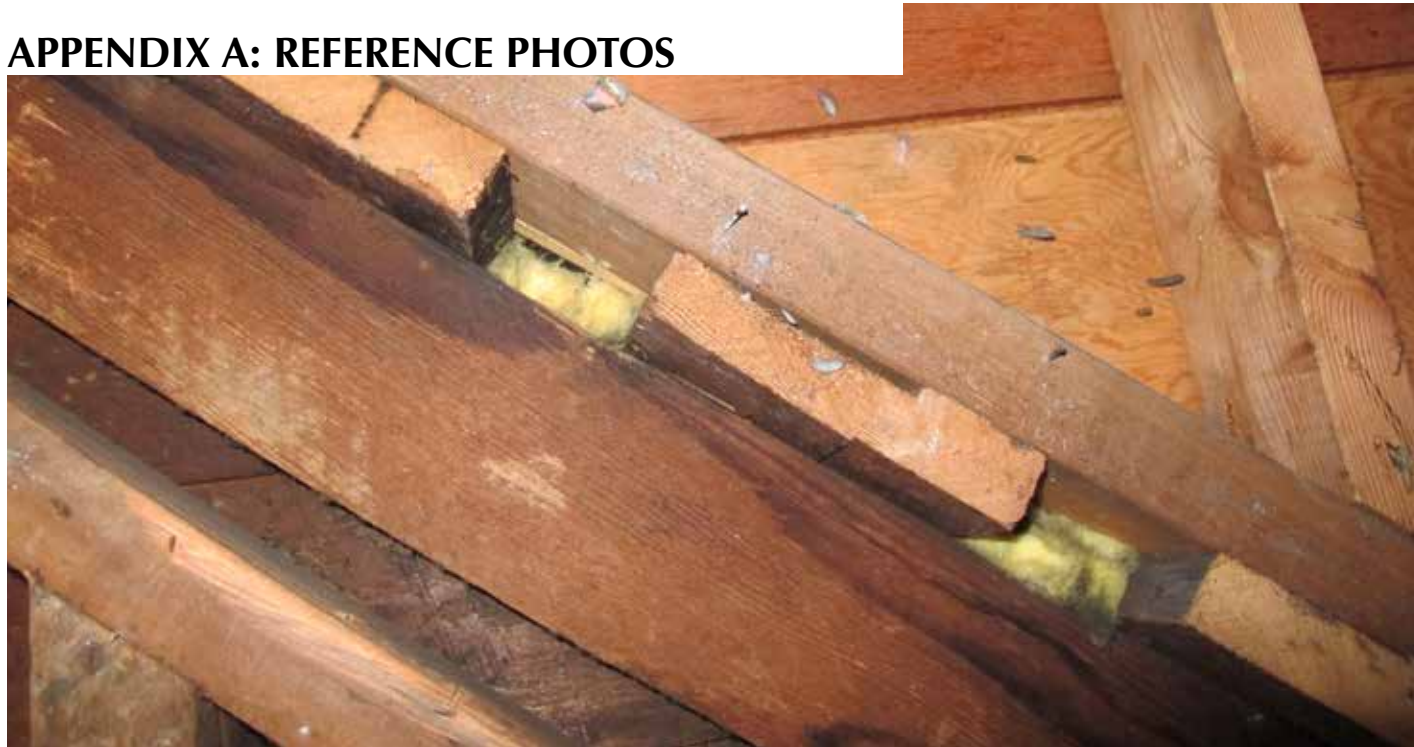
Cut-through roof structure showing original nailing strips.

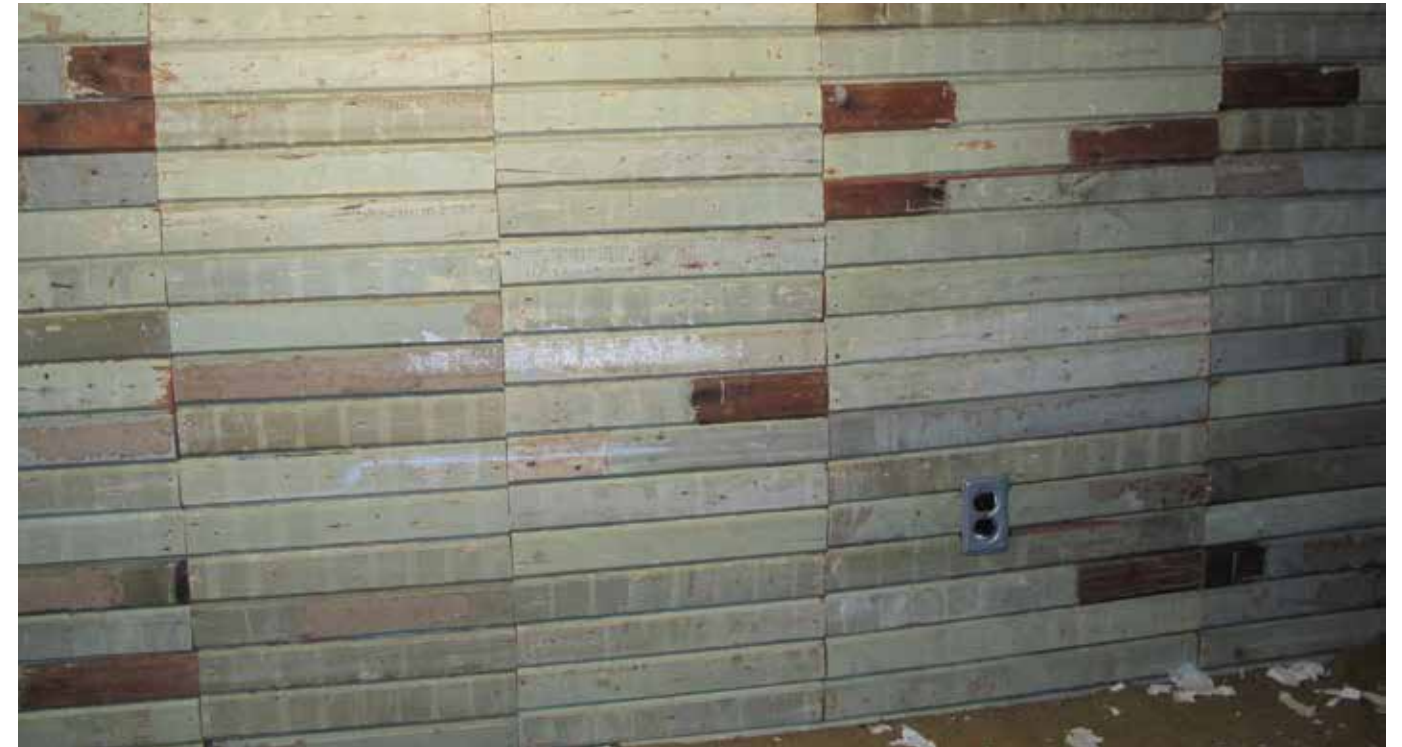
Basement Level wood sidings repurposed as cladding

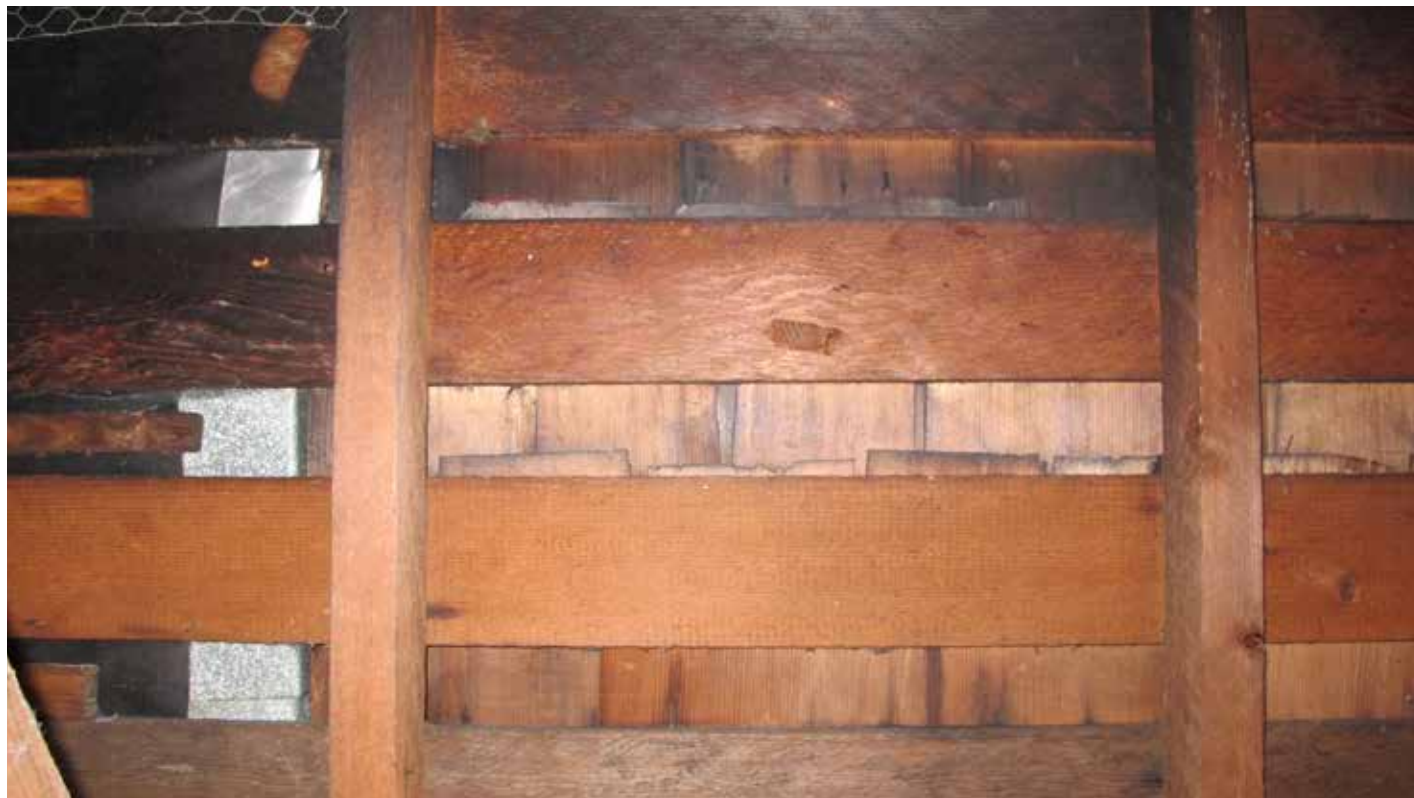
Underside of intact cedar shingle roofing

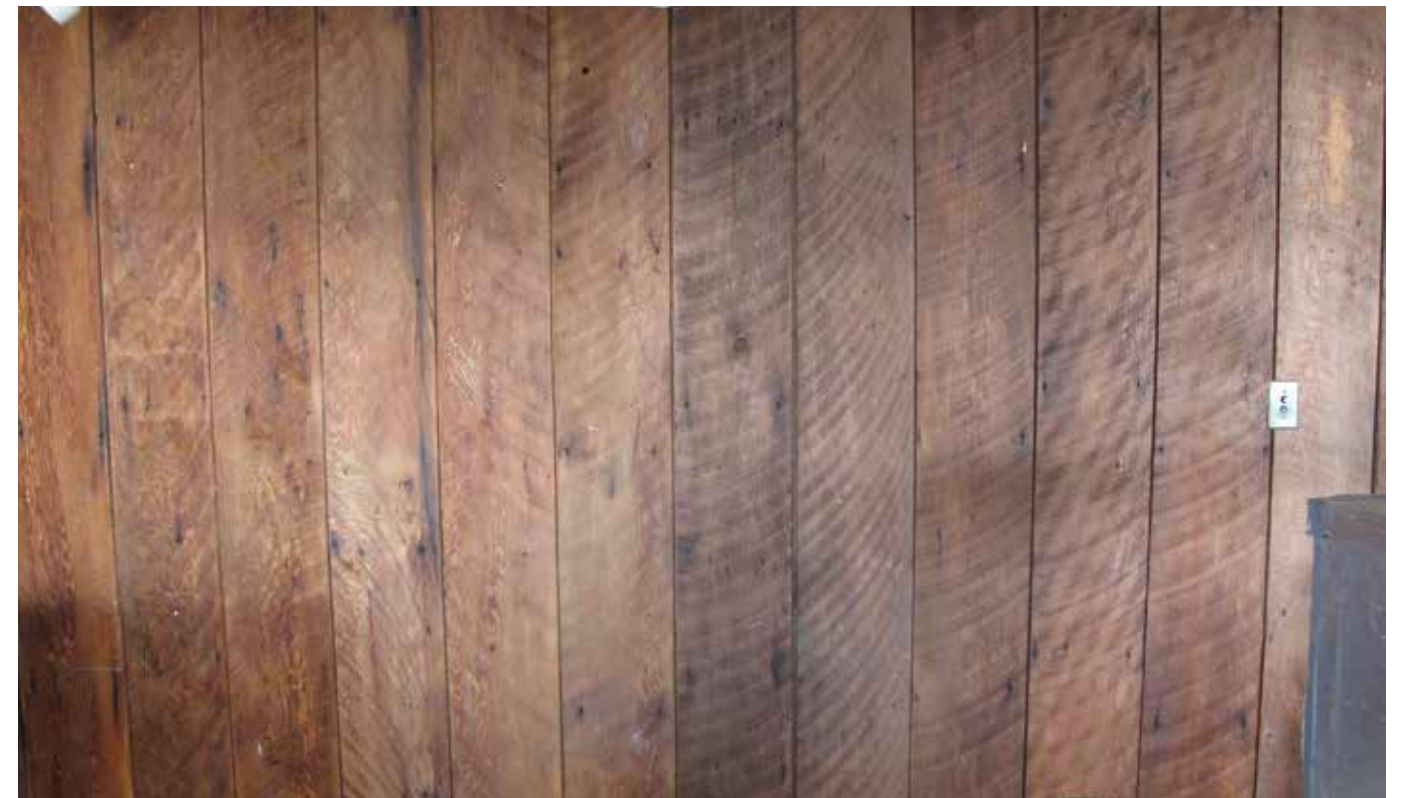
Living Room Sawn Lumber repurposed by homeowners
