For:
Aquila

Submitted to:
Jamie Harper

Date: September 16, 2021
Updated: February 28, 2023
March 22, 2023

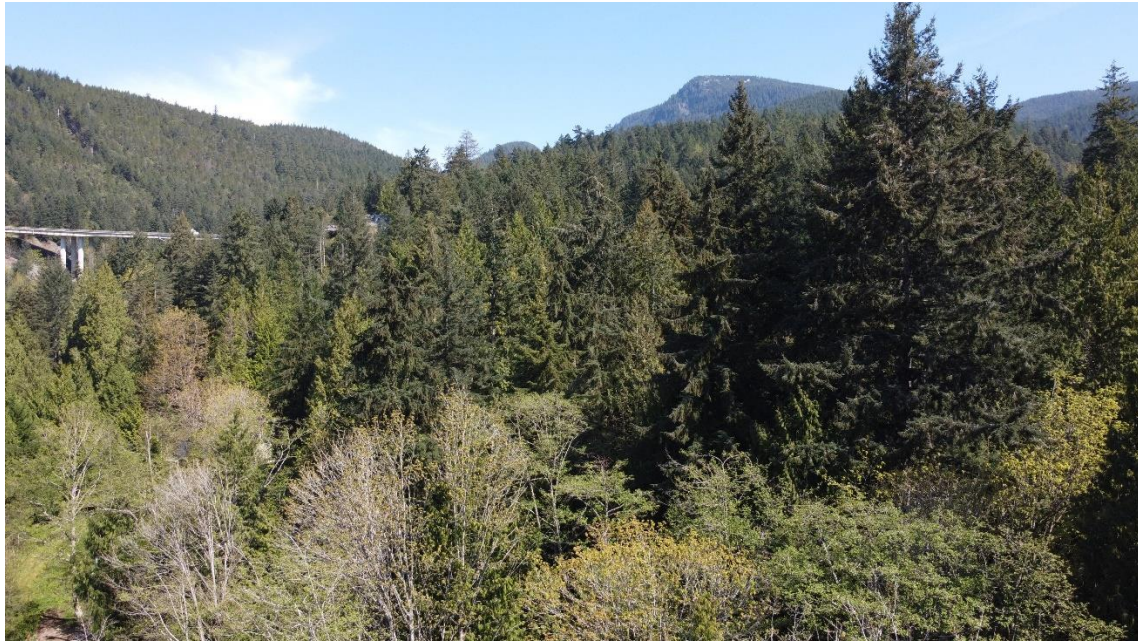
Photo 1. Overhead view of the subject area's canopy. Note transition between deciduous stand at lower elevations and the conifers on the slope. Also note significant Douglas fir at right of frame. (probably tree #2452)

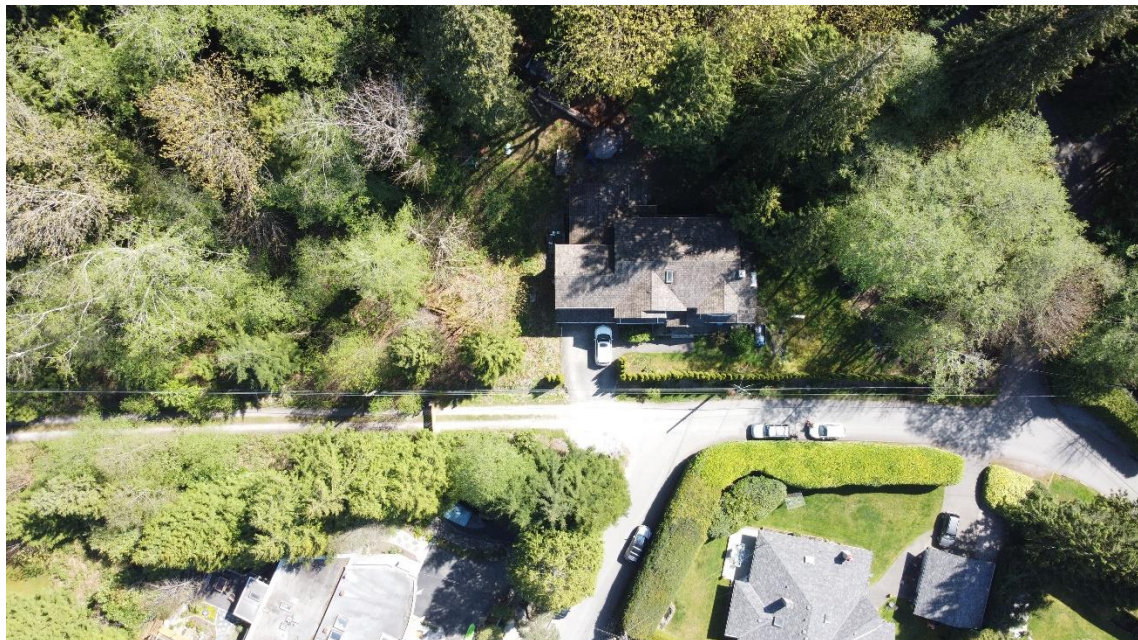
Photo 2. Overhead view of the southwest corner of the site at Daffodil Drive, The ditch is obscured, but the row of offsite trees is visible west (below) the road.

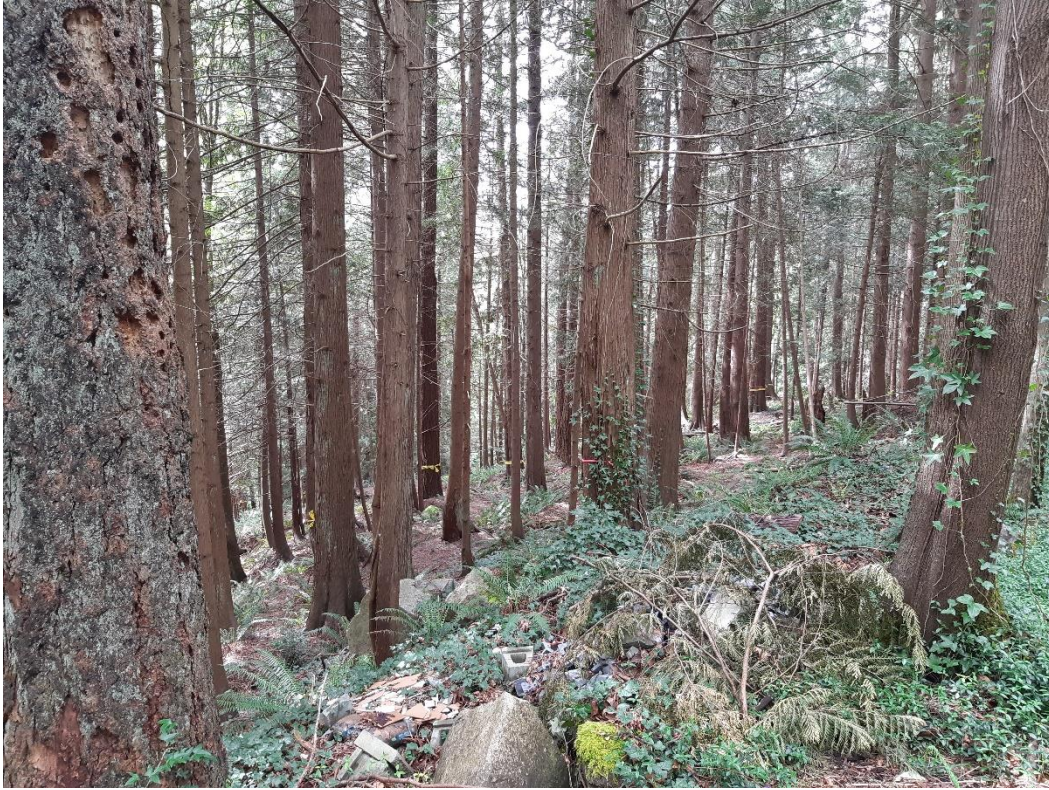
Photo 3. The middle of the site is a dense mix of native conifers with a closed canopy.

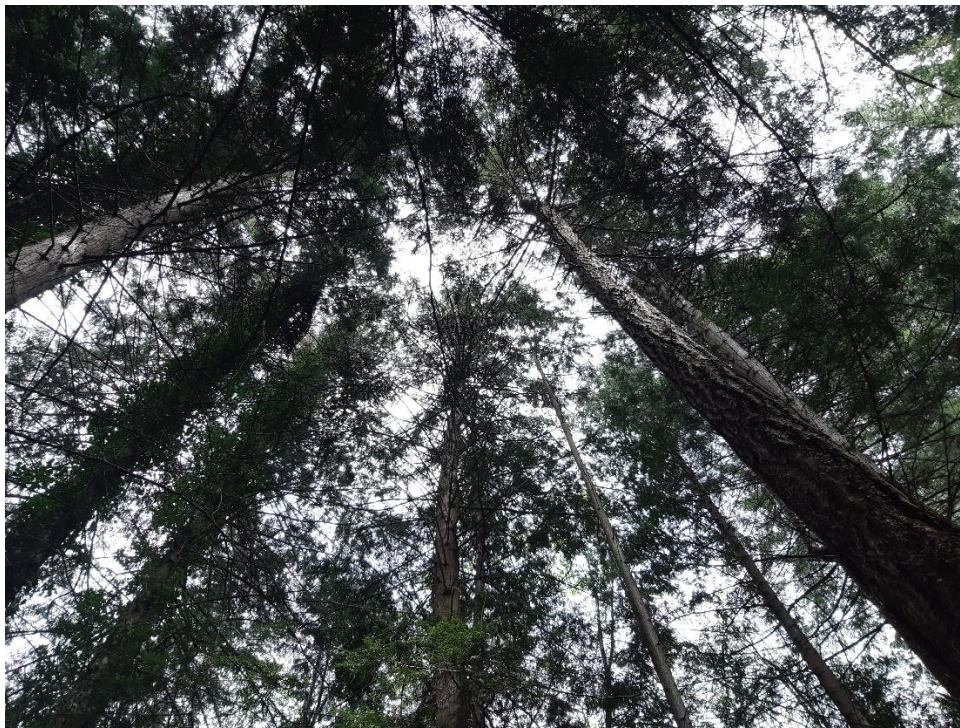
Photo 4. Typical crowns of conifers within the site. These trees have grown in a competitive environment and typically have small crowns and slender stems.

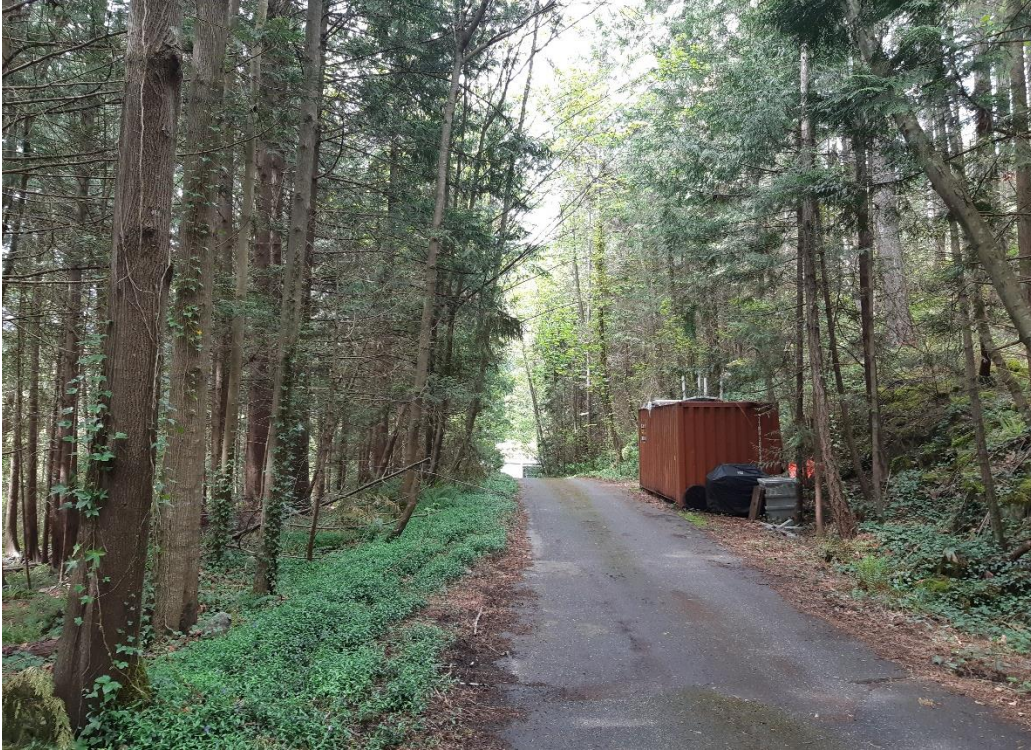
Photo 5. The existing asphalt road / easement at the top of the site

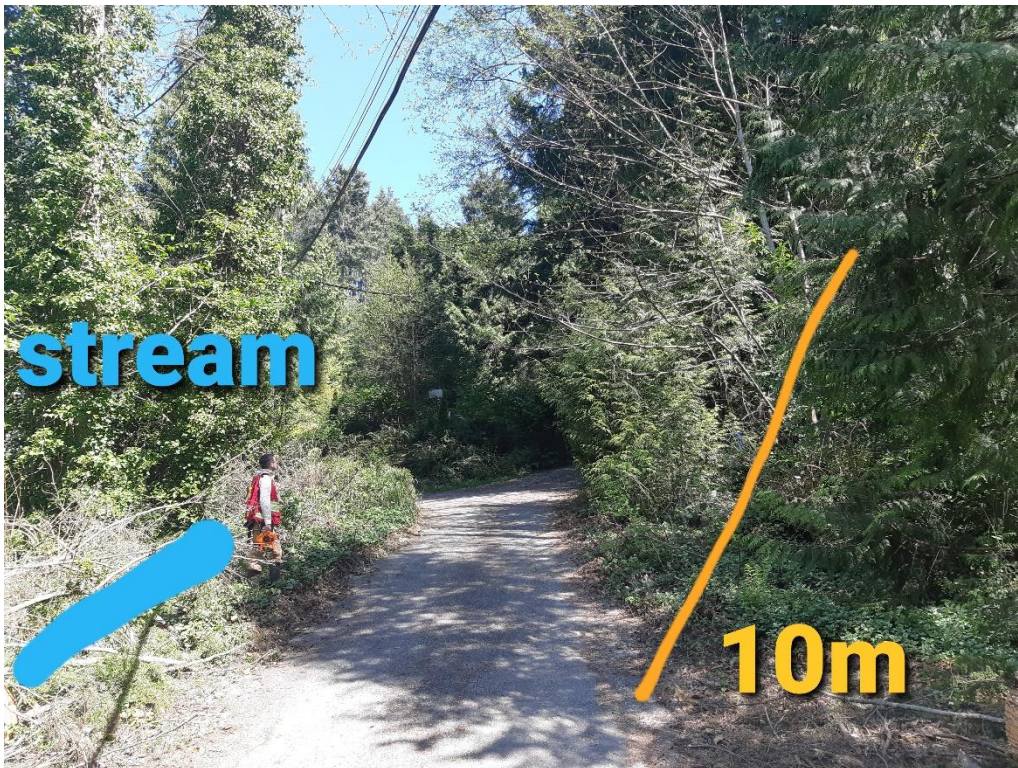
Photo 6. The riparian setback for the tributary. Much of the setback is a gravel road and shoulder, although many small deciduous trees fall within the setback area.

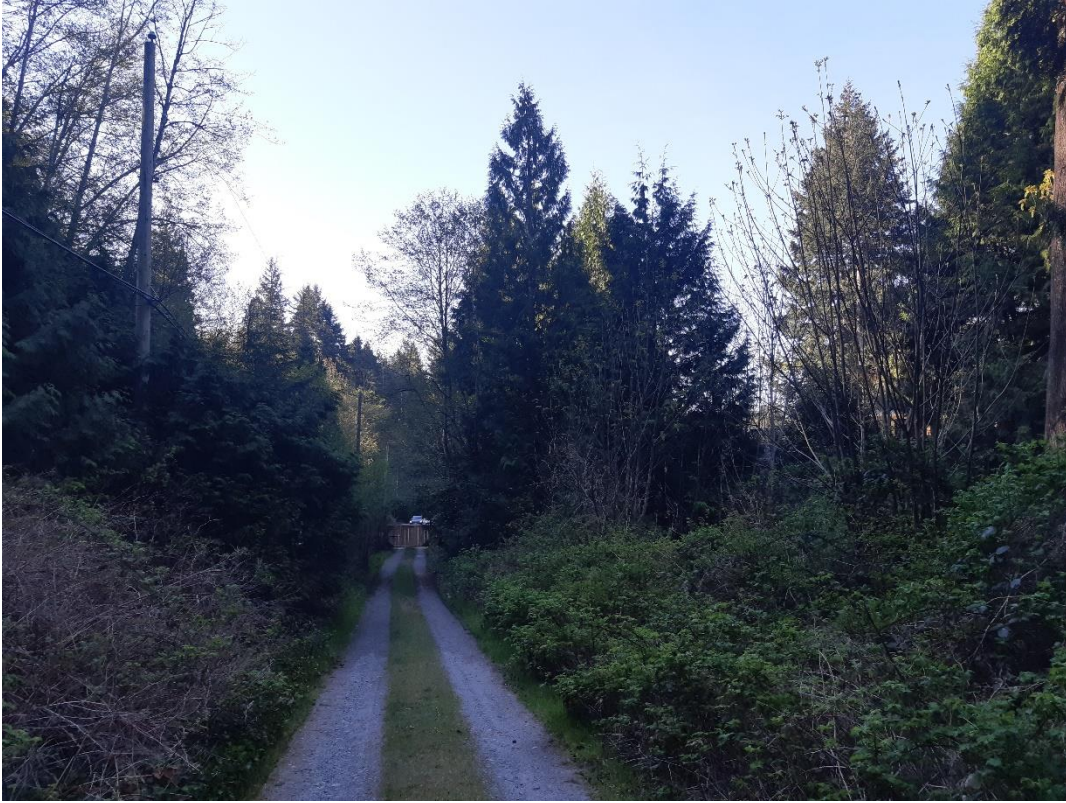
Photo 7. Looking south down the existing gravel driveway. Note open grown crowns of smaller trees along the property line.
