COUNCIL REPORT

Date:	April 20, 2026
From:	Erika Syvokas, Community Planner
Subject:	Heritage Designation of the Navy Jack House

1768 ARGYLE AVENUE, WEST VANCOUVER, BC

HERITAGE CONSERVATION PLAN

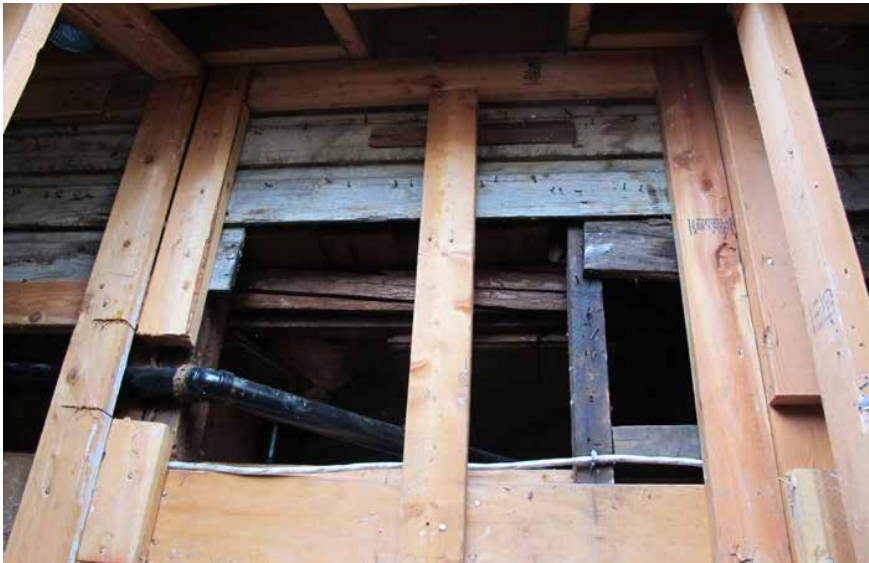
Siding behind later construction, Ground Floor East Side

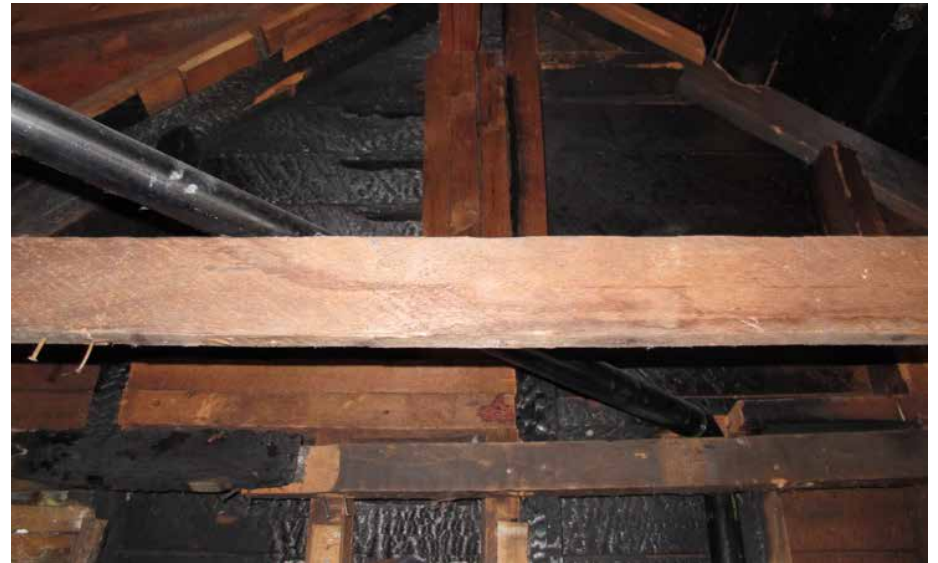
Evidence of chimney fire in the East Gables.

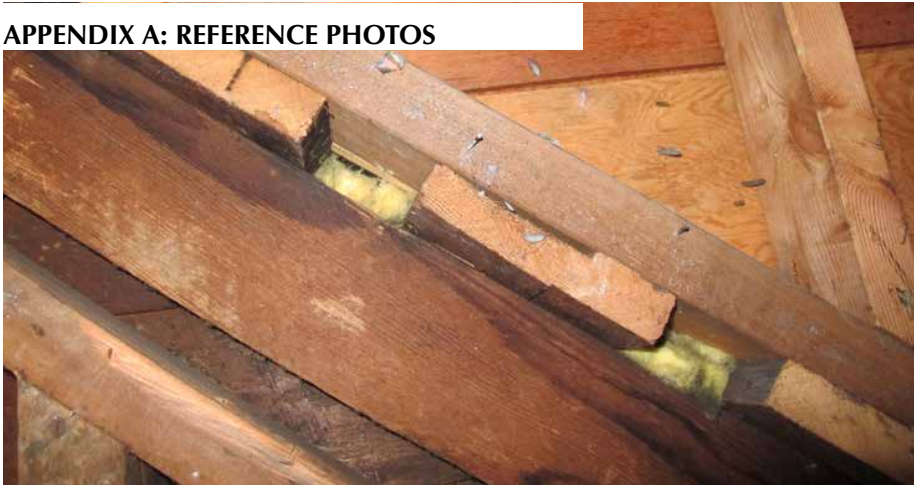
Cut-through roof structure showing original nailing strips.

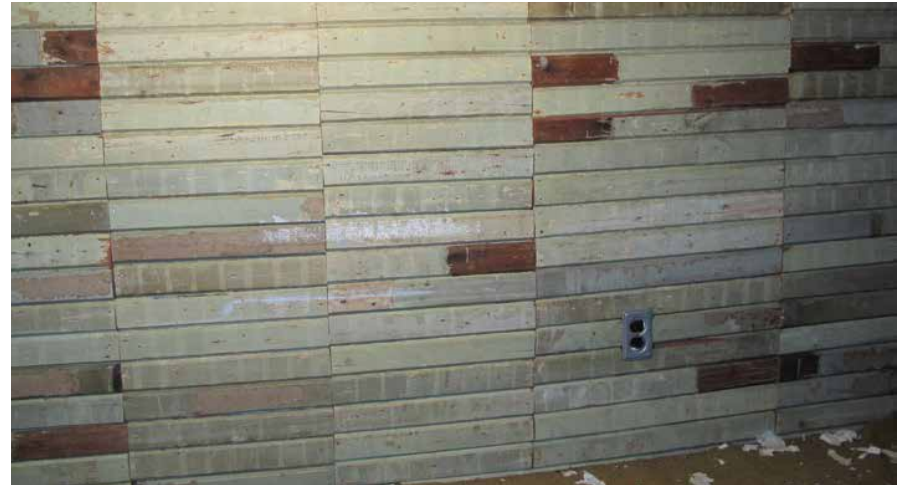
Basement Level wood sidings repurposed as cladding
