NHC Ref. No. 30000457

Subject: 4701 Piccadilly Place South - Creek Realignment Hydrology and Hydraulic Design – 2016 Update for Revision 2 Drawing

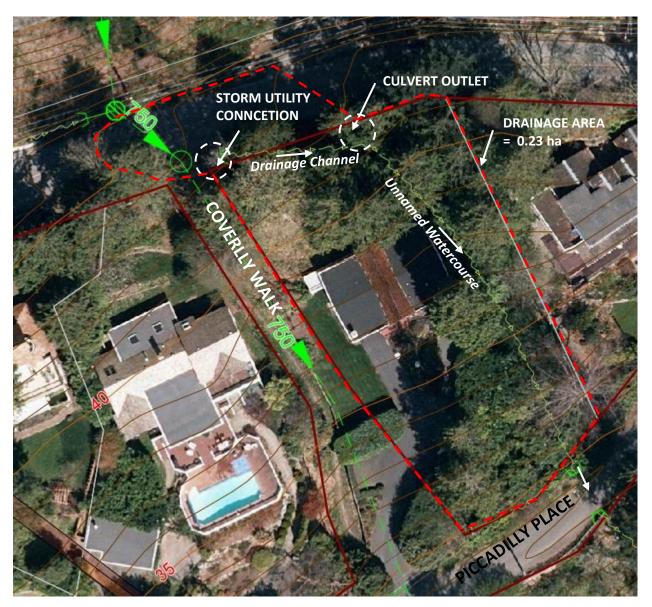
Figure 1. Project Overview and Drainage Area (drainage network and orthophoto from DWV GIS).

The drainage area for the channel is conservatively estimated as 0.23 ha which was determined from field investigation and site survey and is shown on **Figure 1**.

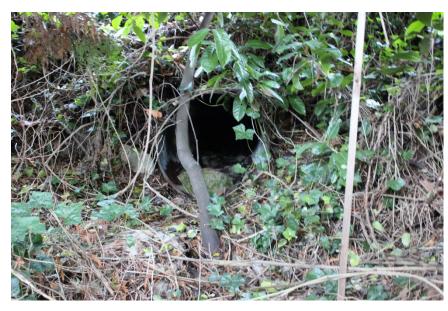
The watercourse originates at the northeast end of the property at the outlet of a corrugated metal pipe under Marine Drive (**Figure 1** and **Photo 1**). During the site visit in December the culvert was dry, despite intense precipitation the previous 4 days; as stated in **Table 1** for the Environment Canada West Vancouver gauge (1108824). Upstream property and road drainage appears to be directed to other systems such as the DWV storm system under Clovelley Walk.

Photo 1. Unnamed watercourse originates at culvert outlet on property at Marine Drive. View looking upstream (North) towards Marine Drive.

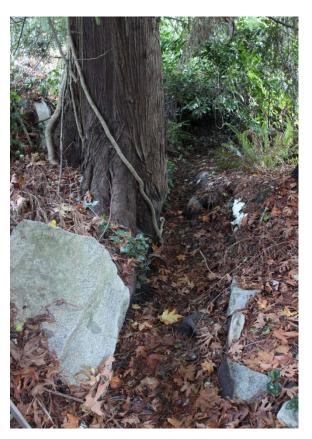
In addition, a small drainage channel, which was likely constructed by previous owners, runs west to east along the north boundary of the property (**Figure 1** and **Photo 2**). Regular flow to the drainage channels appears to have previously been provided by a piped and valve controlled connection from the DWV storm utility (now sealed) (**Photo 3**). The drainage channel currently only intercepts seepage and overflow from Marine Drive and directs it to the unnamed watercourse 4 m downstream of the northern property boundary (**Photo 4**). Similar to the unnamed watercourse, the drainage channel is expected to only convey flow during the most extreme events.

Photo 2. Manmade drainage channel running west to east along north boundary of property. View looking upstream (west).

The existing channel on the north side of the house should be filled with excavated material and compacted.

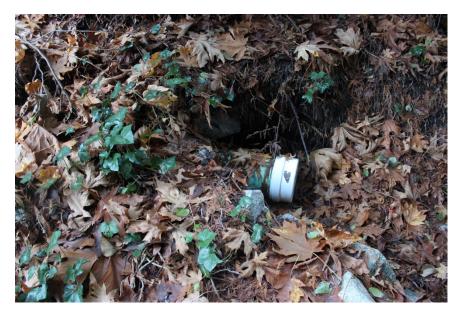
Photo 3. Sealed connection at drainage channel to DWV storm water utility.

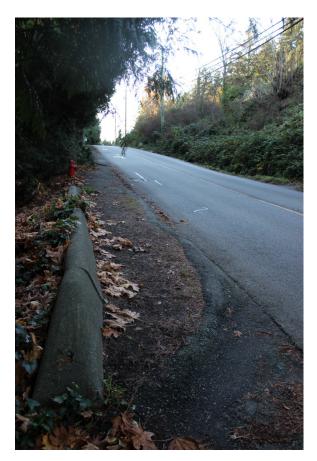
Photo 4. Road drainage from Marine Drive directed to drainage channel. View looking west on Marine Drive.

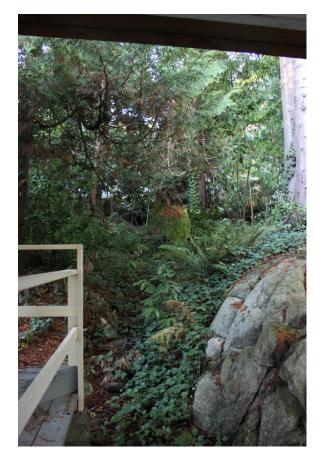
Photo 5. Unnamed watercourse in backyard of existing structure, prior to flowing into concrete lined channel under deck. View looking upstream.

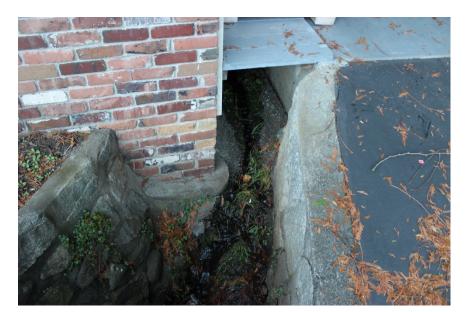
Photo 6. Outlet of concrete lined channel under existing deck. View looking upstream towards existing structure.

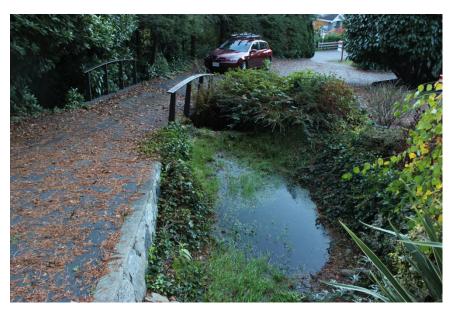
Photo 7. Manmade pond with concrete weir at wood bridge. Limited riparian area at rock wall/asphalt drive. View looking downstream towards Piccadilly Drive.

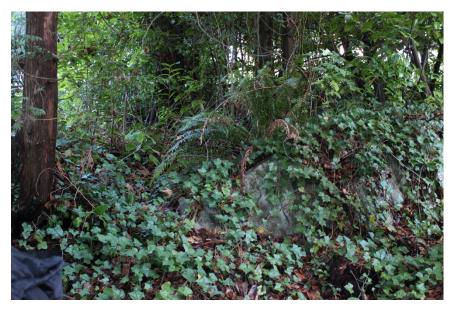
Photo 8. Undefined drainage path at rock outcrop near south east corner of property. View looking upstream towards pond outlet.

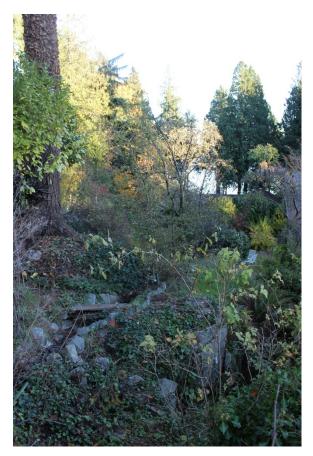
Photo 9. Rock lined channel along 4704 Dogwood Lane. View looking downstream towards Burrard Inlet.
