**DISTRICT OF WEST VANCOUVER**  
 750 17TH STREET, WEST VANCOUVER BC V7V 3T3

**COUNCIL REPORT**

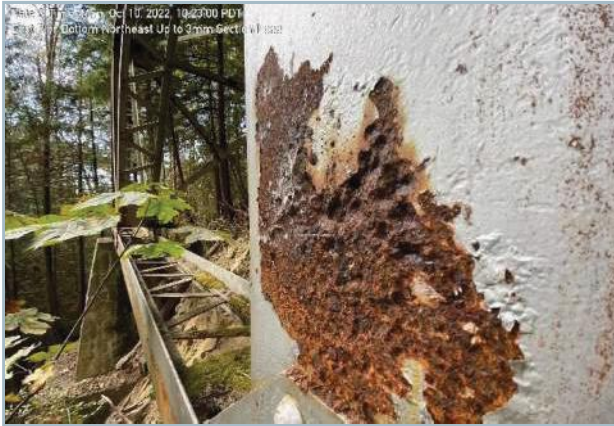
36. Pitting Corrosion with ~3mm Section Loss at Bottom of Northeast Pier

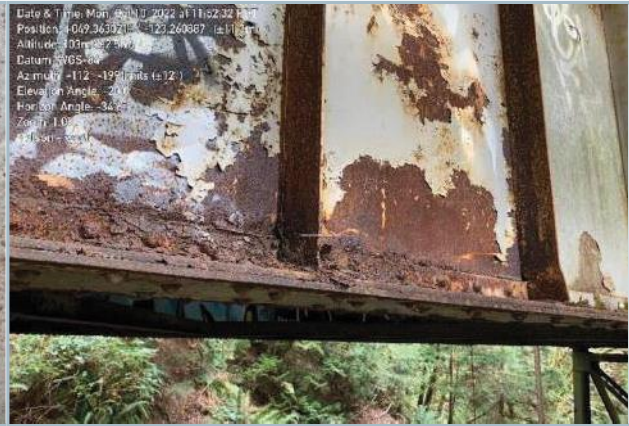
37. Deposit Attack and Accumulation on Bottom Flange of South Girder, Typ. (Note: Deterioration of Rivets)

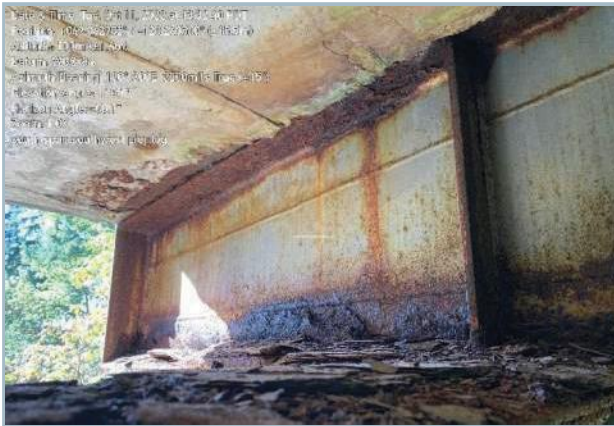
38. Accelerated Uniform Corrosion at Bottom Flange of Floor Beam 5

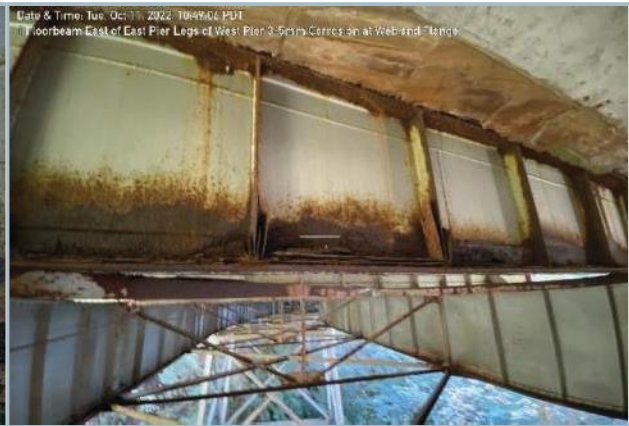
39. 3-5mm Section Loss on Bottom Flange of Floor Beam 9 (Note: Top Flange Corrosion, Typ.)

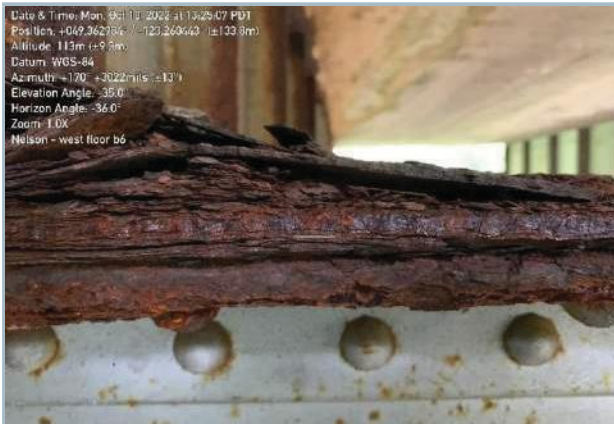
40. Accelerated Uniform Corrosion on Top Flange of Floor Beam 5, Typ.

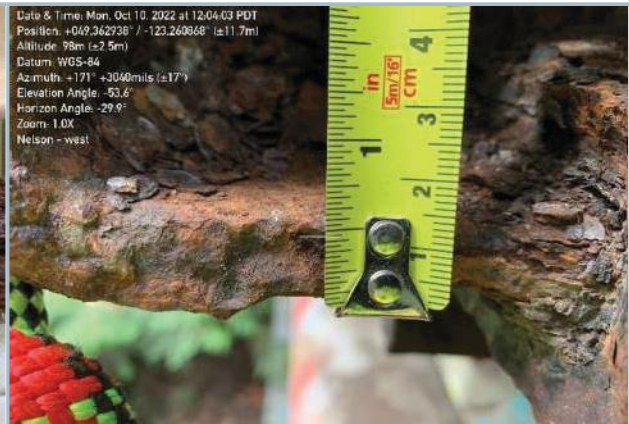
41. 3-5 Section Loss at Bottom Flange of Floor Beam 5 Below Expansion Joint

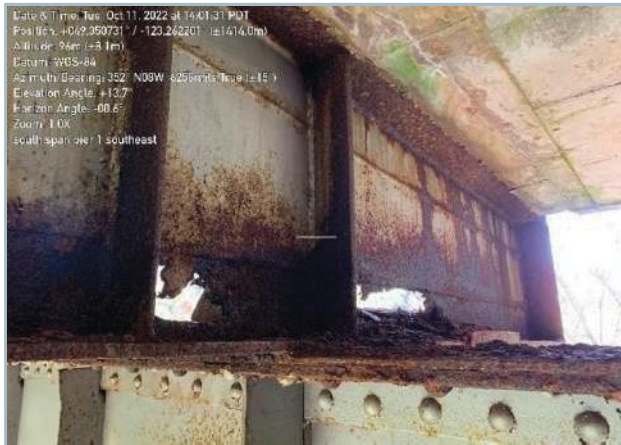
42. Complete Section Loss at Floor Beam 7

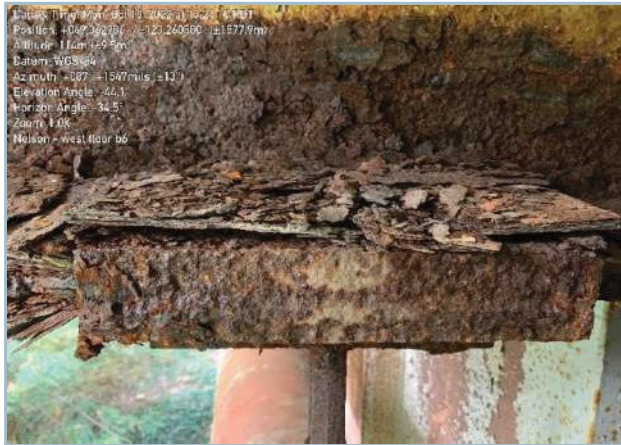
044. Accelerated Uniform Corrosion at Bottom Flange of Floor Beam 6

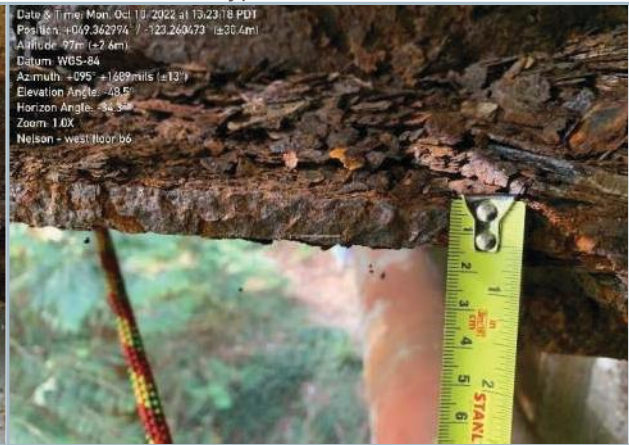
045. 3-5mm Section Loss at Bottom Flange of Floor Beam 6

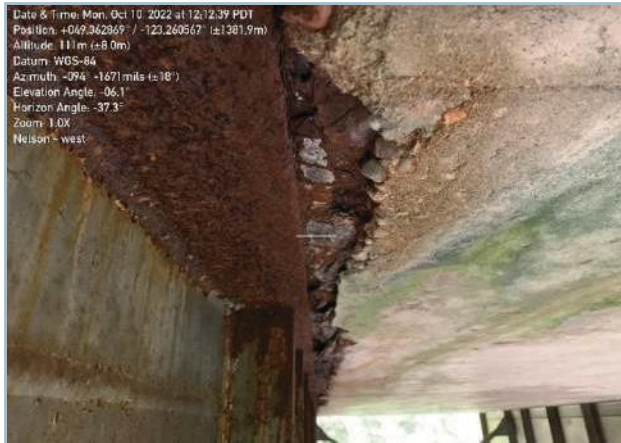
46. Top Flange Corrosion and Spalling of Deck Soffit at Floor Beam 14

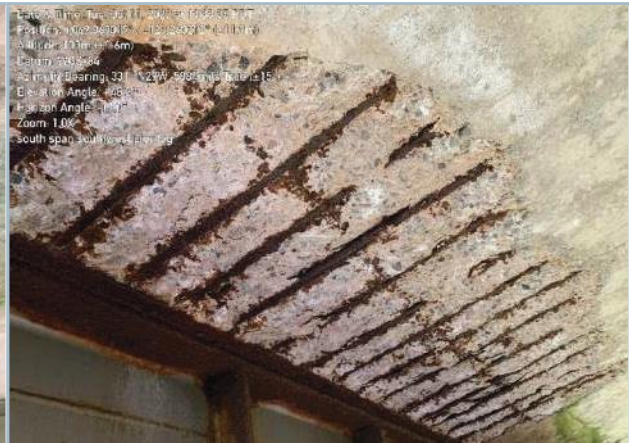
47. Exposed Reinforcing Section of Deck Soffit at Floor Beam 15

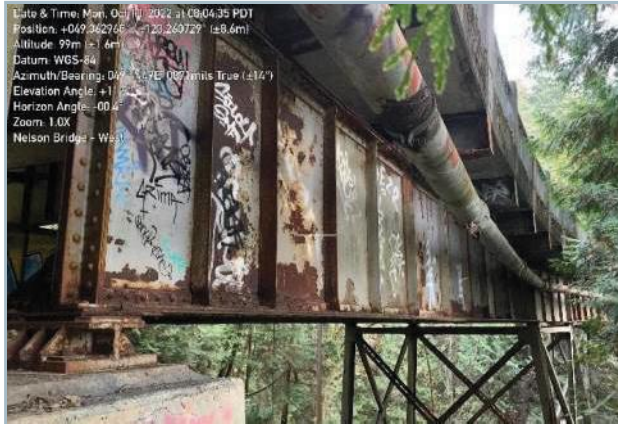
48. South Girder Bottom Flange Corrosion, Typ.

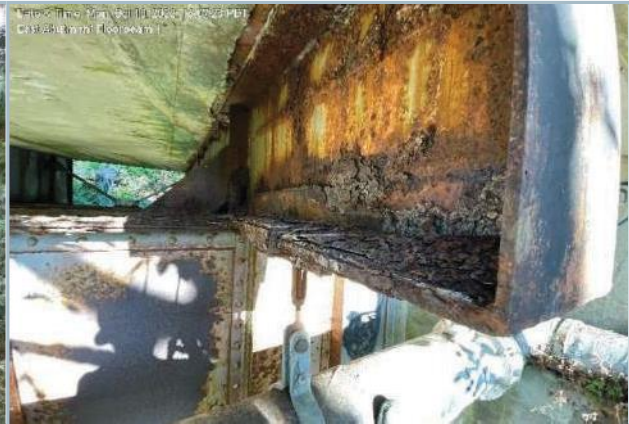
049. Accelerated Corrosion and Deposit Attack on Floor Beam 2

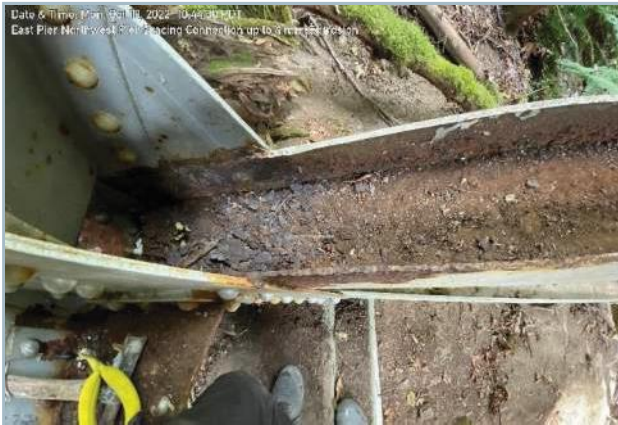
50. 4mm Section Loss at Northwest Base of West Pier

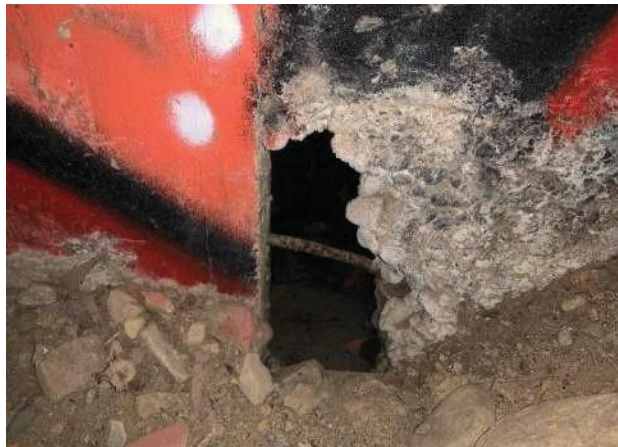
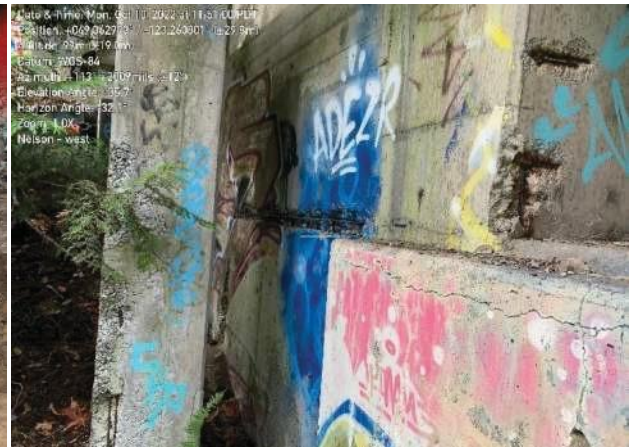
054. Concrete Void at West Abutment South Side Wall 055. Exposed Reinforcing at South Wall of East Abutment

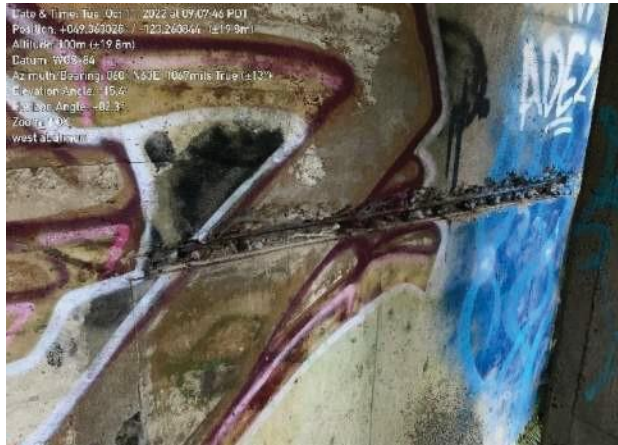
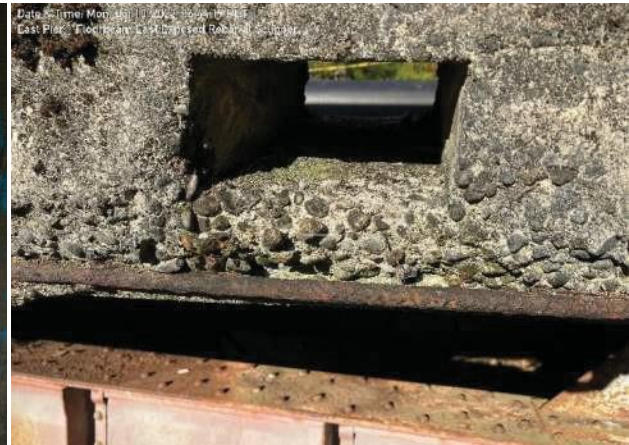
056. Exposed Reinforcing at South Section of West Abutment Side Wall 057. Concrete Spall and Exposed Reinforcing at Midspan of South Girder Profile

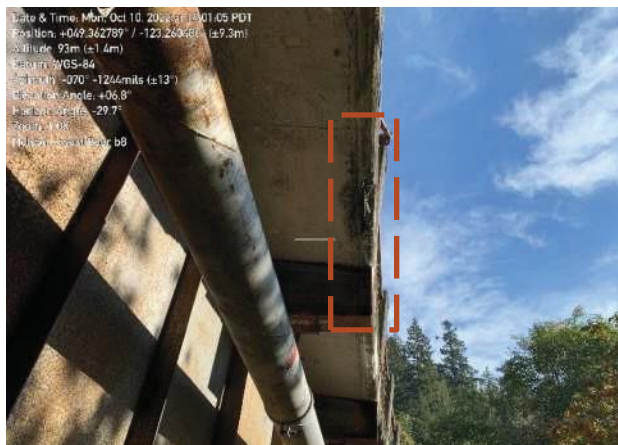
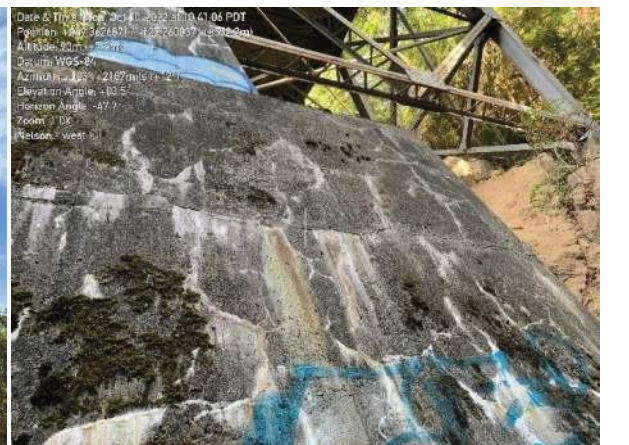
058. Localized Sections of Exposed Reinforcing at Midspan Along South Profile, Typ. 059. Extensive Efflorescence at Southeast Pedestal of West Pier

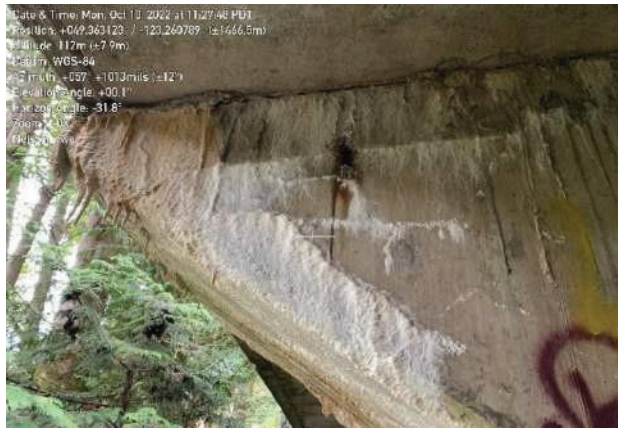
60. Efflorescence on Deck Soffit of West Abutment

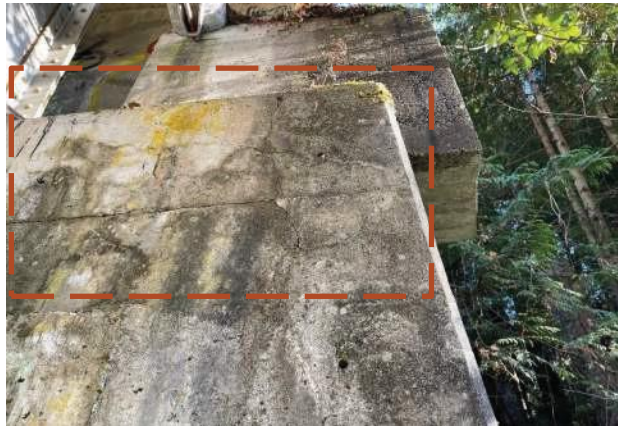
062. Extensive Cracking at East Abutment Side Wall

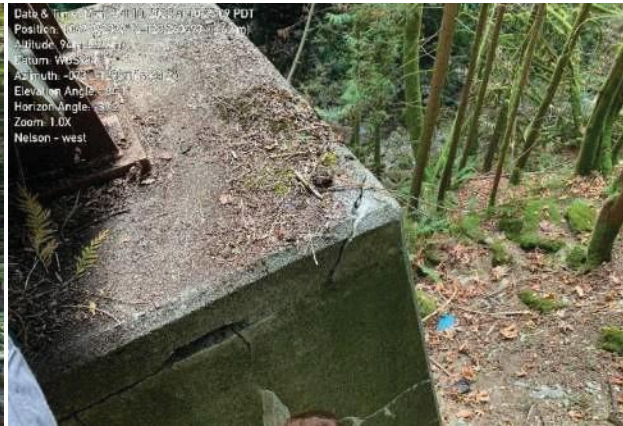
063. Cracking and Separation at Southeast Pedestal of West Pier, Typ.

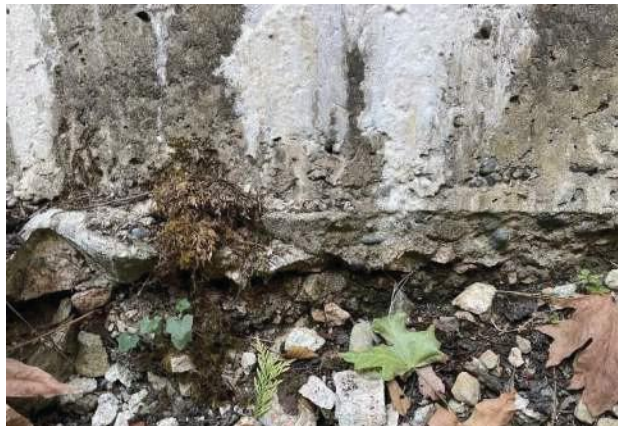
64. Undermining and Aggregate Exposure East Abutment Wing Wall

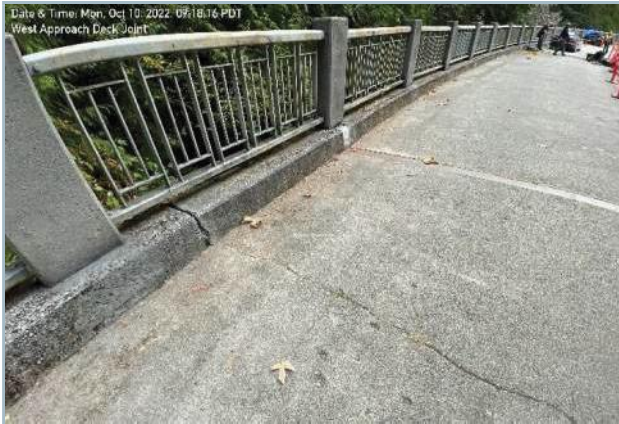
66. Cracking on Asphalt Wearing Surface at West Approach Deck Joint, Typ.

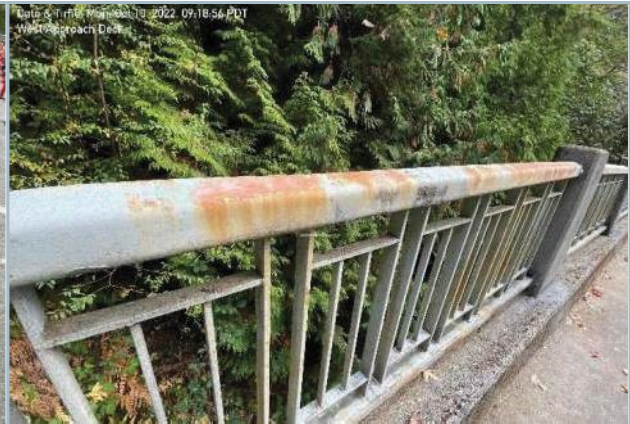
67. Localized Inconsequential Surface Corrosion on Northwest Railing, Typ.

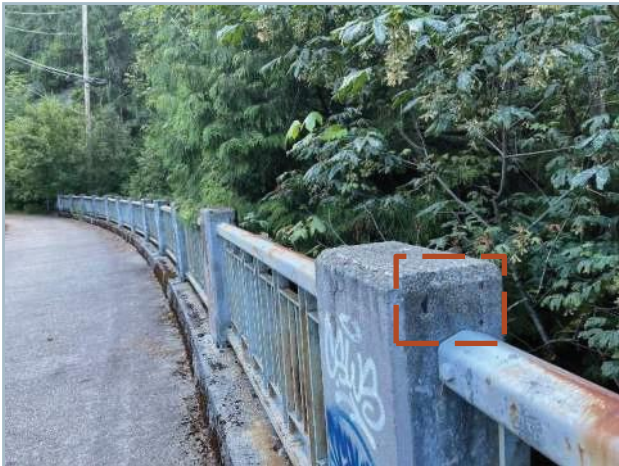
68. Localized Exposed Reinforcing on Deck Parapet at Midspan

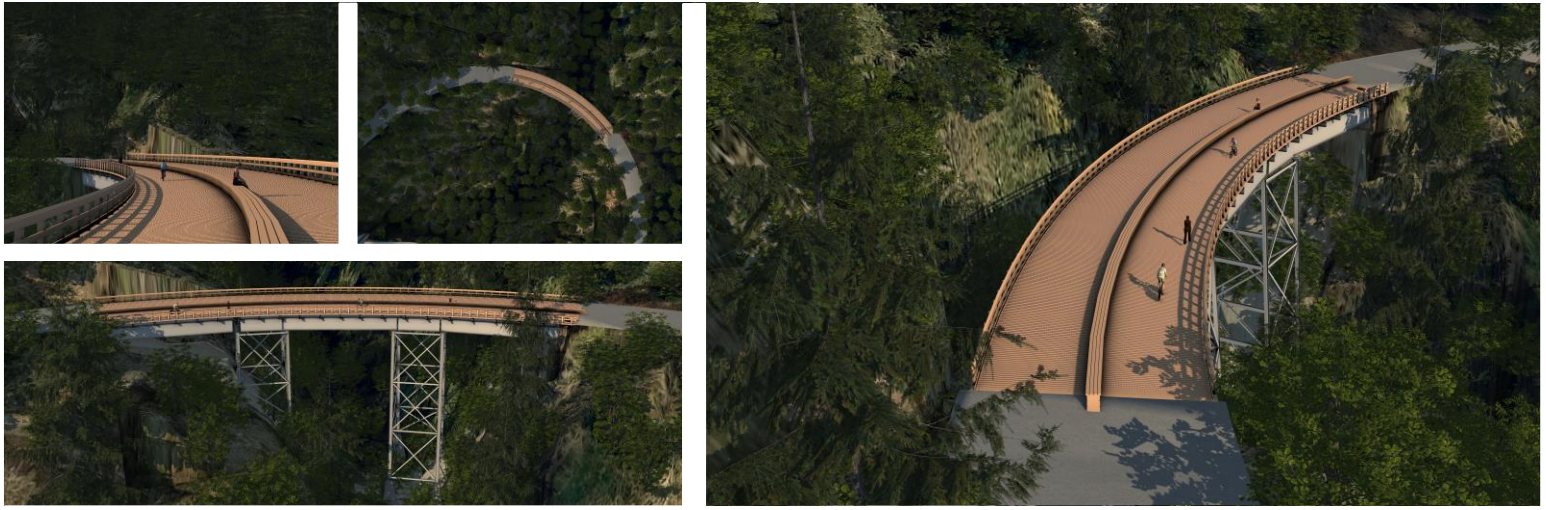
## Nelson Canyon Bridge Full-Width Timber Deck Replacement

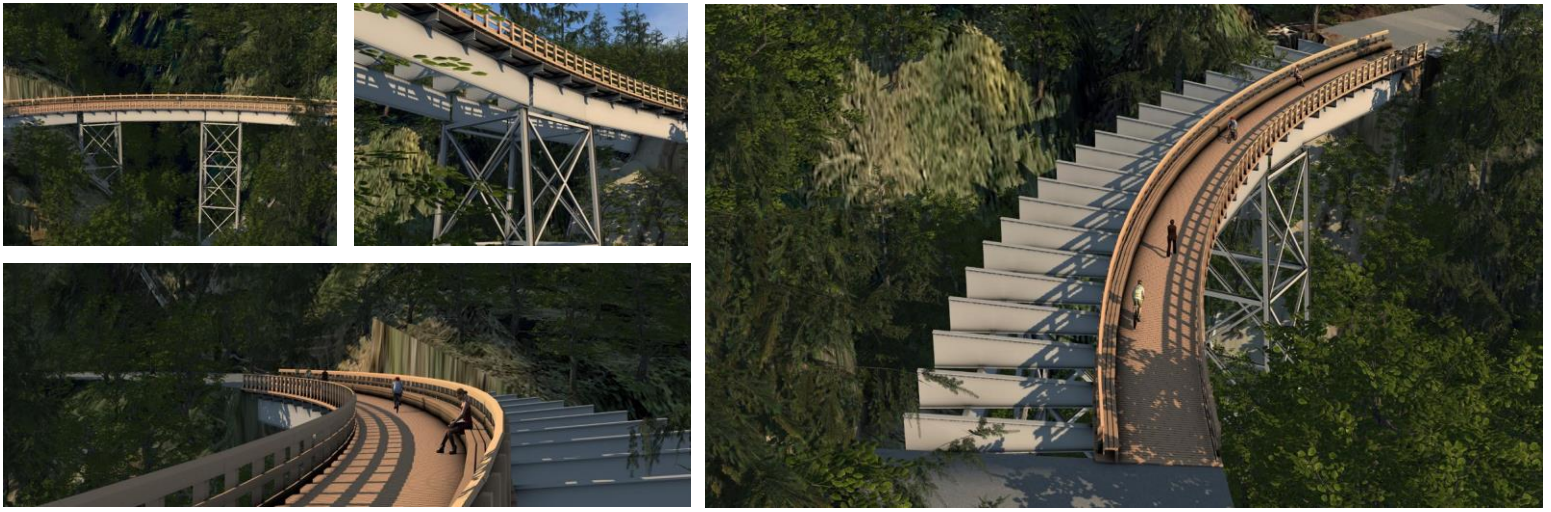
Nelson Canyon Bridge

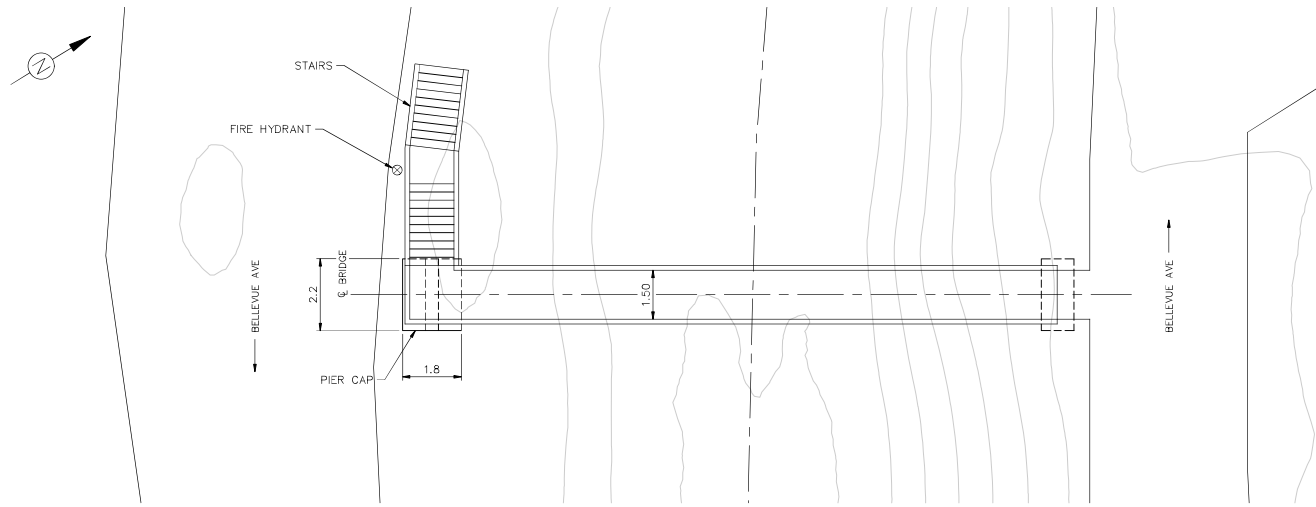
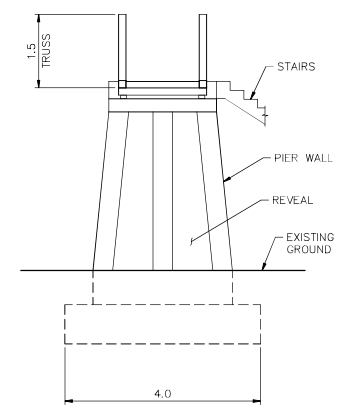
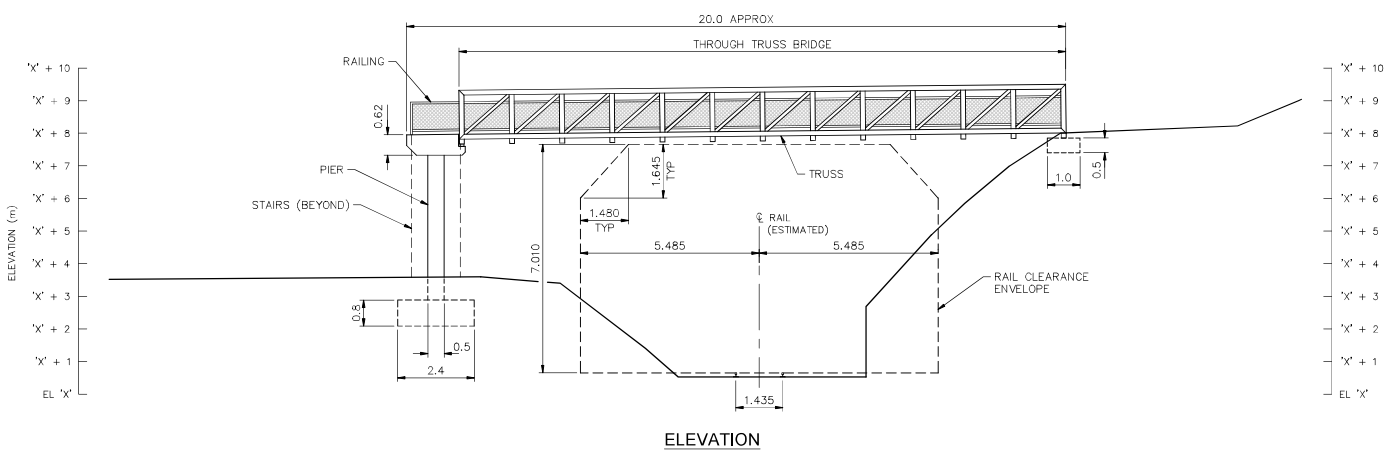
**TYLin**  
 DISTRICT OF WEST VANCOUVER  
 26th STREET PEDESTRIAN BRIDGE REPLACEMENT  
 GENERAL ARRANGEMENT  
 CONCEPT 1
