PROJECT: 4719 PILOT HOUSE ROAD  
 TITLE: LOCATION PLAN  
 SCALE: NOT TO SCALE  
 DATE: 1 JUNE 2014  
 ISSUED: CAULFIELD PANEL REVIEW  
 DRAWING # **1**

PROJECT: 4719 PILOT HOUSE ROAD  
 TITLE: EXISTING HOUSE CONTEXT  
 SCALE: NOT TO SCALE  
 DATE: 1 JUNE 2014  
 ISSUED: CAULFIELD PANEL REVIEW

PROJECT: 4719 PILOT HOUSE ROAD  
 TITLE: NEW HOUSE CONTEXT  
 SCALE: NOT TO SCALE  
 DATE: 3 JUNE 2014  
 ISSUED: CAULFEILD PANEL REVIEW

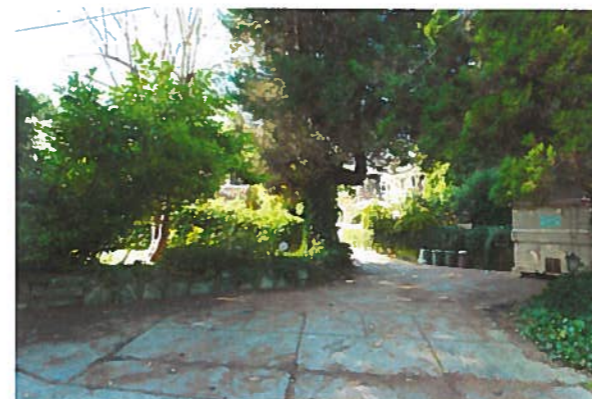
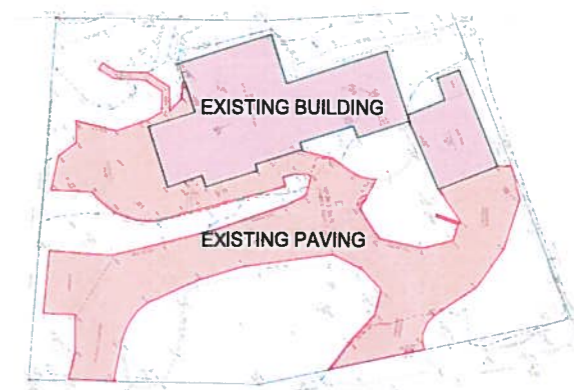
**1** The existing house was once a lovely English cottage in a lush, mature garden looking out to sea. Not any more. The house is literally falling apart, destroyed by rot and ivy and deferred maintenance. It is now a "Grey Gardens" house, completely unsalvageable.

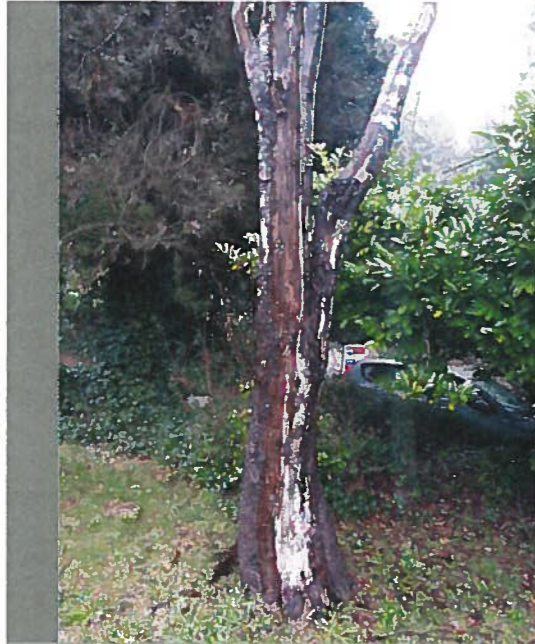
Photo 1. Tree # 7058, this dogwood tree is severe health and structural decline.

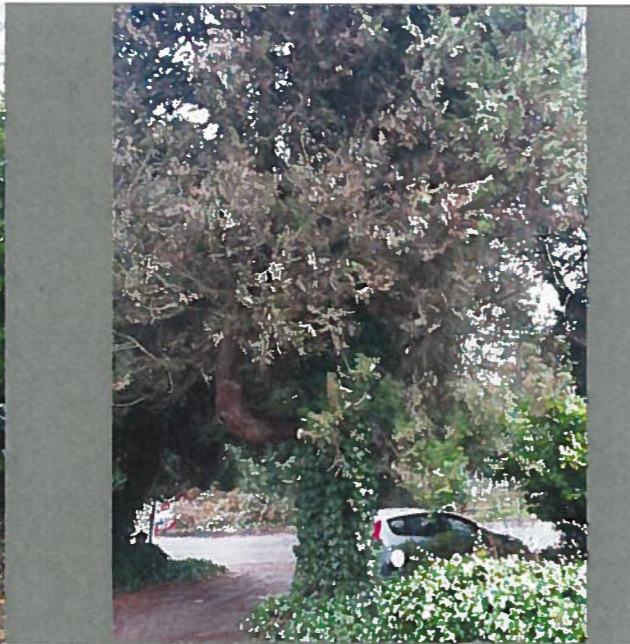
Photo 2. Tree # 7059, previously topped, displaying large patches of crown dieback.

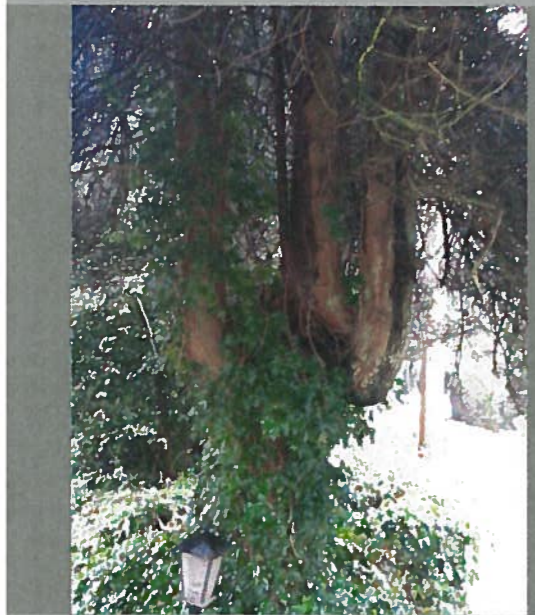
Photo 3. Tree # 7056, previously topped with decay visible at the stem union.

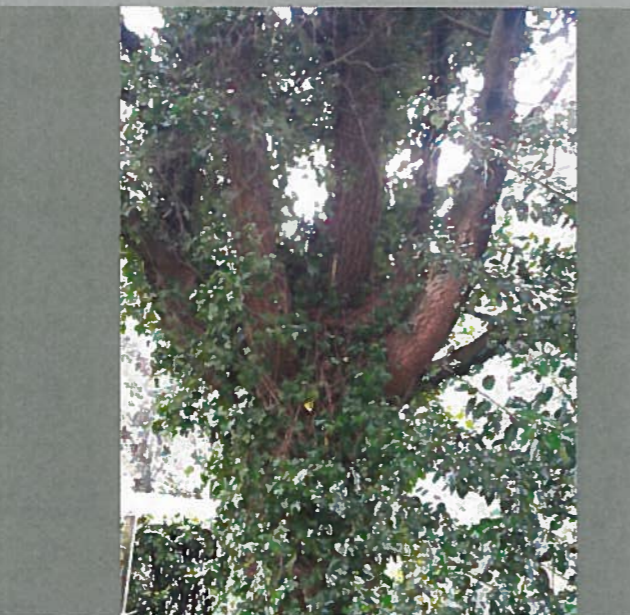
Photo 4. Tree # 5988 previously topped that resulted in the large replacement leaders.

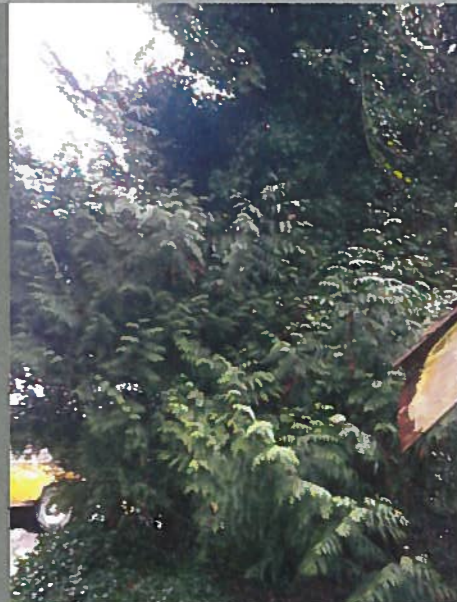
Photo 7. Showing topped tree # 5982.

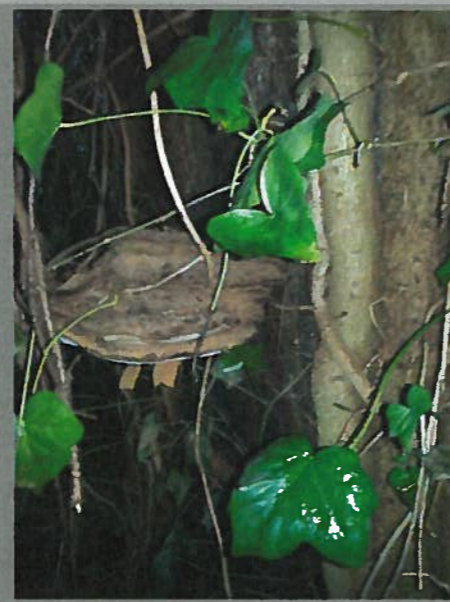
Photo 8. Showing the decay conk growing on Tree # 5983.
