**DISTRICT OF WEST VANCOUVER
INTEGRATED STORMWATER MANAGEMENT PLAN FOR PIPE, WESTMOUNT,
CAVE, TURNER AND GODMAN CREEKS**

**BRITISH PACIFIC PROPERTIES LTD.
PROPOSAL FOR
INTEGRATED STORMWATER MANAGEMENT PLAN FOR PIPE, WESTMOUNT,
CAVE, TURNER AND GODMAN CREEKS IN THE
DISTRICT OF WEST VANCOUVER**

Ecological Overview Report
Integrated Stormwater Management Plan
for Pipe, Westmount, Cave, Turner and Godman Creeks
SLR Project No. 201.88342

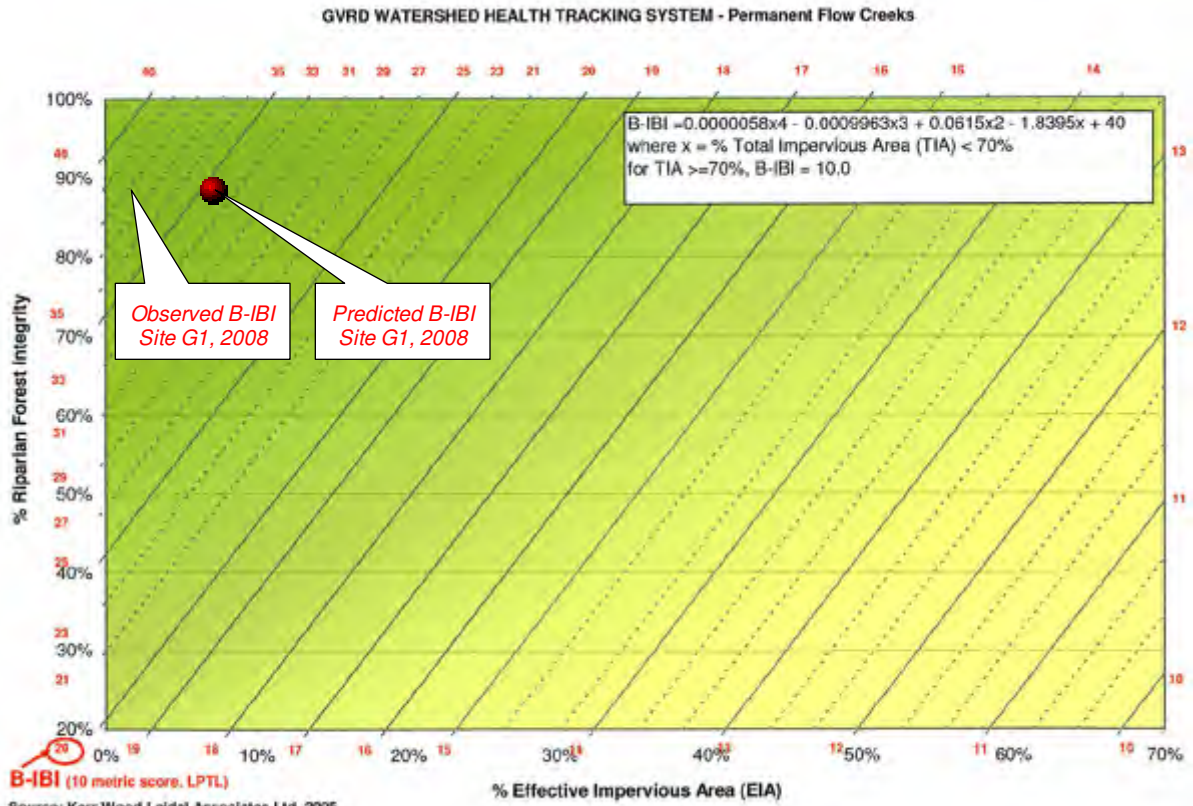
FIGURE 6: WATERSHED HEALTH ASSESSMENT, GODMAN CREEK, SITE G1

The watershed health tracking system recommended by Kerr Wood Leidel (2005) in the ISMP template is based on correlation among three quantifiable biophysical characteristics of watersheds: Percent Riparian Forest Integrity (RFI); Effective Impervious Area (EIA); and the Benthic Index of Biotic Integrity (B-IBI). This report includes derivation of the baseline watershed health of the Godman Creek watershed, based on its RFI, B-IBI and EIA values.

Given that it is located a short distance below Highway 1, the benthic invertebrate population at Site G1 is influenced mainly by conditions in the upper, mostly undeveloped, part of the Godman watershed, and very little by conditions below the highway. For the upper portion of the watershed, the RFI is 88%, and the EIA is approximately 5% (very close to the Total Impervious Area, TIA). The overall B-IBI score for Godman Creek, Site G1, was 38 or "Good".

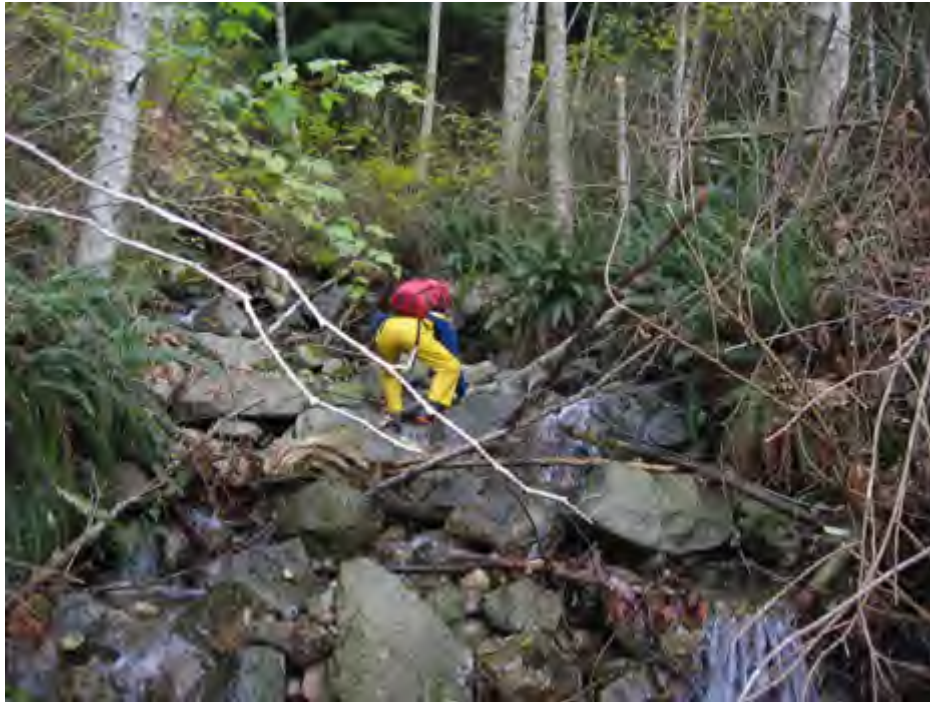
Photo 1: SLR Biologist M. Lashmar climbing up the steep channel of Pipe Creek, above lower Cypress Bowl Road, during the assessment of riparian setbacks (November 18, 2005).

The portion of Pipe Creek above Cypress Bowl Road (within the Rodgers Creek Neighbourhood area) is of moderate size and steep (Photo 1). Channel gradients approach 30% in numerous areas, precluding the presence of resident fish. A mix of boulder-cobble dominates the substrate, with infrequent areas of gravel and fines. Bedrock outcrops are also present.

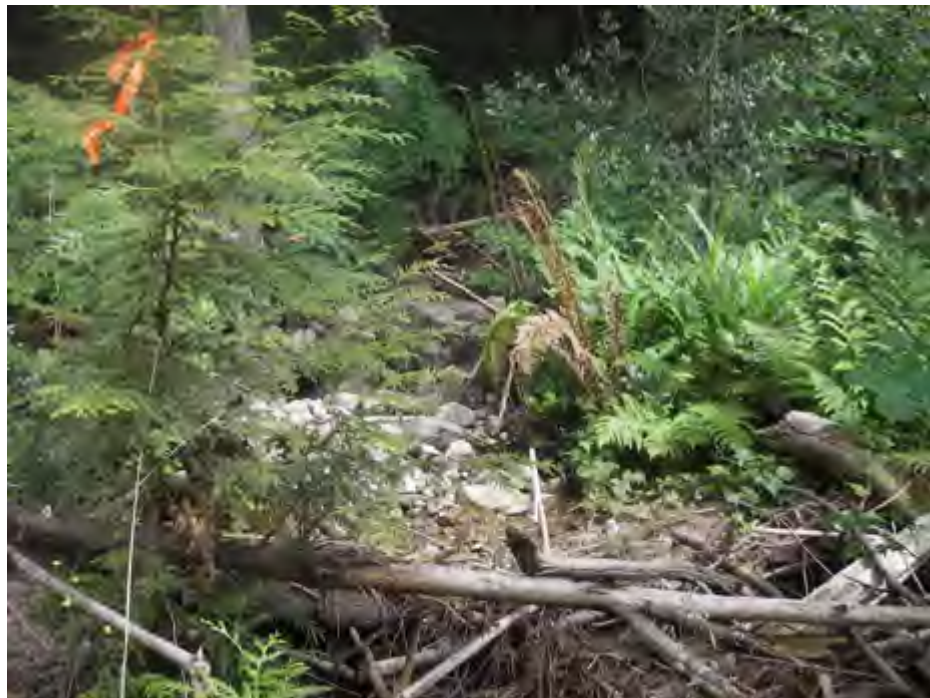
Photo 2: Tributary N, within the Pipe Creek watershed, has a gravel-cobble substrate with occasional boulders; though the channel was dry above lower Cypress Bowl Road in summer 2006, one tailed frog tadpole was found in a pool that still contained water (July 4, 2006).

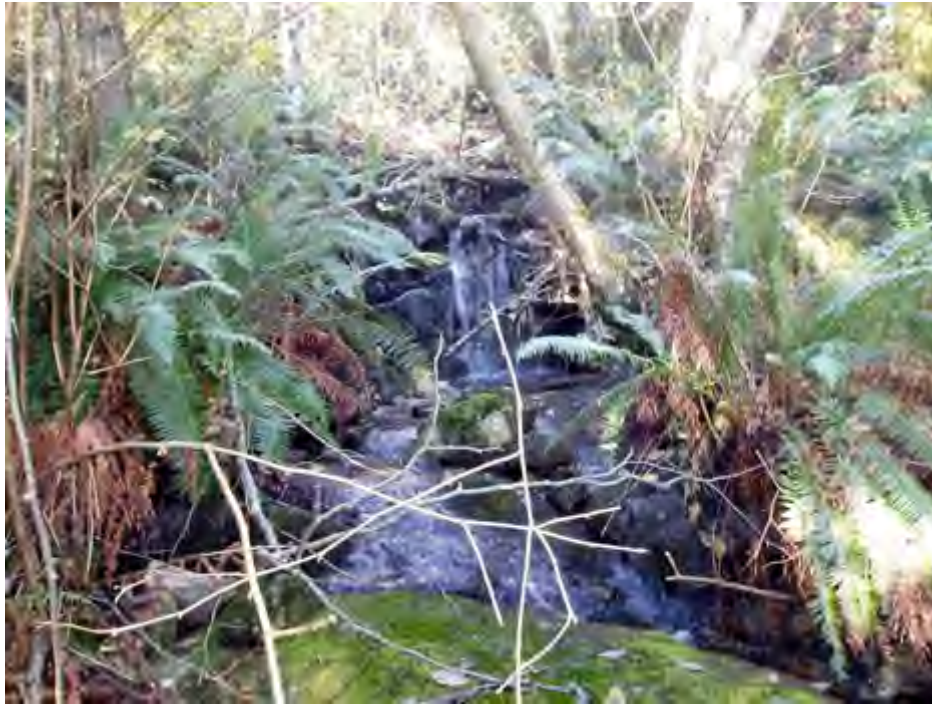
Photo 3: The steep channel of Westmount Creek above lower Cypress Bowl Road contains sections of riffles, steps, pools and chutes, depending on local gradient (November 22, 2005).

Upstream of Highway 1, Westmount Creek is primarily in a natural state. Within the Rodgers Creek neighbourhood area, Westmount Creek flows southward through a channel that averages 4.5 m wide, with an average gradient of approximately 37%. Wetted widths ranged from 1.5 m to 2.3 m, and the morphology is typical of steep stream flow types, including sections of riffles, steps, pools and chutes (depending on local gradient), broken up by downed logs and large boulders (Photo 3).

Substrate is predominately boulders (50%) and cobbles (30%); large patches of gravels and fines were found, however, adjacent to pools and depositional areas, and there are occasional areas of exposed bedrock. Substrate compaction was considered to be at a medium level. A significant amount of in-stream woody debris is present, with most being stable. No fish were observed during fieldwork.

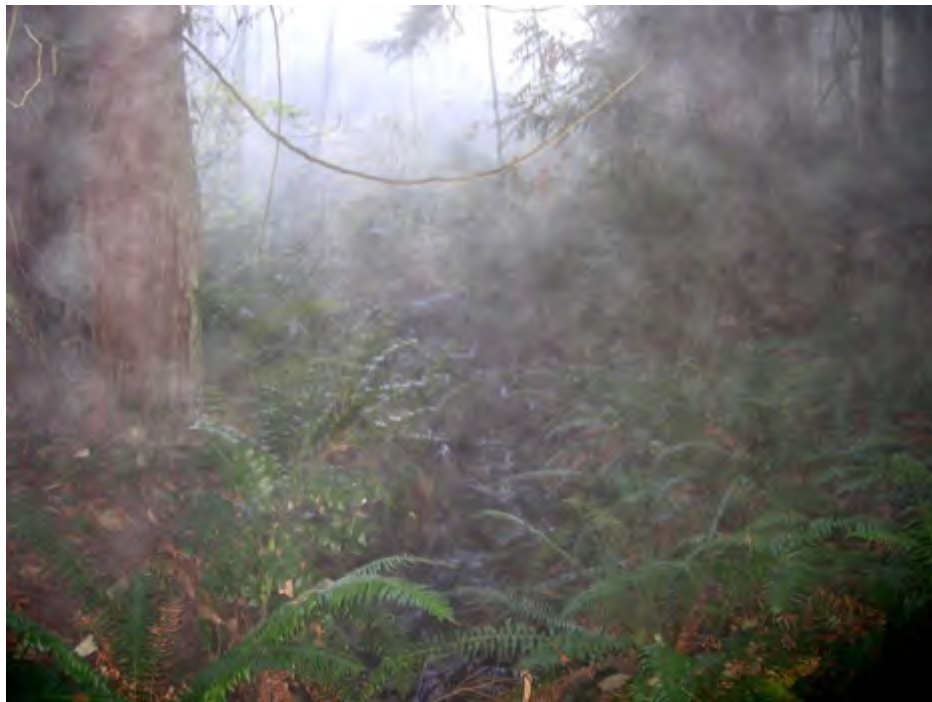
Photo 4: The riparian forest along Cave Creek, above lower Cypress Bowl Road, is characterized by maturing second-growth western redcedar, Douglas-fir, salmonberry, red huckleberry and sword ferns; canopy cover ranges from 75% to nearly 100% (November 22, 2005).

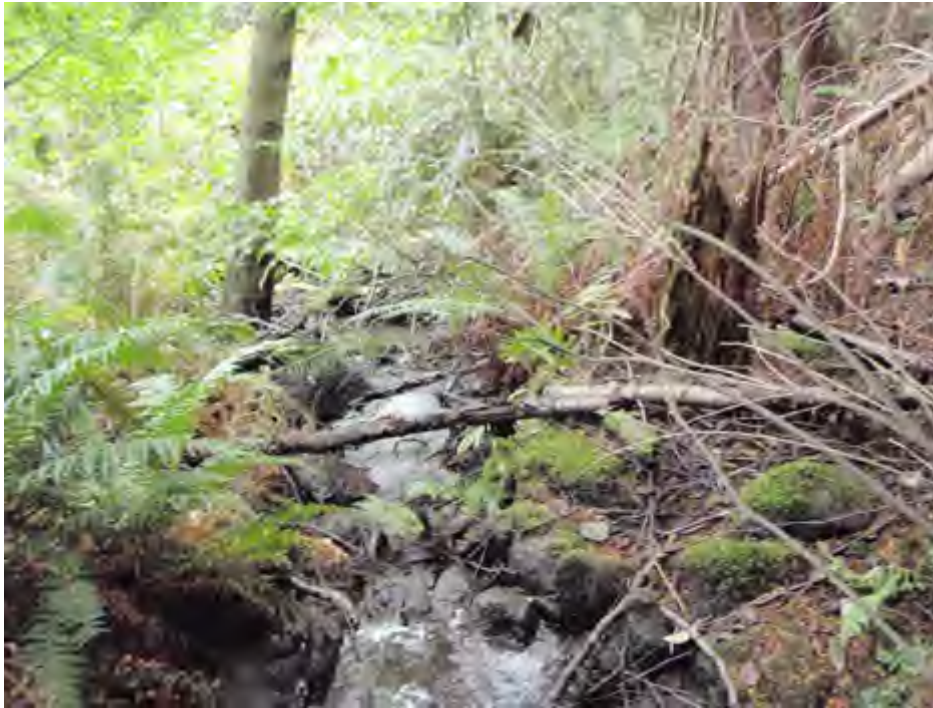
Photo 5: Turner Creek channel, typical step-pool section, above Highway 1 (August 27, 2008).

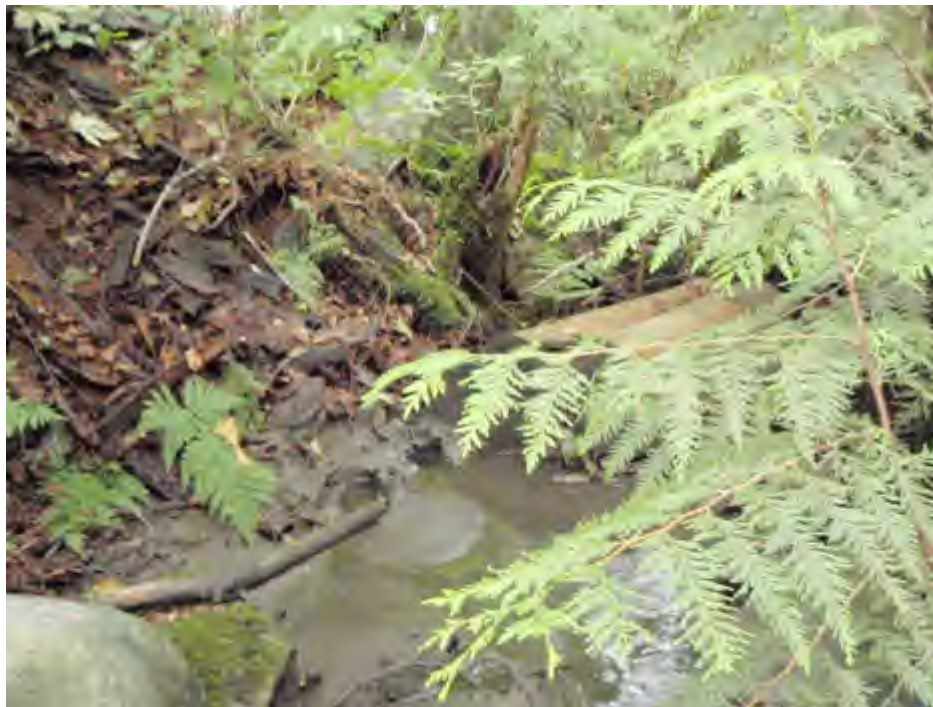
Photo 6: Turner Creek channel, portions of the channel above Highway 1 exhibited sedimentation (August 27, 2008)

No information on Turner Creek was found in the FISS database. It is likely that anadromous cutthroat trout and coho salmon have access as far upstream as the culvert under Marine Drive. The steep gradient above Highway 1 would preclude fish presence, but it is unknown whether resident cutthroat trout inhabit the section of Turner Creek between the highway and Marine Drive.

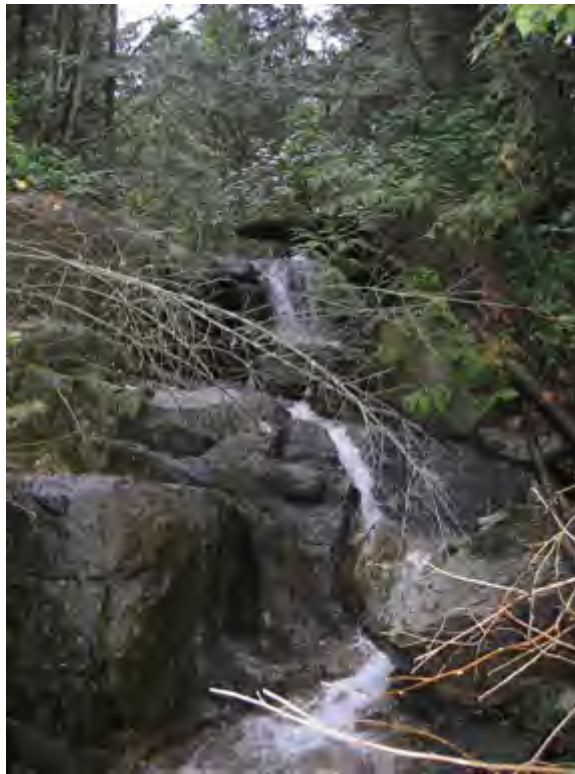
Photo 7: Steep section of the Godman Creek mainstem above Eagle Lake Road (November 24, 2005)

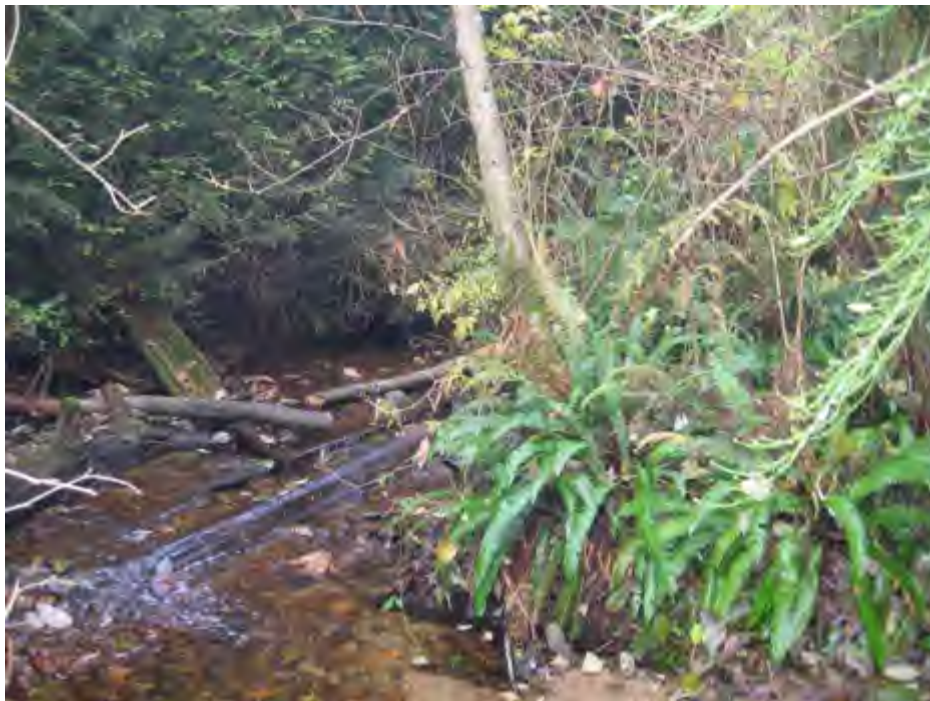
Photo 8: Godman Creek, low gradient section, a short distance downstream of the inflow of the Godman Creek West Branch tributary (November 23, 2005).

Below the points where the East Branch and West Branch enter, the Godman Creek mainstem has lower gradient and substrate of smaller sizes as it flows toward the Upper Levels Highway (Photo 8). This section of the creek, up to the channel drop down to the Upper Levels Highway, has several pockets of potential spawning habitat. Cutthroat trout were captured in minnow traps along this section. The creek is very steep immediately above Highway 1 and would form a fish access barrier (Photo 9). Remnants of an old weir structure and fence were found, a short distance downstream of the BC Hydro right-of-way.

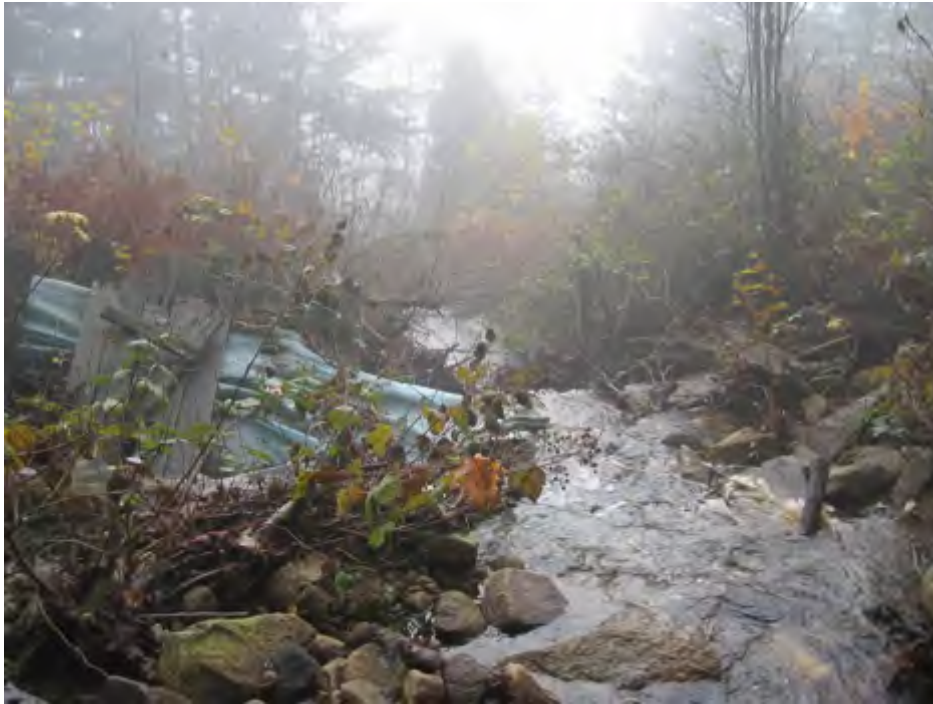
Photo 9: Immediately above Highway 1, the channel of Godman Creek is very steep and would form a fish access barrier; remnants of an old weir structure and fence were found, a short distance downstream of the BC Hydro right-of-way (November 23, 2005).

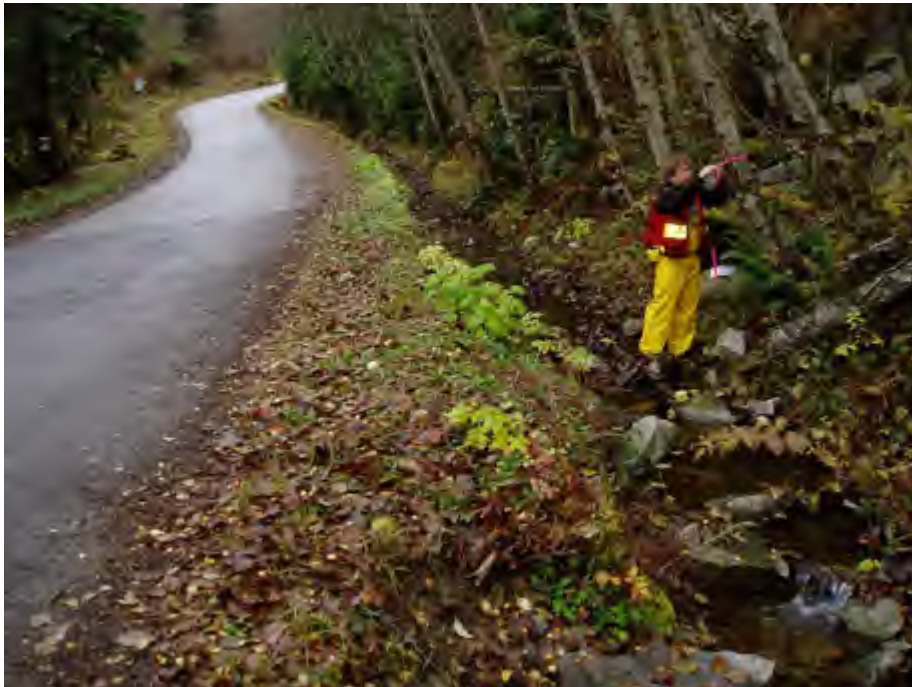
Photo 10: Environmental scientist Chris MacMillan labelling a survey transect along Godman Creek West Branch (November 24, 2005).

The West Branch of Godman Creek originates from a point near the BC Hydro substation and flows approximately 800 m, primarily in the north-side ditch of Eagle Lake Road (Photo 10), to a culvert through which it passes under Eagle Lake Road. This culvert is located approximately 60 m west of the culvert that conveys the Godman Creek mainstem under Eagle Lake Road. During high flows, a portion of West Branch waters may continue along the roadside ditch to join waters of the mainstem.

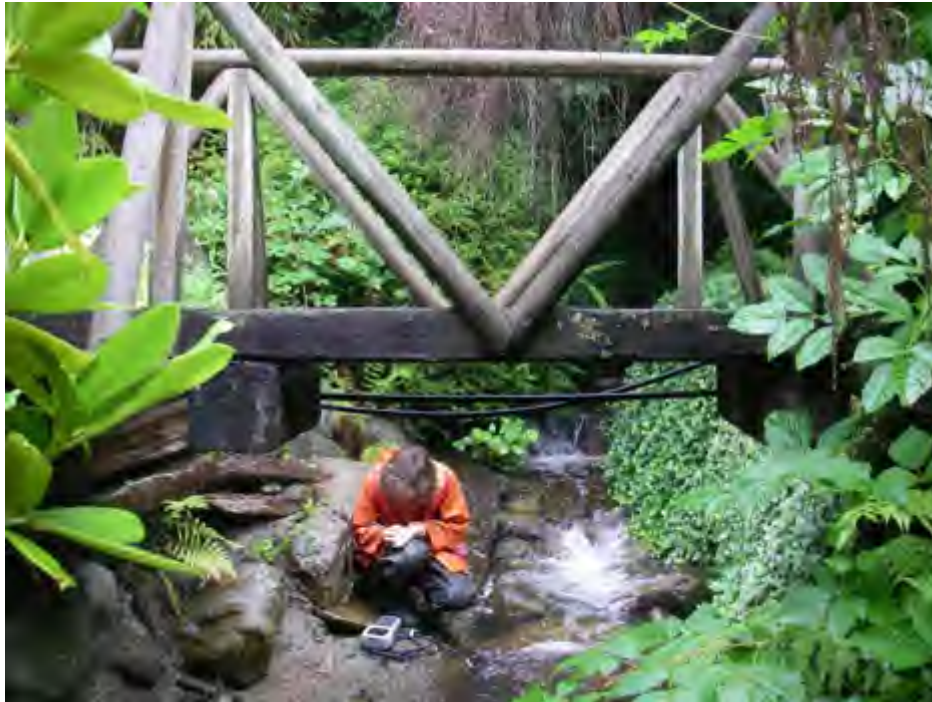
Photo 11: SLR Environmental Scientist Stef Lee measuring Pipe Creek water quality *in situ*, a short distance upstream of Mathers Avenue, using a mini-sonde and data logger (August 27, 2008).

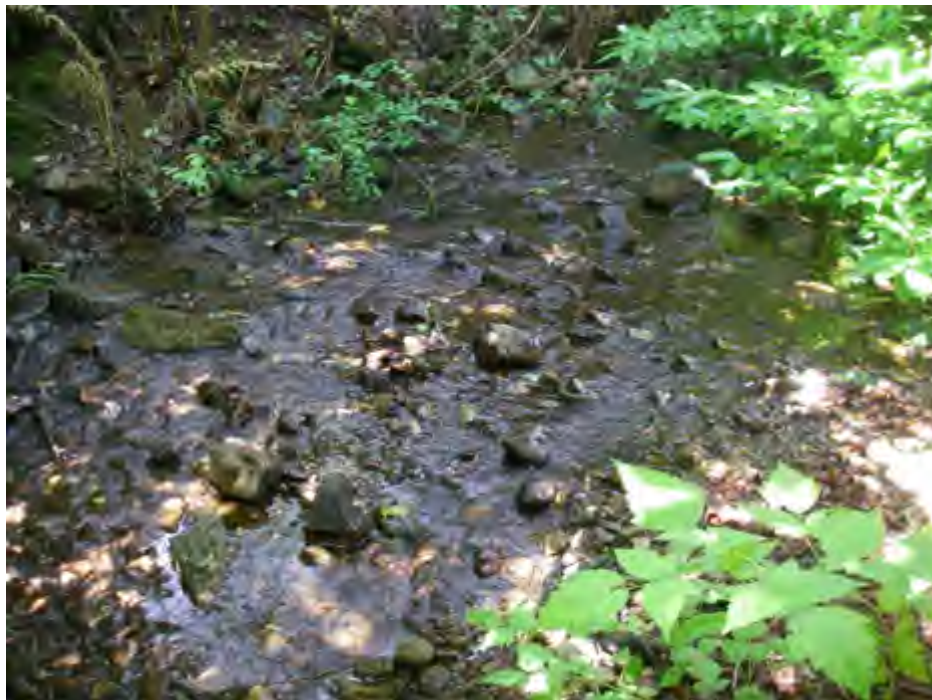
Photo 12: Godman Creek, Benthic Invertebrate Sampling Site G1, view upstream from a point immediately above a footbridge downstream of Westridge Avenue (August 27, 2008).

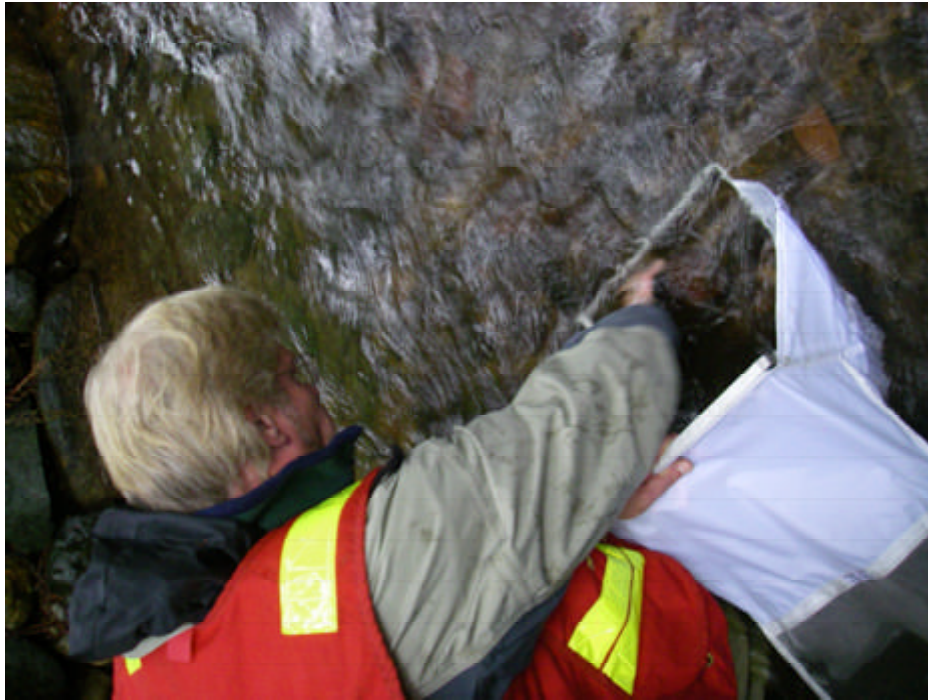
Photo 13: SLR Biologist John McCulloch using a Surber Sampler to collect a sample of benthic invertebrates at Godman Creek Site G1 (August 29, 2008).

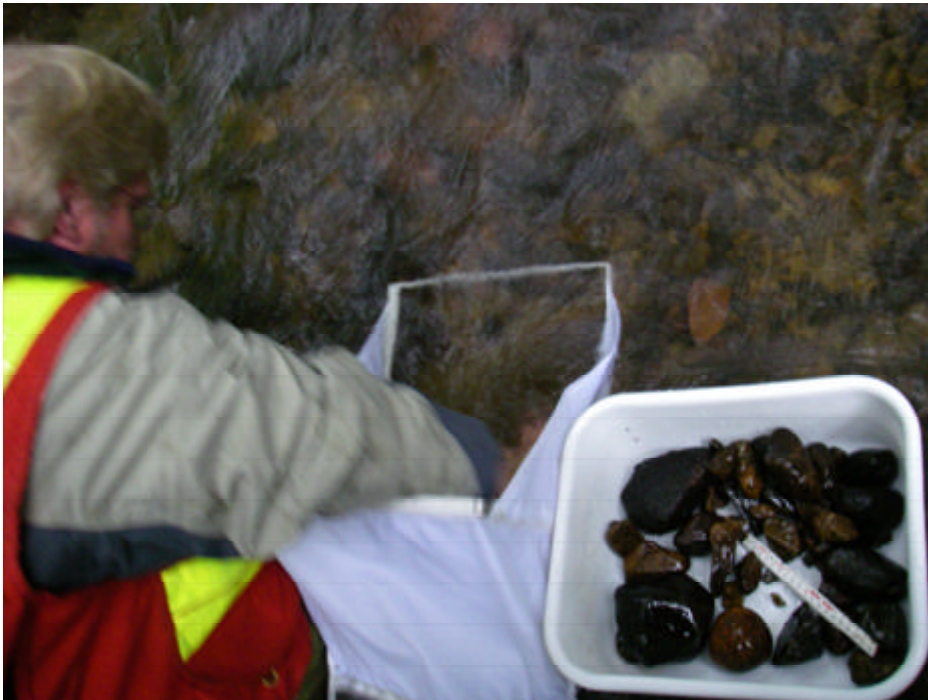
Photo 14: SLR Biologist John McCulloch transferring substrate material from the Surber Sampler to a plastic tub, Godman Creek Site G1 (August 29, 2008).

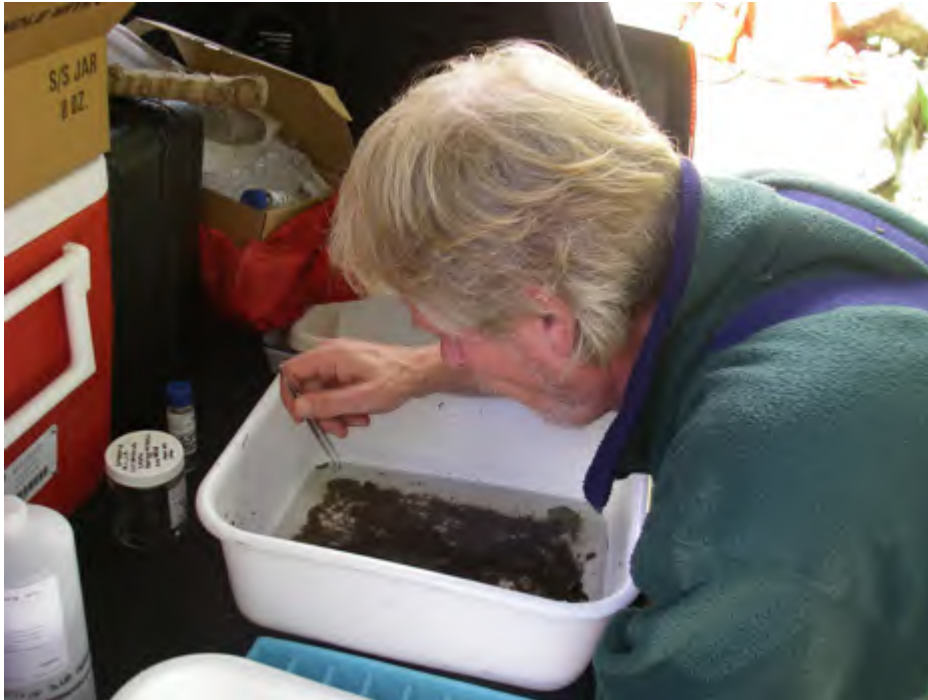
Photo 15: SLR Biologist John McCulloch using jeweller's forceps to field-sort benthic invertebrates sampled from Godman Creek Site G1 (August 29, 2008).

jeweller's forceps to the sorting tray. Benthic invertebrates from each replicate were picked from the sorting trays with jeweller's forceps, eyedroppers, or spoons and placed in separate ice cube trays filled with stream water (Photo 15).

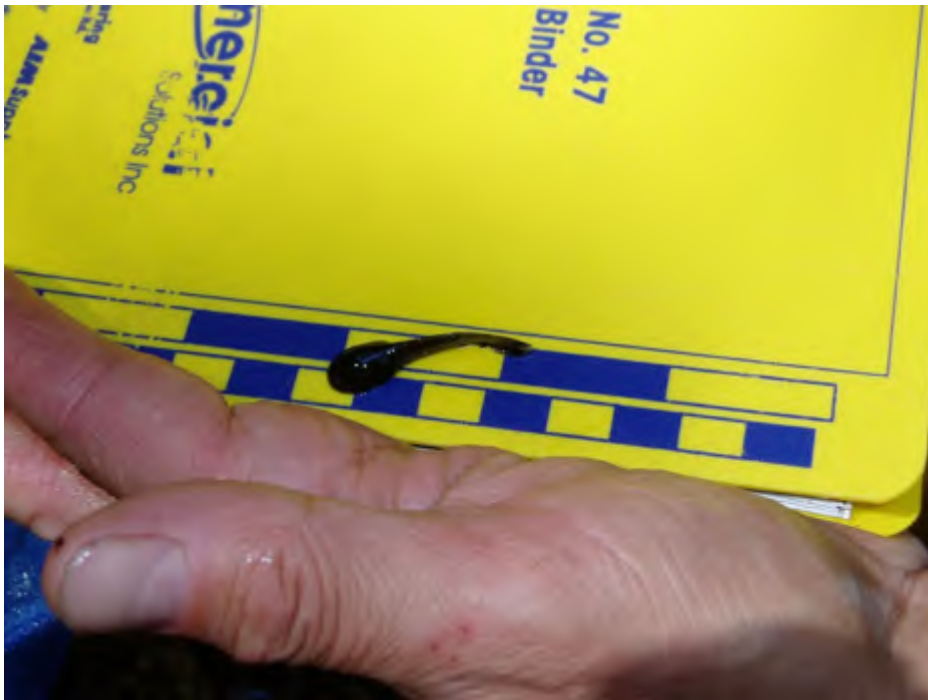
Photo 16: Coastal tailed frog tadpole captured from a pool along Godman Creek, above Eagle Lake Road (June 26, 2006).

During June-July 2006, SEACOR resurveyed streams identified during the November 2005 surveys as having either previous sightings or higher potential coastal tailed frog habitat. Table 17 summarizes results of the November 2005 and June-July 2006 baseline coastal tailed frog surveys. No coastal tailed frogs were observed along Pipe, Westmount, or Cave creeks, though one tadpole was found in Tributary N of Pipe Creek. Tailed frog tadpoles were also identified in the section of Godman Creek above Eagle Lake Road (Photos 16, 17 and 18).

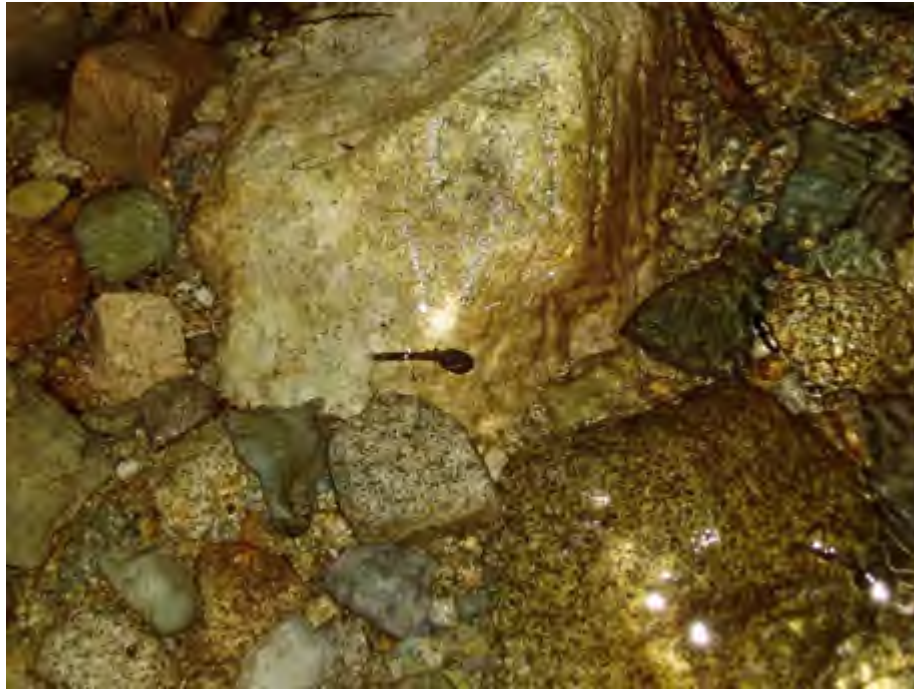
Photo 17: Coastal tailed frog tadpole captured from a pool along Godman Creek, above Eagle Lake Road, after being released (June 26, 2006).

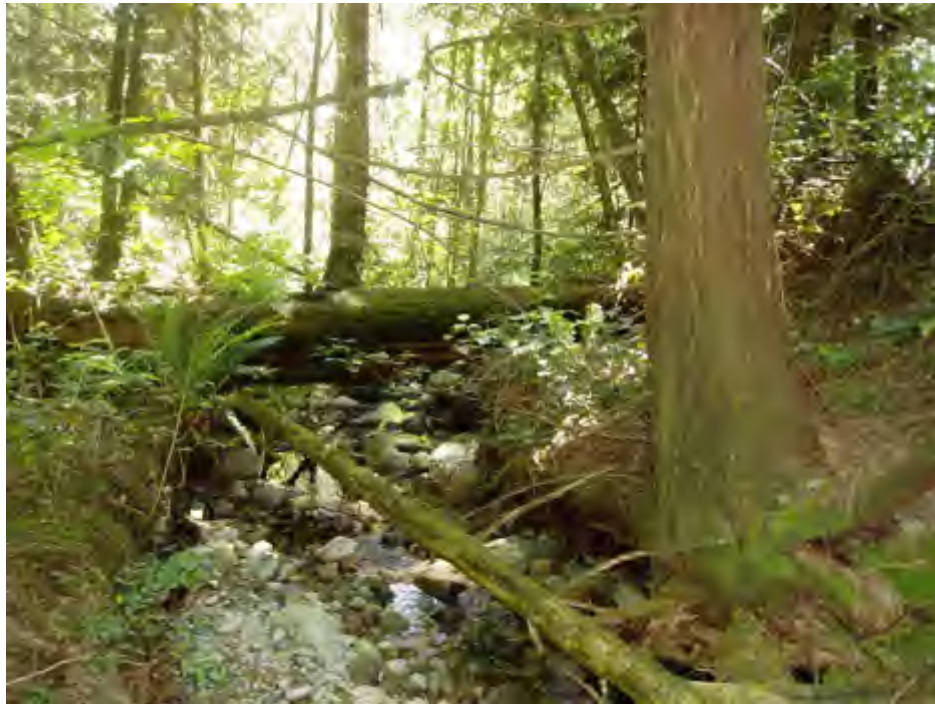
Photo 18: Habitat along upper Godman Creek in which the coastal tailed frog tadpole depicted in Photos 16 and 17 was found (June 26, 2006).

Two at-risk species of frog, the coastal tailed frog and the red-legged frog, have been found within the ISMP study area. The coastal tailed frog has been found along Tributary N of Pipe Creek and along the mainstem of Godman Creek, above Eagle Lake Road. The red-legged frog has been found near the wetland along Godman Creek, below Eagle Lake Road.
