**APPENDIX A**  
**Shoreline Walk & History**

### **3 Shoreline Walk - Geology, Ecology and History of West Vancouver Shoreline**

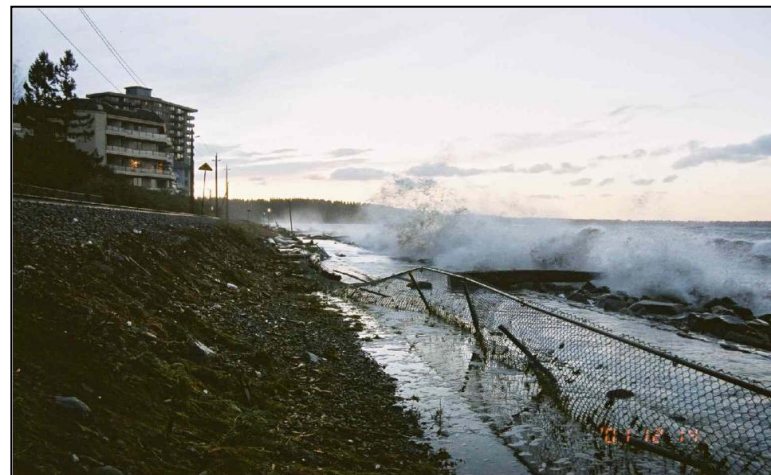
Along a developed shoreline such as West Vancouver, sand dunes and rocky cliffs have been replaced with hard-faced concrete sea walls to protect developments. Instead of absorbing or dissipating wave energy and suction load, hard-faced structures reflect waves back down the shore. The deflected waves, aided by gravity, carry more sediment as

they travel down the sloping shore to deeper waters. As this process continues and more sediment is lost from the upper shore, the beach loses its natural slope and no longer slows waves as they approach. The waves reach the concrete sea wall with greater force and are therefore deflected with even more energy, and so the cycle escalates. Eventually waves may erode the beach to a point where the structure of the sea wall itself is undermined and no longer able to effectively protect the shoreline.

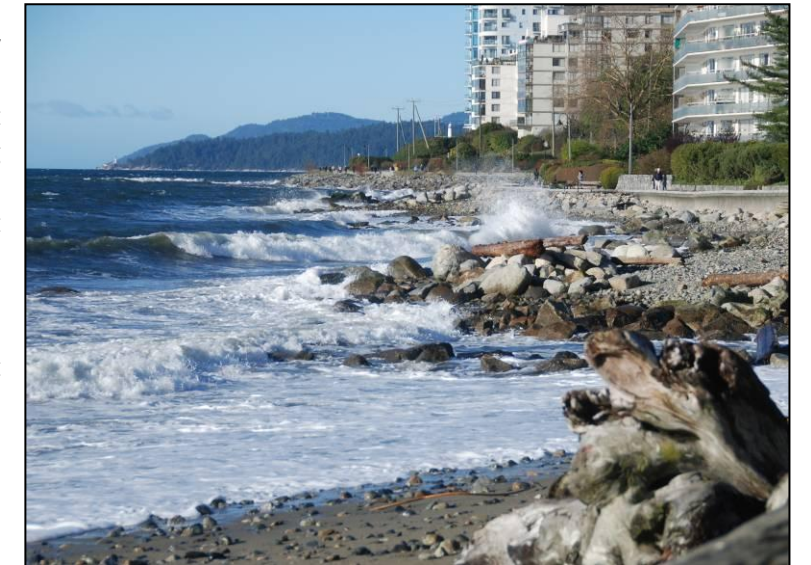
The West Vancouver shoreline is particularly vulnerable to longshore drift, which occurs because the waves approach the shore from the Strait of Georgia at an oblique angle. Waves typically move laterally along the beach from west to east, carrying fine sediments along the shoreline until they reach a structure that blocks their path causing them to settle or until there is no more shoreline and they drift to deeper waters. Rocks, groynes, piers and wharves can create a stable toe along the shoreline, interrupting long-shore drift and trapping sediments thereby preventing beach erosion upstream. However, a misplaced structure will cut off sediment supply to the rest of the beach, causing erosion downstream.

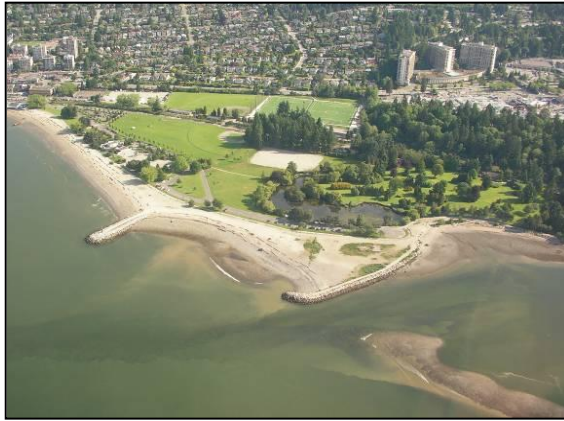
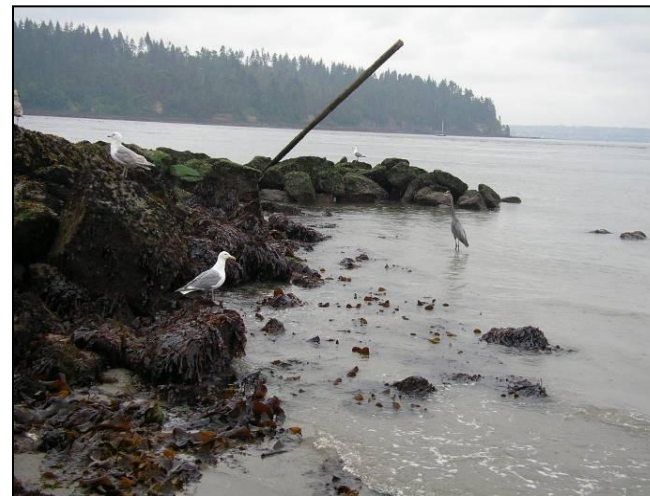
In 1965, in response to erosion at Ambleside Recreational beach, sand and cobble were removed from the mouth of the Capilano River and used to nourish the upper shore. Two rock groynes were constructed in 1987 in a further attempt to preserve the beach, however continued gradual erosion at the site warranted a detailed review of the structures and the local coastal processes. In their 2005 assessment, the EAC noted that the toe of the groynes extended only to the low water level, providing little protection to the lower shore. The pilot project to enhance the shoreline protection and habitat features was first conceived in 2006, with work beginning in 2007. As per the suggestions of the EAC, the design involved the placement of rock at the nose of the

At Capilano Groyne (see drawing 5321-D-01.1) boulders were positioned at the end of the existing toe, lengthening the groyne and creating a more gradual slope. Extending the groyne in this manner stabilized lower shore sediments and the partially buried boulders also acted as wave trips. The subtidal boulders provided a stable surface on which kelp, other algae and invertebrates could grow, creating valuable fish habitat and a dynamic, biological coastal defence system. At Totem Groyne (see drawing 5321-D-02.1), large boulders were used to create a 1 m high subtidal algae wall to extend the toe of the groyne, encourage near-shore sediment transport and provide optimal conditions for algae growth and critical fish habitat.

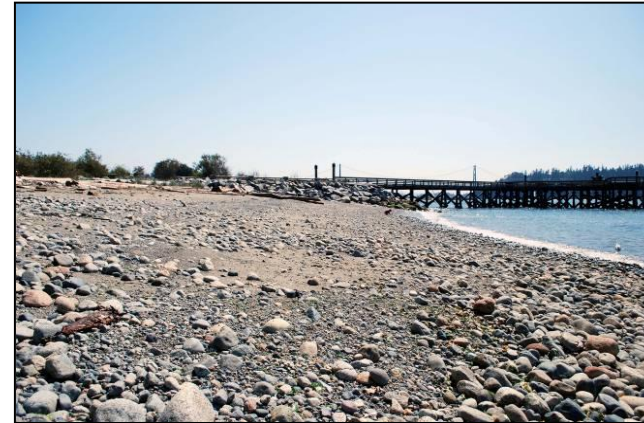
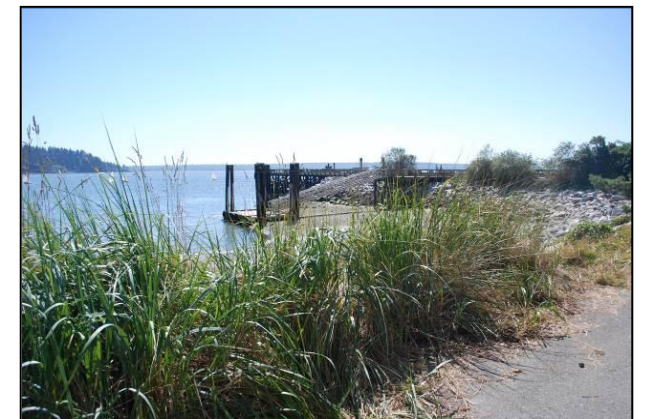
Long-shore drift has caused the continued deposition of sand and cobble on the 'overfull' beach on the west side of Ambleside Pier, the sediments leaked from the tip of the beach and filled the embayment to the east, but were too fine to form a stable beach below the armour rock. Chronic infilling impeded safe public access to the boat ramp and float.

To stabilize fine sediments on the upper shore rocks were reclaimed from the existing riprap wall and positioned in the low intertidal and subtidal zone creating a drift sill. The rocks also provided stable habitat for kelp, algae invertebrates and fishes. Some rocks were repositioned around the Vinson Creek outflow to optimize freshwater input to the mussel beds.

In 2009, access to the boat ramp and float was restored by removing the sand and cobble infill. The material was used to construct new habitats along the upper shore between 15<sup>th</sup> Street and Lawson Pier (see following sections). In addition to this, the riprap wall between the boat ramp and float access was reconstructed to create a habitat bench for colonization by riparian plants.

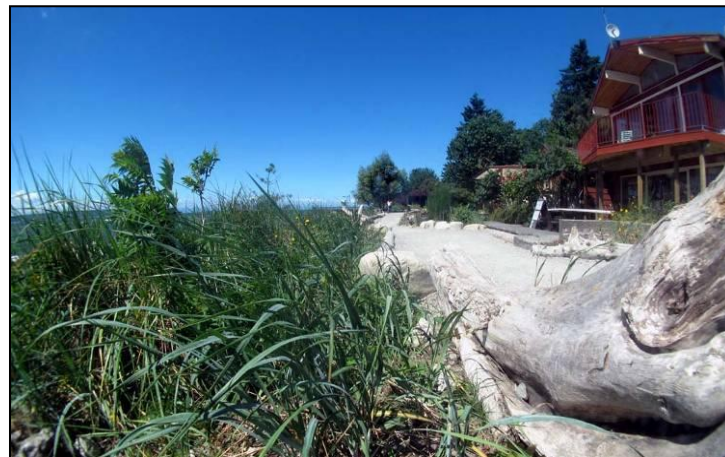
A significant stretch shoreline between Ambleside Pier and Lawson Pier was fronted by concrete sea walls and private residence. The hard-faced sea defences at the back of the beach had contributed to wave driven erosion. Public access to the beach was greatly impeded by private property and a narrowing shoreline. Lawson Pier (see Section 5.4) obstructed the transport of sediments from the west and existing sediments were carried east to Ambleside Pier. Two broken concrete culverts surfaced mid shore, creating an unsightly physical obstruction on the mid-shore.

Private properties along the sea front were purchased by DWV for the purposes of waterfront regeneration. Public access across the site was greatly improved by the removal of concrete sea wall sections and construction of a naturalized footpath along the upper shore between 15<sup>th</sup> street and Lawson Pier. The pathway was protected by logs and large boulders; salt marsh habitat was created alongside to provide additional protection, stabilization of sediments and creation of valuable natural habitat. Reclaimed sand and cobble from the dredging of Ambleside boat ramp was used in the enhancements and to nourish the upper shore.

The concrete culverts were removed and replaced by boulders to reduce scouring and dissipate the fresh water flow across the mussel beds. The boulders also acted as mid-shore wave trips to prevent waves from reaching the remaining hard-faced sea walls. Patches of intertidal habitat boulders were positioned along the lower shore to act as tombolos, interfering with long-shore drift and trapping sediments along the mid shore.

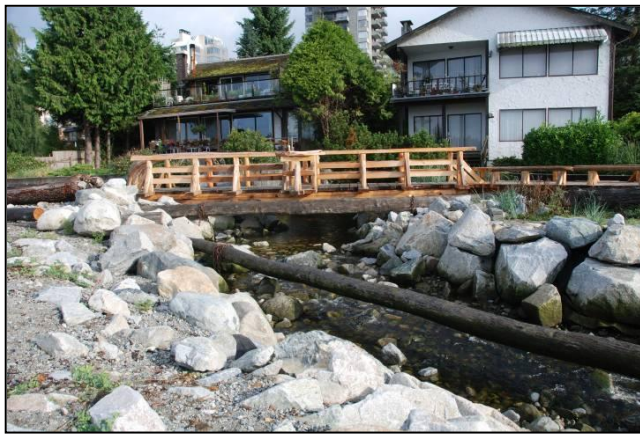
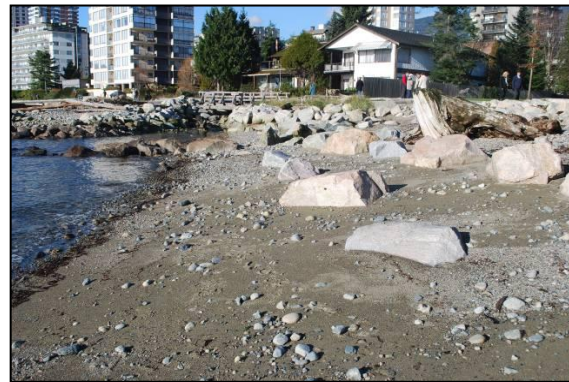
Bordered on either side by residences, Lawson Creek was boxed in by hard-faced concrete sea walls. The creek outflow fed onto a low profile beach, during rain events high velocity flows caused considerable scour along the channel and beach. The sediments transported in the creek were carried out to sea with little retention on the upper shore. The low-profile cobble and pebble beach offered little natural resistance to waves and the lack of stable substrate resulted in diminished intertidal habitat for invertebrates and algae.

The hard-faced concrete sea walls were replaced with an elevated upper shore, irregular riprap sea defences and high value salt marsh habitat. A new trail was created along the upper shore providing access from John Lawson Park to the foreshore and across the site. A footbridge was constructed across the creek in 2008, providing safe access across the creek and protecting the creek from disturbance with support from the Lanskaill Fund.

The creek channel was stabilized with large riprap and which directed the flow laterally along the shore to promote the retention of sediments for beach nourishment. Logs and boulders were carefully placed to create riffle pools and shelter for fish, providing ideal habitat. Large boulders were dug in to the lower intertidal zone as wave trips to protect the upper shore and provide large stable attachment points for algae, and marine invertebrates.

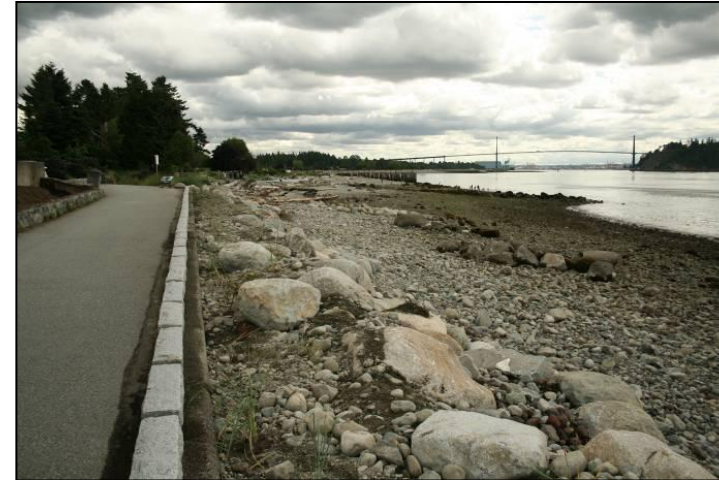
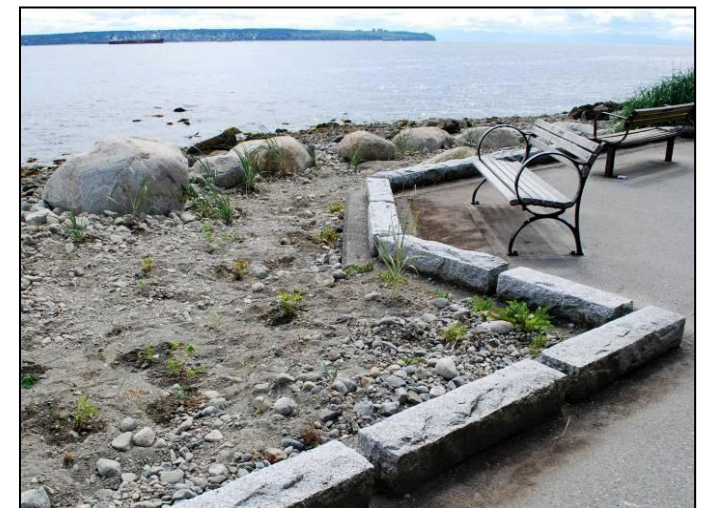
A hard-faced concrete sea wall fronted the centennial Seawalk along the upper foreshore between Lawson Creek and McDonald Creek. The low profile cobble beach offered little natural resistance to waves and wave erosion posed a threat to the shoreline and structural integrity of the sea wall. The low profile beach and sea walk restricted access to the beach to two points. Small pockets of dune grass and salt marsh grew on isolated patches of upper shore with little room for available expansion.

Large habitat boulders were strategically positioned along the lower and mid- intertidal to create valuable habitat for algae and marine invertebrates along an otherwise unstable shoreline. The boulders were partially buried to act as wave trips, preventing waves from striking the concrete sea wall and reducing anthropogenic wave erosion. To improve the upper shore habitat the existing riprap was re-worked to increase the salt marsh habitat bench, allowing the dune grass patches to spread naturally. This salt marsh habitat was initially focused around the seating areas to create aesthetically and ecologically valuable habitat pockets, to increase public access to the foreshore and encourage public engagement with the shoreline.

In 2011, the DWV obtained a large amount of native rock from a construction project in the British Properties. The boulders were used to construct additional shoreline protection features. Following successful establishment of the dunegrass bench, some of the newly obtained boulders were used to extend the easterly dunegrass bench the full length of the sea wall. The bench was planted with dunegrass, beach pea, western dock and sea lupine to create high value riparian habitat to further increase biodiversity and aesthetic value at the site, while replacing the hard-faced sea wall with soft shoreline protection.

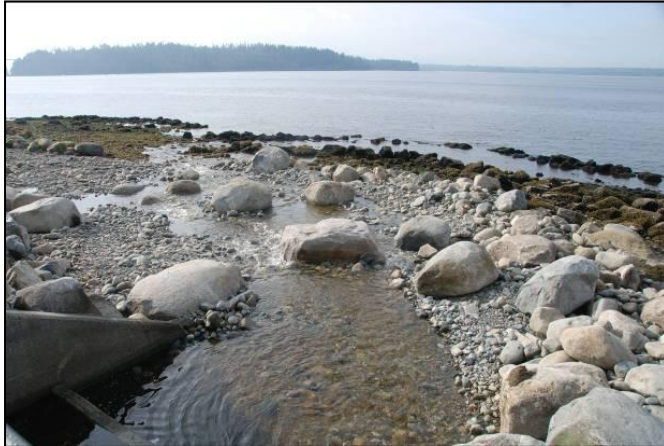
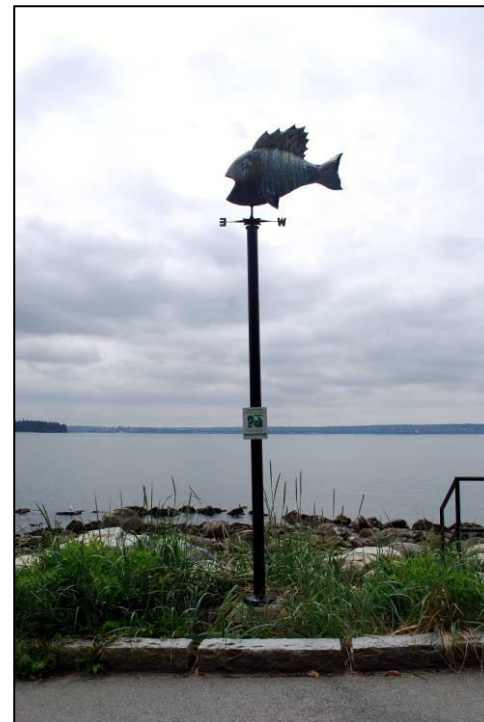
Like Lawson Creek, McDonald Creek and bypass are the primary sources of sediments to the foreshore west of the Capilano River. However, with the urbanization of West Vancouver much of the riparian watershed was removed and the creek was redirected through culverts. The creek and bypass outflows were directed on to the mid shore through a box culvert, and high velocity flows caused significant scouring of the beach. The hard-faced sea wall was covered with large riprap, which prevented safe access from the Seawalk to the foreshore. A lack of stable material along the foreshore provided little habitat for algae or invertebrates.

Surplus rock was taken from the riprap wall along the upper shore, and used to create habitat features and structure the creek and bypass flows. The creek was re-directed laterally across the shoreline to promote the retention of sand and gravel along the upper and mid shore. Following the shoreline enhancement works, a single heavy rainfall event in 2007 produced 100 truckloads of sediments which were retained on the upper shore and naturally distributed along the beach to Lawson Pier

The relocated boulders also served as wave trips, breaking waves along the lower shore to protect sediments along the upper shore. They also provided large, stable attachment points for rockweed, sea lettuce, barnacles, mussels and other marine species, improving the biodiversity of the site. Signage was created above the creek outflow which, along with a colourful art installation created by local school children, created a point of interest to engage the public with the natural environment and raise awareness of the importance of protecting fish habitat.

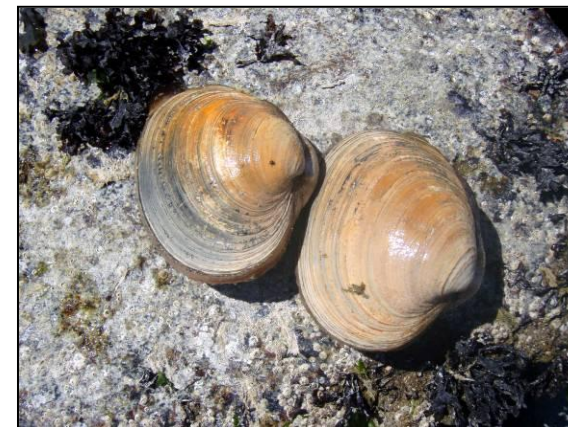
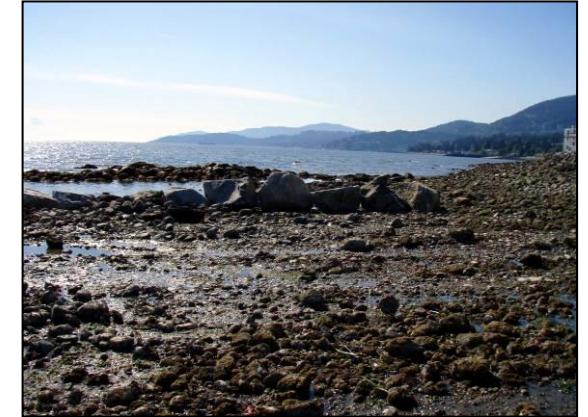
The enhancement features installed at Navy Jack Point increased the productive capacity of the site by strategically positioning boulders to provide suitable hard substrates for colonization by kelp, to create valuable fish habitat and stabilize fine sediments to protect eelgrass. The subtidal reef also created a stable toe, securing sediments along the shoreline to the west of the point, and provided wave protection for the sea wall. Because of the existing biodiversity the goal was to create features that would easily blend into the existing shoreline.

The boulders were placed to create a drift sill running perpendicular to the shoreline. The drift sill extends from the lower intertidal to the subtidal zone, creating habitat suitable for a wide range of species with differing requirements. Surveys conducted several months later found that the habitat feature had quickly become amalgamated into the existing habitat and exhibited 95% barnacle and mussel coverage, in addition to algal growth.

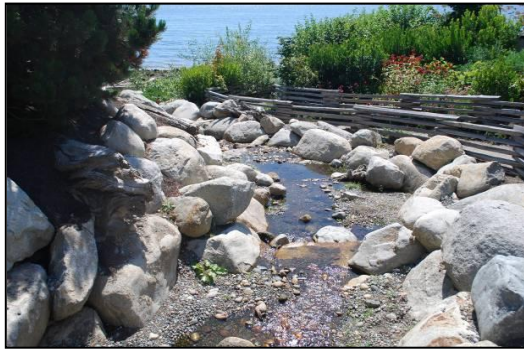
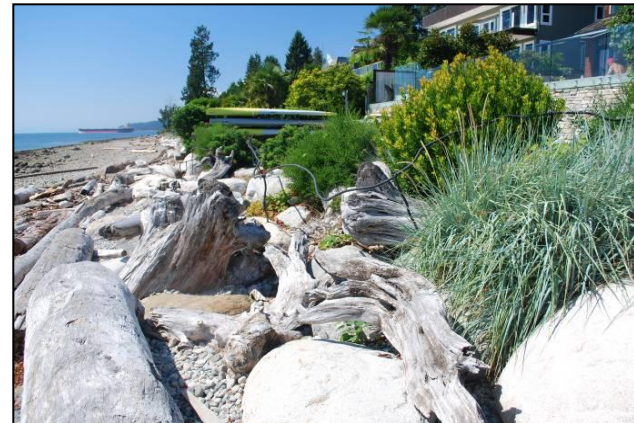
Shoreline enhancement works at the 27<sup>th</sup> Street foreshore were another private-public partnership. The foreshore had experienced considerable erosion leaving a low profile cobble shoreline. A sub-surface culvert outflow onto the foreshore contributed to beach erosion along the mid shore and the concrete sea walls of the private residences fronting the shoreline had amplified wave erosion. A construction project at the site provided an opportunity to improve and restore the shoreline by replacing the hard-faced concrete sea walls with a more naturally protective, irregular shoreline and significantly improving the natural habitat and biodiversity.

The sub-surface culvert was 'day-lighted' which allowed the design of a creek bed and high value habitat feature. The channel was elevated and logs and boulders were used to create riffle pools which stepped the stream down to the foreshore. The creek was channelled into an S-shape to reduce the flow rate and promote the retention of sediments on the upper shore. The existing invasive vegetation was removed and native riparian habitat was planted along the banks of the stream and the upper shore. The steep footpath to the shore was replaced with a snaking trail, which followed the curve of the new stream to create a gentle gradient. The salt marsh habitat and stream were protected from pedestrian traffic by a wooden split rail fence and seating was added at the edge of the pathway.

The upper shoreline was elevated and the riparian habitat bench was extended in front of the properties neighbouring the creek. Large riprap and anchored logs were strategically positioned to protect the salt marsh, upper shore and property from waves. Drift sills and tombolas were constructed along the mid-shore to guide and trap sediments along the upper shore. Wave trips along the mid- and lower shore provided improved protection from wave erosion and impacts while providing stable substrate for colonization by algae and invertebrates. A subtidal reef (see 5147-D-01.1 and 5151-D-01.1) was created to provide stable substrate for nearby kelp beds, creating fish habitat and improving shoreline defences.

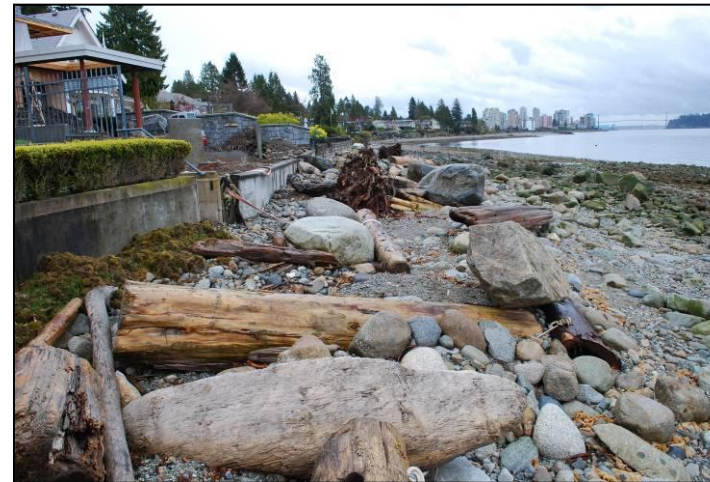
The re-development of 2854 Bellevue Avenue created an opportunity for privately funded shoreline restoration work along the intertidal zone and upper shore and at the Rodgers Creek outflow. The creek is recognized as potential salmon habitat although no spawning salmon have been observed in the creek since 2006, despite fry releases in the late 1990's and 2000. The Pacific Stream Keepers Association (PSKA) considered channelization of the creek and its effect upon the flow rate as one of the major concerns (PSKA, 2009). The shoreline had experienced significant erosion, and primarily consisted of unstable cobble substrate with some mussel and green algae coverage; hard-faced sea walls along the upper shore had

The property owners at 2854 and 2860 Bellevue Avenue funded restoration works to replace the hard faced sea wall with soft shoreline protection measures along the upper and lower shore, and in front of Rodgers Creek. Specially placed boulders and large woody debris were positioned in front of the sea walls of the three properties west of Rodgers Creek. By creating wave trips and elevating the upper shore they disrupt wave energy and preventing overtopping of the sea wall and erosion. Native riparian vegetation will be planted between the wave trips and the sea wall where there is sufficient space. Large boulders were placed along the lower shore to create an intertidal reef, providing additional wave protection as well as increased habitat for algae, invertebrates and fish.

At the mouth of Rodgers Creek large boulders were positioned along the lower intertidal zone and backfilled with cobble to create an elevated berm. The berm will improve wave defenses, provide stable substrate for colonization by algae and invertebrates, and disseminate fresh water flow over an increased area of the intertidal zone support algae and invertebrate populations. The feature will also prevent channelization at the creek outflow, creating a staging pool for spawning salmon, improving accessibility of the creek.

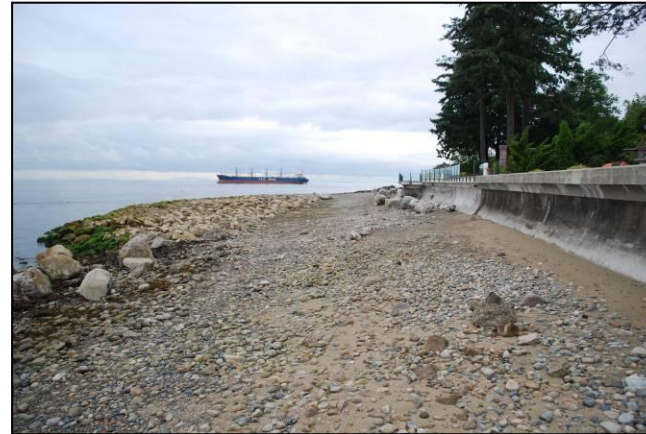
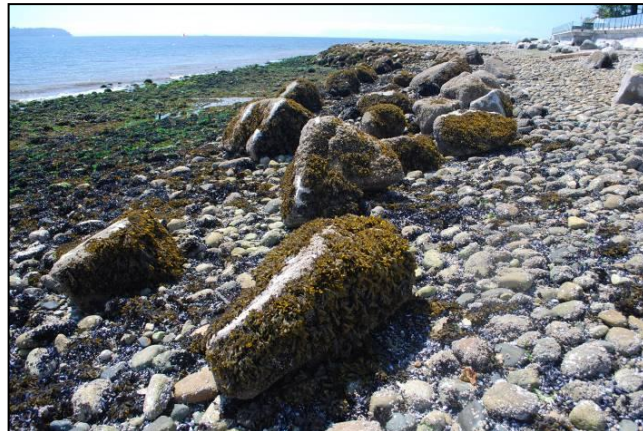
The existing shoreline was bordered by the private residences of Ferndale Avenue and Evergreen Avenue; concrete sea walls constructed to protect the properties contributed to wave erosion. The erosion had exposed the sewer system infrastructure at the site making it vulnerable to damage. The beach was low profile and primarily cobble, with few fine sediments; a small patch supported by dune grass existed along the upper shore to the east of the site, but was vulnerable to erosion. The lower intertidal and subtidal zone had some coverage by barnacles, muscles, rockweed and green algae however a lack of large substrates reduced habitat available to broad-leaf algae and fish.

The old sewer pipe and manhole had become compromised due to beach erosion and wave impacts, the pipe and manhole were replaced. An elevated berm was created along the mid shore in front of 4270 Evergreen Avenue to trap and retain fine sediments on the upper shore. The berm was constructed using reclaimed materials, natural beach cobble and logs which were securely anchored. The seaward edge of the berm was lined with large riprap boulders for stability, to create improved wave protection for the upper shore, and to create stable lower intertidal habitat for algae, invertebrates and fish. The berm was designed to be constructed in four phases expanding eastwards along the mid-shore, with each extension blending into the previous, eventually running the extent of the concrete sea walls.

Additional large boulders were partially buried along the upper shore. In front of the sea wall, to stabilize fine sediments and provide improved wave protection by 'tripping' waves and diffusing wave energy before they meet the sea wall. Post-construction surveys have recorded increased sediment retention on the upper shore and almost complete coverage of the intertidal habitat boulders by invertebrates and algae.

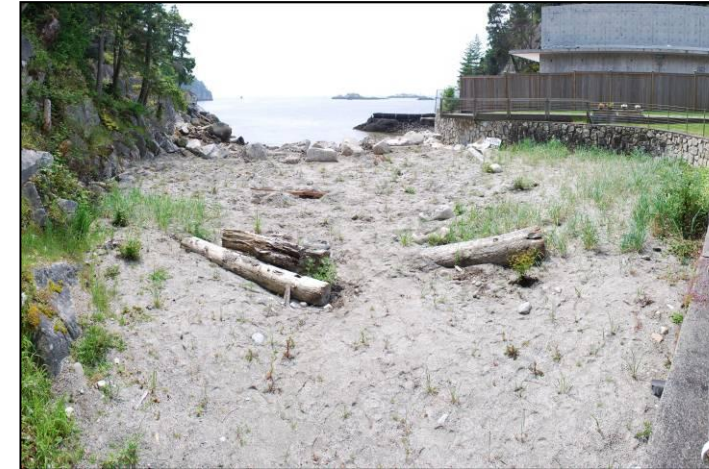
The shoreline enhancement and protection works at Seaside Place were also privately funded. The shoreline forms a natural south-east facing embayment, encircled by steep granite bedrock cliffs. The three inner properties have concrete sea walls which had amplified wave erosion leaving a low profile shoreline that became jammed with logs and debris.

After the first winter season the upper shore features were adjusted. The salt marsh was further elevated, extended towards the mid-shore and planted with Nootka rose and ocean spray to increase the biodiversity. The riprap drift sill and berm were dismantled; the rock was placed along the mid shore and covered with cobble to increase the beach profile. Large boulders were partially buried along the lower shore as wave trips and to create valuable subtidal habitat for fish, algae and invertebrates.

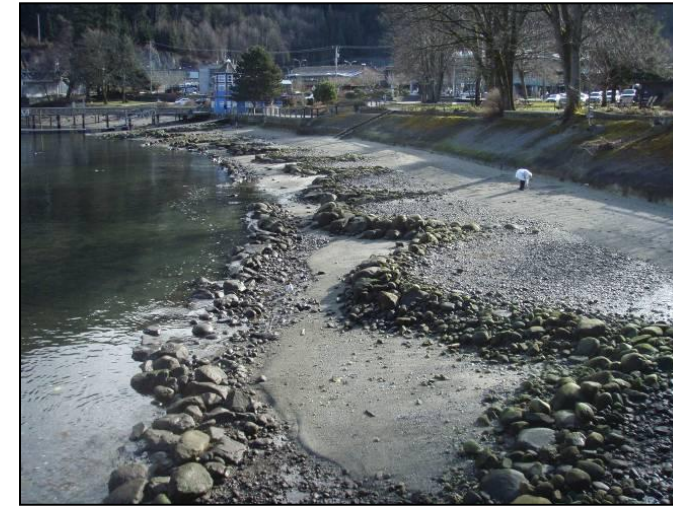
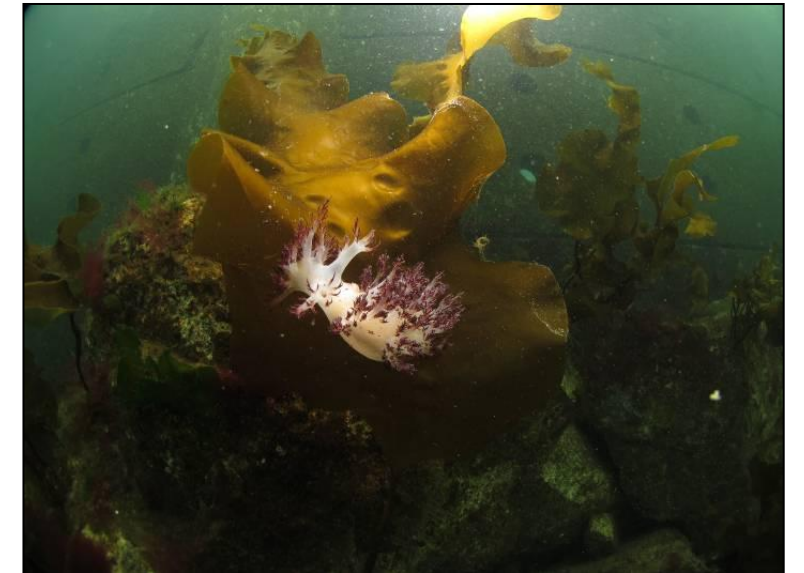
The shoreline enhancement works at Horseshoe Bay represented the first corporate partnership stemming from the SPP and pilot projects. The works were conducted as mitigation and compensation for works at the BC Ferries Terminal. The shoreline at Horseshoe Bay is a popular public amenity with a sandy beach, marina and busy ferry terminal.

Fine sediments were used to rebuild the upper shore and increase the beach profile and a series of nine semi-circular berms were constructed along the mid shore to stabilize the upper shore and trap new sediments. The berms were filled with cobble, with larger boulders positioned around the edge to reduce wave impacts on the upper shore and provide intertidal habitat for various species. Partially buried boulders were placed along the lower shore to protect the upper shore from waves and create additional attachment opportunities for invertebrates and algae. Boulders were used to reduce the flow rate of the culvert outlet on the beach to reduce scouring and to disseminate fresh water across the intertidal zone. A kayak access point was constructed on the foreshore and the area of infill in the marine was dredged to create safe boat access to the moorage facilities.
