# VINSON RESIDENCE

1425 GORDON AVENUE,  
WEST VANCOUVER

CONSERVATION PLAN

APRIL 2016

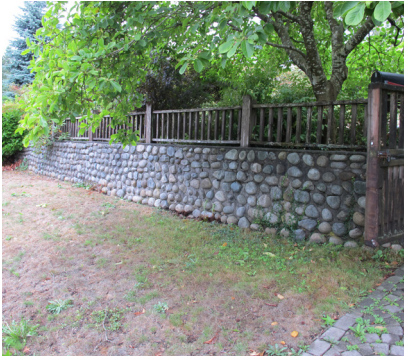
<p><b>Rehabilitation</b></p> <ul style="list-style-type: none"> <li>Relocating the house further from the lane will increase the visibility of the heritage house, while preserving the intent of the Vinson Residence's deeper setback from the street than the neighbouring houses.</li> </ul>
<p><b>Later stone wall with wood top rail, garage</b> There is a later stone wall with an upper wood top rail near the front of the property. The wall, and existing garage at the rear of the site have no heritage value and may be demolished.</p>

<p><b>Rehabilitation</b></p> <ul style="list-style-type: none"> <li>The existing stone wall with wood railing is not original and may be preserved or removed.</li> <li>The later stone wall with wood railing may be replaced with a new fence, or other landscaping feature that is distinguishable from, but compatible to the historic character of the site.</li> <li>The garage may be demolished.</li> </ul>

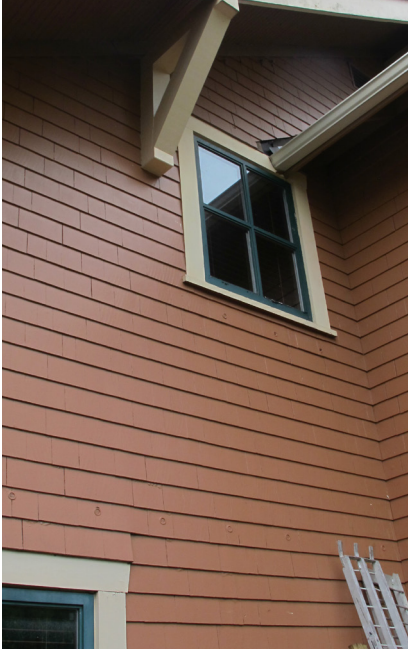
<p><b>Preservation &amp; Rehabilitation</b></p> <ul style="list-style-type: none"> <li>• Preserve the original wood-frame structure of the 1921 building.</li> <li>• Design structural and seismic upgrades from the inside, where possible, without impacting interior character-defining elements that are to be protected.</li> <li>• Utilize Alternate Compliance Methods outlined in the VBBL for fire and spatial separations including installation of sprinklers where required.</li> </ul>
<p><b>Original wood cladding</b> The original cedar shingle cladding is still extant, and generally in good condition.</p>

<p><b>Preservation &amp; Rehabilitation</b></p> <ul style="list-style-type: none"> <li>• Preserve and repair the original cedar shingle cladding on the front facade in-situ.</li> <li>• Preserve and repair original cedar shingle cladding on the west and rear elevations in-situ, if possible.</li> <li>• Due to fire separation issues, the original cedar shingles on the east elevation must be replaced with non-combustible cladding. This will involve implementing a rainscreen and new shingle-style cladding to match the original shingles closely.</li> <li>• If not possible to retain the original cedar shingle cladding on the west and rear elevation, the strategy for the east elevation should be used on the west and rear elevation.</li> </ul>

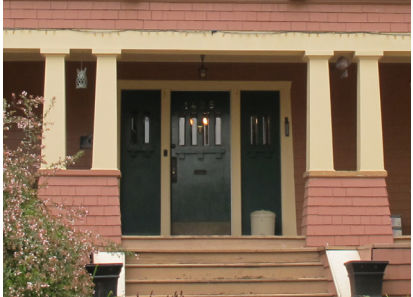
Item	Image	Conservation Recommendations
<p><b>Original porch columns</b> The front porch features eight square, tapered wood columns with simple capitals, in paired and triple groupings.</p>

<p><b>Preservation</b></p> <ul style="list-style-type: none"> <li>• Preserve the original square tapered wood porch columns of the Vinson Residence in situ, if possible.</li> <li>• If the porch is disassembled during relocation then the columns should be placed back in their original locations after relocation.</li> </ul>
<p><b>Balustrade and handrails</b> The original porch balustrade has been removed in places, but was still on site at the time of the visual review. The stairs feature low side walls with no handrail.</p>

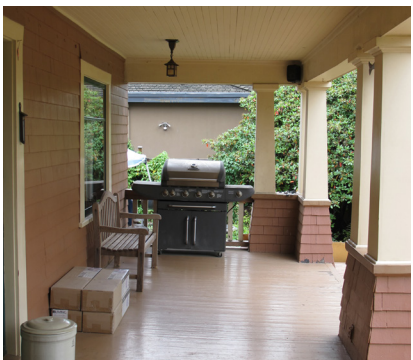
<p><b>Porch decking and soffit</b> The original tongue-and-groove porch decking and soffit are still extant. The decking runs perpendicular to the front facade, and the soffit runs parallel.</p>

<p><b>Preservation</b></p> <ul style="list-style-type: none"> <li>• The original tongue-and-groove porch decking and soffit should be preserved.</li> <li>• If the porch is disassembled during the relocation of the house, the tongue-and-groove porch decking and soffit should be reinstated. The porch decking should run perpendicular to the front facade, and the porch soffit should be parallel to the front facade.</li> </ul>

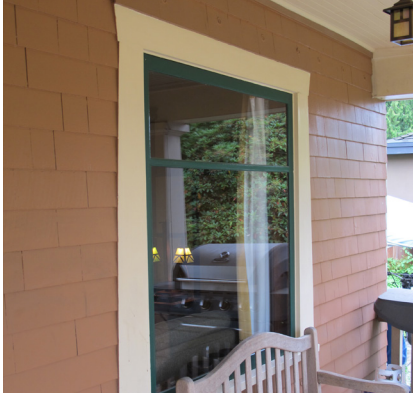
Item	Image	Conservation Recommendations
<p><b>Original windows</b> Original window assemblies include: bipartite casements divided by thin wood muntins into four lites of true-divided glass; bipartite casements with clear fields of glass; double-hung 1-over-1; and fixed.</p>

<p><b>Preservation</b></p> <ul style="list-style-type: none"> <li>• An initial visual review suggests the original windows to be in good or repairable condition.</li> <li>• Preserve and repair the remaining original windows of the Vinson Residence using the guidelines on the following page.</li> <li>• Original sleeping porch casement windows may be relocated on the sleeping porch wall.</li> </ul>
<p><b>Later windows</b> Most windows of the Vinson Residence have been replaced over time. Later windows may be replaced with new double-glazed wood windows.</p>

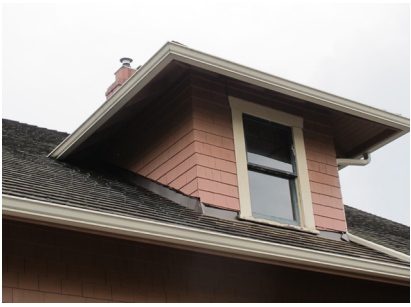
Item	Image	Conservation Recommendations
<p><b>Existing roof</b> The roof was recently replaced and appears to be in good condition after a brief visual review from the ground.</p>

<p><b>Preservation</b></p> <ul style="list-style-type: none"> <li>The existing roof should be preserved, if possible.</li> </ul>
<p><b>Original elements</b> The roof features original wood brackets, bargeboards, raftertails and tongue-and-groove soffit.</p>

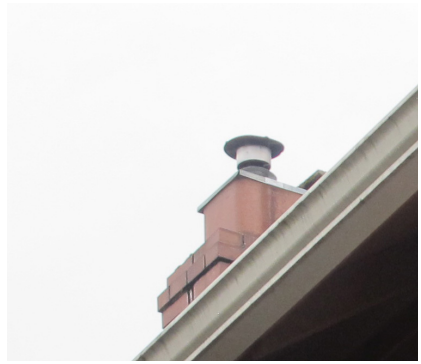
Item	Image	Conservation Recommendations
<p><b>Original internal chimney</b> The Vinson Residence features an original internal chimney with a later cap.</p>

<p><b>Preservation</b></p> <ul style="list-style-type: none"><li>• Preserve the original internal chimney. If the fireplace is converted to gas or electric, the appropriate venting should be done through the existing chimney shaft, if possible.</li></ul>

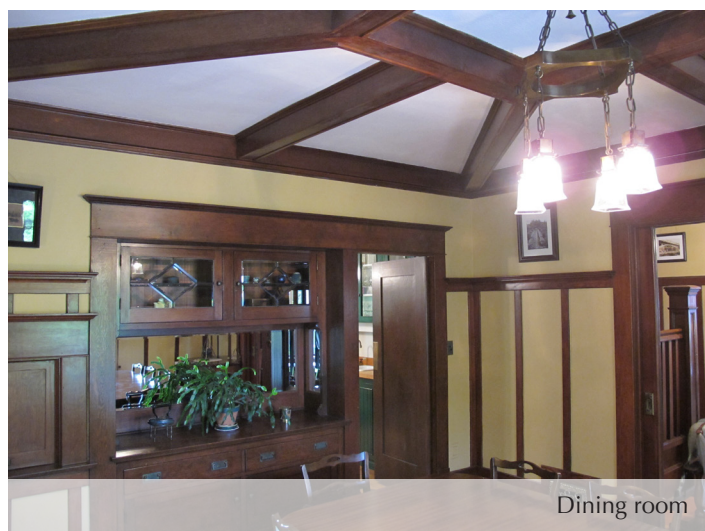
## 6.2 DINING ROOM

Description	Conservation Recommendations
<p>The intact original features of the dining room include: hardwood floors; plaster; decorative wood mouldings; wood window trim; wood swing door and pocket doors; wood ceiling beams; and built-in cabinetry.</p>	<p><b>Preservation</b></p> <ul style="list-style-type: none"><li>• The worn hardwood floors may be replaced with new hardwood floors.</li><li>• Preserve the wood pocket doors, wood ceiling beams and built-in cabinetry in-situ, if possible.</li><li>• Preserve the remaining intact original features of the hall, as possible.</li></ul>

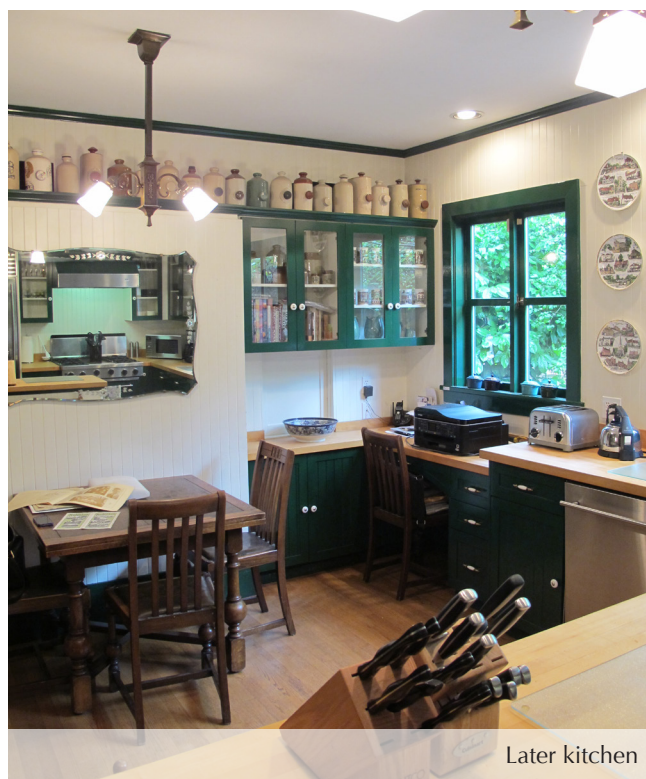
Later kitchen

Description	Conservation Recommendations
<p>The kitchen is not original, and it is not known if the hardwood floors are original. There is a Dutch door leading to the rear porch. The existing kitchen does not contribute to the heritage character of the interior, and may be replaced.</p>	<p><b>Rehabilitation</b></p> <ul style="list-style-type: none"><li>• The kitchen may be rehabilitated as necessary.</li></ul>

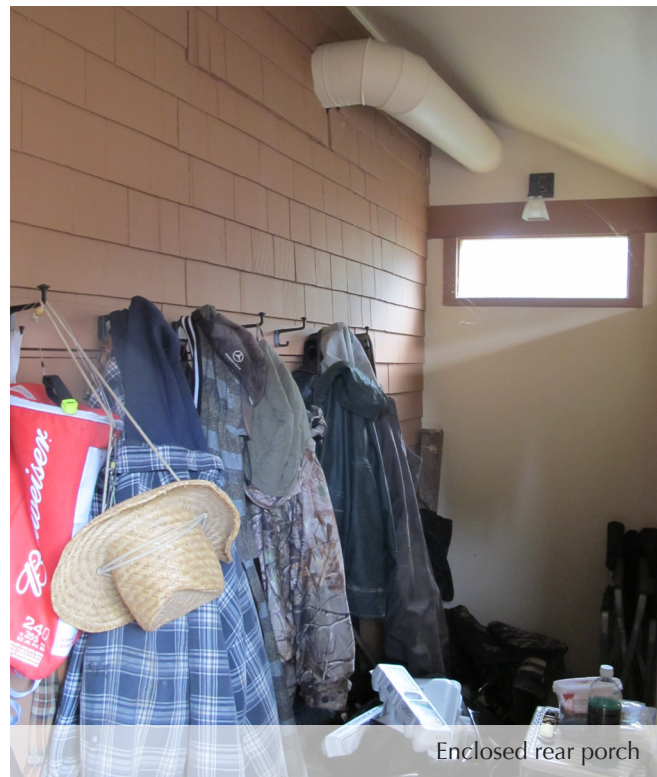
Enclosed rear porch

Description	Conservation Recommendations
At some point in time the rear porch was enclosed.	<b>Rehabilitation</b> <ul style="list-style-type: none"><li>• The rear enclosed porch may be rehabilitated as necessary.</li></ul>

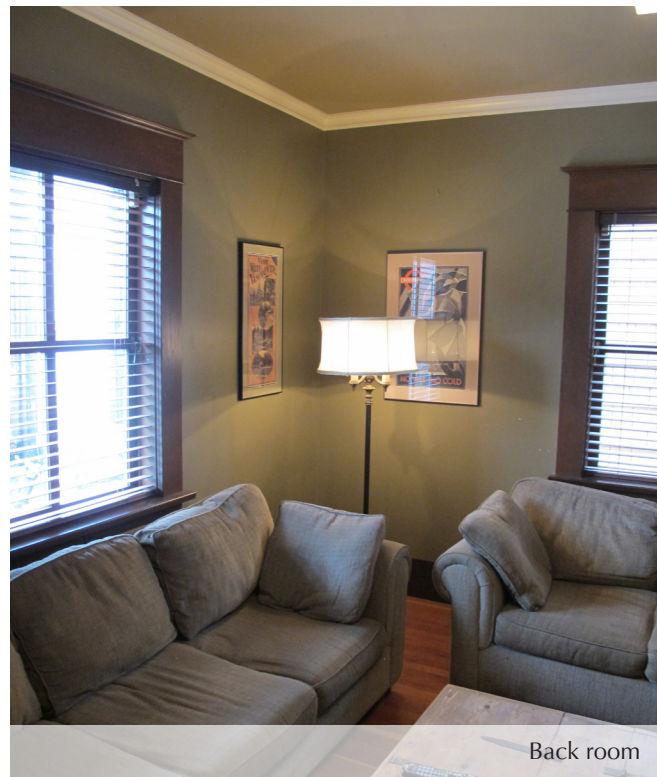
## 6.6 BACK ROOM

Description	Conservation Recommendations
<p>The intact original features of the back room include: hardwood floors; plaster; wood mouldings; and wood window trim.</p>	<p><b>Preservation</b></p> <ul style="list-style-type: none"><li>• The worn hardwood floors may be replaced with new hardwood floors.</li><li>• Preserve the remaining intact original features of the hall, as possible.</li></ul>

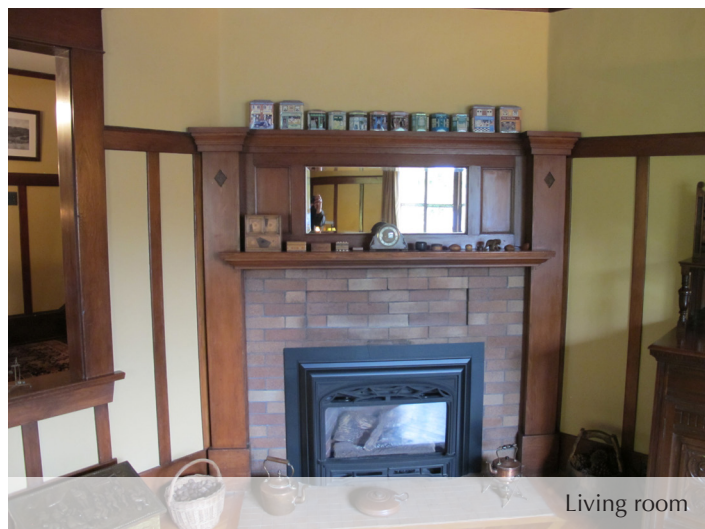
## 6.7 LIVING ROOM

Description	Conservation Recommendations
<p>The intact original features of the living room include: hardwood floors; plaster; decorative wood mouldings; wood window trim; an open entry with square tapered columns and wood beam; wood and brick corner fireplace with wood mantle and inset paneling; and a coffered ceiling with wood beams.</p>	<p><b>Preservation</b></p> <ul style="list-style-type: none"><li>• The worn hardwood floors may be replaced with new hardwood floors.</li><li>• Preserve the open entry with square tapered columns and wood beam, wood and brick corner fireplace with wood mantle and inset paneling, and coffered ceiling in-situ, if possible.</li><li>• Preserve the remaining intact original features of the hall, as possible.</li></ul>

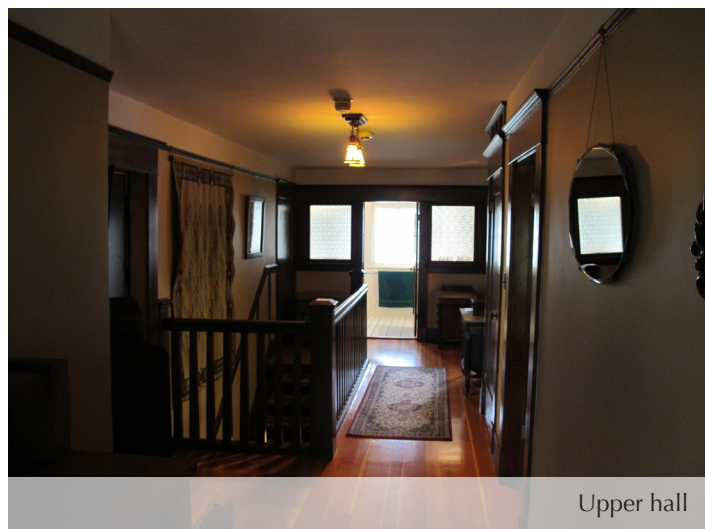
Upper hall

Description	Conservation Recommendations
<p>As part of the rehabilitation of the house, it is proposed to make changes to the layout of the upper floor.</p>	<p><b>Rehabilitation</b></p> <ul style="list-style-type: none"><li>• To maintain visual continuity from the lower floor, the balustrade around the staircase opening should be preserved, if possible.</li><li>• Rehabilitate the upper floor as necessary.</li></ul>
