DUNSTER & ASSOCIATES
Environmental Consultants Ltd.

**A Review of Forest and Individual Tree Conditions
at the Proposed Daffodil Drive Subdivision,
West Vancouver, BC.**

April 27, 2016

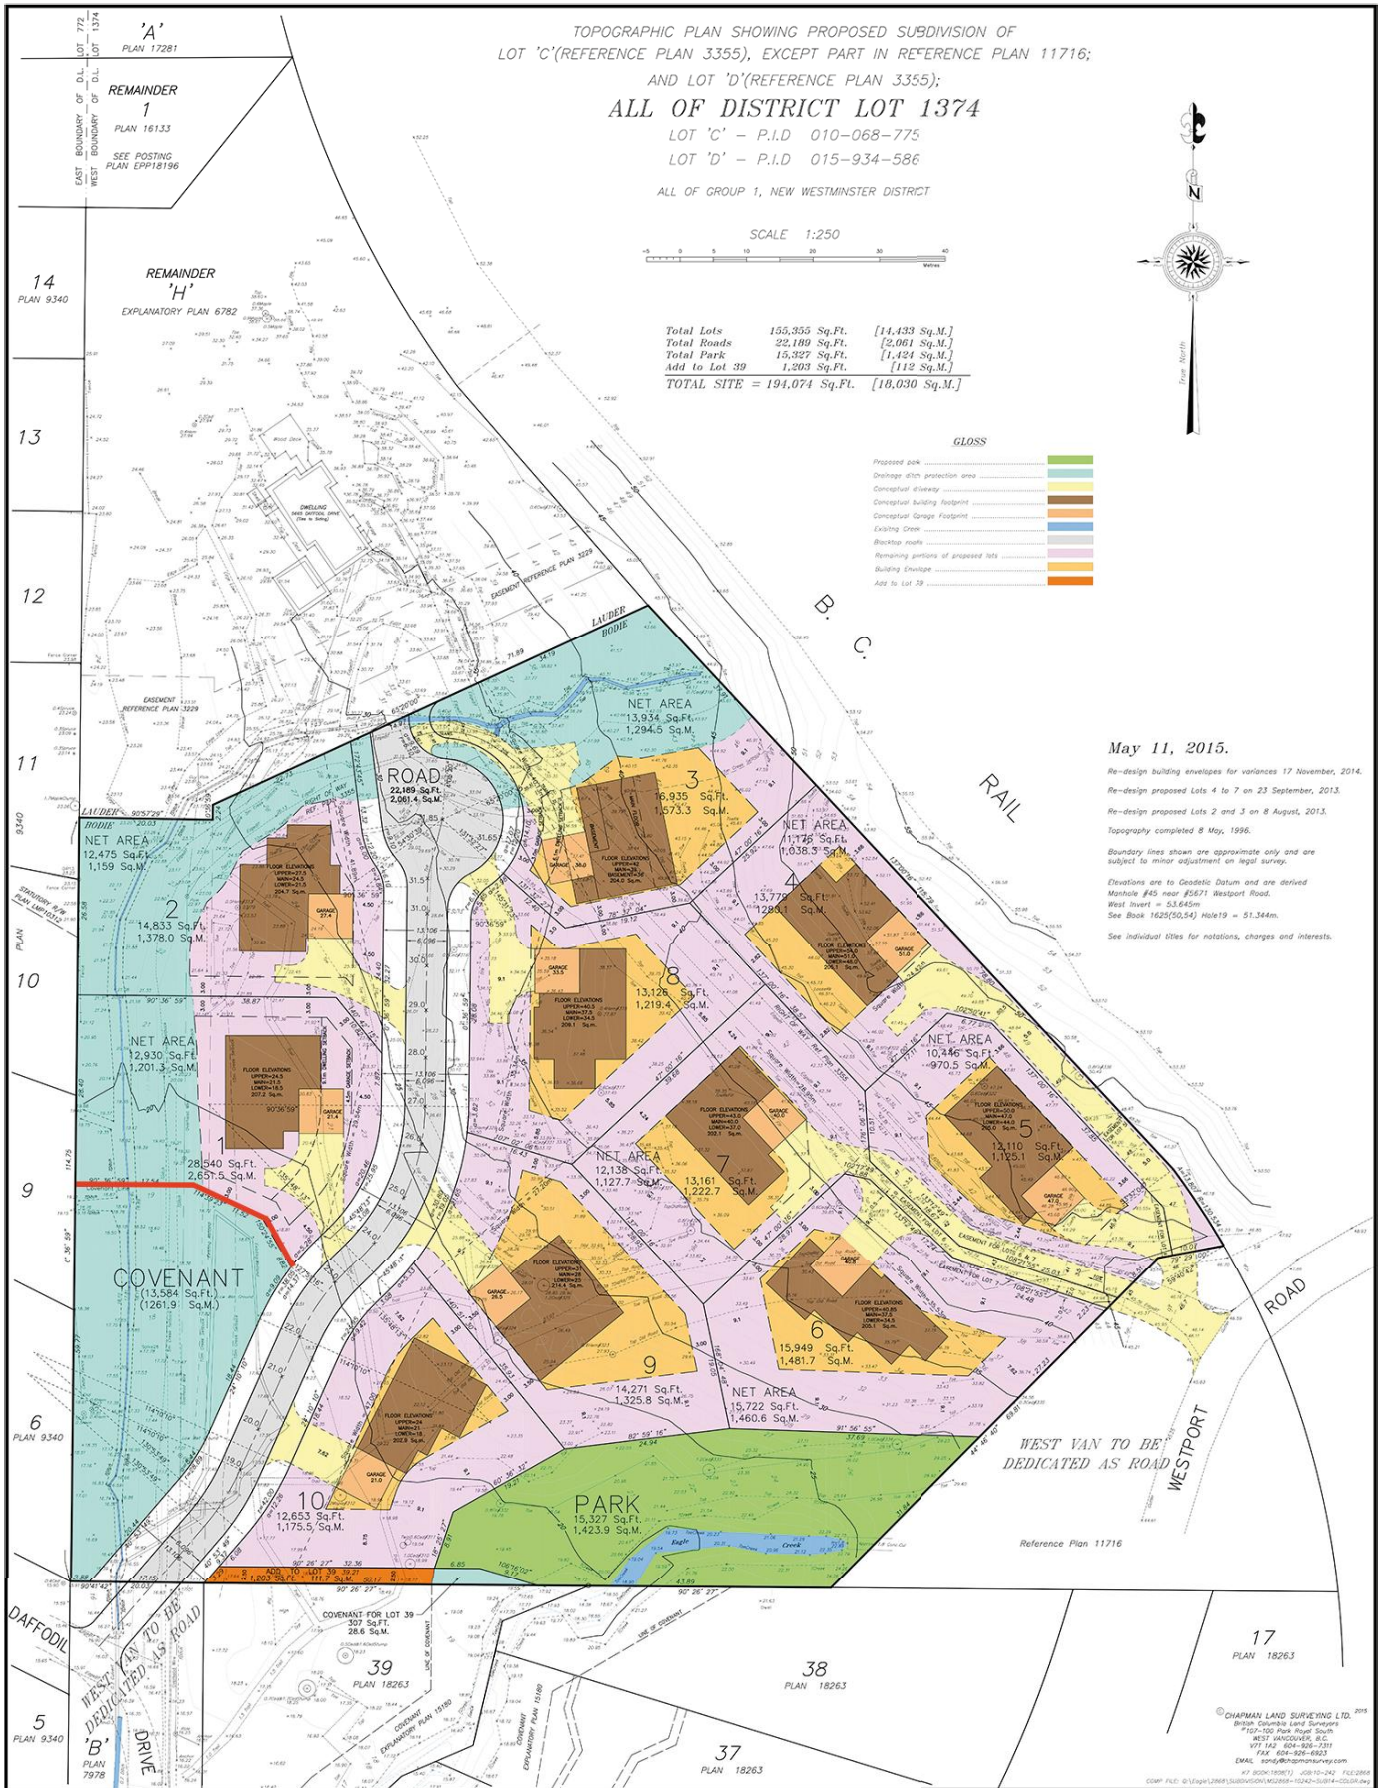
Figure 2. Proposed subdivision plan.

In figure 2, the dedicated park area seen as the green polygon at the south boundary. Along the west edge there is a covenant area (blue, bounded by the red line in the north), as well as a further area identified as 'Drainage ditch protection area' also in blue extending along the north boundary. In between the proposed building envelopes (lilac colour) are areas of land to be left relatively undisturbed.

Figure 2 shows the latest plan including proposed building footprints, building envelopes, covenant and park areas, and other potential tree retention zones.

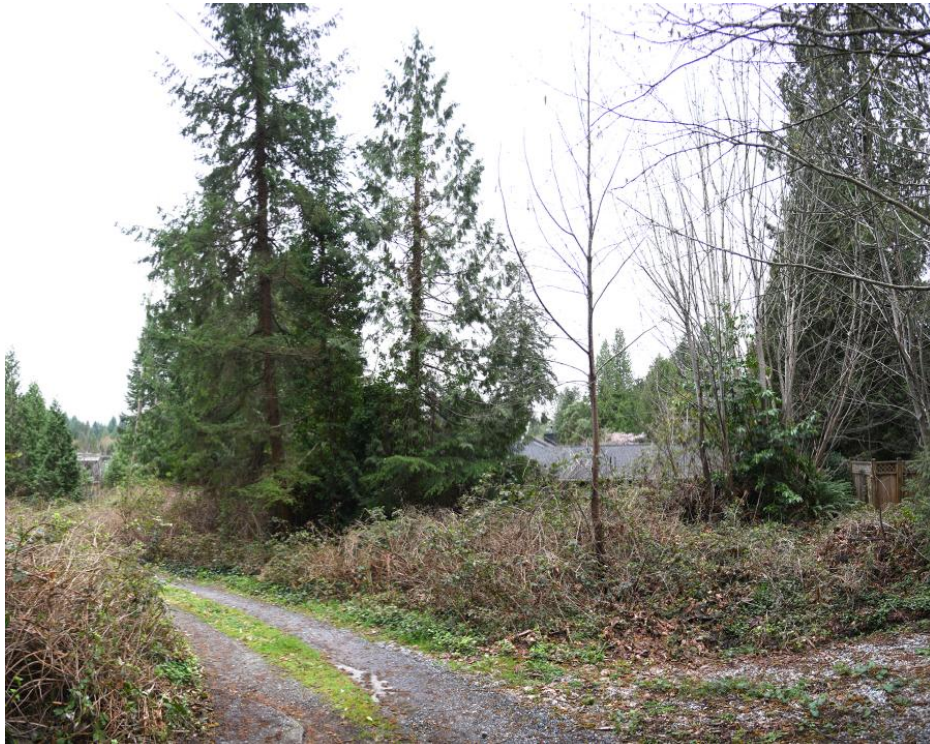
Figure 4. Upper end of existing gravel road.

Figures 4 and 5 show these areas.
