## 3.0 SITE & AREA CONTEXT

### 3.1 SITE LOCATION

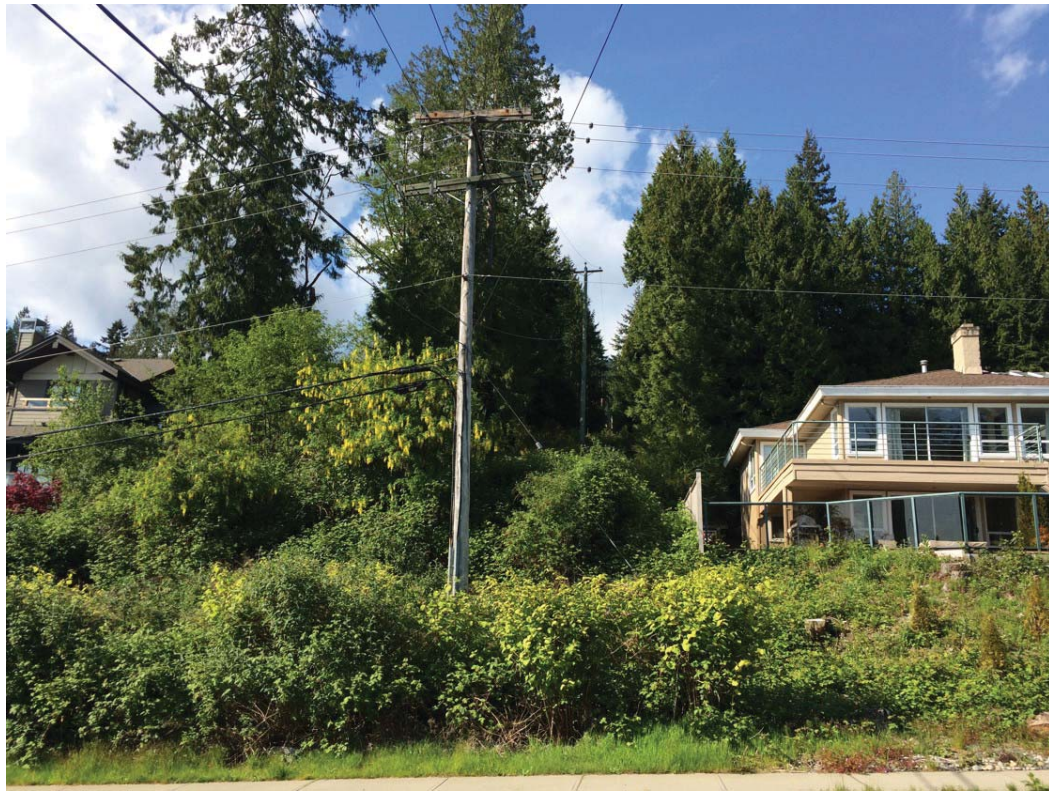
Figure 3 – Unopened Road Allowance from Skilift Road up 25th Street

There are 2 unopened road allowances extending to the land, one is 20 meters wide running north from Skilift Road along the 25th Street alignment. (see Figure 3)

There is a second road allowance off of Skilift Road along the 25th Street alignment. Creus carefully considered the possibility of utilizing this road allowance as a surface access route to the proposed subdivision. The grade, however, is comparatively steep with existing grades ranging from 25% to 35%. Because of the steep grade, Creus concluded that the 25th Street road allowance is unable to accommodate a viable surface access road.

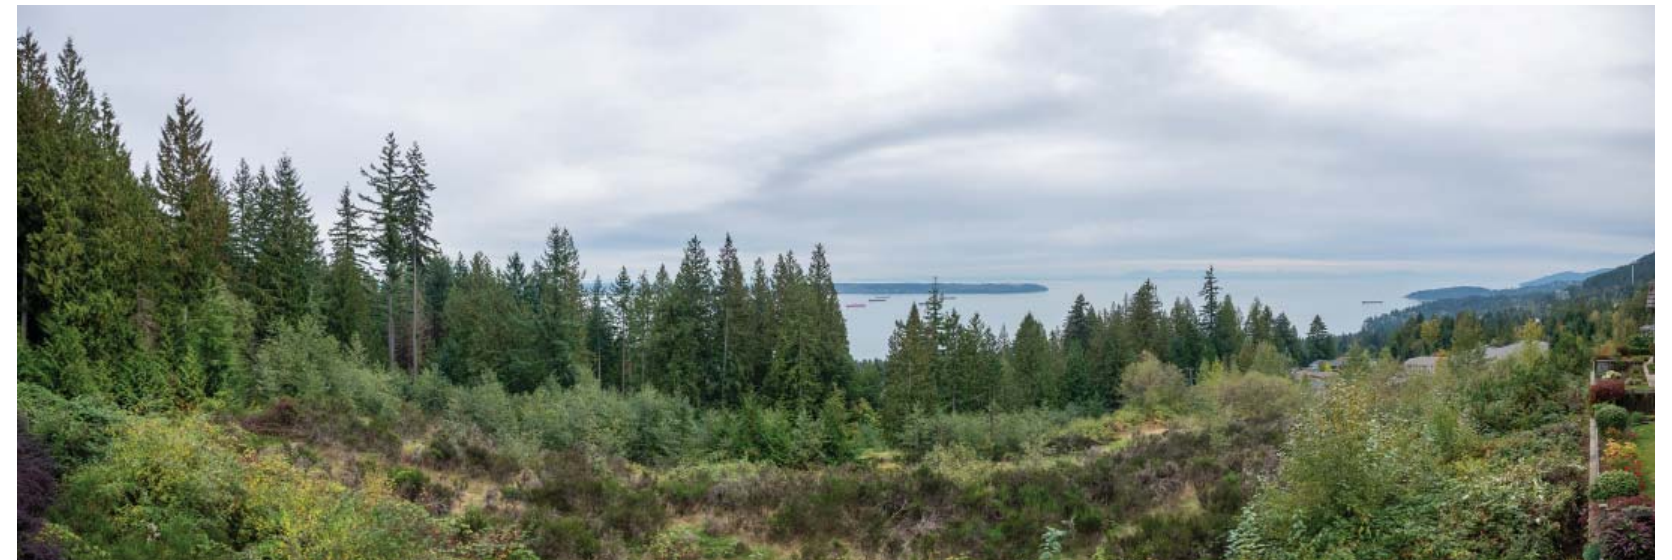
The majority of the site has been cleared with some scattered existing mature and immature trees remaining. The trees are a mixture of western red cedar, Douglas fir and Hemlock. There are also areas of salmonberry and salal on the property. Skidder roads traversing all 4 lots accommodate 4-wheel drive vehicles.

View South over the entire site

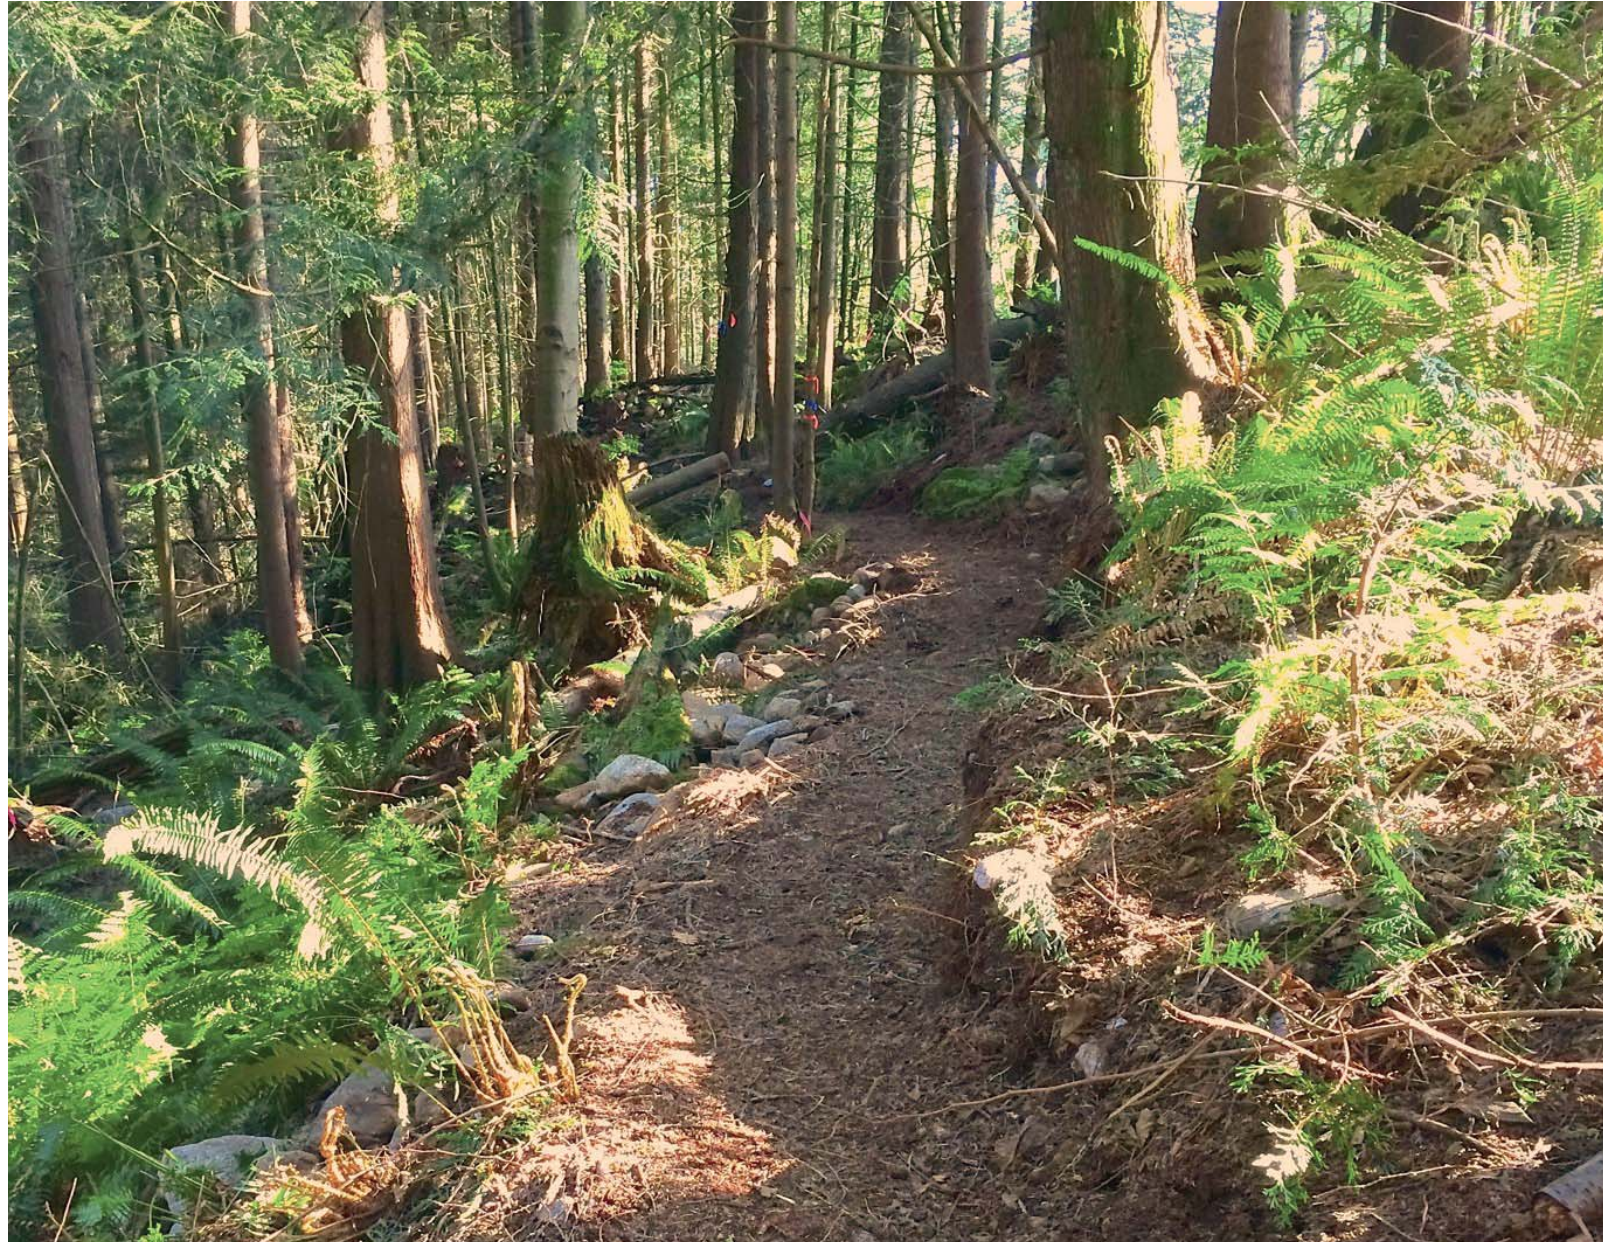
A trail runs through the eastern portion of the property along the ravine about 6 to 8 meters down slope from, and roughly parallel to, the top of the ravine bank. The trail has an average grade of about 20%.

*View of the trail on Lot 6 in the Marr Creek ravine*

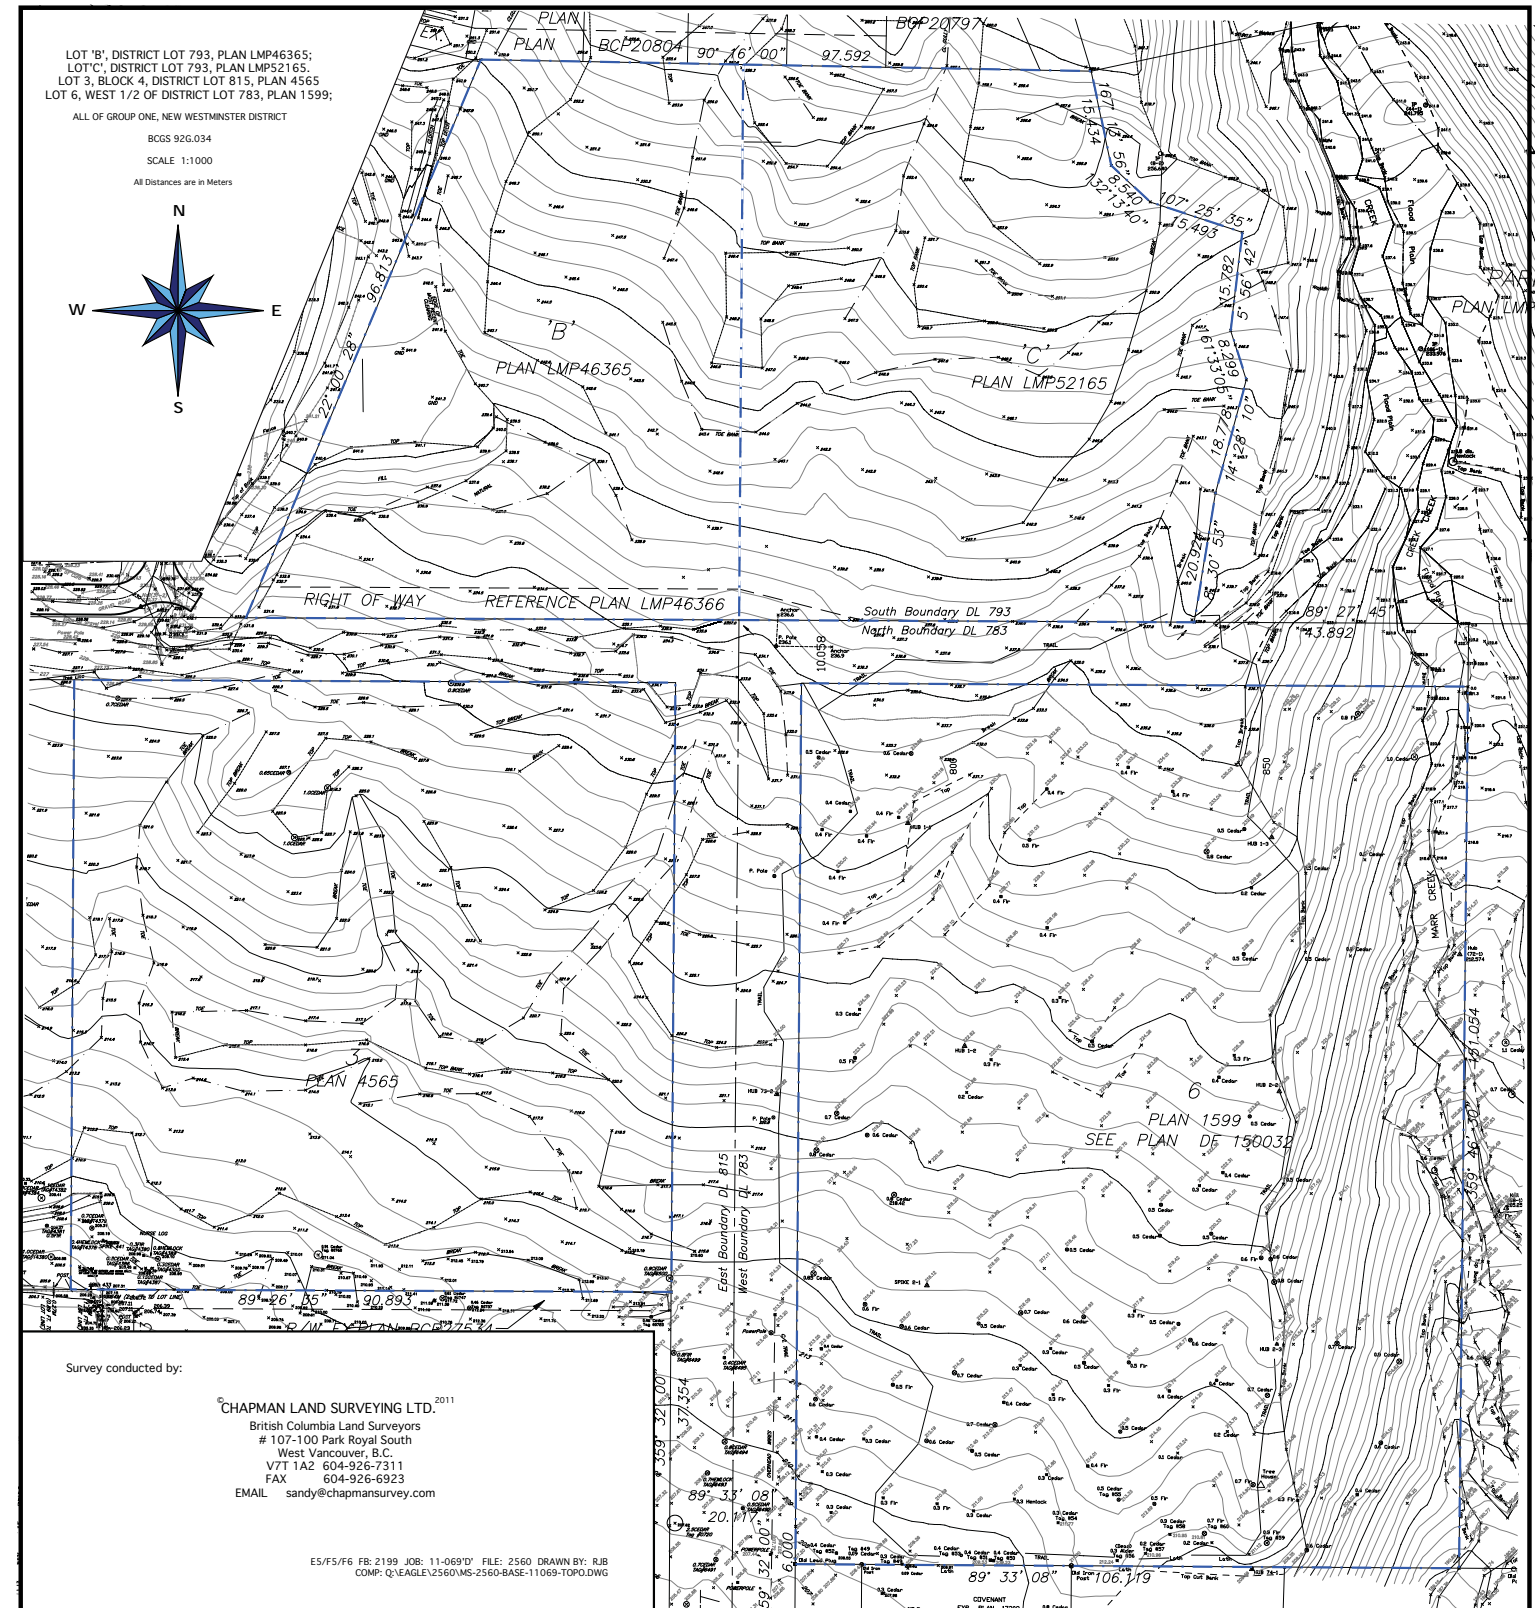
Figure 5 - Site Survey

The site slopes steadily to the south at a relatively consistent grade of 20% (or 11°). The lower end of the property is at an elevation of 210 meters, while the upper end of the property is at 260 meters (for larger version of the Topographic Survey refer to Appendix 20).

The Marr Creek ravine is the most significant feature on the property. It is well established and runs north to south along the full length of the eastern side of the site. The ravine averages between 70 and 80 meters in width and 15 to 20 m in depth with steep ravine slopes, upwards of 50% (see Appendix 7).

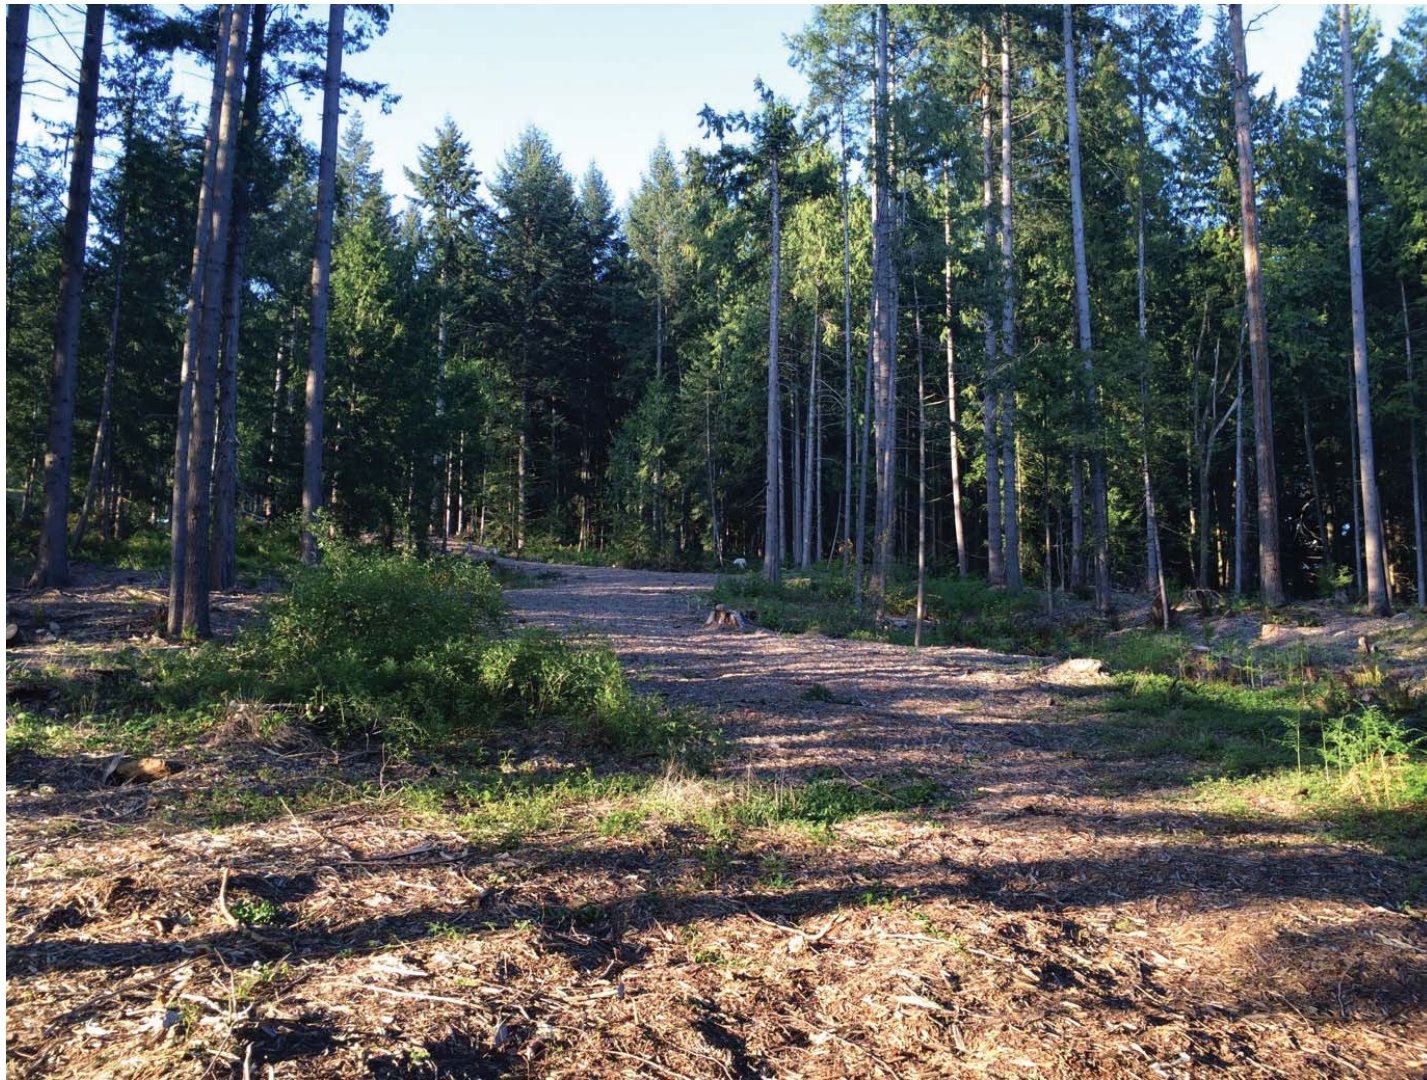
*View of Lot 6 looking uphill to the north*

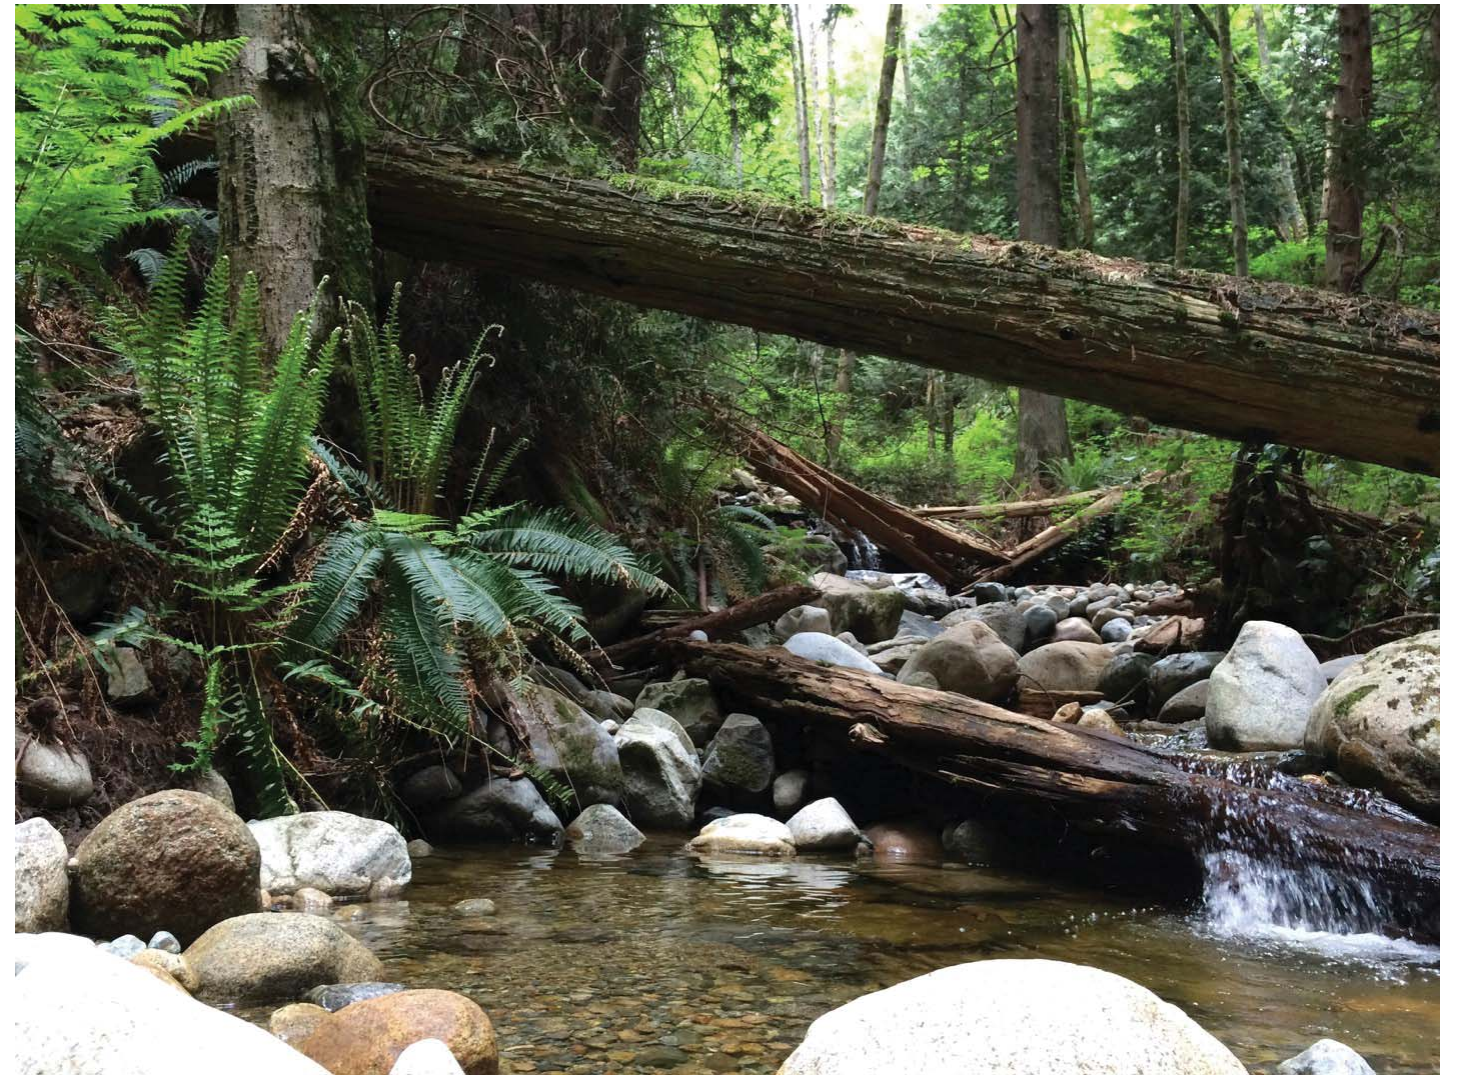
The grade of the creek is similar to the general grade of the property at approximately 20%. Elevation of the creek varies from 190 meters in the south to just over 240 meters at the north end. The creek averages between 5 and 10 meters in width.

*View looking north along Marr Creek*
