# Capilano Pacific Trail

July 25, 2022

# Presentation Outline

1. Overview
2. Landslide Remediation and Permanent Trail Decommissioning
3. Sewer Infrastructure Reinstatement
4. Trail Realignment

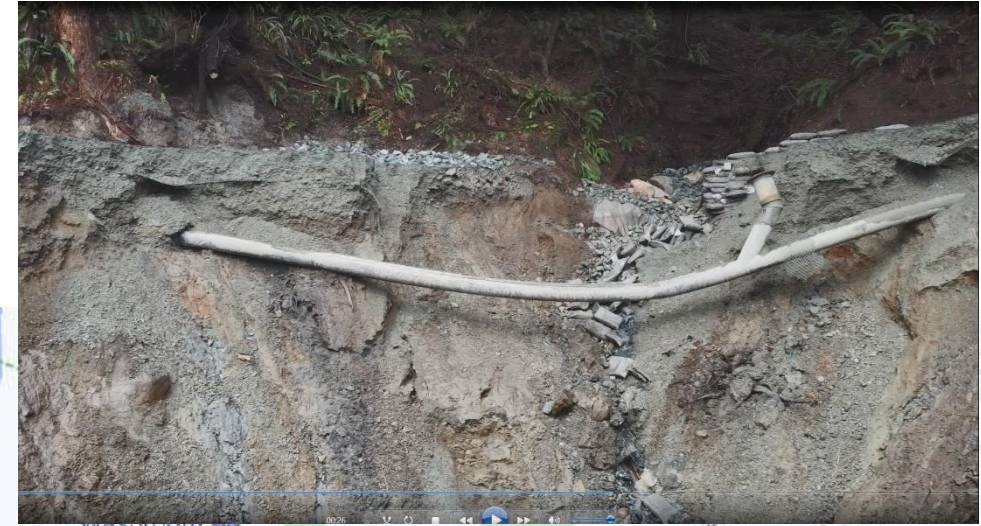
Subsequent Landslide – January 13

Landslide Location

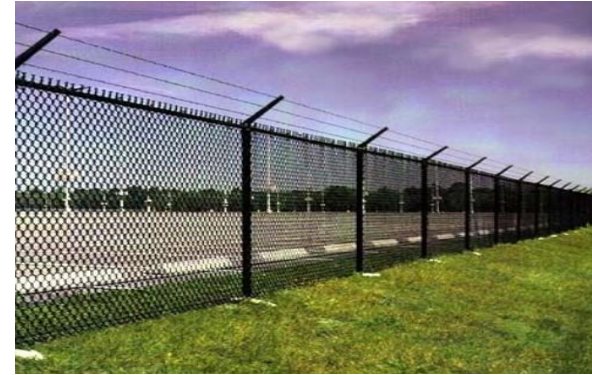
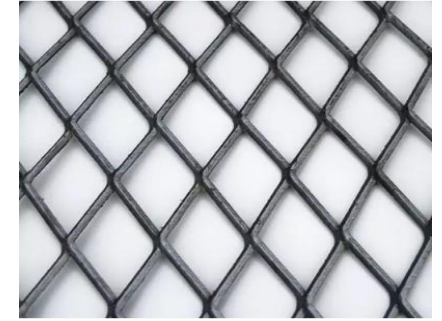
# Existing Trail Decommissioning

- \$30,000 for permanent fencing at the north and south sides of the landslide area, including main access gate and permanent signage
- \$65,000 for decommissioning of the existing sewer and hydroseeding the slide area
- it is proposed that this work be funded by through a combination of the Weather Related Incidents Reserve for the trail decommissioning and the Sewer Utility for the sewer decommissioning as described above
