COUNCIL REPORT

Date:	May 5, 2026
From:	Erik Wilhelm, Senior Community Planner
Subject:	Proposed Heritage Alteration Permit for 4798 The Highway

To present to Council a proposed Heritage Alteration Permit that would permit a new 2-storey residence at 4798 The Highway.

Wildfire Hazard DP Area Assessment Report

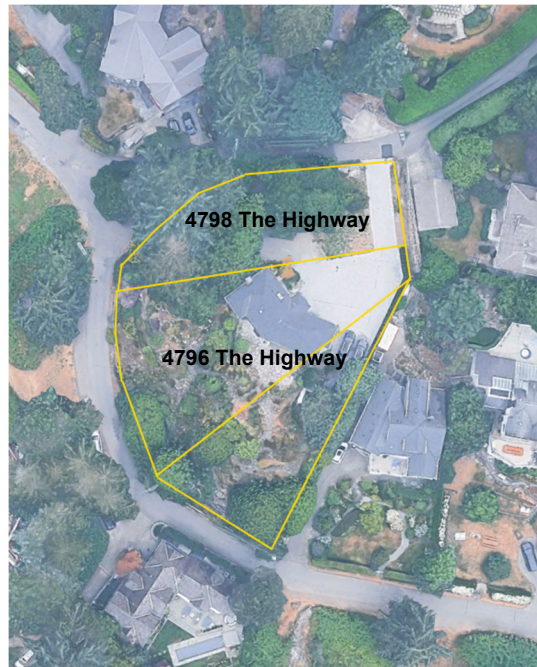
Figure 2 - Aerial map showing historical 3-lot residential site

The subject site, 4798 The Highway, was formed by subdivision in 1904 as part of one of the original subdivisions in the Lower Caulfeild area. Since 1986, the site formed part of a larger residential site that consisted of 3 lots owned by one owner (Figure 2).

The existing residence to the south, at 4796 The Highway, straddles the existing lot lines of that site and has a legally non-conforming setback adjacent to the subject site¹ (Figure 2).

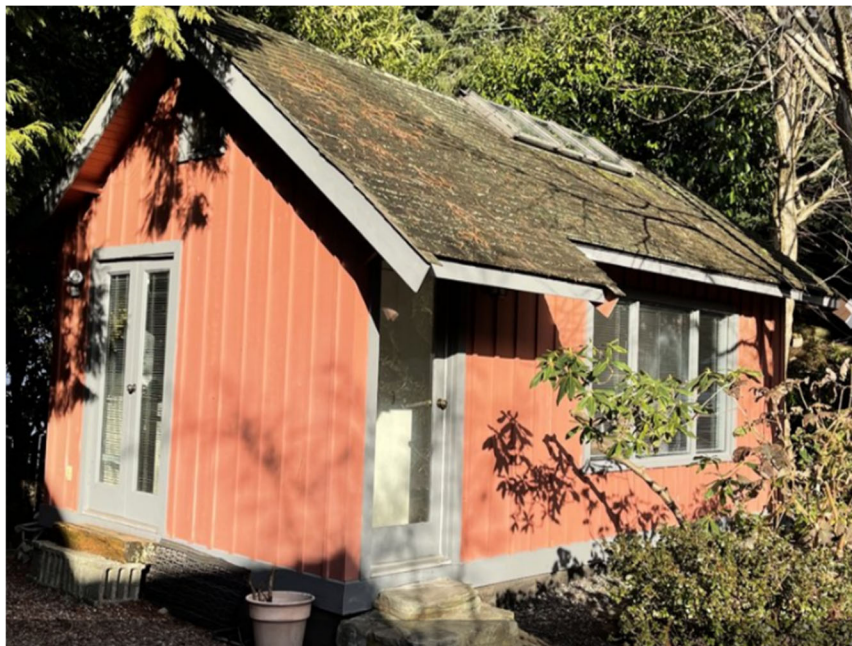
Figure 5 – Photograph of small residence located on the subject site

The subject property is generally flat, 876.6 m² (9,435.5 sq. ft.) and zoned RS3. There is a cluster of coniferous trees on the western portion of the site, deciduous trees on the northern portion of the site and a centrally located gravel area. As previously described, there is a gravel driveway located on the eastern portion of the site within the easement area (see Figure 4). There is a small standalone residence located on the property in the northwest corner which is proposed for removal. This small structure was used by the previous owner as accessory accommodation (Figure 5)³.

³ The small existing residence onsite is located 8.4 ft. from the front lot line adjacent to The Highway and does not have any identified heritage value.

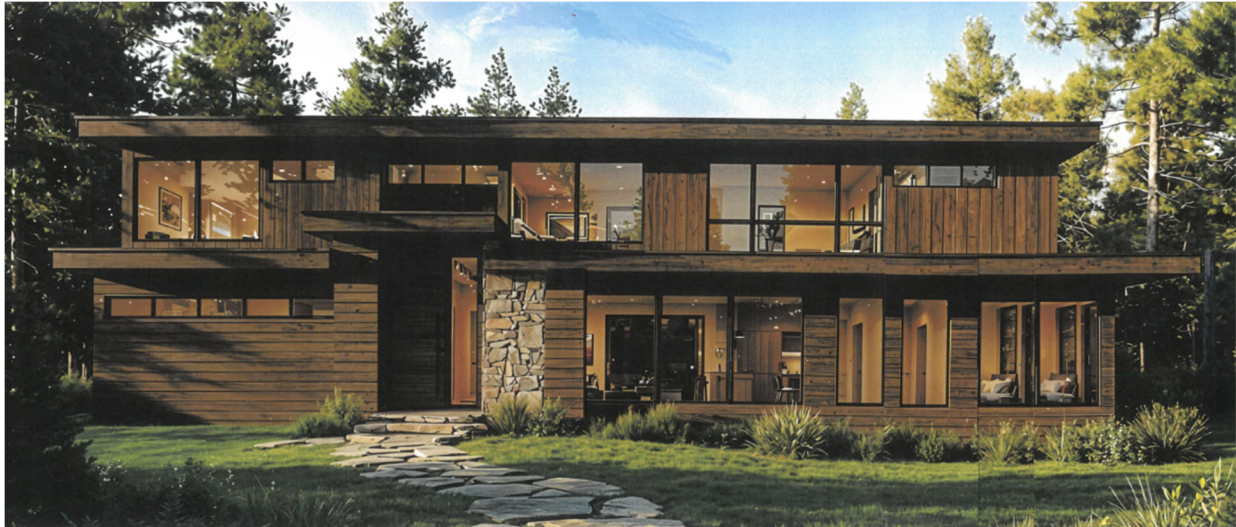
The revised proposal includes generally the same massing (two-storey detached residence, without a basement or secondary suite), with a refined design consistent with West Coast modern architecture. The revisions made are intended to address key neighbourhood concerns and better align with Zoning Bylaw setbacks and the Lower Caulfeild Heritage Conservation Area guidelines. Revisions include a reduced floor area⁴, adjusted siting, and refined material and landscaping selections to address neighbourhood concerns (Figures 8, 9 and 10).

Figure 8 – Rendering of proposed/ revised dwelling (viewed from The Highway [street])

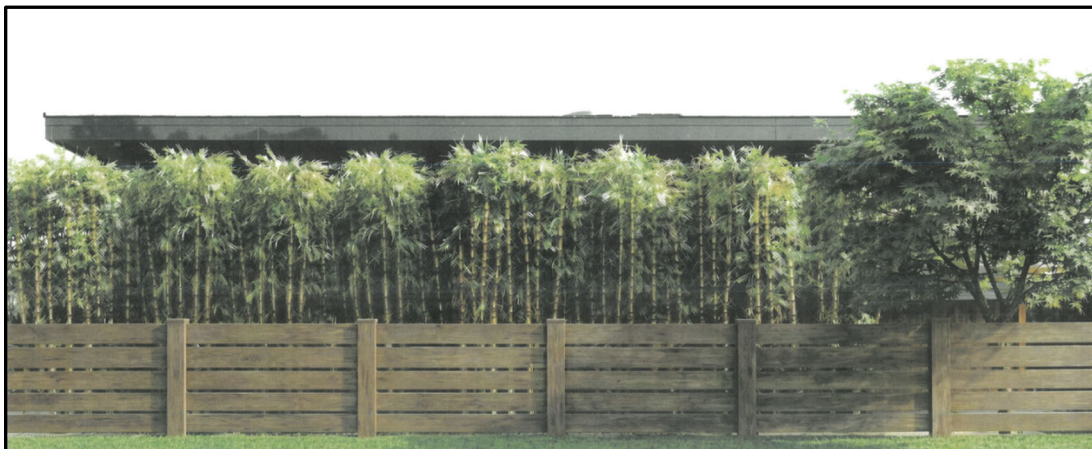
Figure 10 – Rendering of rear of property (viewed from neighbouring property 4796 The Highway)

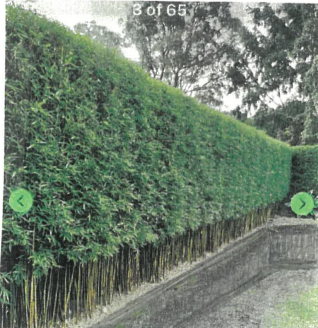
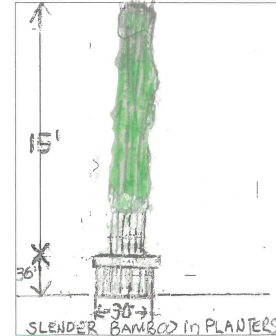
Drawing Title
LANDSCAPE CONCEPTUAL PLAN

Conceptual Landscape Plan (siting of residence determined by site plan)

REPLACE EXISTING FENCING 5' 1'X6' VERTICAL BOARDS WITH NEW MATERIAL.
