DISTRICT OF WEST VANCOUVER
750 17TH STREET, WEST VANCOUVER BC V7V 3T3

COUNCIL REPORT

Date:	September 8, 2023
From:	Erika Syvokas, Community Planner
Subject:	Proposed Heritage Revitalization Agreement, Heritage Designation and Development Permit for 1591 Haywood Avenue
File:	1010-20-22-074; 1610-20-5234 and 5235

CONSERVATION PLAN
OCTOBER 2021, COMPLETED MARCH 2022
REVISED MAY 2022
INCLUDING STATEMENT OF SIGNIFICANCE

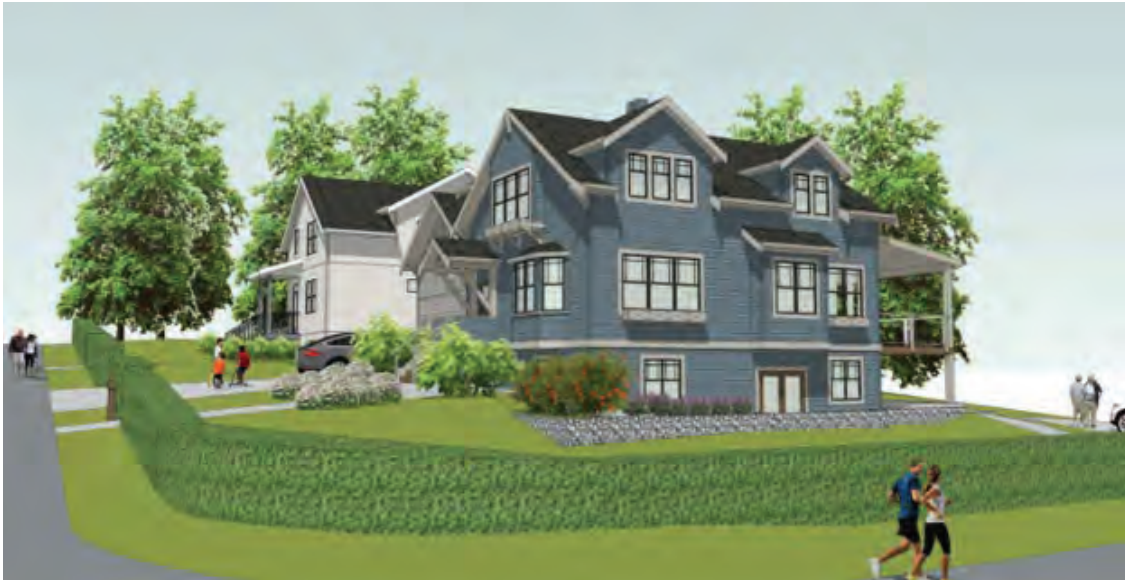
Figure 4: Rendering of the Restored Clegg House

To the extent possible, the original appearance of the Clegg House will be conserved and restored (a rendering of the restored Clegg House is shown in Figure 4). The original double hung windows will be restored, and new, hand built, wood windows will replace the non-original replacement windows. The Clegg House will retain its current orientation towards 16th Street, and the south and west elevations will remain virtually unchanged. Due to increasing the ceiling height of the basement, the house will be taller than it sits today. However, by moving the house to the south, the ridge of the roof of the house will be slightly lower due to the natural declining slope of the property. The front porch will be restored, with the existing columns removed and new roof brackets will be installed. The flower box studs will be restored and new flower boxes will be installed. The new garden level suite in the Clegg House basement will feature nine-foot ceilings, multiple points of egress, and a covered patio, creating an attractive garden level suite. The heritage conservation of the Clegg House will be carried out consistent with the recommendations of the Heritage Conservation Plan in **Appendix 'C'** (see Appendix 'B' to the proposed HRA bylaw).

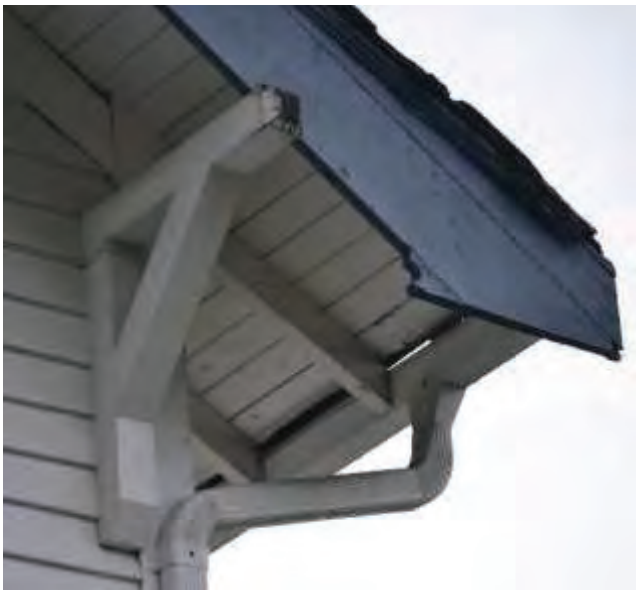
The original roofing was cedar shingles as exposed from the attic; the current vintage asphalt shingles (installed on plywood over the cedar shingles) is in fair condition. To our knowledge, at the end of its useful life. The wooden details associated with the roof include knee-brackets at gable ends with pointed end, open tongue-and-groove board soffits, exposed rafter tails, bargeboards with swollen tails, roof edge mouldings, and ridge key, headboards, and top of wall moulding. The broken framing of the roof creates a slight flair of the roof profile. The bargeboard end is swollen to cover the flair profile and its tail is augmented by the addition of wooden trim pieces. There are three knee-brackets at each gable end. The headboard makes the transition between the siding and the overhung soffit. The narrow roof fascia is hidden by eavestroughs. These wooden elements are in fair condition, although cracked bargeboards and damaged roof edge mouldings are visible throughout. Dormer, box window, and porch roofs are discussed below. The main roof is not insulated, but insulation lays on top of the second-floor ceiling. The small vent at the top of the front and back gable ends provides the only roof ventilation, which is unsightly and insufficient. The attic is accessible by a trap located in the ceiling of the second-floor hall.

Figure 19: Open soffit with exposed rafters, bracket, and barge board

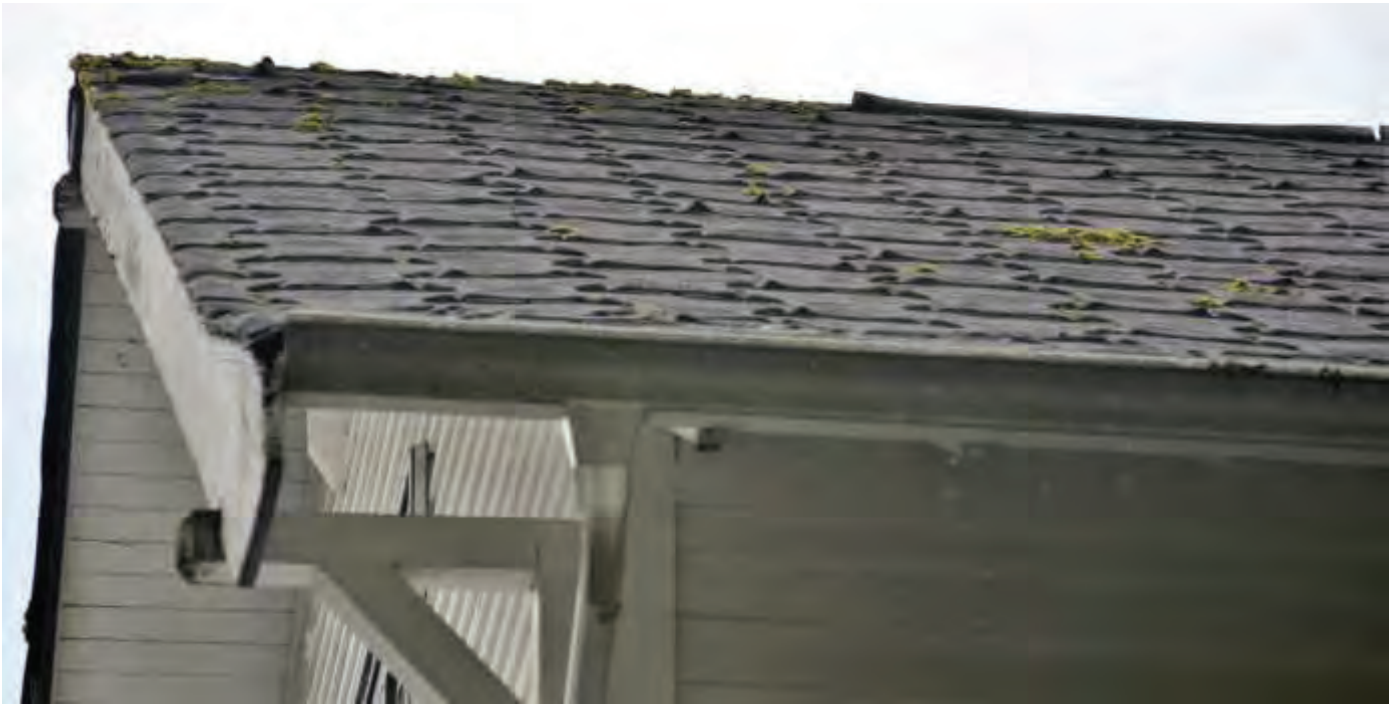
Figure 21: Vintage asphalt roofing with gable end bargeboard and knee-bracket on the left and eavestrough on the right

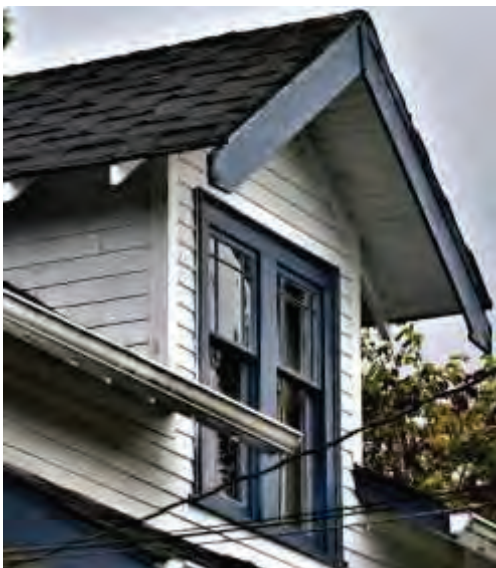
There are two existing gabled dormers, one on the south side and the other on the north side. Both dormers are off-centered on their respective sides. The dormers are clad with wooden lap siding with corner boards, consistent with the house siding. There is one dormer which has shingle cheeks on the south elevation. The gabled dormer roofs do not have a flare. The roof details include a generous overhang with an open soffit, tongue-and-groove boards, and exposed rafter ends. The dormer bargeboards have a downturned swollen tail similar to the main roof. Wooden lap siding is in good condition thus indicating that the overhang and flashing are effective. All dormer details appear in good condition.

Figure 22: Shingle dormer cheek at south elevation

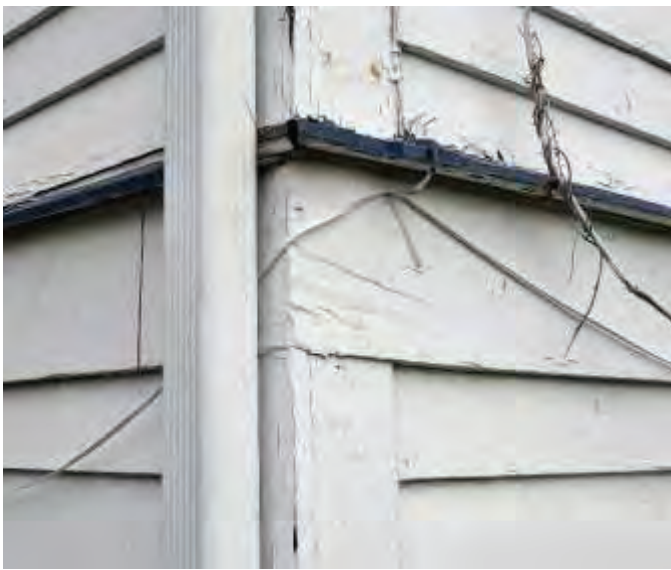
The Clegg House cladding consists of a narrow lap siding above the main floor and wider board lap siding below. The two sidings are separated by a belt board running horizontally around the house at main floor level. Corner boards define each elevation of siding. There is a continuous wooden flashing on top of the belt boards thus diverting internal water and condensation to the outside. This detail is reminiscent of a water table which is usually located on top of the foundation to protect the walls below grade. Here the flashing projects approximately two inches beyond the cladding surface. The wooden flashing is in poor condition but appears to be mostly intact. A flush plate defines the bottom edge of the siding. Little exposed foundation wall is visible below the cladding. The exposed concrete foundation is not protected. The siding and associated details are in fair condition.

Figure 24: Lap siding, Water Table, Belt and Corner boards,

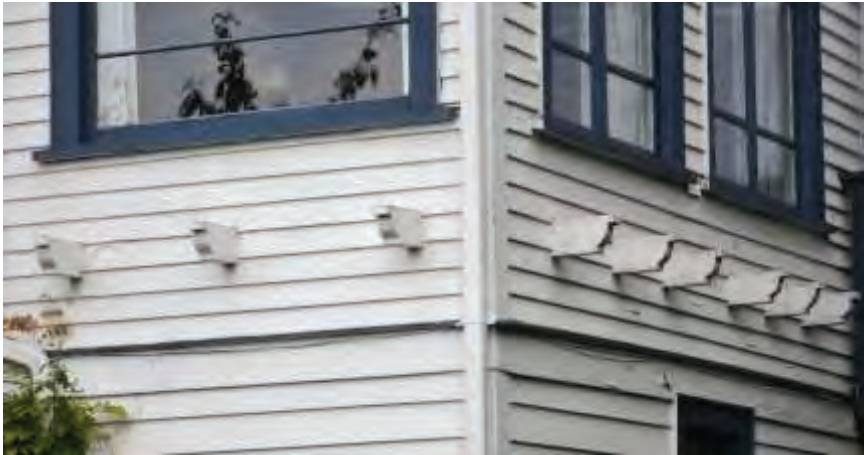
Flower box studs are located below the main floor windows of the south and east elevations. This is a common detail in the houses of the Late Craftsman Style; these also existed below the main and second floor windows on the front of the house as visible in *Figure 72*. The studs project beyond the exterior walls approximately 18 inches below the windowsills. The tail of the studs is shaped like a decorative bracket. Generally, these studs are in good condition.

Figure 28: South and east elevation flower box studs

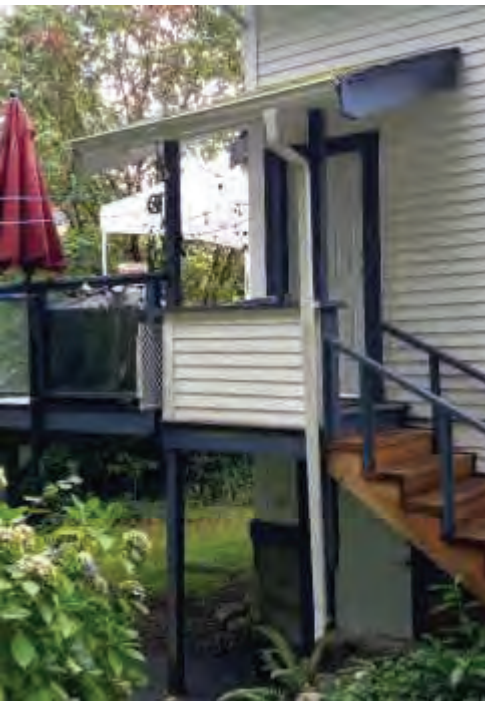
The back porch, which provides access to the main floor kitchen, has a lean-to shed roof supported by two square columns. Details of the back porch roof include an open soffit, exposed framing, and rafters, eavestrough, bargeboards with chamfered tails, and edge moulding. A solid balustrade defines the north side of the landing. A large deck on the east side of the house is attached to the back porch landing. Closed riser stairs with a crude wooden railing runs along the north wall. The underside of the stair landing is open. The back porch and its roof are in fair condition.

Figure 34: Back porch with roof, landing, and doors

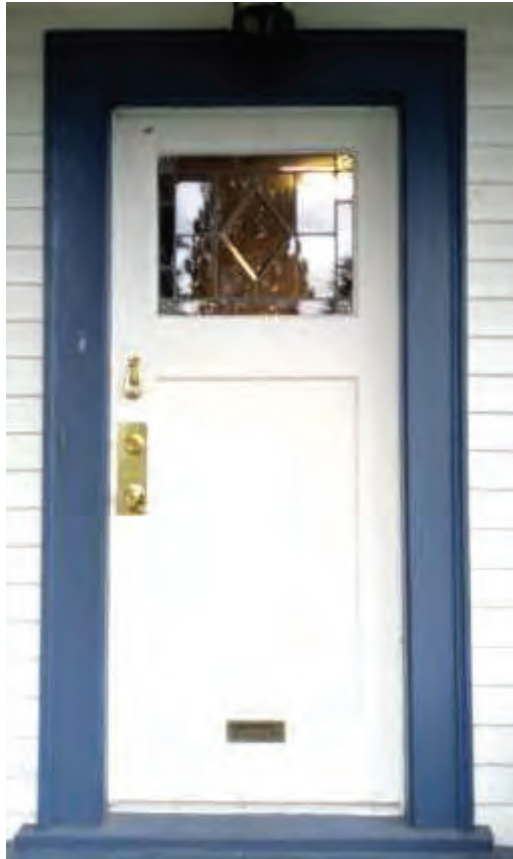
The front door is offset on the left inside of the house, thus providing access directly to the foyer on the main floor. The door is a solid wood panelled door with an upper lite of cut-glass panes. The exterior door casing is wide with a raised sill. The interior door casing is consistent with the details of the interiors. The door assembly is in good condition. The kitchen door is a common panel door and the one to the basement is a crude contemporary door.

Figure 54: Front door exterior

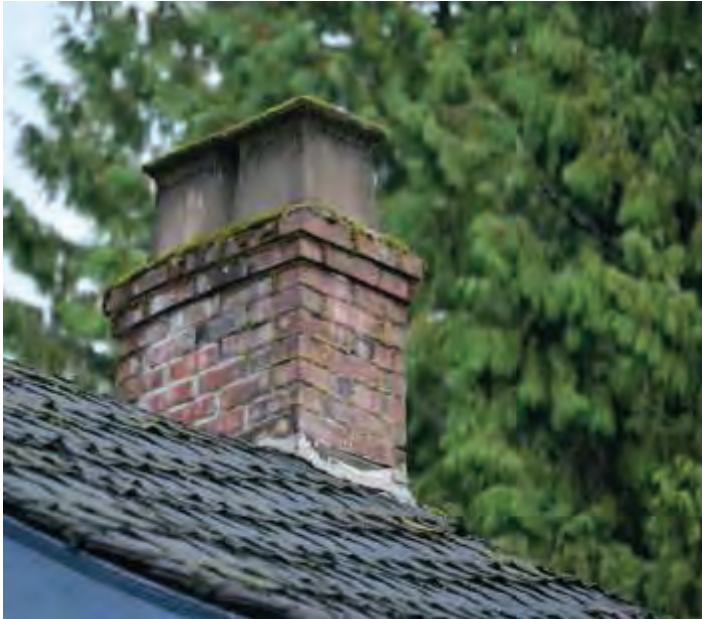
The brick chimney is barely visible from the adjacent streets since it has a short, exposed shaft located in the middle of the house. The shaft above the roof is in fair condition. Moss is growing at the top of the masonry shaft and cap. The fireplace is an important feature of the main floor. The fireplace includes a decorative wood mantle. The fireplace is in good condition. The brick shaft rising through the attic has been sloppily repointed and shows signs of continued water penetration.

Figure 58: Internal chimney shaft above roof

Since the front porch will be dismantled in order to accommodate the relocation of the house, the original knee-brackets supporting its roof will be restored. The window flower boxes will be reinstated at the Clegg House, thus enhancing the exterior of the Craftsman style house. The proposed back deck staircase roof will also be restored after the moving of the house. Masonry chimneys are important character-defining elements of the Craftsman Style, and the exterior shaft of the brick chimney will be restored.

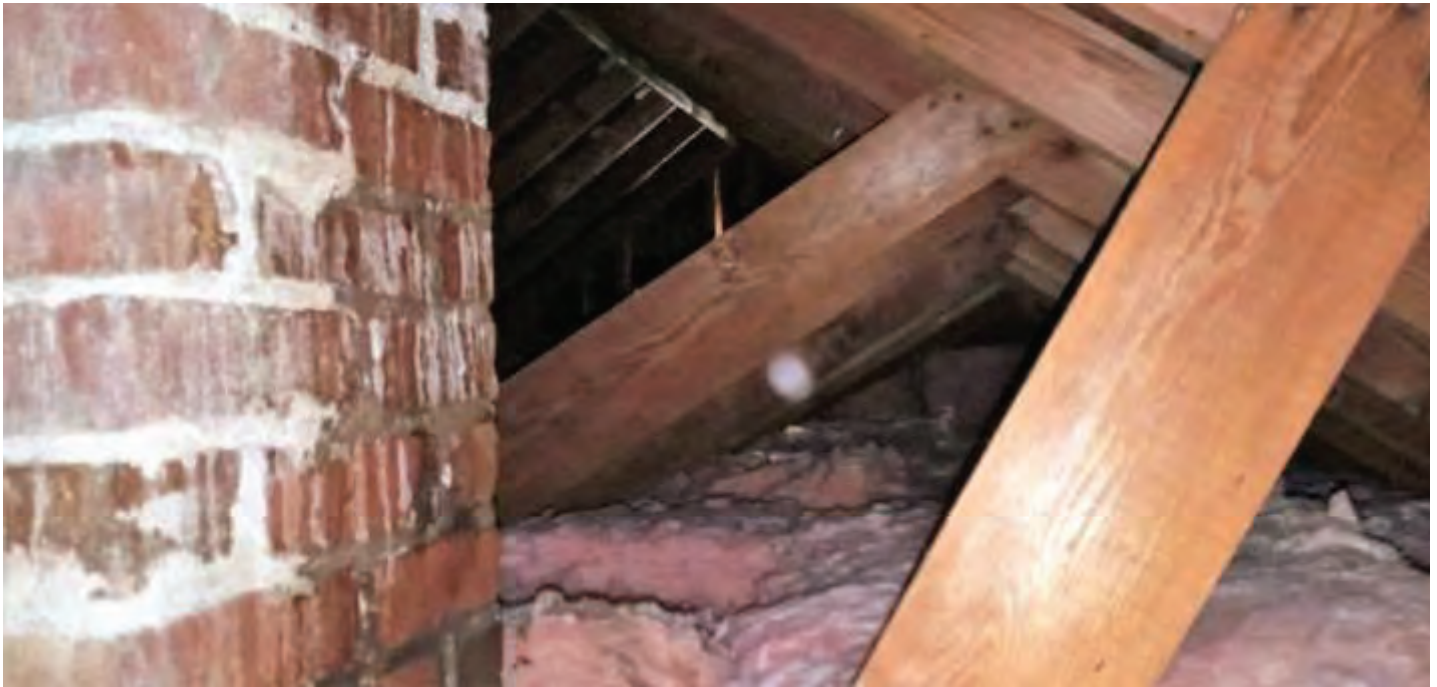
Figure 60: Chimney through attic space, with wooden trusses and bat insulation on above ceiling

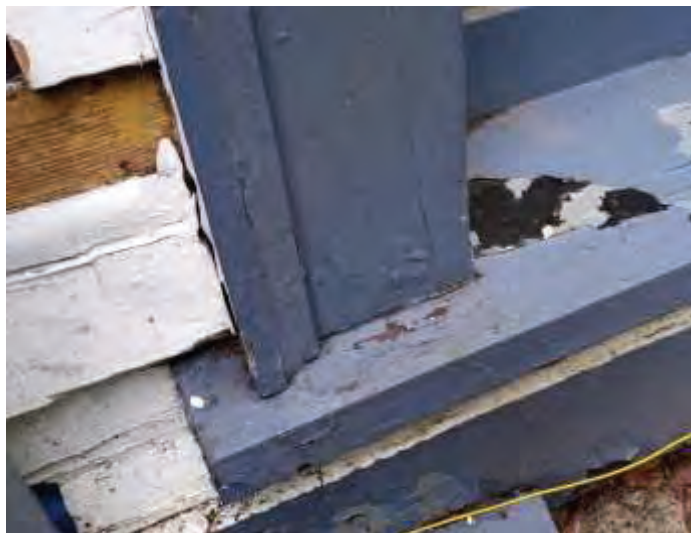
The exterior paint of the siding and trim has been neglected and is generally in poor condition. Cracking and peeling are visible all over the house exterior. Original colours can be seen on the north elevation, where siding with natural look exists beneath the white coat. Black painted wood trim around windows is also visible. The black colour was common in the Victorian era, but it was not typical of the 1920's.

Figure 61: Black trim colour beneath the blue accent paint

The proposed exterior colours have been reviewed by the Vancouver Heritage Foundation (VHF) staff. Built in 1929, the Clegg House could have been painted with colours included in the VHF True Colour program. Although the period of this house is transitional into a modern palette, the choice of Victorian/Edwardian colours is still appropriate, since several Craftsman Houses maintained the “True Colours” well into the 1930’s. See *Your Old House – True Colours* by S. Halfnight and D. Luxton on behalf of the Vancouver Heritage Foundation 2001.

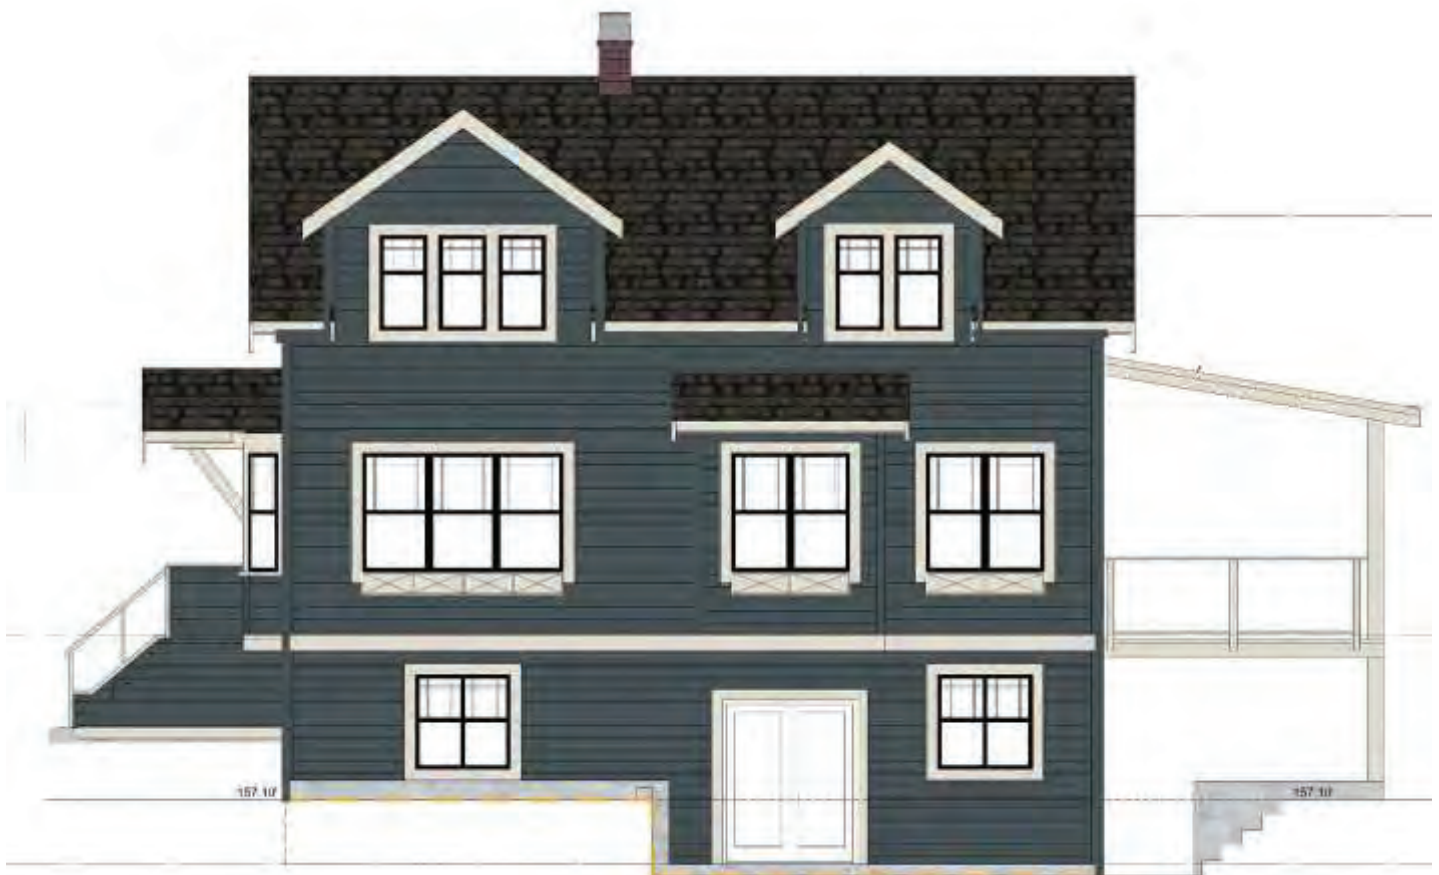
Figure 76: Proposed south elevation with new dormer and basement entrance _ Focus Architectural Inc

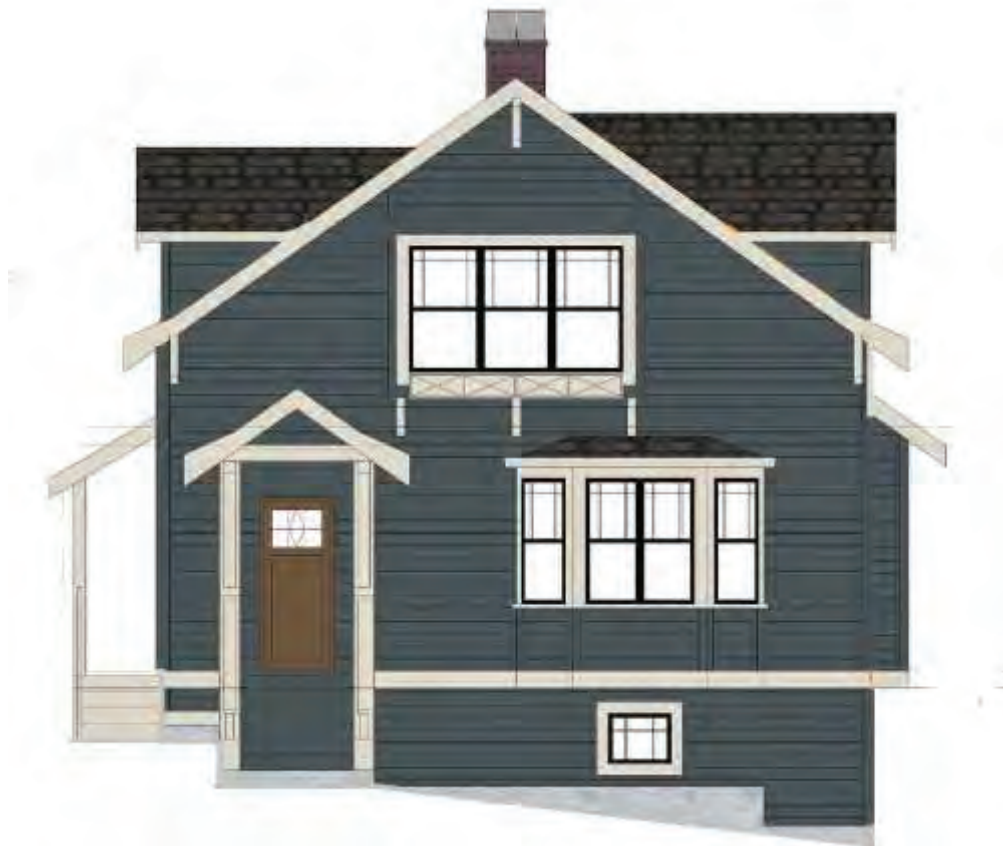
Figure 78: Proposed West elevation with link to garage on the left inside_ Focus Architectural Inc

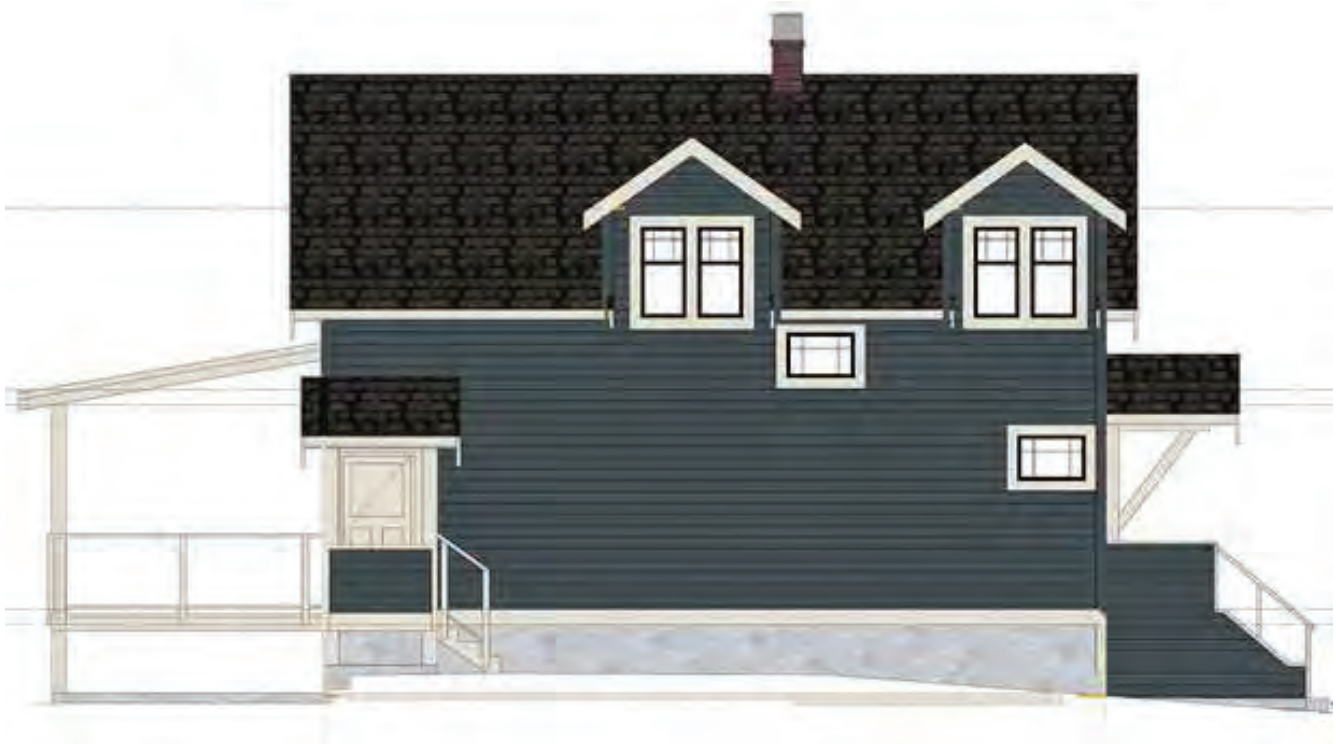
Figure 79: Proposed North Elevation with additional dormer_ Focus Architectural Inc

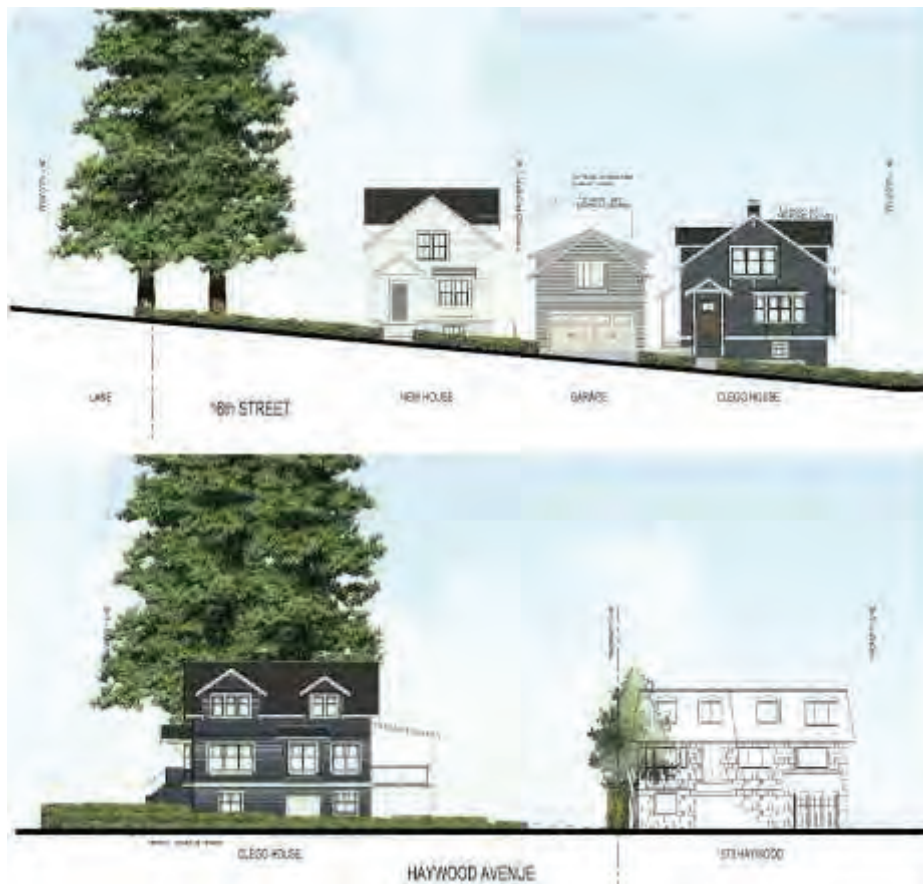
Figure 81: Street elevation with 16th Street on top and Haywood Avenue at the bottom_ Focus Architectural Inc

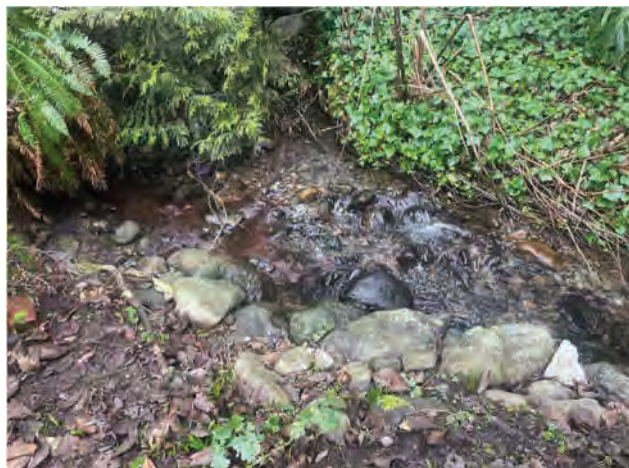
Photo 2. Creek substrate conditions at upstream extent of Creek on Subject Property (2022-02-15).

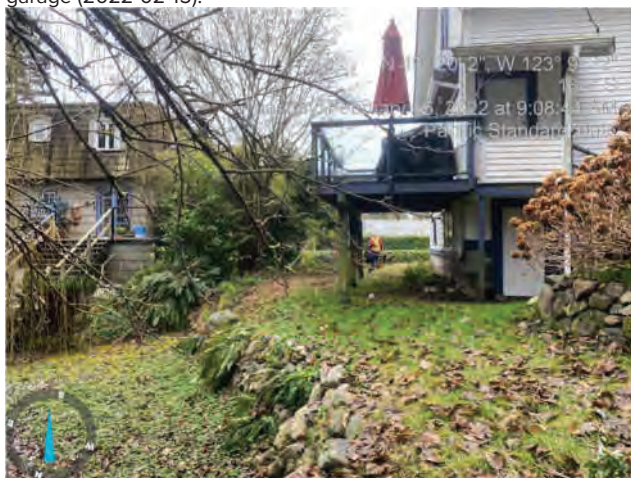
Photo 3. Existing house and stone retaining walls, benched areas within the 5-m Setback on the Subject Property (2022-02-15).

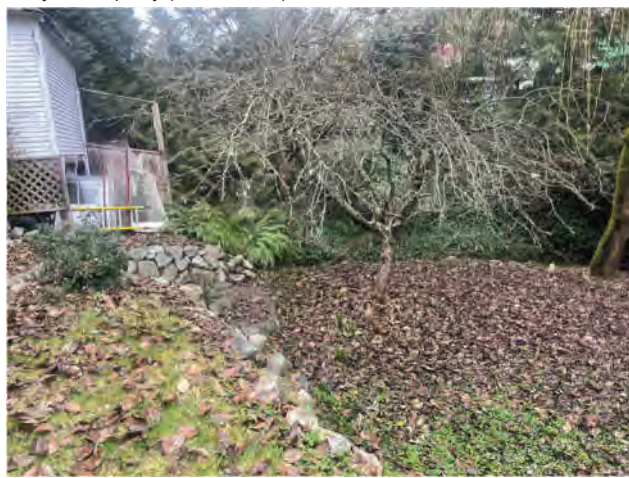
Photo 4. Riparian conditions and Creek on Subject Property within 15 m setback (2022-02-15).

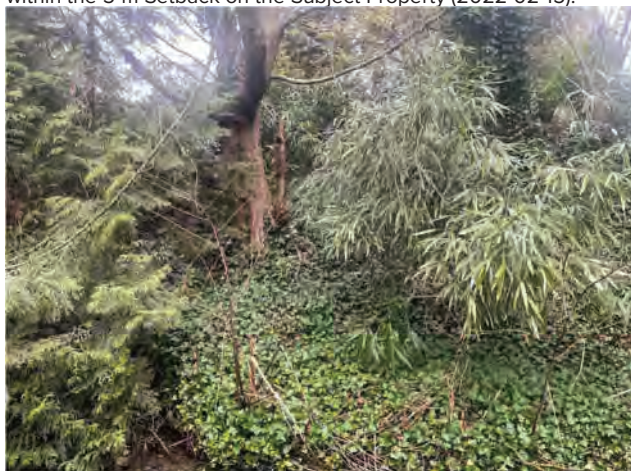
Photo 5. Northern bank – invasive species proposed for removal (2022-02-15).
