District of West Vancouver

DEVELOPMENT PERMIT NO. 22-074

CIVIC ADDRESS: 1591 HAYWOOD AVENUE

CLEGG HOUSE

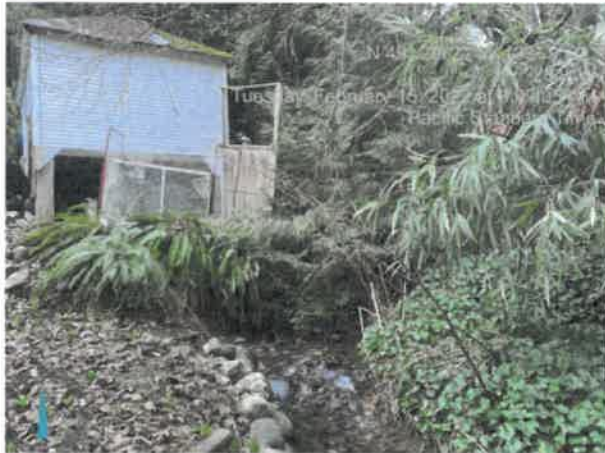
Photo 1. Existing conditions looking west towards the existing garage (2022-02-15).

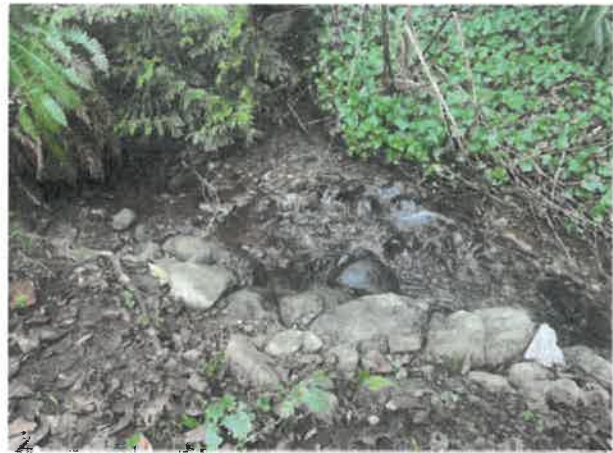
Photo 2. Creek substrate conditions at upstream extent of Creek on Subject Property (2022-02-15).

The Subject Property contains a 13.5 m section of the Creek flowing from northwest to southeast. This reach of the Creek flows as an open channel with a bankfull width of 1 – 2 m. The banks are steeply cut, but shallow in height (approx. 0.5 m). The southern bank is shallow and flattens out within 0.5 m to become grassy lawn. The northern bank is steep and overgrown with numerous invasive species, including English ivy (*Hedera helix*), ornamental bamboo (*Phyllostachys sp*) and Knotweed (*Fallopia sp*). It is not possible to determine the state of the stream bank on the northern side due to overgrowth of these species. The substrate of the Creek consists of gravels, cobbles, and sand, with some mid-sized boulders, with a gradient of approximately 2 to 4%. Downstream of the Subject Property, the Creek flows predominantly as an open channel through residential properties to the outlet at Ambleside Beach, near the mouth of Burrard Inlet, with the exception of seven road crossing culverts. From the Subject Property to the confluence with Burrard Inlet is approximately 1.1 km, with a total stream length of 2.85 km.

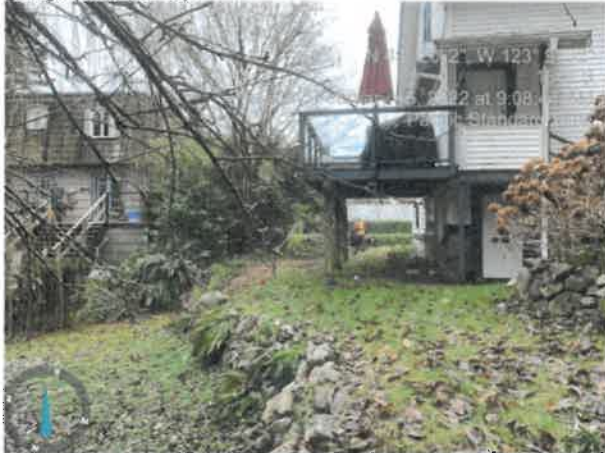
Photo 3. Existing house and stone retaining walls, benched areas within the 5-m Setback on the Subject Property (2022-02-15).

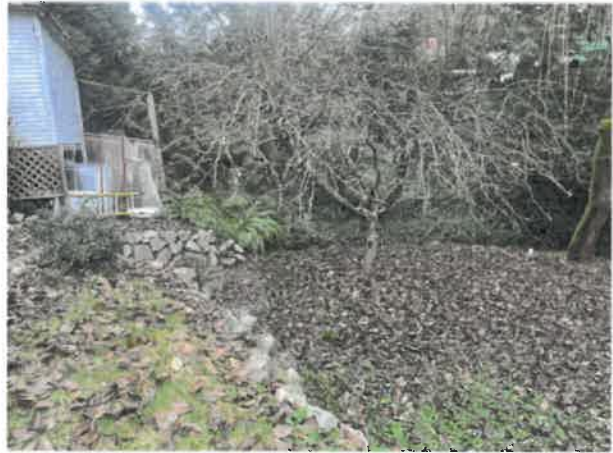
Photo 4. Riparian conditions and Creek on Subject Property within 15 m setback (2022-02-15).

Riparian vegetation within the Subjects Property's 15-m Setback consists of lawn, non-native naturalized garden species and invasive species. Vegetation on the northern bank contains native shrubs (sword fern (*Polystichum munitum*)) and a variety of invasive species. The following invasive species were observed within the 15 m setback to Vinson Creek: English ivy (*Hedera helix*), yellow archangel (*Lamium galeobdolon*), Himalayan blackberry (*Rubus armeniacus*), cherry laurel (*Prunus laurocerasus*), ornamental bamboo (*Phyllostachys spp.*) English holly (*Ilex aquifolium*) and spurge laurel (*Daphne laureola*). SEI suspects a very small infestation of knotweed spp. (*Fallopia spp.*) exists on the northern bank. SEI observed three to five dead stems but has not been to site during the growing season. The existing garage proposed for removal is located adjacent to ToB (within 1.5 m) on the southern bank of the Creek.

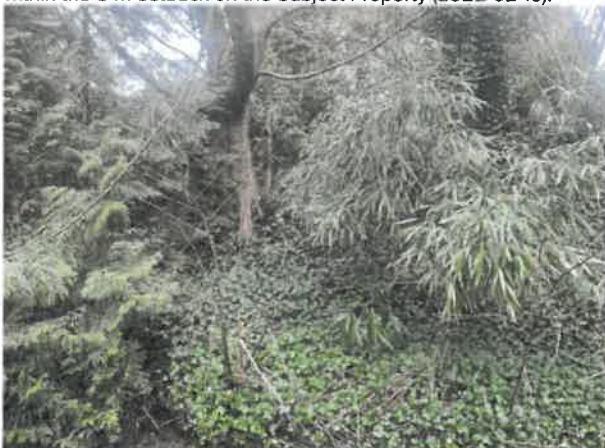
Photo 5. Northern bank – invasive species proposed for removal (2022-02-15).

All invasive plant species should be removed (with their root structures) within from the Invasive Species Management Area polygon. Invasive plant species within the polygon located along fence lines, stairs, retaining walls, deck edges or steep slopes where machine access is restricted, or where vegetation may be integral to existing structural components or slope stability, should be removed by hand. Invasive species located in riparian areas where machine access is available may be managed through other mechanical means (e.g., use of a small-rubber tracked machine). Extensive species-specific best management practices information exists regarding the removal and control of invasive species, and if requested, Sartori Environmental Inc. can provide further direction during the landscaping/vegetation maintenance phase of the proposed works to ensure adequate removal and disposal. All root structures and topsoil should be disposed of in an appropriate manner.

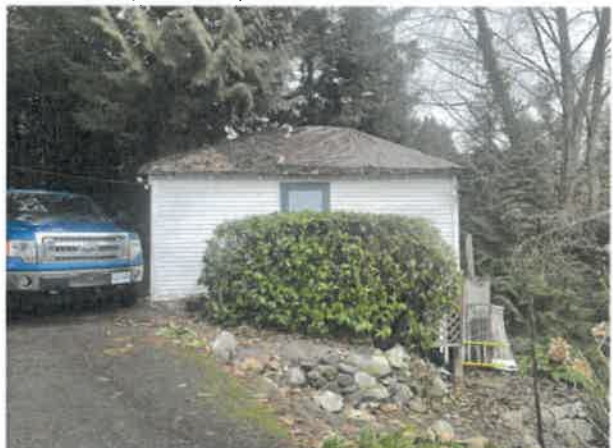
Photo 6. Existing garage proposed for removal (2022-02-15).

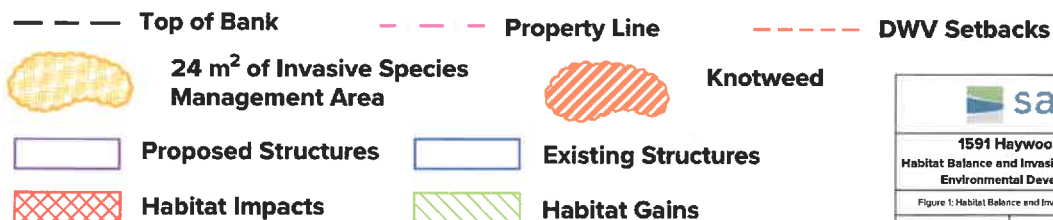
1591 Haywood Avenue, DWV
Habitat Balance and Invasive Species Management Area
Environmental Development Permit Figure

Net Habitat Gain

+ 6 m²

Invasive Species Management

As two protected trees are proposed for removal within the 15-m setbacks, replanting of native trees at a 2:1 ratio is proposed to replace those trees within the riparian area of the Creek. A total of 2 conifers and 11 deciduous trees are included in the Riparian Restoration Plan. Tree replacement criteria for the two proposed trees has been included in the Riparian Restoration Plan.

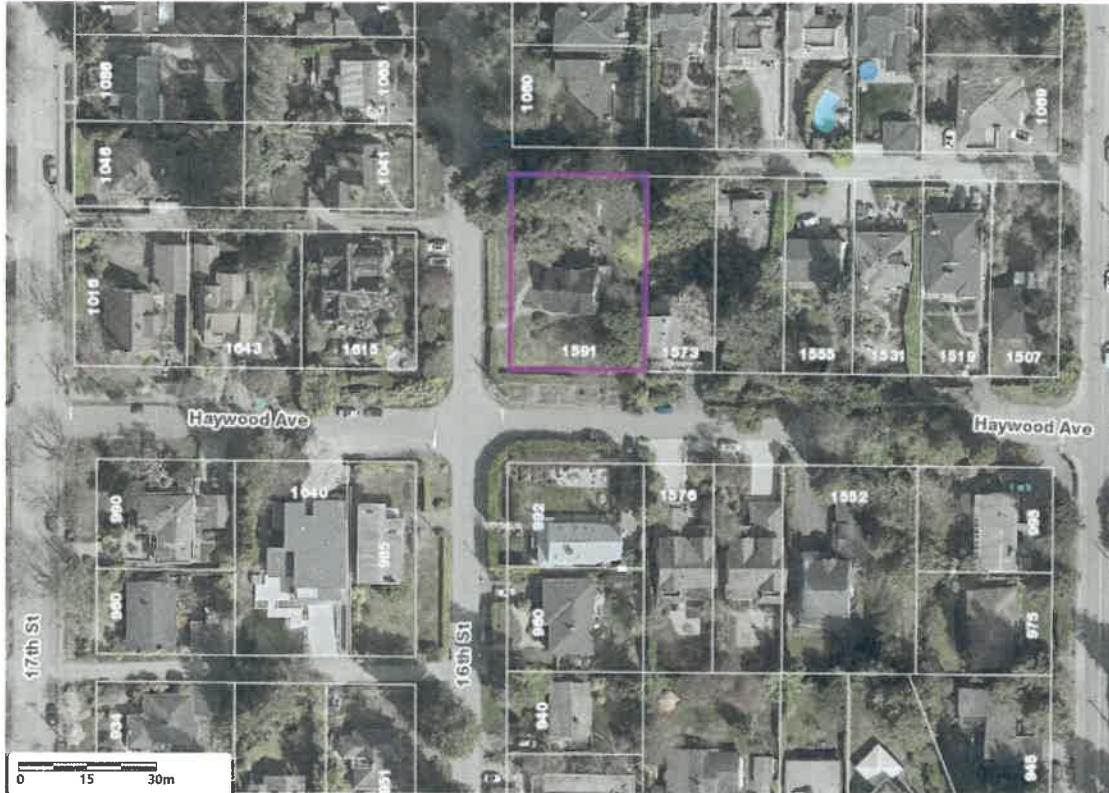
Figure 1. An aerial image of the site.

One lot comprises the property 1591 Haywood Ave, West Vancouver, BC. as presented in Figure 1.
