COUNCIL REPORT

Date:	January 17, 2024
From:	Hanna Demyk, Planning Technician
Subject:	Proposed Coach House Development Permit for 1160 Sinclair Street
File:	1010-20-22-143

Wildfire Hazard Assessment Report 1160 Sinclair Street, West Vancouver

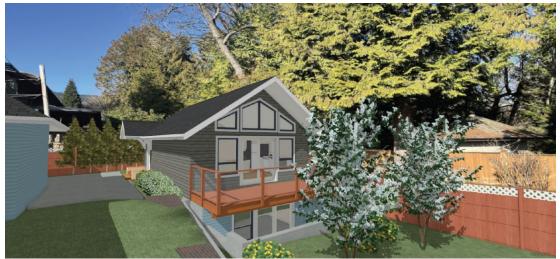
Figure 2 – Rendering of proposed coach house (for illustrative purposes only)

The proposal also includes a private deck for the coach house, pedestrian pathway from Sinclair Street to the coach house along the north property line, expansion of the existing parking pad to add space for an additional parking space, as well as tree work and landscaping on site (Schedules A, B, and C of **Appendix A**). The proposal is subject to a Coach House DP and Wildfire Hazard DP. No zoning variances are proposed.

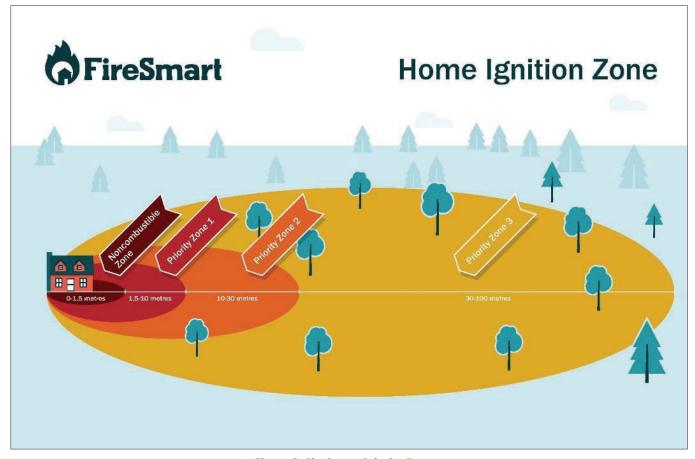
Figure 3. FireSmart Priority Zones.

FireSmart uses the concept of FireSmart Priority Zones (FPZ) to determine where and how hazard assessment should be conducted, and to determine appropriate mitigation measures (Figure 3). Within these zones, the recommendations are to reduce the potential fire hazard by treating flammable vegetation and/or fuels in close proximity to the planned development (Section 3.0). The execution of these recommendations will reduce the likelihood of fire spread. The guidelines for each FireSmart Priority Zone are provided below, but recommendations for each property may vary from what is listed here depending on the site context.

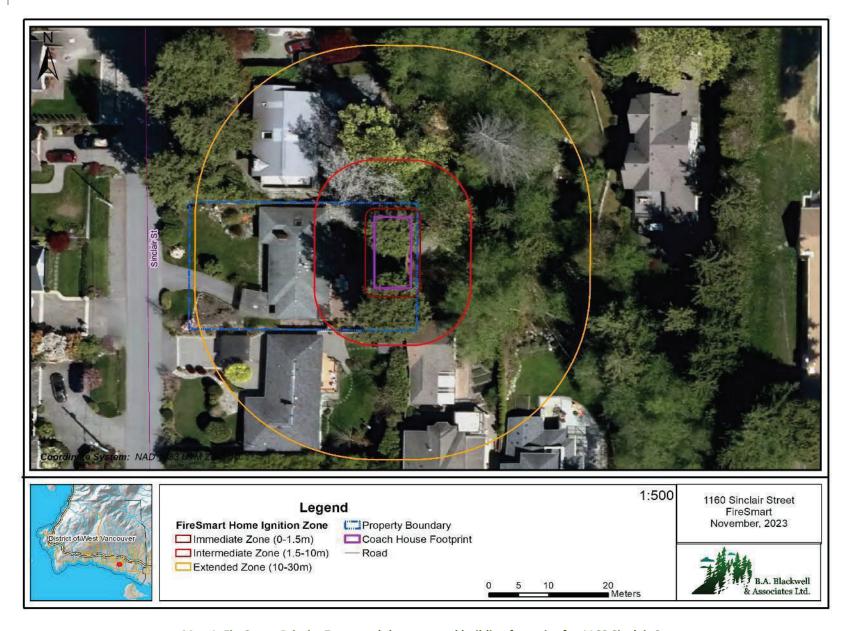
Map 1. FireSmart Priority Zones and the proposed building footprint for 1160 Sinclair St.

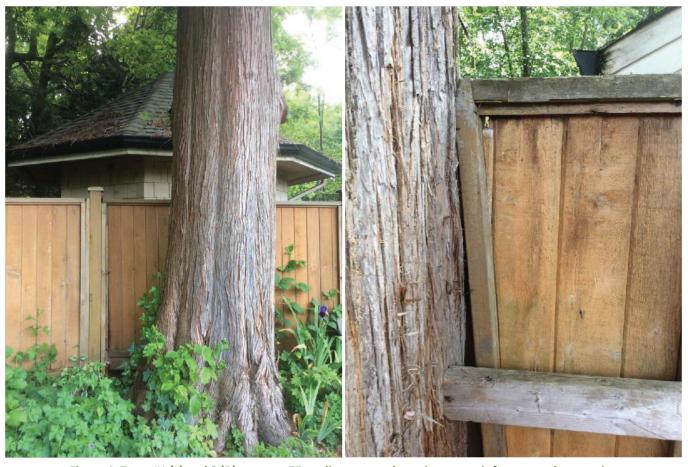
Figure 4. Trees #1 (L) and 3 (R) are over 75cm diameter and require a permit for removal or pruning

Trees #1, 3, and OFF1 (Figure 4) are protected by Tree Bylaw 4892 due to being over 75cm DBH. Tree #1 is too close to the proposed coach house to be safely retained. To mitigate the damage caused to tree #3 in the future, it is recommended that the existing wood fence on the eastern side of the property be altered to accommodate its protection during construction.

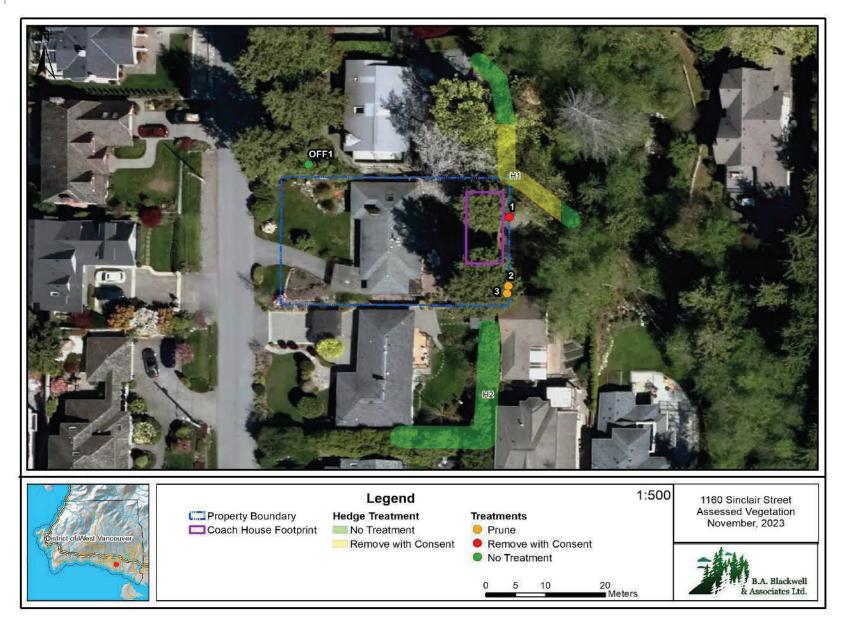
Map 2. Coniferous vegetation assessed on or adjacent to 1160 Sinclair St.

A total of six coniferous trees and hedges were assessed and are described in Table 3. Table 2 summarizes the vegetation assessed by location. Vegetation shared between the subject property and an adjacent property are listed under the adjacent property. Recommendations considered wildfire hazard, condition of vegetation, impacts from proposed construction, and distance from flammable vegetation beyond the property boundaries.

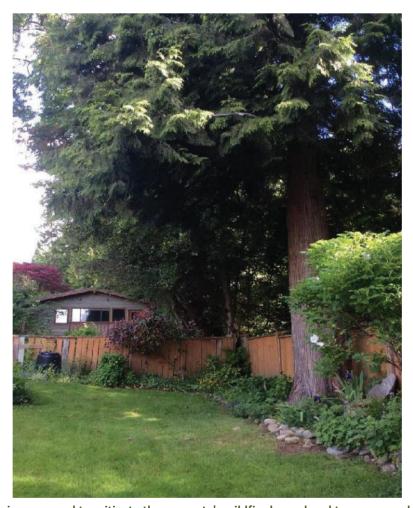
Figure 5. Tree #1 requires removal to mitigate the property's wildfire hazard and to accommodate new construction

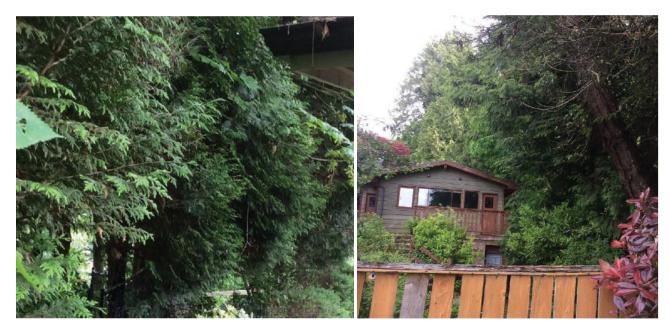
Figure 6. Cedar hedge #H1 is recommended for partial removal within 10m of the planned coach house

Written consent was not received for the removal of the portion of cedar hedge #H1 that overlaps with the neighbouring properties of 1190 Sinclair St., 1231 Sinclair Crt., and 1797 Inglewood Ave. Since no written consent was provided by the neighbours, removing only the portion of #H1 **entirely** on 1160 Sinclair Street will result in the fire hazard for this property being mitigated to the highest reasonably possible level.

Recommended removals include some flammable coniferous vegetation within Priority Zone 1 (within 10m of the planned building footprint) and all vegetation within 1.5m of the planned building footprint. Tree #1 (Figure 5) and H1 (Figure 6, Map 3) are recommended for removal. The removal of tree #1 requires written consent from the property owner of 1797 Inglewood Ave and a permit form DWV due to its status as a protected tree. The removal of portions of hedge #H1 (Figure 6) requires permission from 1190 Sinclair St., 1231 Sinclair Crt., and 1797 Inglewood Ave.

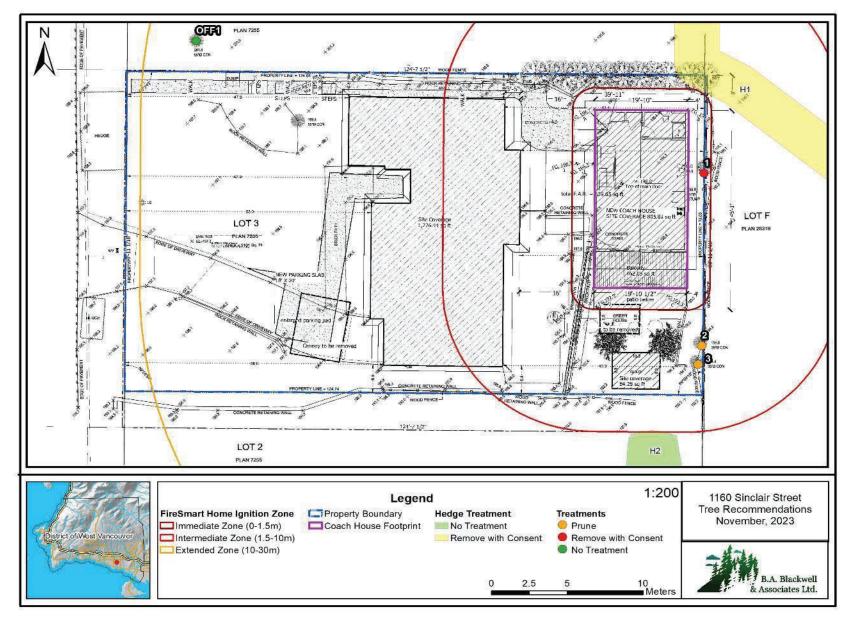
Map 3. Map of treatment recommendations for vegetation on and adjacent to new construction

Tree #2 and 3 are recommended for pruning 5m away from the coach house as their crowns will come within close proximity to the coach house. Trees must only be pruned on the property of 1160 Sinclair St. Tree #3 will require a tree permit from DWV for any pruning work to be done.

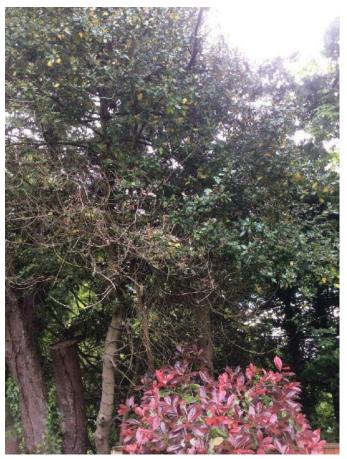
Figure 8. Invasive English holly at 1190 Sinclair St. is recommended for removal to prevent future spread

English ivy (Hedera helix), English holly (*Ilex aquifolium*), and English laurel (*Prunus laurocerasus*) were found on or adjacent to the property during the assessment. It is recommended that these invasive plants be cut and the roots dug out during excavation/development activities. Remove all vegetation parts off site; dumping onto adjacent land is not acceptable. For the removal of the specimen English holly, consent must be granted by the property owner at 1190 Sinclair St. (Figure 8); removal of this tree is strongly recommended, as the crown extends onto the property above the proposed building site, and is likely to spread once the ground below becomes disturbed during construction.

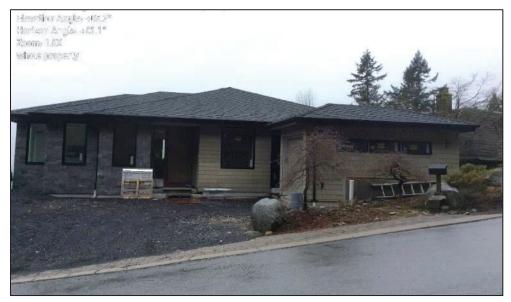
Figure 9. Example of a failed PDI

In order to obtain an occupancy permit, properties under development within the Wildfire Hazard DPA must have a QP demonstrate that all of the fire hazard mitigation measures that were recommended in the wildfire hazard report have been completed. Figure 9 shows a property that failed the first Post-Development Inspection (PDI), and Figure 10 shows the same property once the PDI was completed. All construction and landscaping (including lawn installation, if applicable) must be completed before booking a Post-Development Inspection. Failure to follow the recommendations in this report may result in delays in obtaining final occupancy.

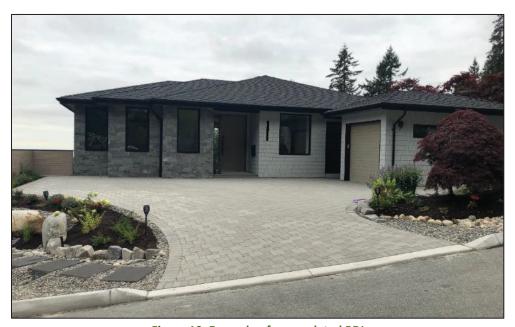
Figure 10. Example of a completed PDI

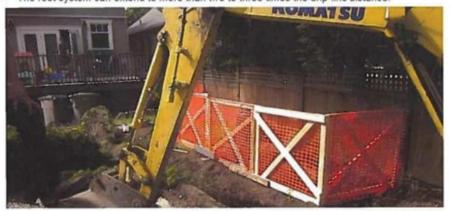
- A tree's root system grows within the top 60 cm of the surface of good quality, well drained and uncompacted soil.
- · The root system can extend to more than two to three times the drip-line distance.

Tree fencing-wood framed snow fence

The best way to ensure that tree protection zones (TPZ) are maintained is to install tree protection barriers (fences) around the TPZs of all retained trees. It is recommended that an ISA Certified Arborist is contracted to attend the site at regular intervals to ensure that barriers remain in good condition and to address any issues that may arise as the project progresses.

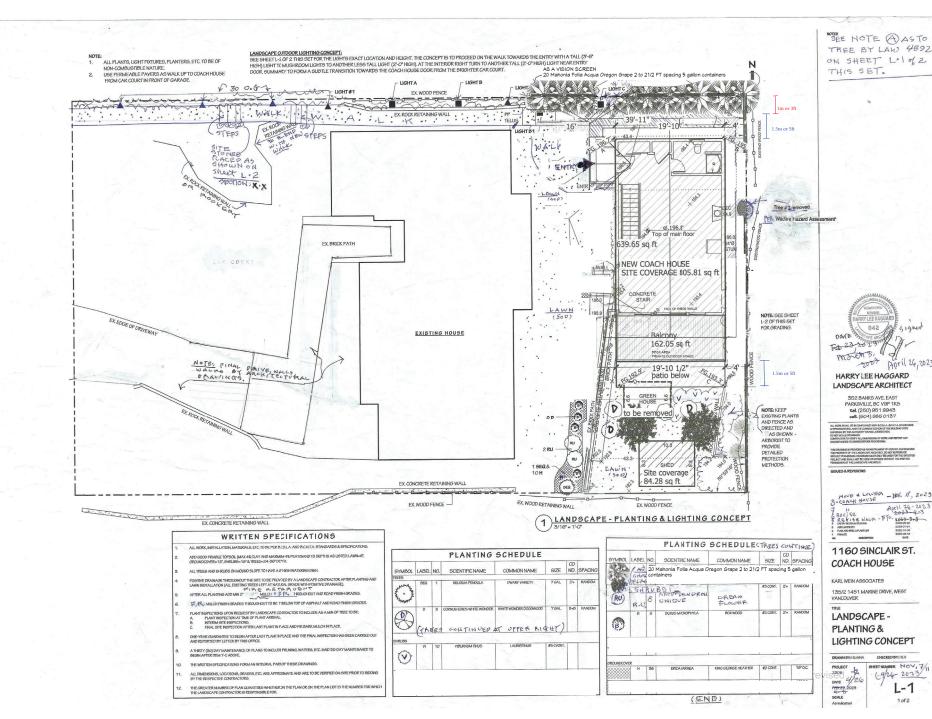
Schedule C

THIGH) LIGHT TO MUSHROOM LIGHTS TO ANOTHER LESS TALL LIGHT (2-0" HIGH). AT THE INTERIOR RIGHT TURN TO ANOTHER TALL (2-0" HIGH) LIGHT NEAR ENTRY EXISTING ROCKERY IN THIS AREA (18" TO 20" HT.) ADD TO SETS OF STEPS NOTE: FROM TELUS POLE TO STEPS REBUILT STONE RETAINING WALL TO ACCON NEW WALKWAY AND 3' WADE PLANTER TO GO UP TO GOVER LIGHT 1A OF FOUR AND 5" RISERS (1) MOODEN FENCE AS A VISION SCREEN
20 Mahonia Folia Acqua Oregon Grape 2 to 21/s
2 Ff spacing 5 gallen containers
2 Ff Spacing 5 gallen Containers
2 Ff Spacing 5 gallen Containers PLANTS SEE SHEET L-1 LIGHT # HOUSE EX BRICK PATH NOTE EXISTING LAWN TO REMAIN AS IS WALK OVER EXISTING ROCKERY EX. CONC. RETAINING WALL. 5" R 15" T EXISTING EXISTING MALK MALK HOUSE (ROCKERY TO STAY AS IS AS NEEDE DISTANCE DETERMINED ON SITE BY BY LANDSCAPE CONTRACTOR SECTION "X-X" NEW STEPS 5" R 15" TR NOTE: KEEP EXISTING PLANTS AS DIRECTED EXISTING ROCKERY NOTE: SITE STONE PLACED BY LANDSCAPE CONTRACTOR Ā. () PLAN VIEW FOR GRADE TRANSITION STEP TO BE 1/3 INTO GRADE EX. MOOD RETAINING MALL EX. WOOD FENCE STABLE SOUND AND SAFE STEP AND SIDEWALK EX. CONCRETE RETAINING WALL
