BINNING HOUSE

CONSERVATION PLAN

THE BINNING HOUSE CONSERVATION PLAN

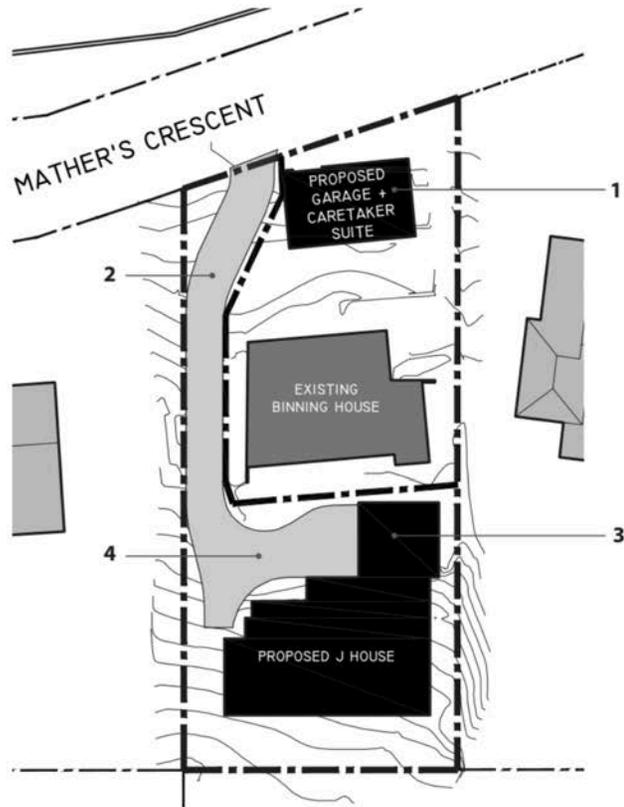
Original Proposal 2017

1. Consider the volume and siting of the proposed new garage and caretaker suite;
2. Access to the new j_House;
3. Volume, scale and proximity of the j_House in relationship to the Binning House;
4. Reconsider the extent of manipulation of the landscape to accommodate the proposed driveway.

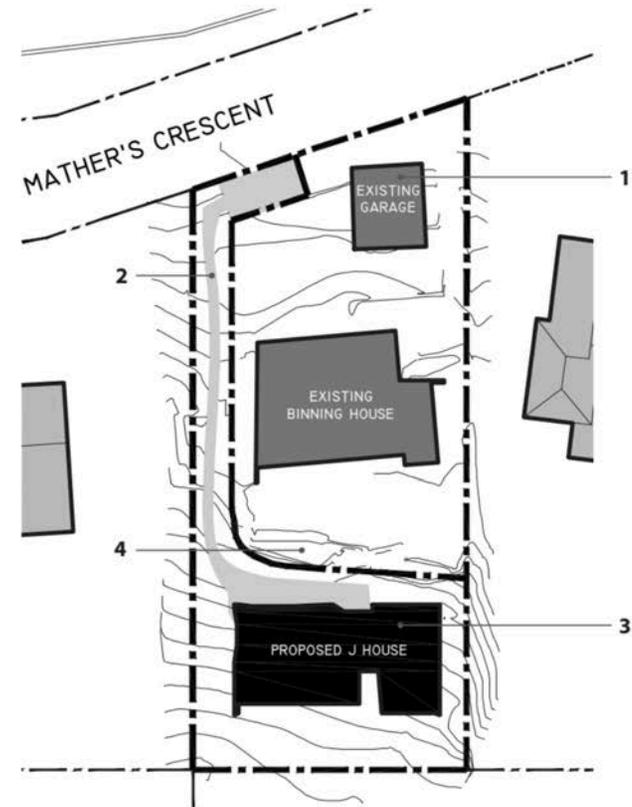
Revised Proposal 2018

1. New garage + caretaker suite omitted. Existing garage to be restored.
2. Access to the new j_House is via an exterior footpath from off-street parking.
3. j_House is now 40'-0" away from Binning House and 5'-0" lower than Binning Main Floor.
4. Footpath in lieu of driveway / Landscape designed to conceal the j_house and its access.

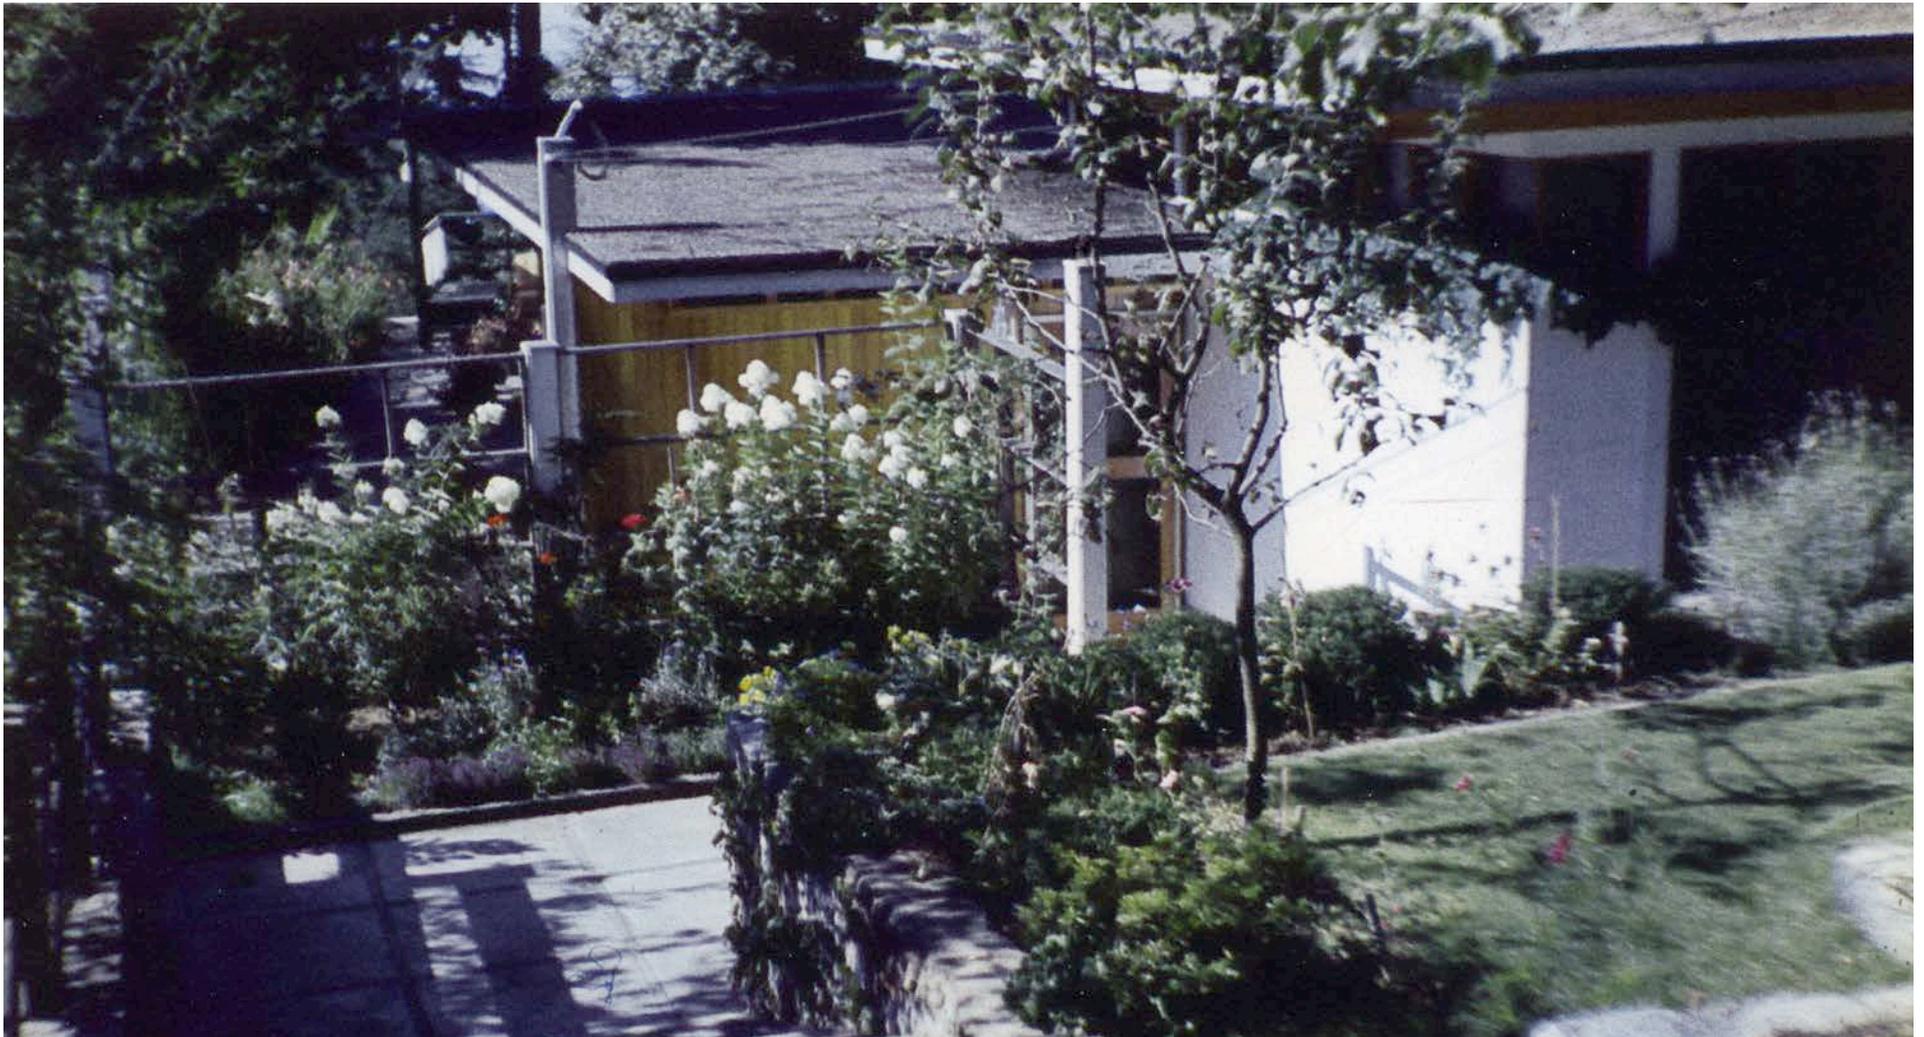
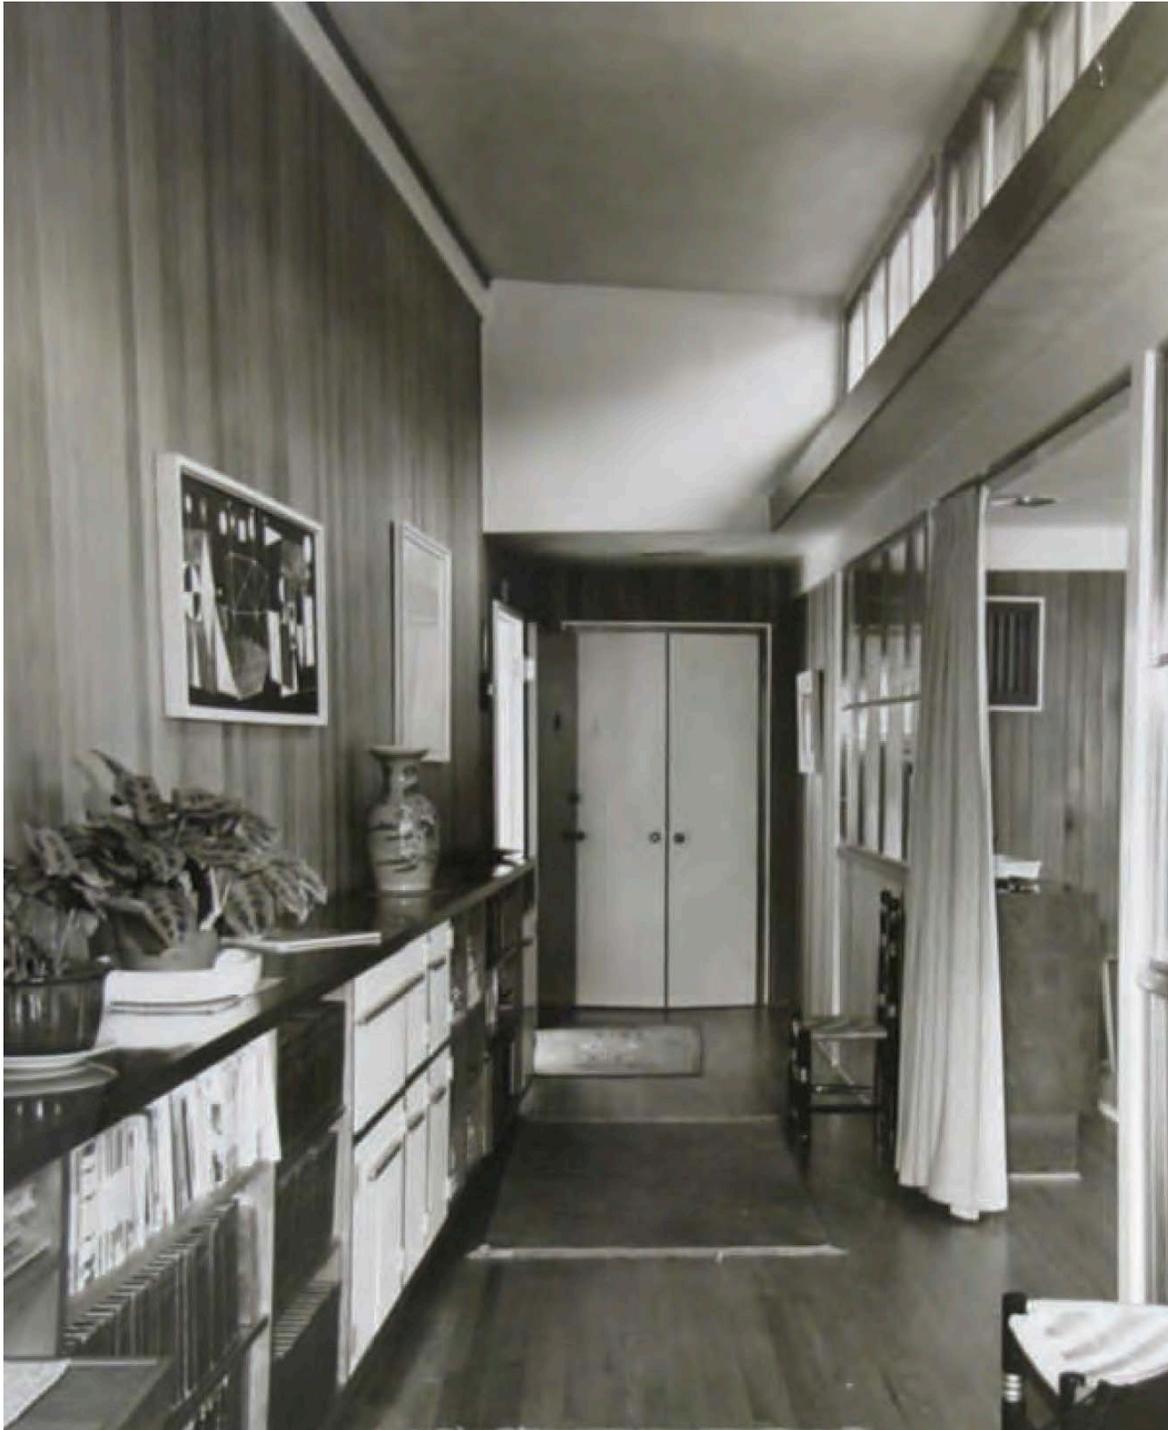
The conservation and revitalization of this significant heritage site involves the subdivision of the existing property to allow an infill dwelling, and conversion of the existing residence into a private gallery.

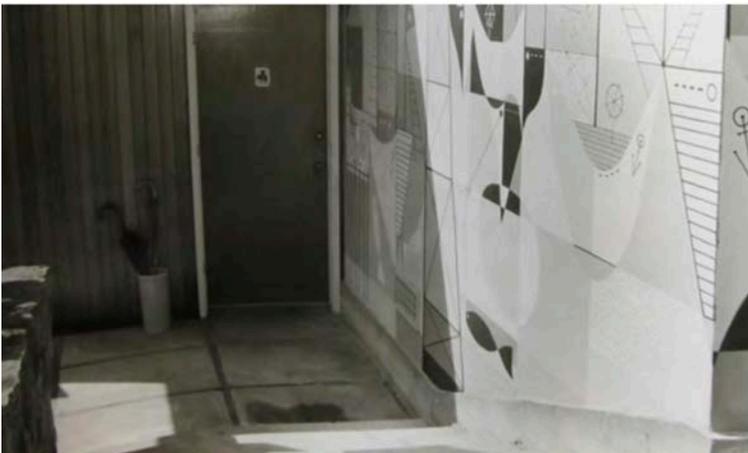
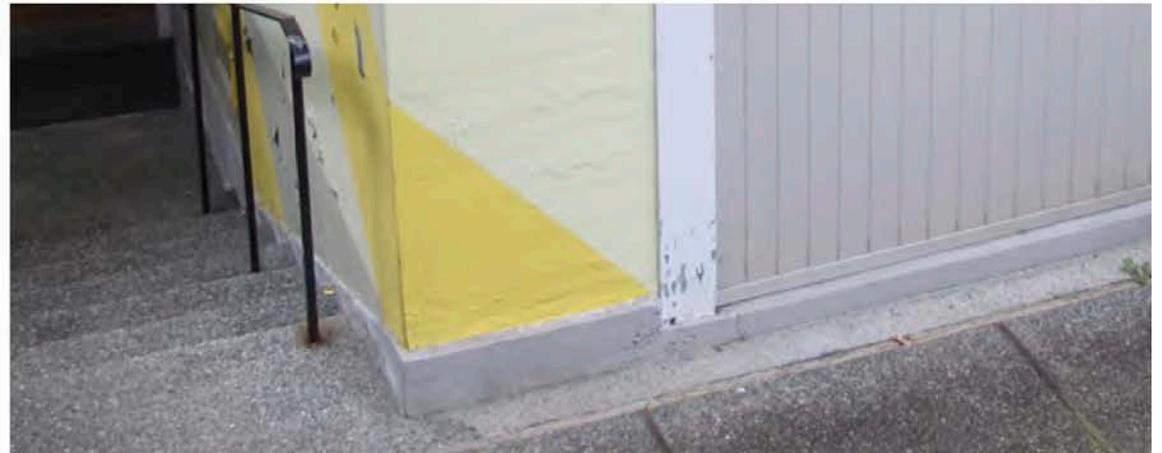
- Form, scale, and massing:
 - The form, scale and massing remains intact, save for a few alterations, and will be preserved.
 - The bathroom, added in 1989 to the west elevation and a later shed attached to the bathroom will be removed.
- Masonry:
 - Concrete foundation, chimney, and stonework will be preserved and repaired as necessary.

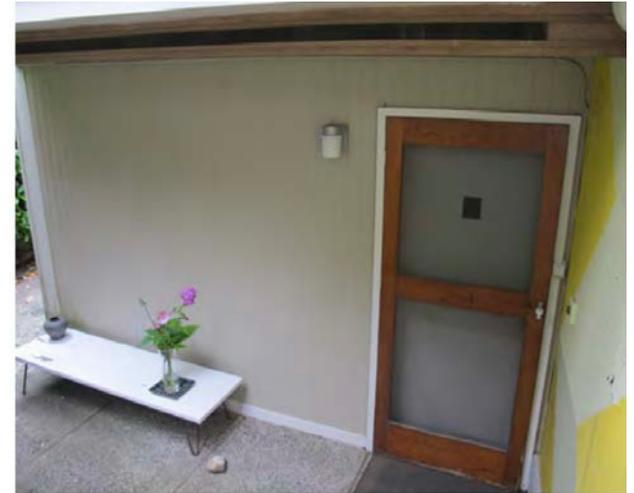
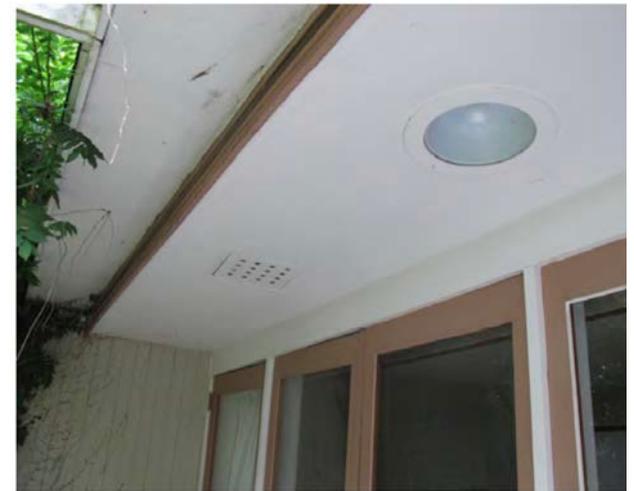
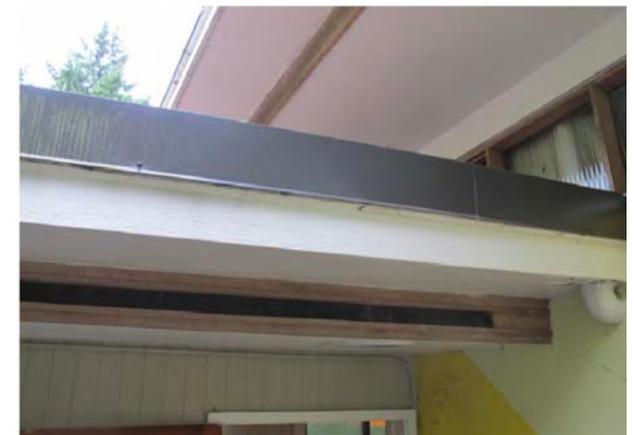
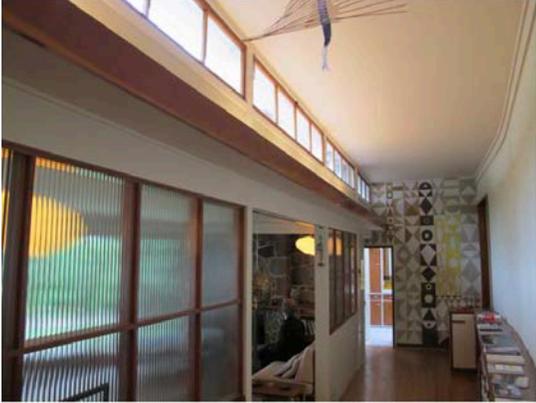
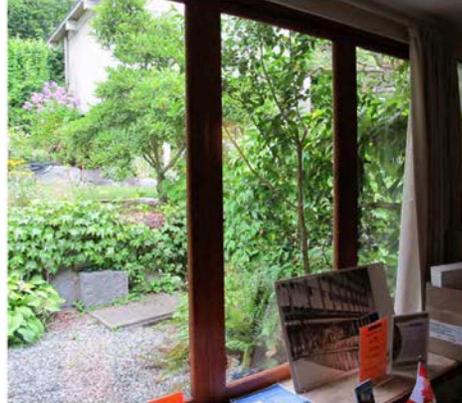
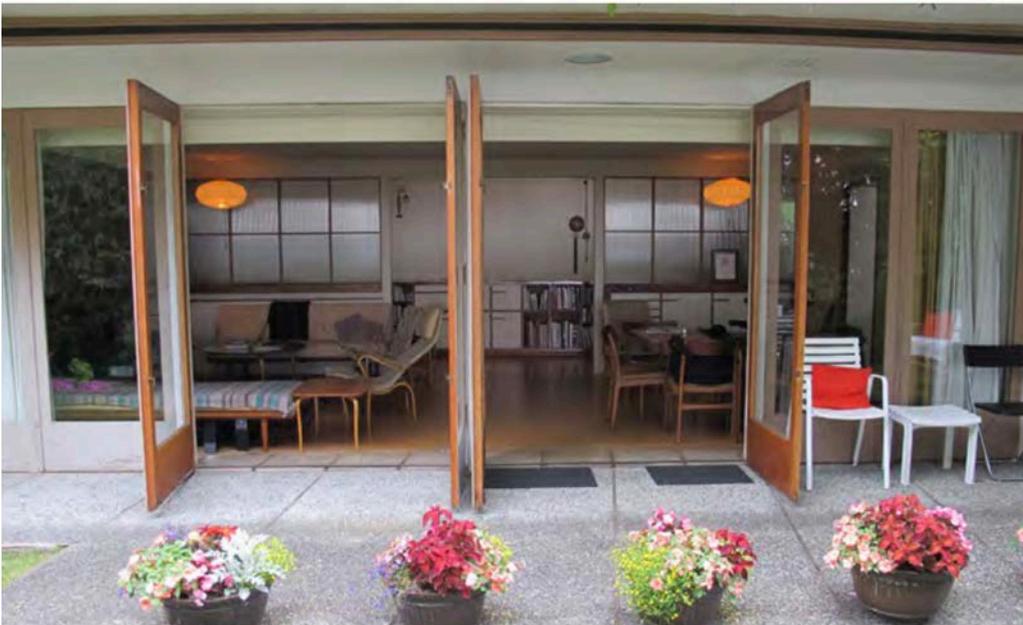
- Wood:

- The main structural system of the Binning House consists of post-and-beam above the concrete foundation walls.
- Other exterior wood elements include panelling, and corner and baseboards.
- The soffits of the cantilevered roofs are finished with painted wood cladding, which is in good condition.
- Wood elements will be preserved and repaired as necessary.

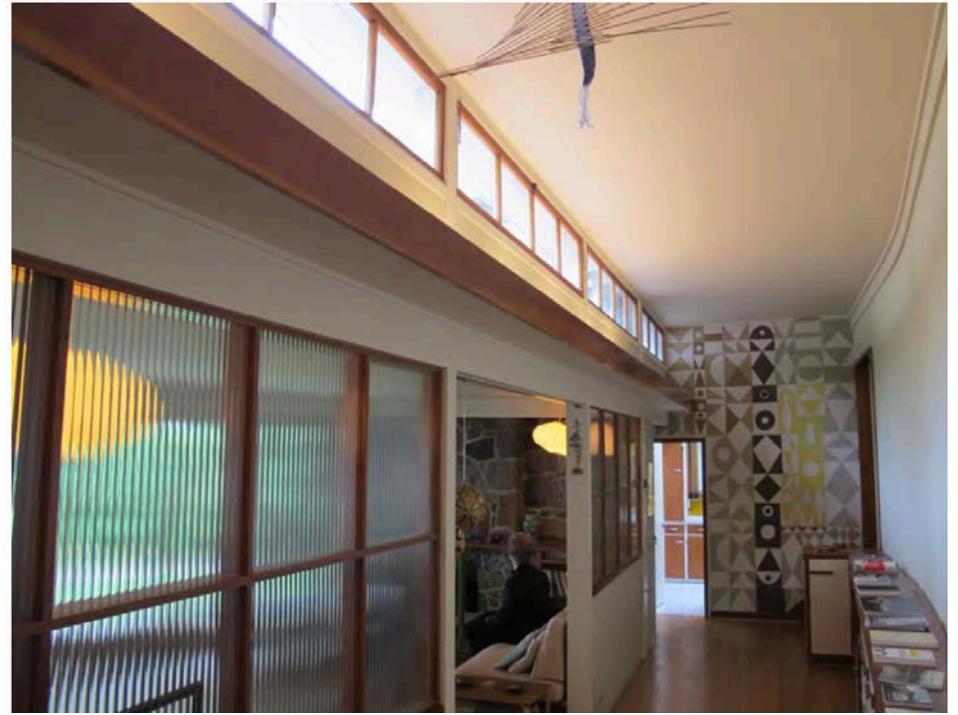
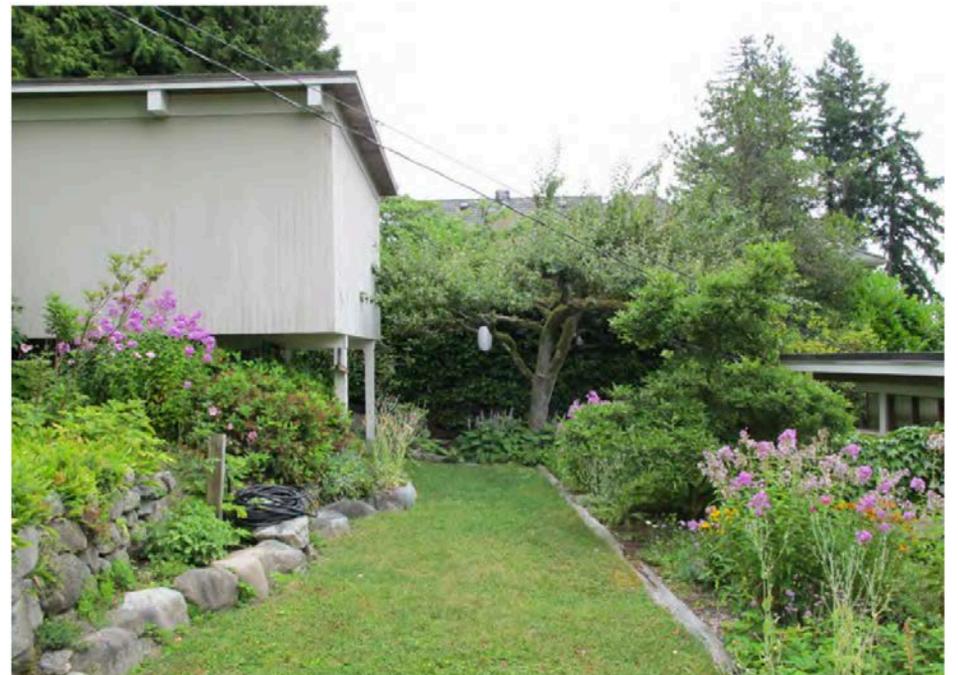
- Windows and Doors:
 - The Binning House incorporates daylight and views as central features of the architectural design; the window and doorframes are made of local cedar.
 - Original windows and doors will be preserved and repaired as necessary.

- Interior:
 - The interior of the Binning House, including the main hallway, living room, bedrooms, and B.C.'s studio, will be preserved. The original kitchen and bathroom cabinetry will also be preserved.
- Garage:
 - In 1966, the early carport near the street was replaced with the existing structure built into the sloping hill, which will be preserved.

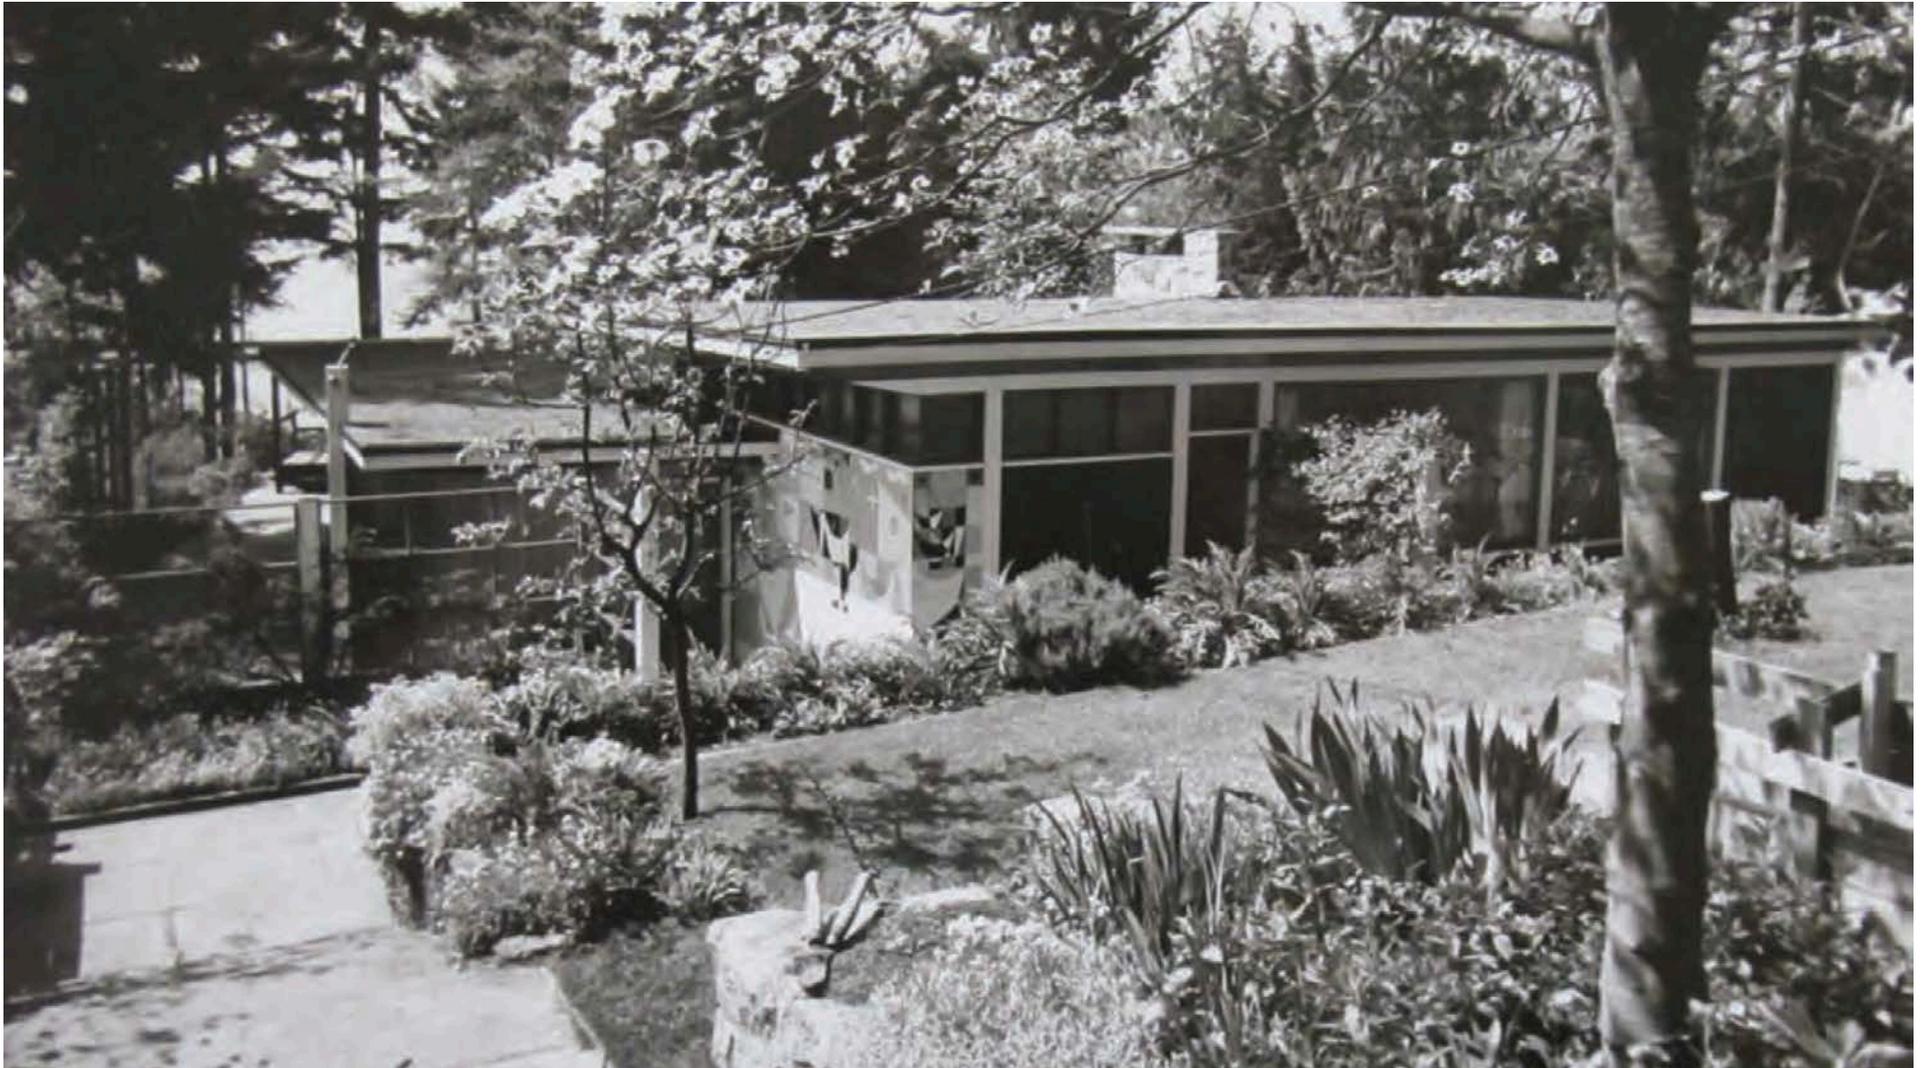
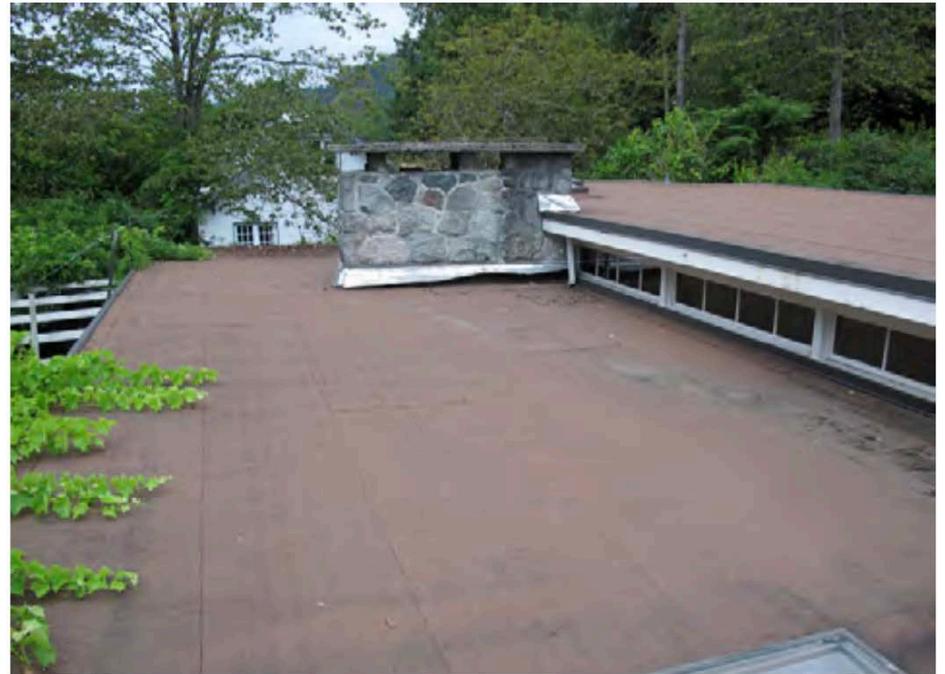
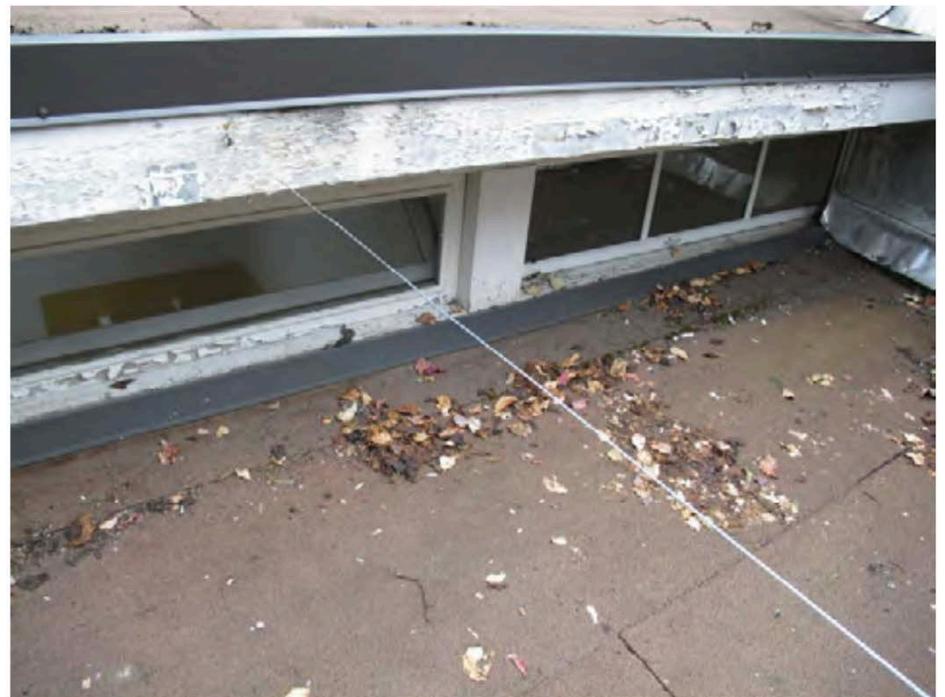
- Roof/Drainage/Chimney
 - The existing roof will be rehabilitated, including sufficient slopes, permanent drainage system and new flashings
- Structural Timber
- Mechanical
- Electrical
 - The existing electrical system will be rehabilitated.

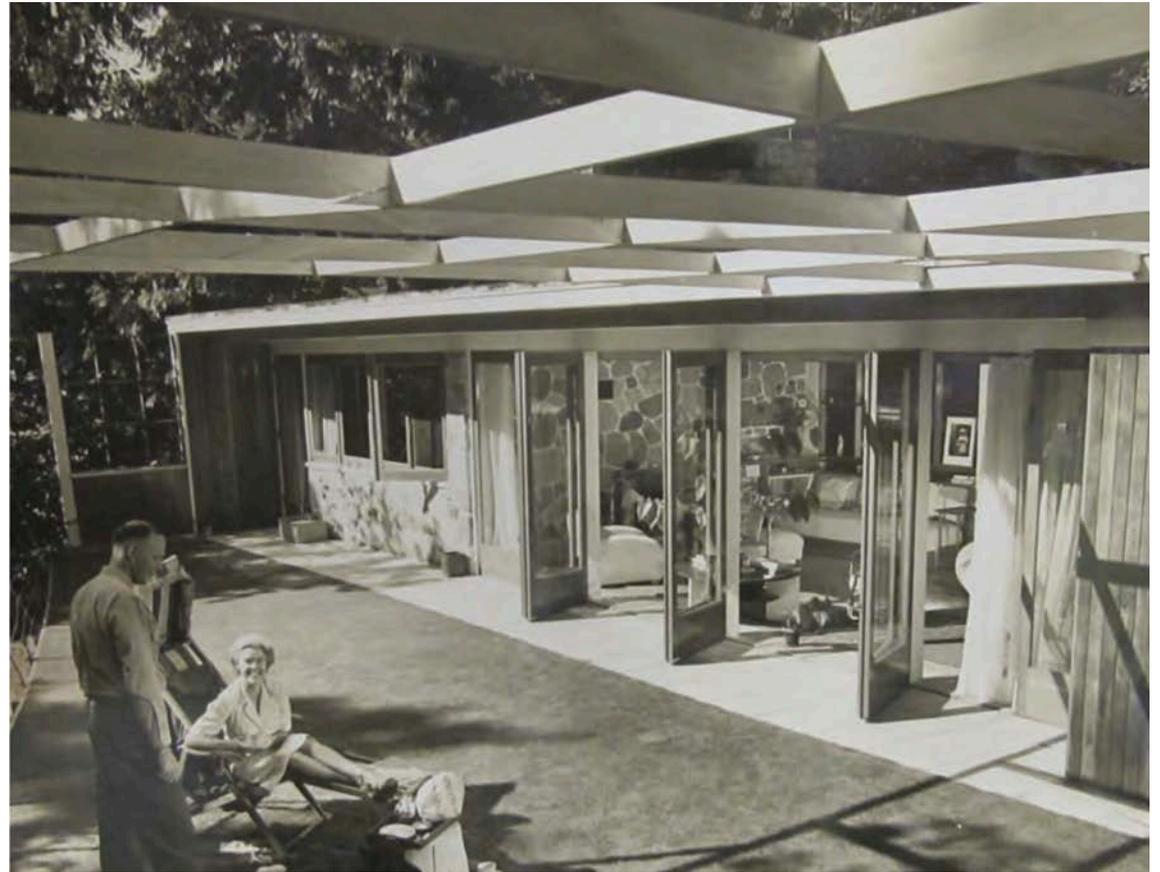
- Trellis:
 - The original large wood trellis was later replaced by a shallow trellis, which extends the full length of the south façade.
 - The original trellis will be restored.

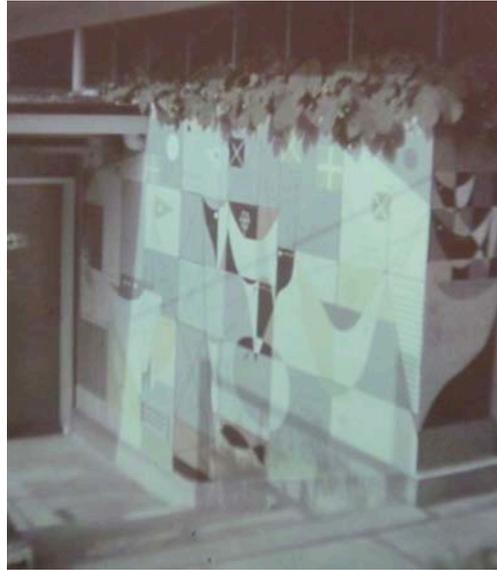
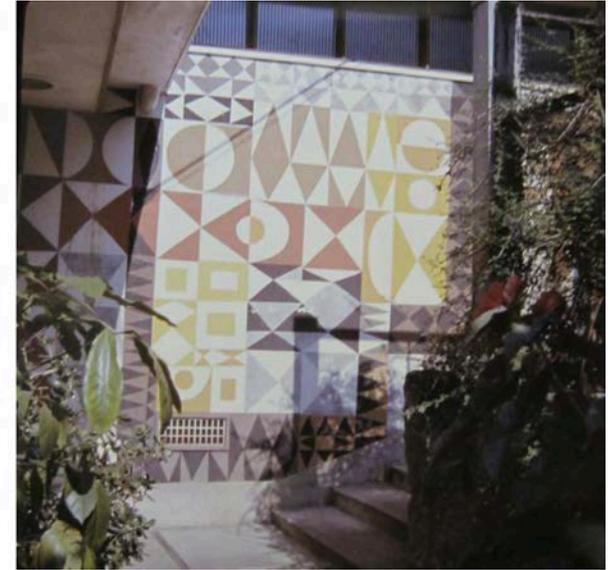
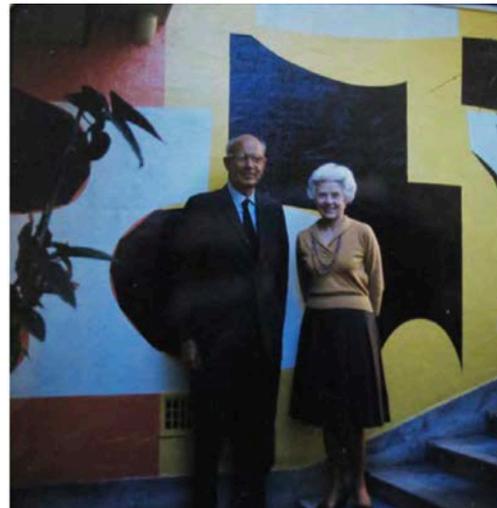
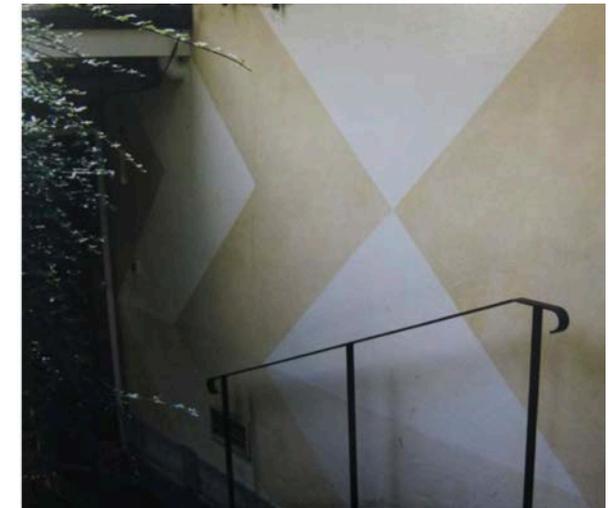
- Mural:

- The northeast corner wall, leading to the main entrance, has displayed a total of four decorative murals painted by Binning between the 1940s and late 1960s or early 1970s.
- Discussions are underway regarding the approach to mural restoration.

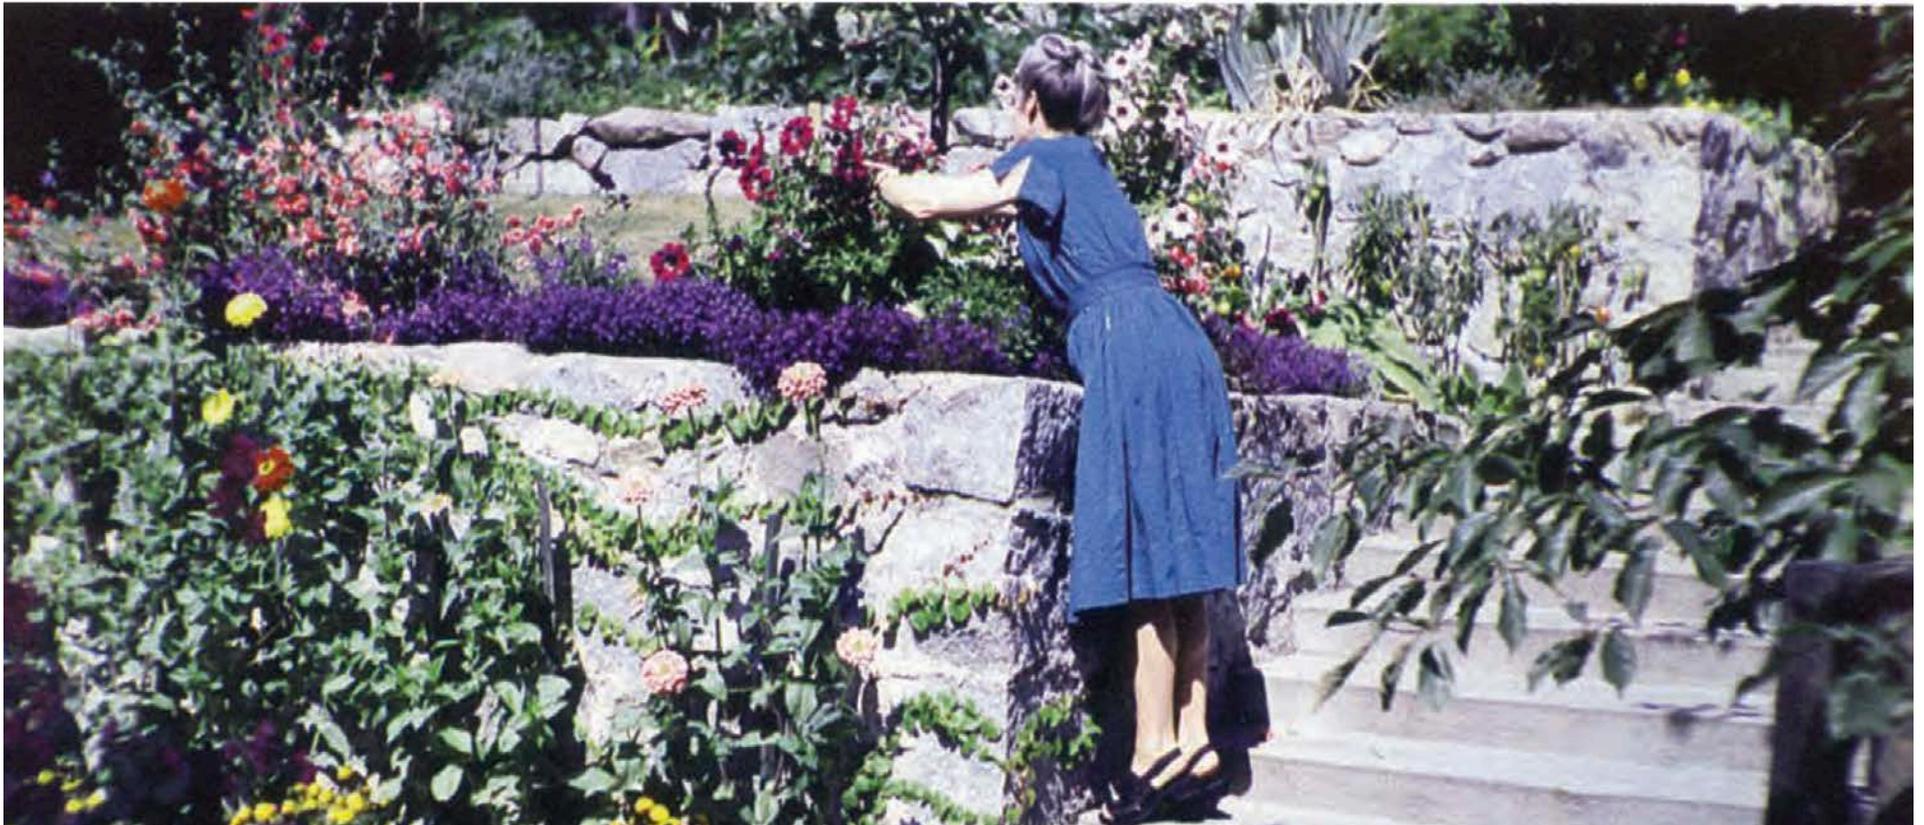
- Landscape:

- A crucial element to the interior-exterior nature of the Binning House, the landscape features will be restored.
- Through photographic evidence of the garden in its early state, the team has worked to identify the plant species and post-war style of planting that Jessie & B.C. Binning had created.
