Notice of Consideration on June 22, 2026

4798 The Highway

Proposed Heritage Alteration Permit 24-090 for 4798 The Highway

Wildfire Hazard DP Area Assessment Report

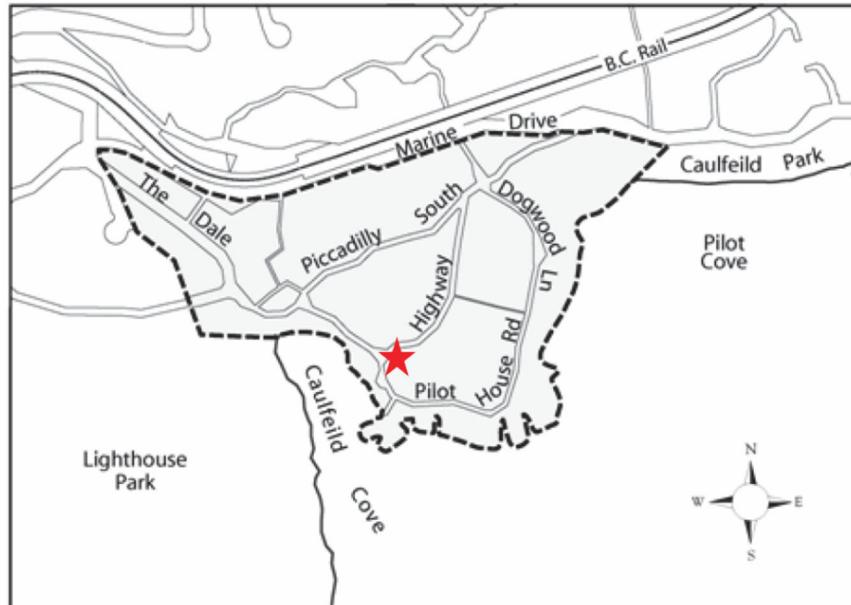
Figure 1 – Lower Caulfeild Heritage Conservation Area

The OCP designates a portion of Lower Caulfeild as the “Lower Caulfeild Heritage Conservation Area” (Figure 1; with the location of 4798 The Highway shown). Accordingly, new residences, amongst other

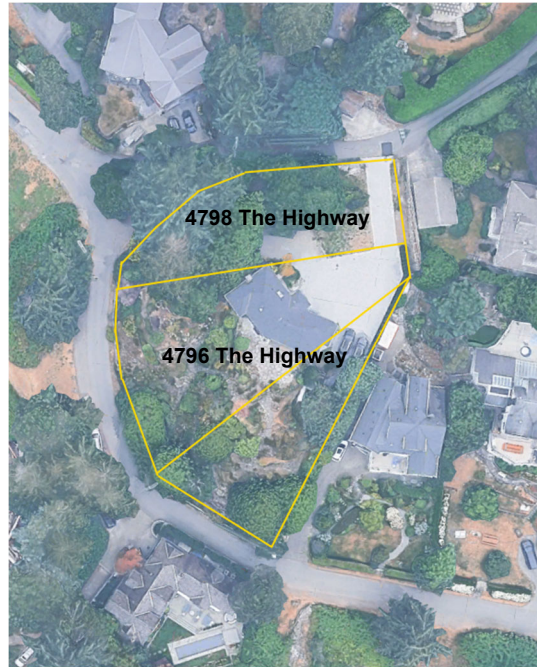
Figure 2 - Aerial map showing historical 3-lot residential site

The subject site, 4798 The Highway, was formed by subdivision in 1904 as part of one of the original subdivisions in the Lower Caulfeild area. Since 1986, the site formed part of a larger residential site that consisted of 3 lots owned by one owner (Figure 2).

The existing residence to the south, at 4796 The Highway, straddles the existing lot lines of that site and has a legally non-conforming setback adjacent to the subject site¹ (Figure 2).

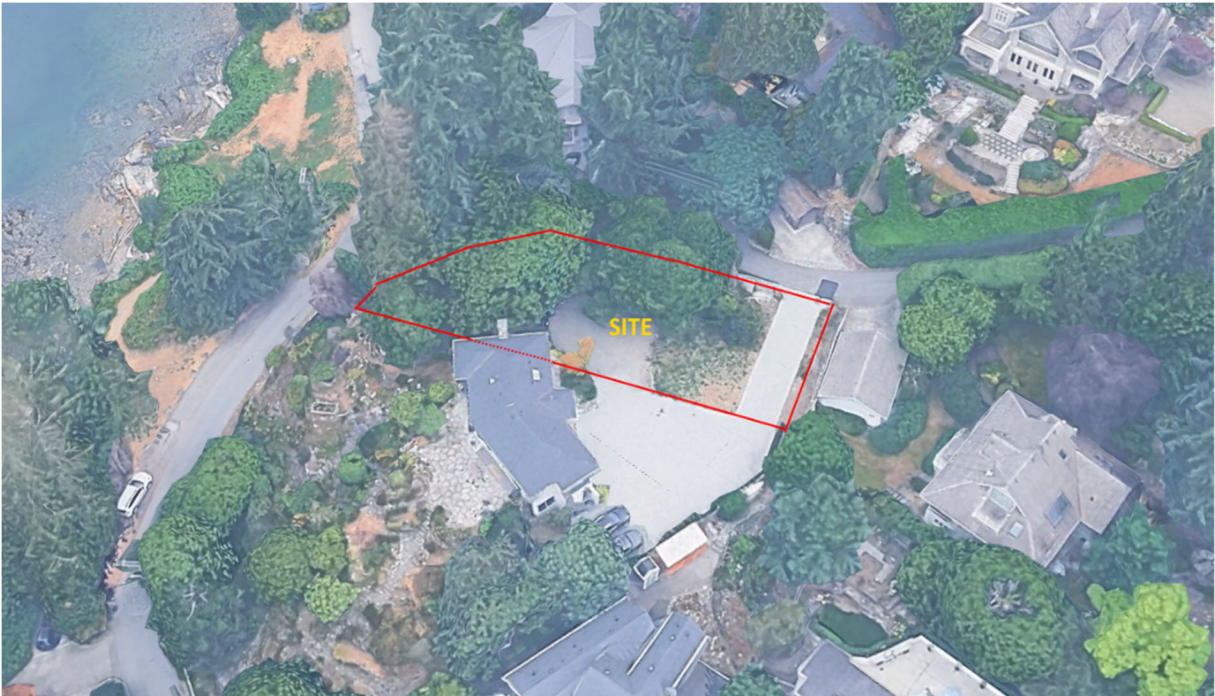
Figure 4 – Aerial image of the subject site and immediate area

The subject property is generally flat, 876.6 m² (9,435.5 sq. ft.) and zoned RS3. There is a cluster of coniferous trees on the western portion of the site, deciduous trees on the northern portion of the site and a centrally located gravel area. As previously described, there is a gravel driveway located on the eastern portion of the site within the easement area (see Figure 4). There is a small standalone residence located on the property in the northwest corner which is proposed for removal. This small structure was used by the previous owner as accessory accommodation (Figure 5)³.

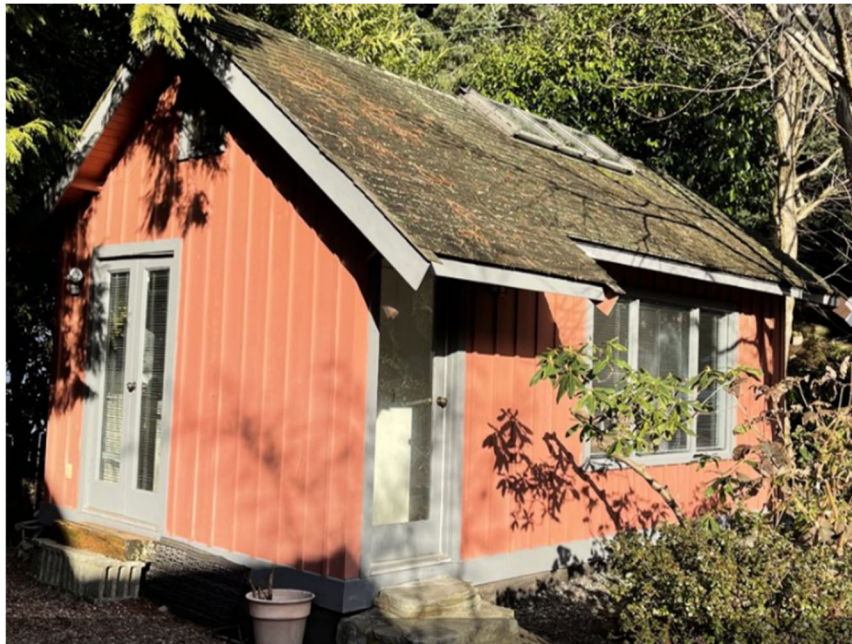
Figure 5 – Photograph of small residence located on the subject site

³ The small existing residence onsite is located 8.4 ft. from the front lot line adjacent to The Highway and does not have any identified heritage value.

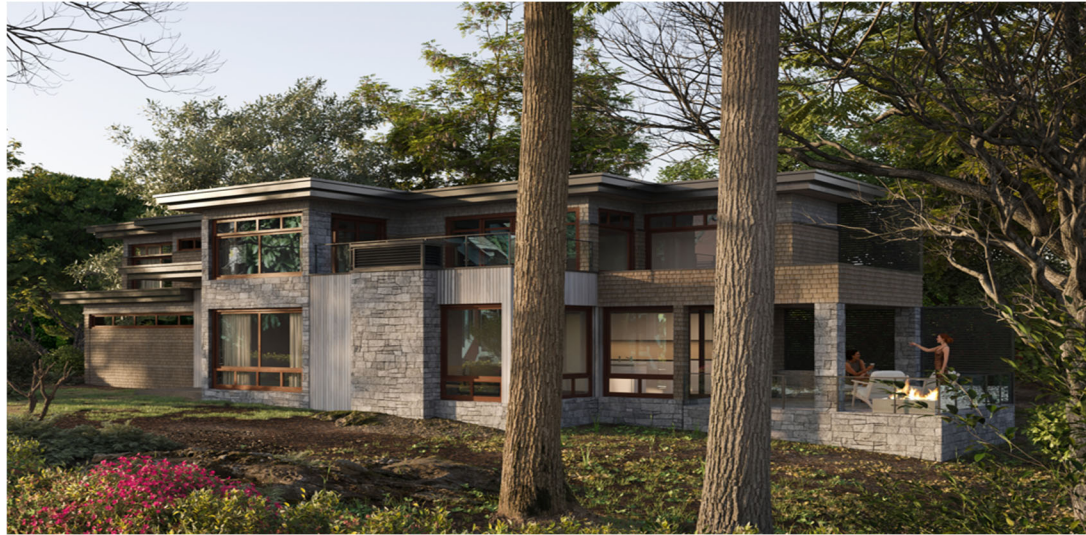
Figure 6 – Rendering of Previous Proposal

The previous proposal included a two-storey residence, with a contemporary architecture, as seen in Figure 6. The proposal required a 2.63 m (8.62 ft.) front yard setback variance to allow for the proposed size and siting of the dwelling (see Figure 7).

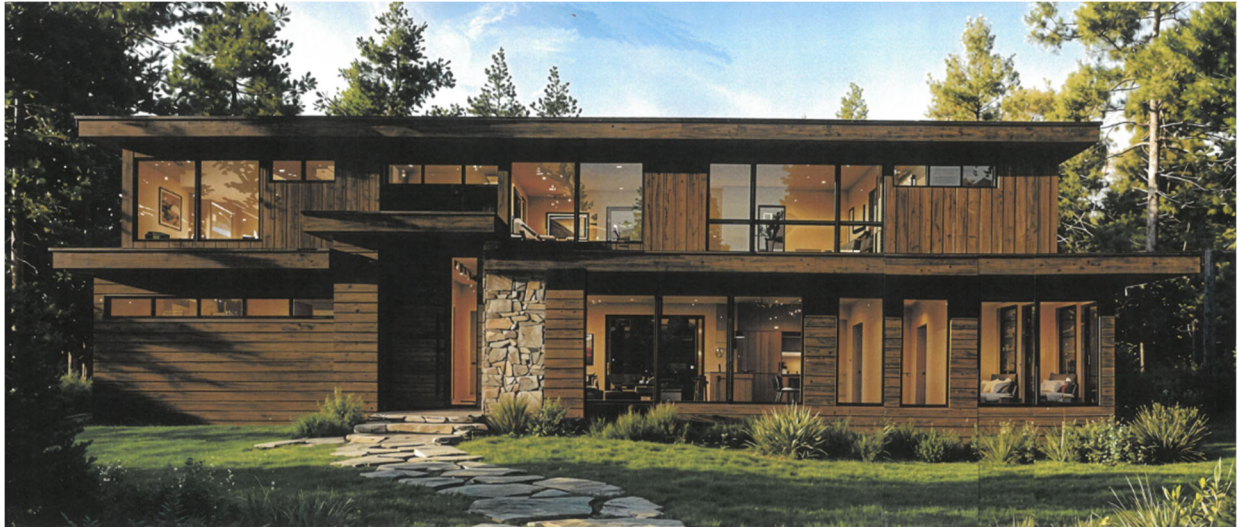
Figure 8 – Rendering of proposed/ revised dwelling (viewed from The Highway [street])

The revised proposal includes generally the same massing (two-storey detached residence, without a basement or secondary suite), with a refined design consistent with West Coast modern architecture. The revisions made are intended to address key neighbourhood concerns and better align with Zoning Bylaw setbacks and the Lower Caulfeild Heritage Conservation Area guidelines. Revisions include a reduced floor area⁴, adjusted siting, and refined material and landscaping selections to address neighbourhood concerns (Figures 8, 9 and 10).

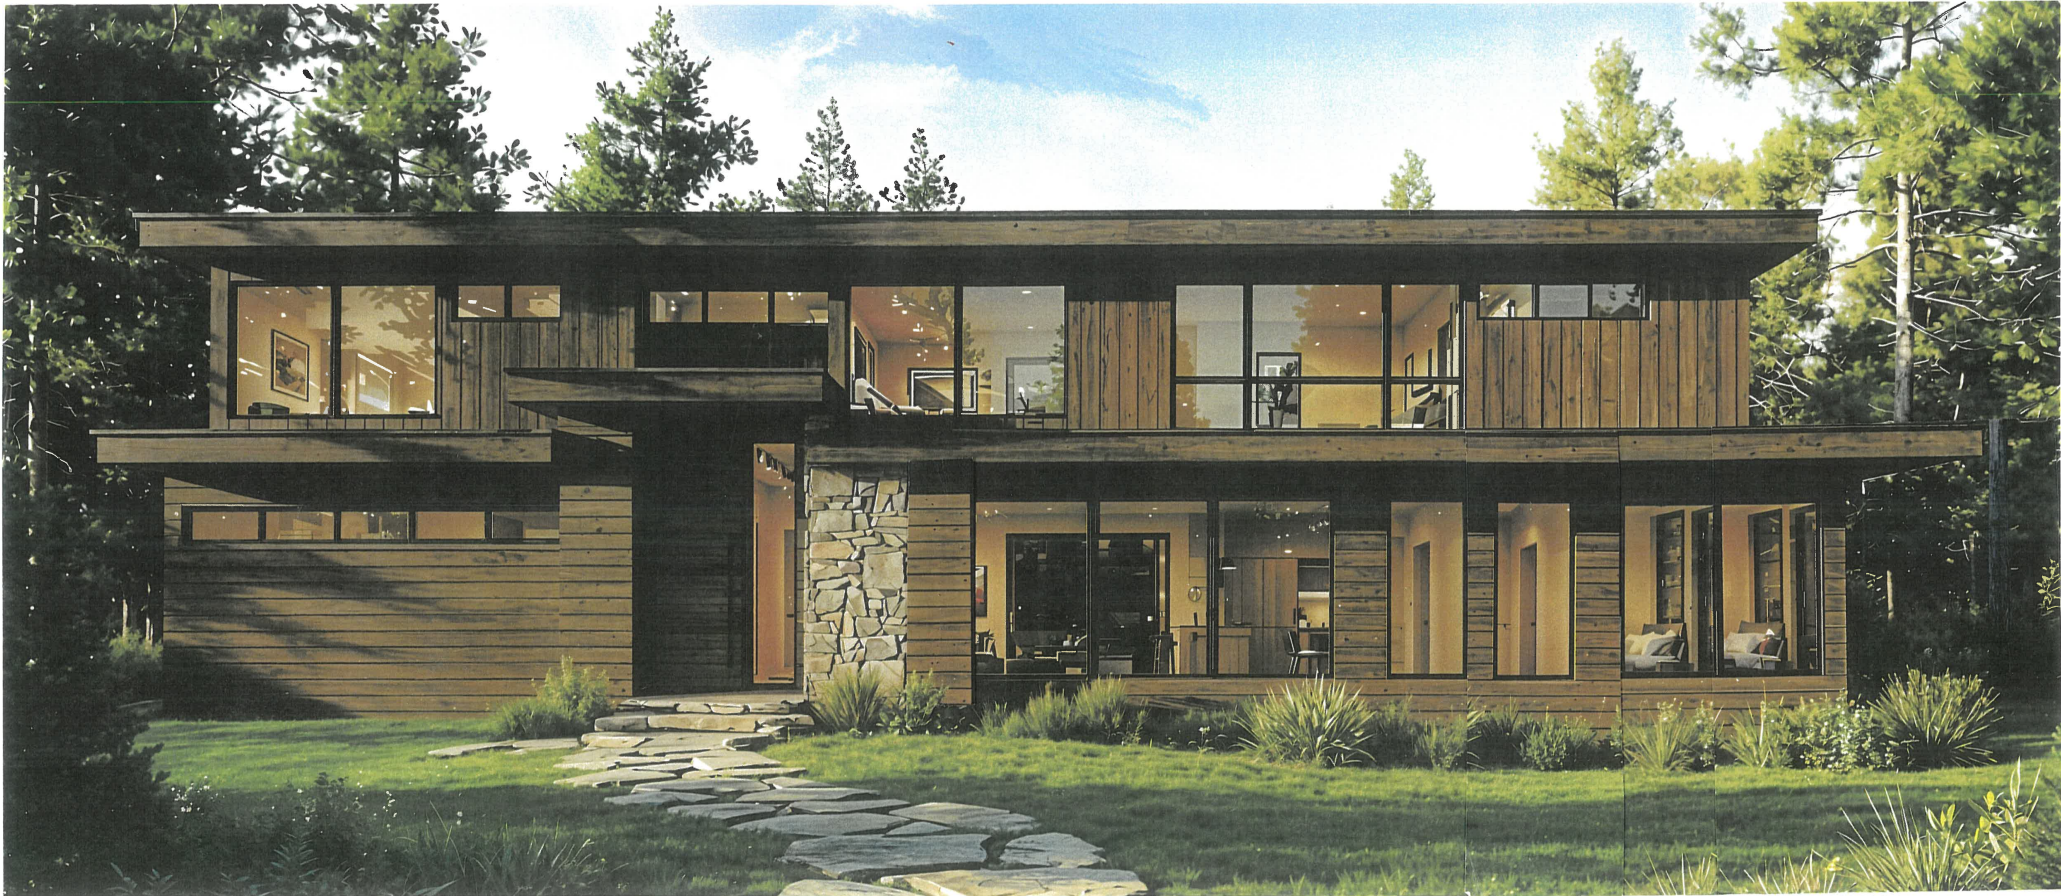
Rendering of residence (viewed from the street)

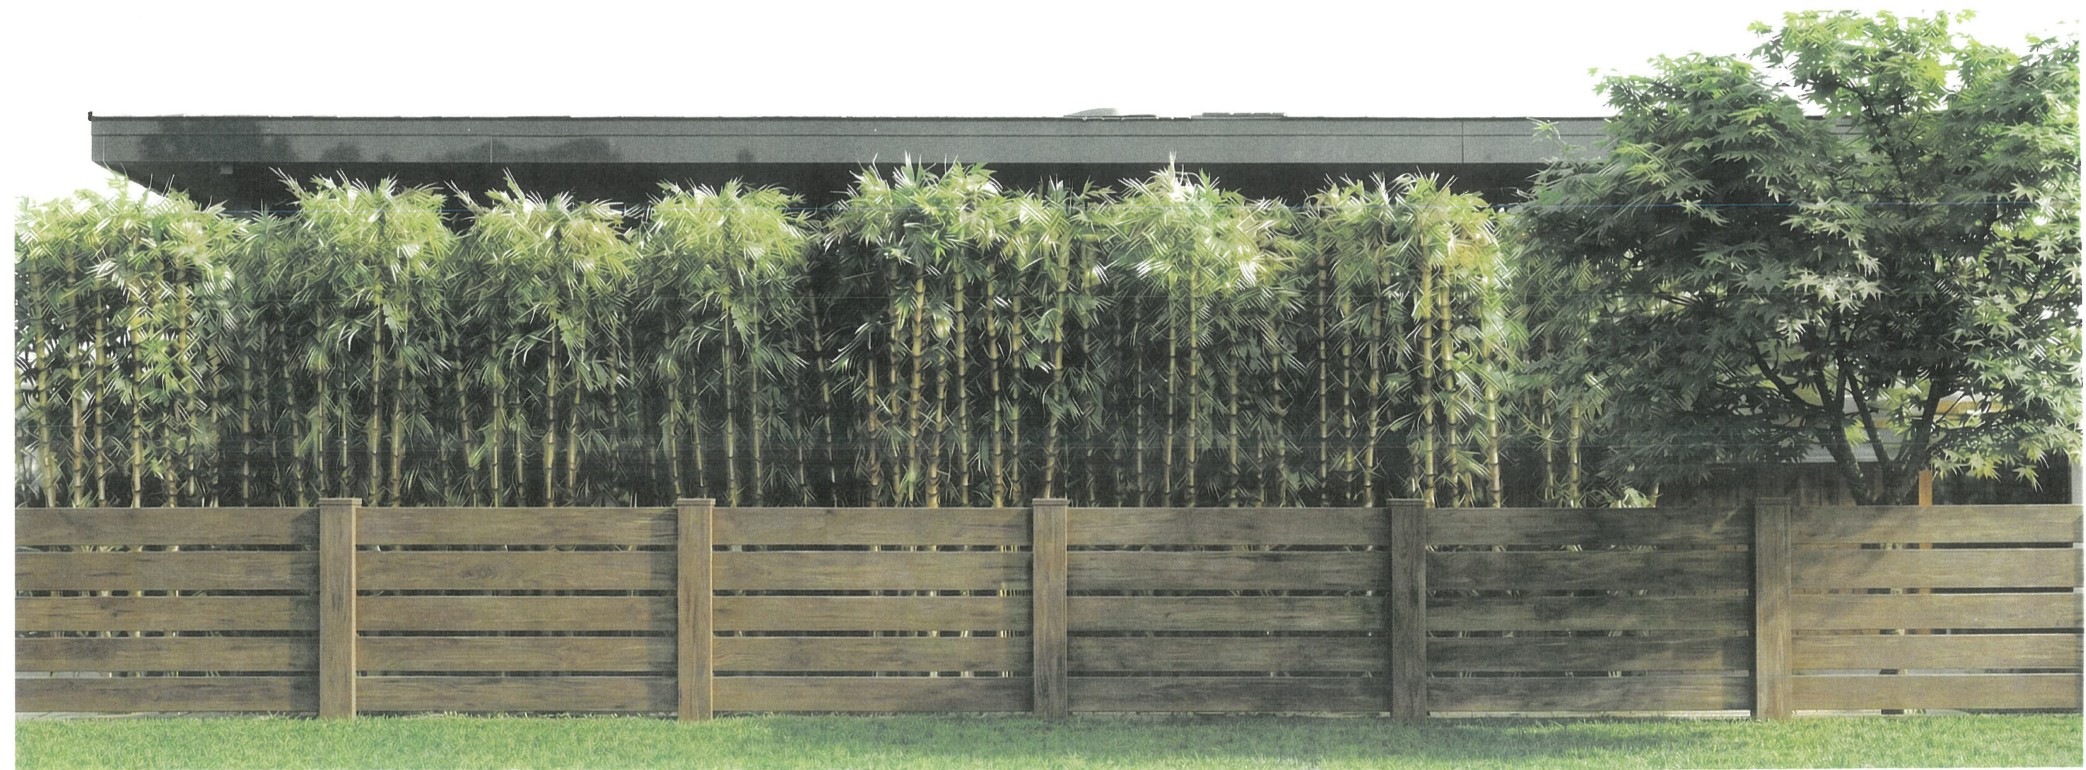
Rendering of residence (when viewed from southern neighbour)

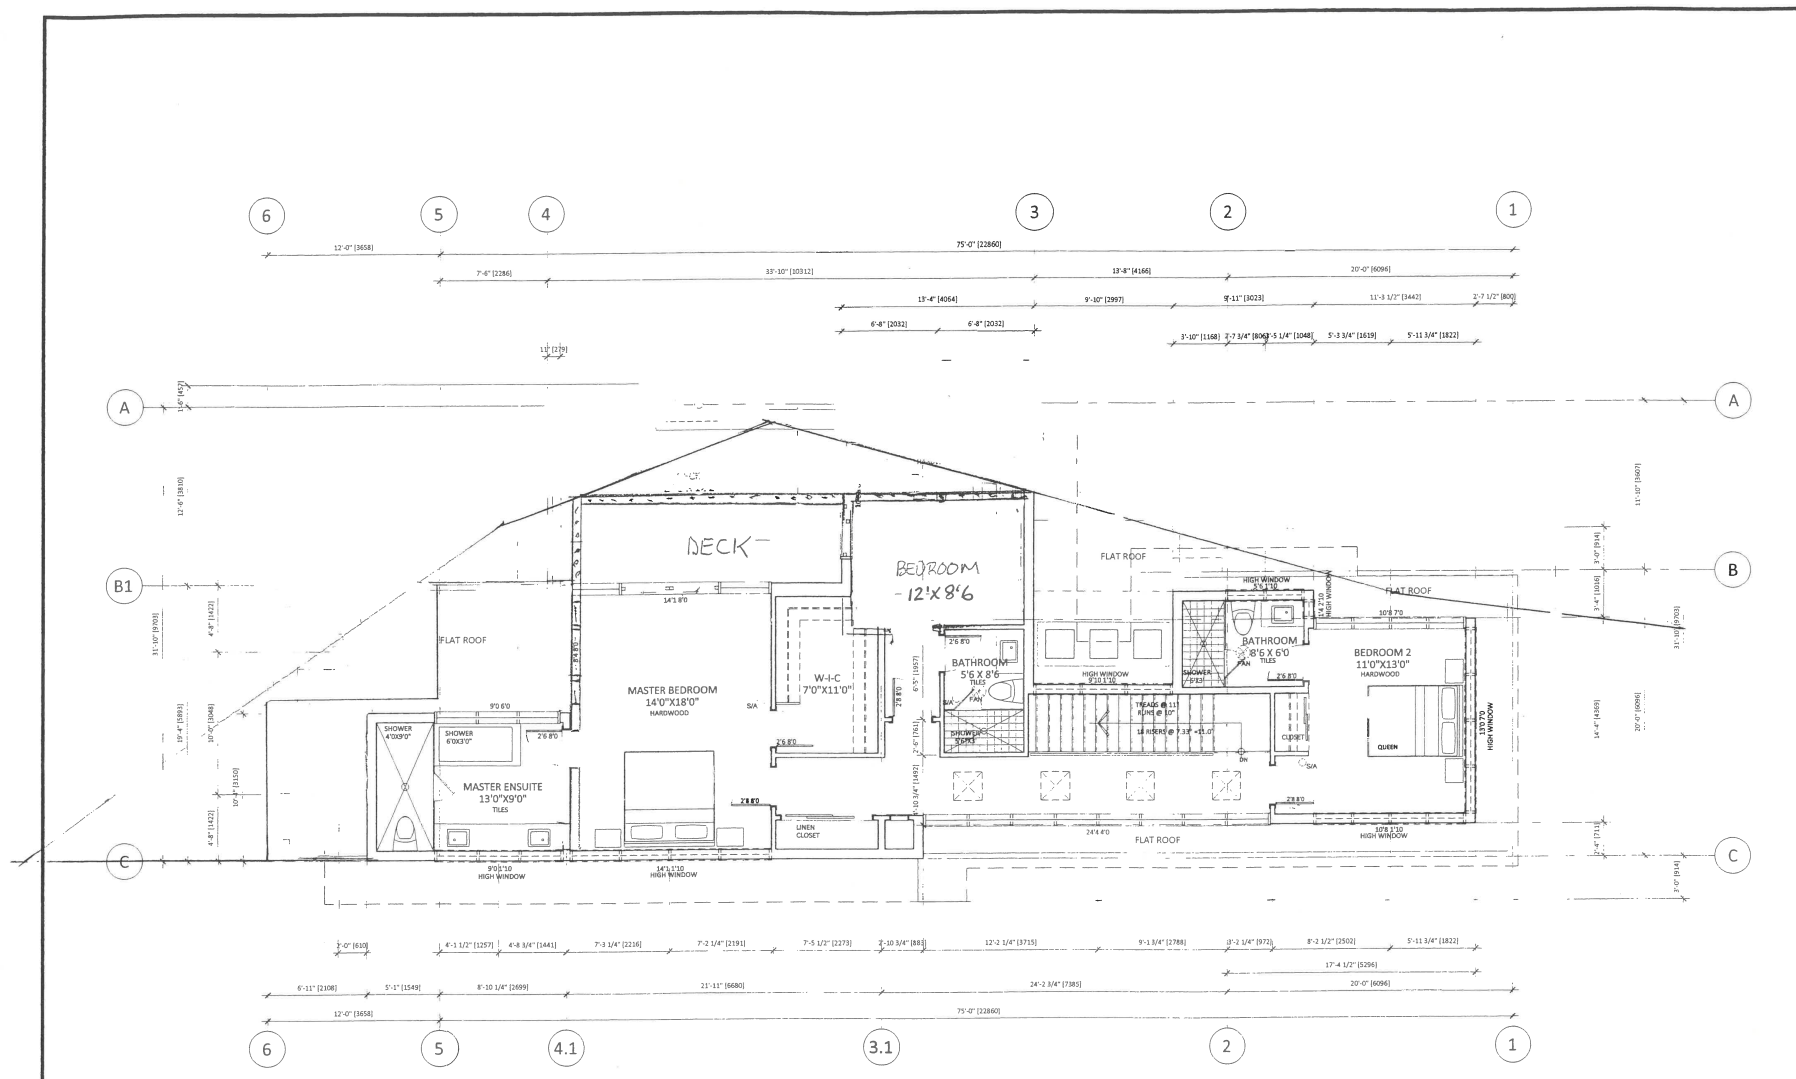
1 UPPER FLOOR PLAN
 SCALE 1/4" = 1'-0"
 RESIDENCE

1272 SQFT =
 118.21 m²

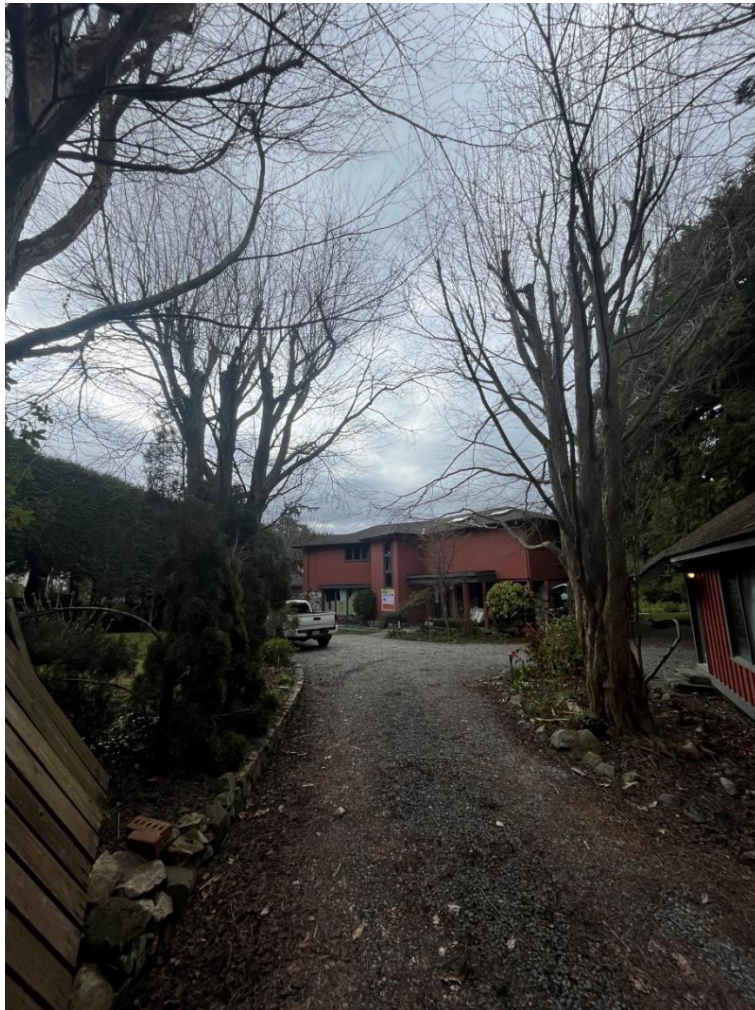
Photo 1. View of the property from The Highway (Looking South).

The proposed development includes demolishing the existing dwelling and coach house and building a new single-family dwelling and foundation in the southern portion of the property. The existing driveway will be removed, and a new driveway will be built along the eastern property line. This driveway will be used to access the property south. Additional hardscaping will be installed around the new home.

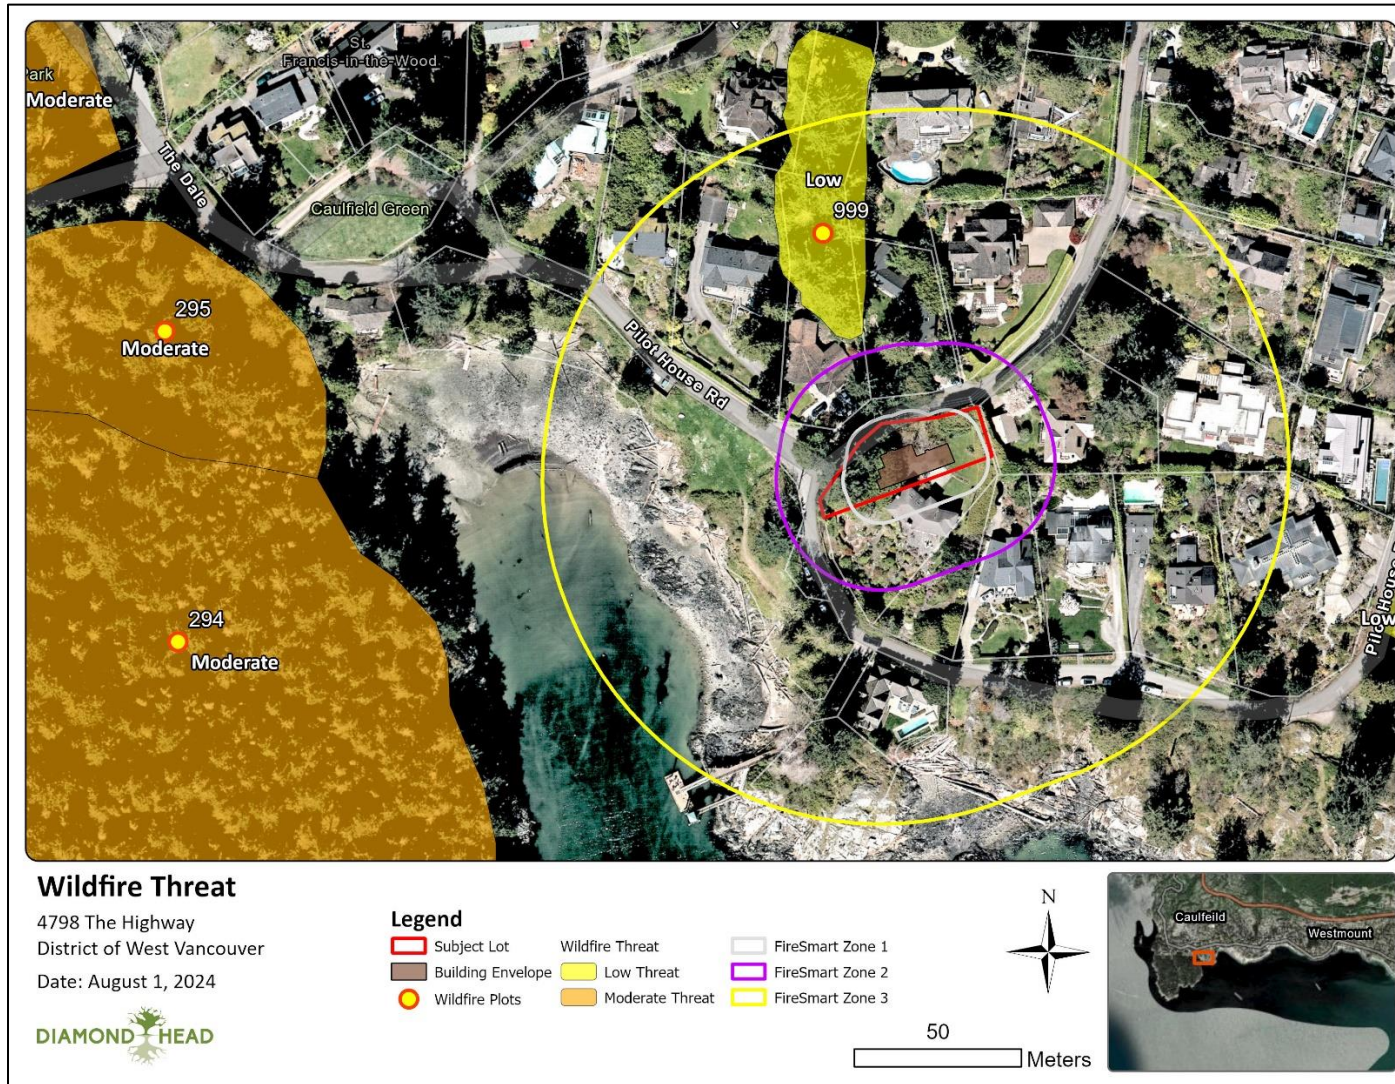
Figure 5. Wildfire threat near the subject site.

The C5 stand approximately 30 metres from the subject site is isolated from the large forests of Lighthouse Park and exhibits below average density and canopy closure, and has minimal dead and downed material or standing dead stems. This stand poses a low wildfire threat. Crown fire in this stand is unlikely under most fire weather conditions. However, surface fire may occur and pose a threat of ignition to nearby homes.

The M2 and C5 stands in Lighthouse Park were assessed to have a moderate wildfire threat. These stands share similar structural characteristics that relate to their moderate wildfire threat. Ladder fuels are patchy, conifer dominant, and generally separated from the canopy by a fuel strata gap of 6-9 metres. The forests of Lighthouse Park are located on a peninsula between the Howe Sound, Burrard Inlet and Strait of Georgia. As a result, the C5 and M2 stands within the park are exposed to winds that affect the canopy and regularly bring down smaller branches and foliage. Additionally, hemlock health issues have killed or damaged many large trees. These two factors have contributed to the above average surface fuel load in these stands and are a leading cause for the moderate wildfire threat observed within the M2 and C5 stands of Lighthouse Park. A crown fire in these stands would likely require extreme fire weather conditions, such as high winds following a period of drought-like conditions. However, these forests are separated from the site by approximately 150m of non-vegetated area, reducing the risk they present to the subject site.

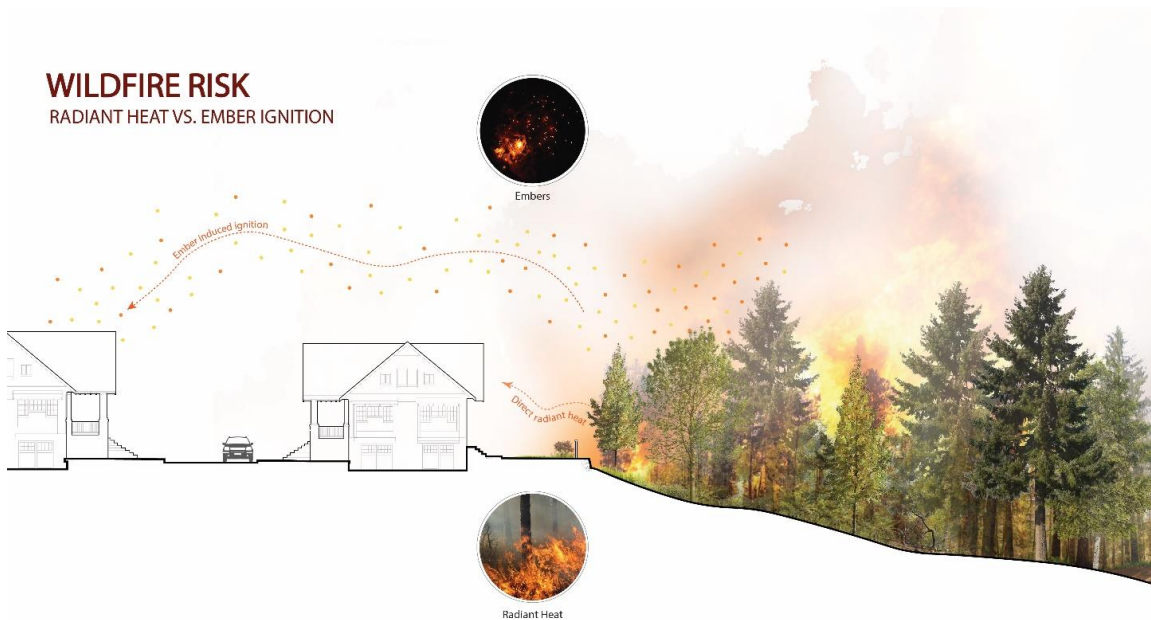
Wildfires threaten structures primarily through radiant heat and ember ignition. Radiant heat threatens structures when a wildfire establishes in adjacent vegetation and the heat is sufficient to ignite the construction materials. This requires proximity between the wildfire and the structure. Ember ignition occurs when a wildfire spreads embers or firebrands throughout an area, which can then ignite structures. Embers can spread several kilometers, and therefore can threaten structures that do not directly interface with forests and natural vegetation.

Figure 6. Ignition pathways in the interface. Radiant heat threatens structures within 10m of the forest edge while embers spread to structures within the interior of the development.

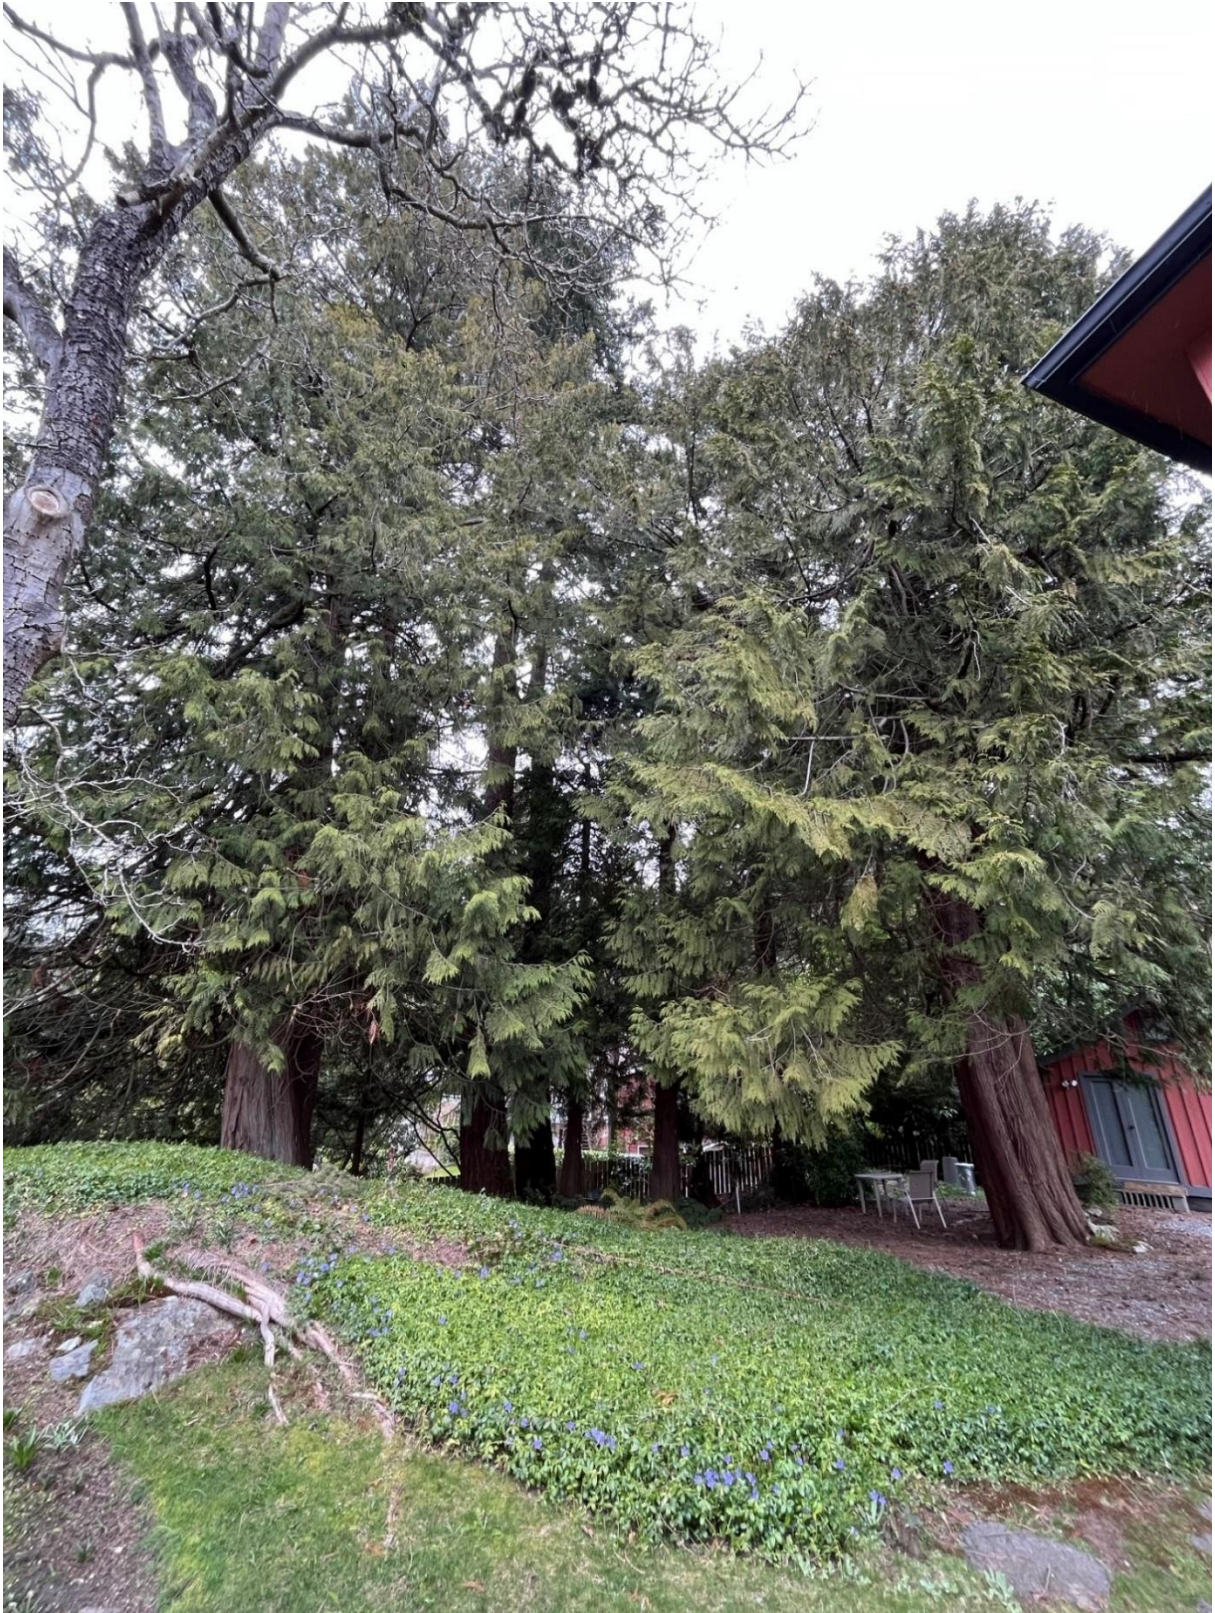
Photo 2. Coniferous vegetation in western portion of property. Most will be removed to accommodate development.

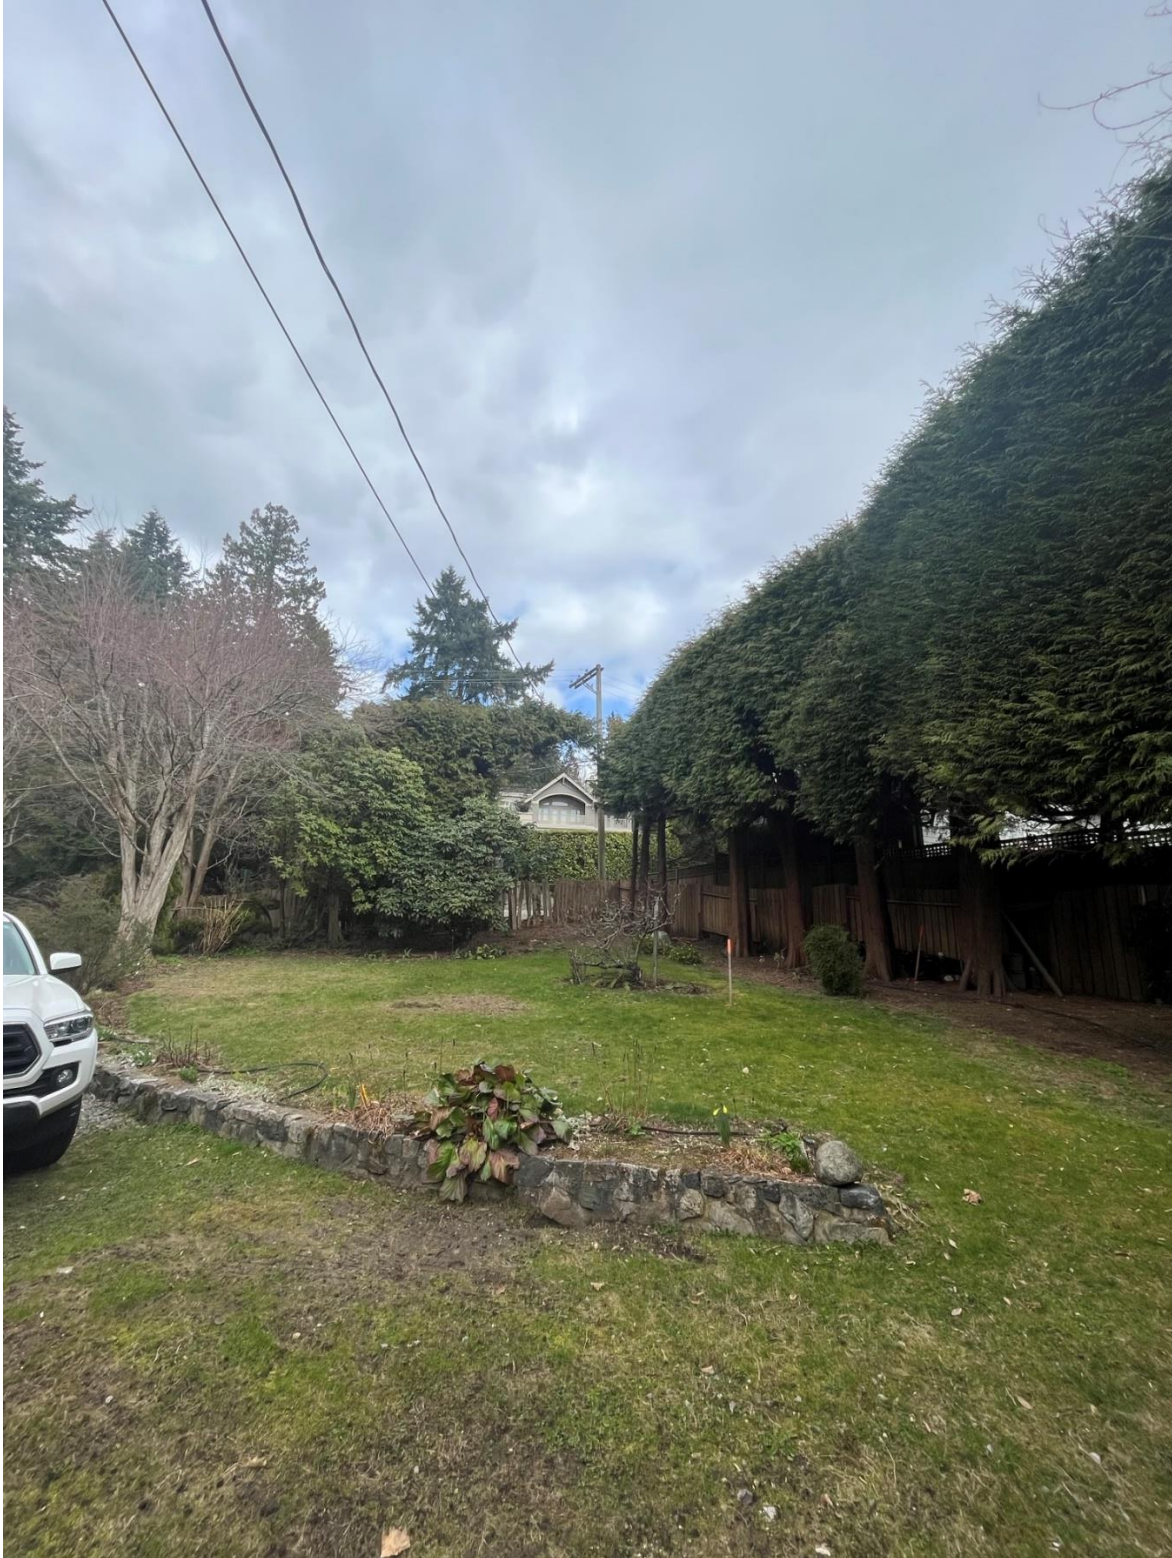
Photo 3. 8994-9000 along the east property line that make up a large cedar hedge row to be removed to accommodate to new driveway installation.

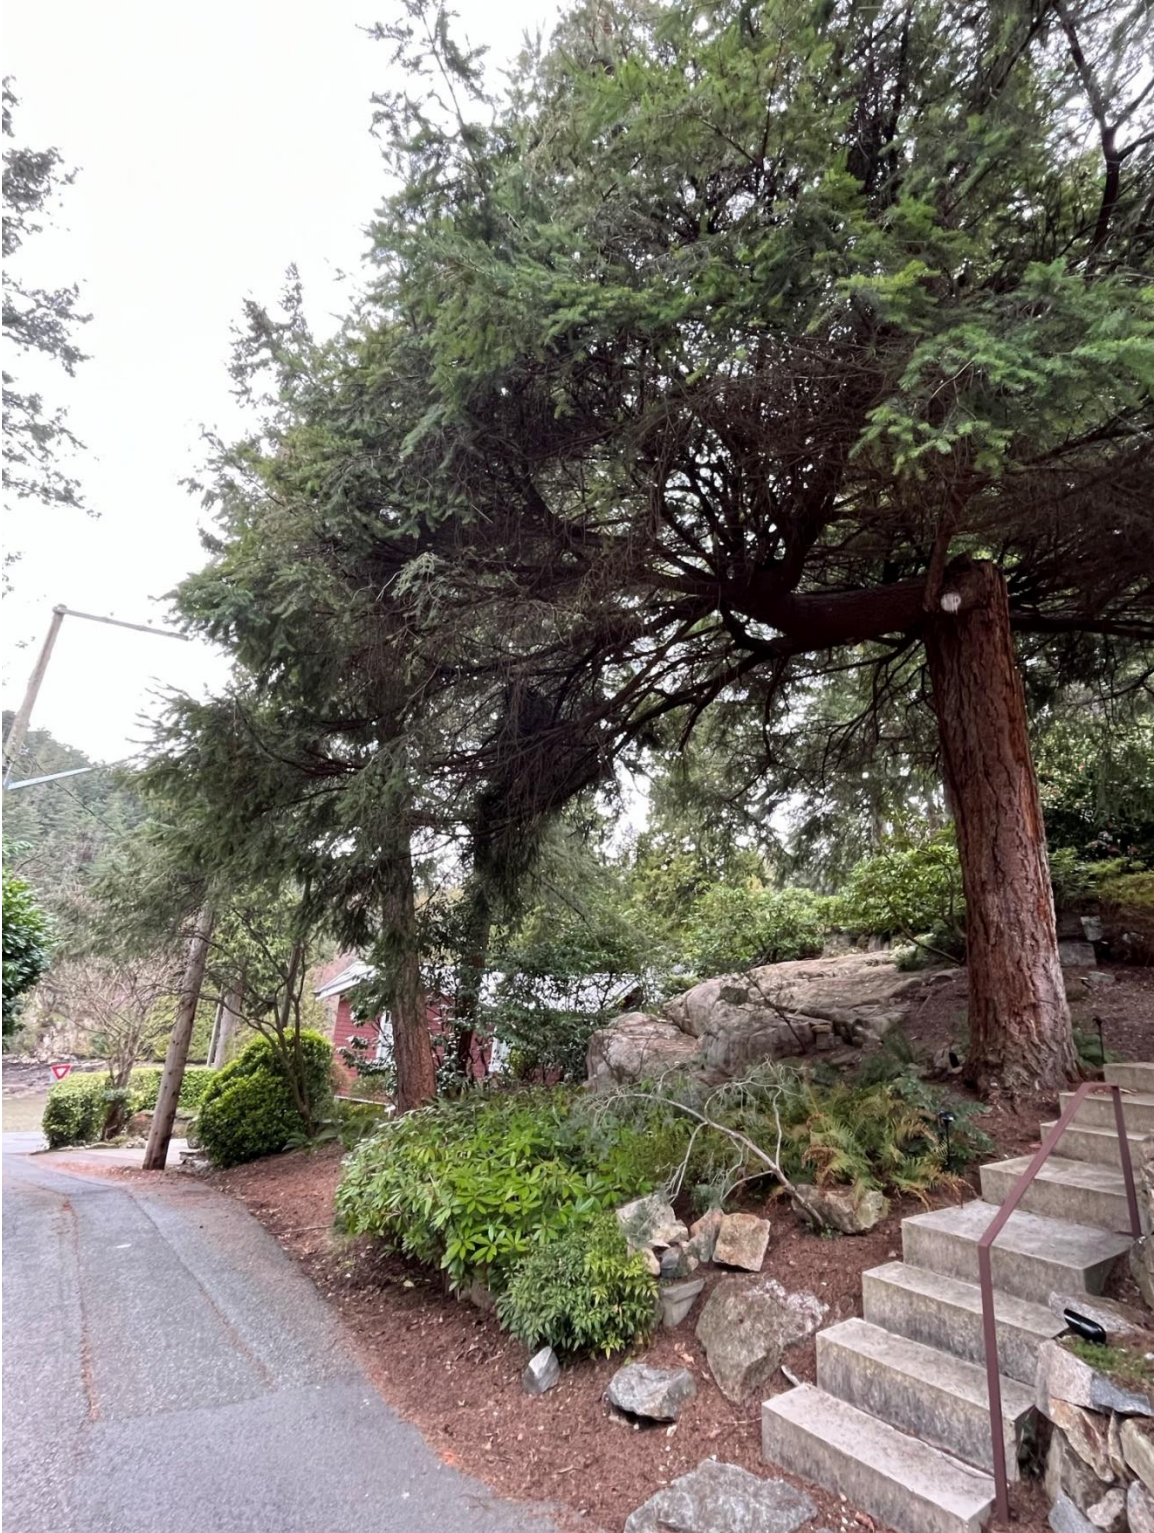
Photo 4. OS02 and OS03 with crowns that extend into a 10m fuel-free buffer.

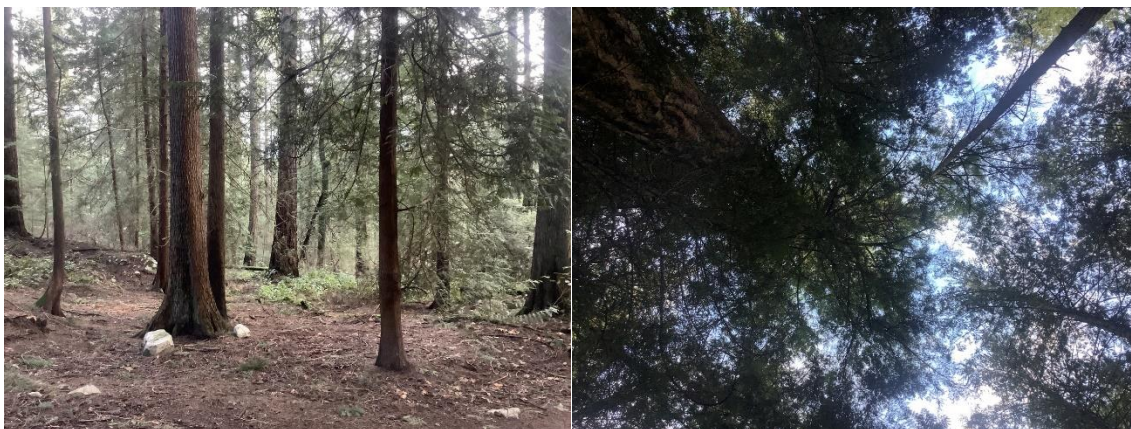
Photo 5. Coniferous fuels in Lighthouse Park.

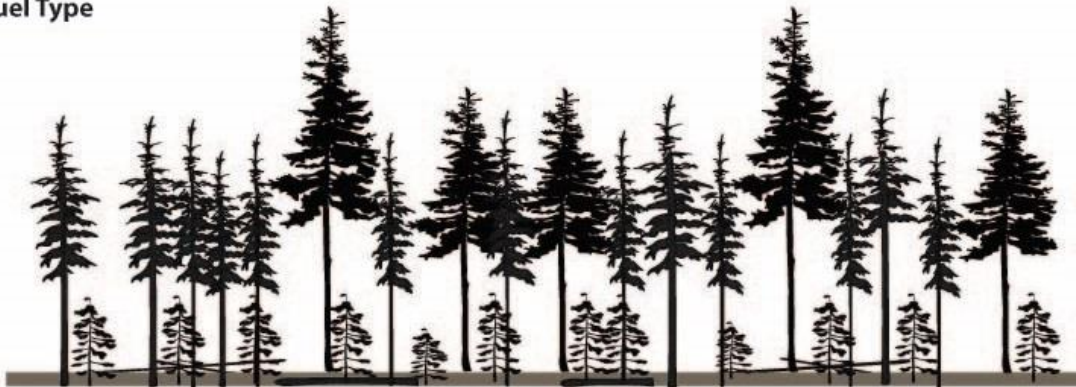
C3 – Multistoried Second Growth Conifer Stand – High Risk

This fuel type is characterized by a uniform mature second growth conifer dominated stand. This stand consists of mature Western Red Cedar (*Thuja plicata*) and Western Hemlock (*Tsuga heterophylla*). There is also a minor component of dominant Douglas-fir (*Pseudotsuga menziesii*) in the stand. Compared to a C5 stand, a C3 stand is more densely stocked (1000-2000 stems per ha) and there is a lower crown base height (usually 4-8 m). The understory is more densely stocked with Western Redcedar and Western Hemlock. The ground fuel component consists of moderately dense fine fuel layer (>7cm) and a low percent cover of large woody debris (>7cm). A crown fire in a C3 stand takes less energy to create than a C5 stand.

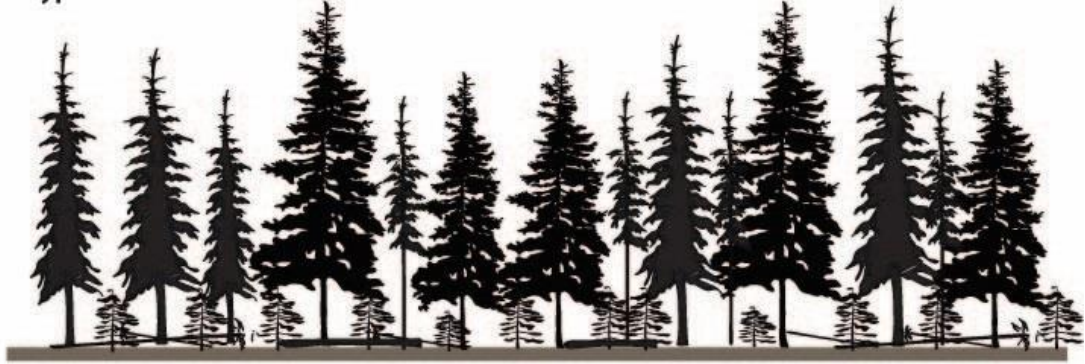
M2 Fuel Type

This fuel type consists of a mixed conifer and deciduous tree type. This stand is not uniform in structure and is composed of a wide variety of species. These may include and not limited to:

These stands usually consist of less than a 70% of conifer trees, reducing the wildfire risk. There is usually a low crown height (5m) and a high percentage of ladder fuels. There is a high percent cover of suppressed trees, but they are usually composed of deciduous species.

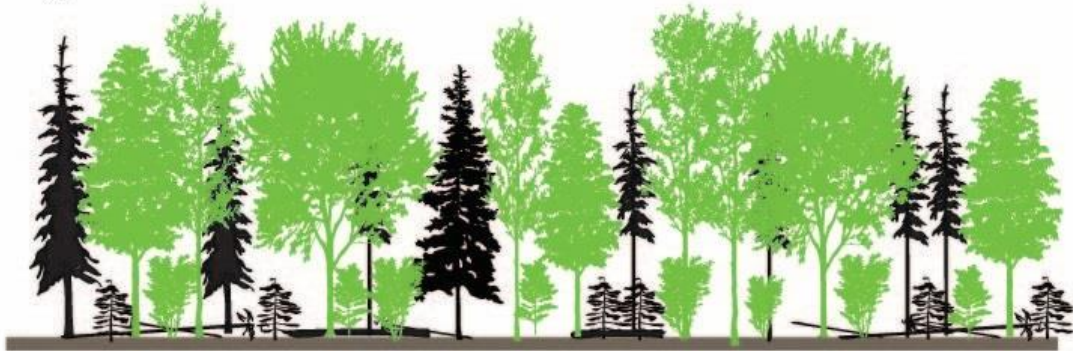
D1 Fuel Type

This fuel type is dominated by deciduous trees consisting mostly of Red Alder (*Alnus rubra*), Bigleaf Maple (*Acer macrophyllum*), and Paper Birch (*Betula papyrifera*). D1 stand structure is not uniform with a wide variety of tree ages. There is a well-developed shrub layer, but is mostly composed of low-flammable species. Crown fires are not expected because of the deciduous fuel type. D1 stands on the coast can be used as fuel buffers as they present a low wildfire risk.
