BINNING HOUSE

2968 MATHERS CRESCENT, WEST VANCOUVER

CONSERVATION PLAN

APRIL 2017

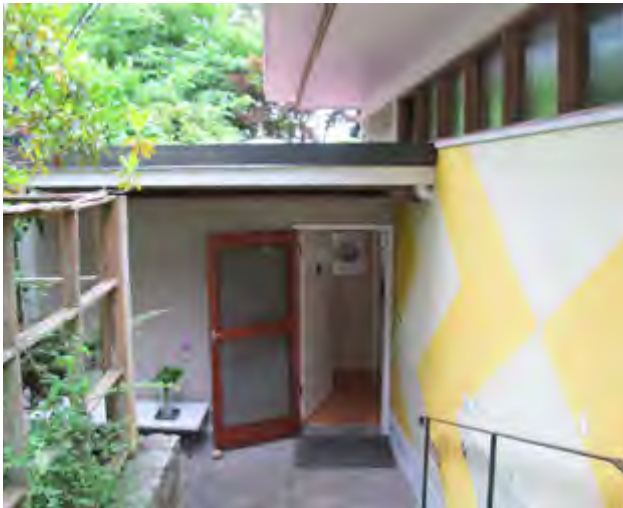
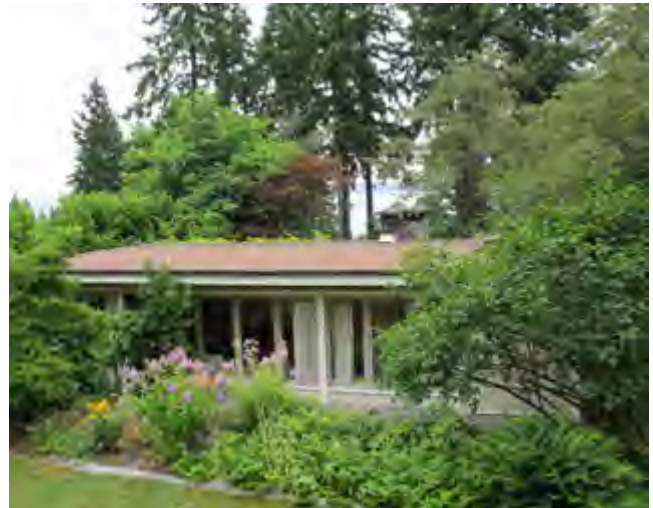
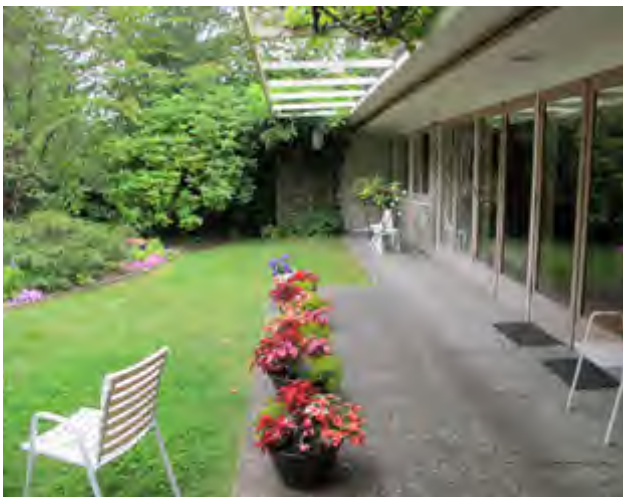
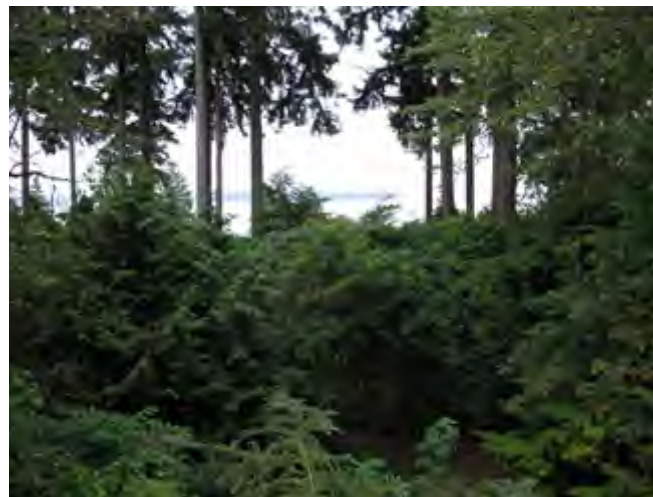
4.3 FORM, SCALE, MASSING

The Binning House consists of two stepped, almost rectangular volumes with low massing covered with flat roofs that follow the sloping lot. Combining these elements with post-and-beam construction allowed the design of an open plan and split levels with different ceiling heights to suit the hilly site and orienting it towards the south sloping hill. Large south-facing windows, wide terraces and wooden trellises create a perceived extension of the interior space to the exterior and transition between the inside and outside.

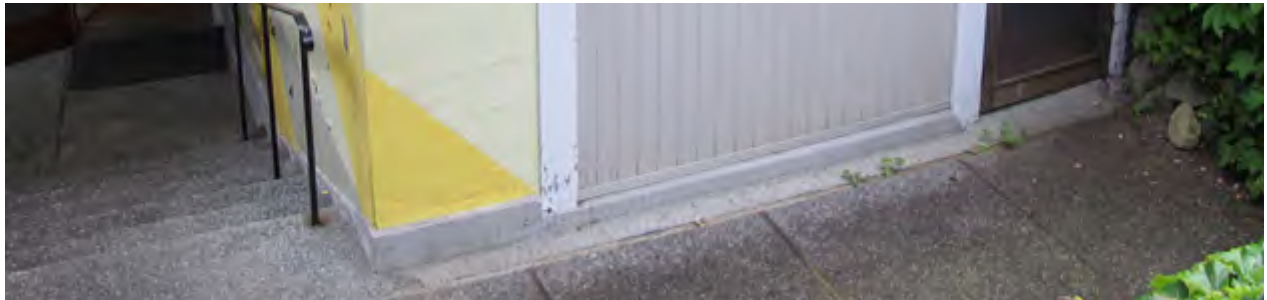
foundation, front entryway

The concrete slab and walls are generally in good condition except efflorescence, a sign of rising water, is notable at the foot of the basement walls. Some moisture ingress from above is evident on the eastern basement wall and may be caused by the light well or a leaking kitchen sink, which should be verified. Settling of the west portion of the house was noted and the condition is currently being monitored over a one year period. Upon completion of the monitoring program, necessary repairs will be made.

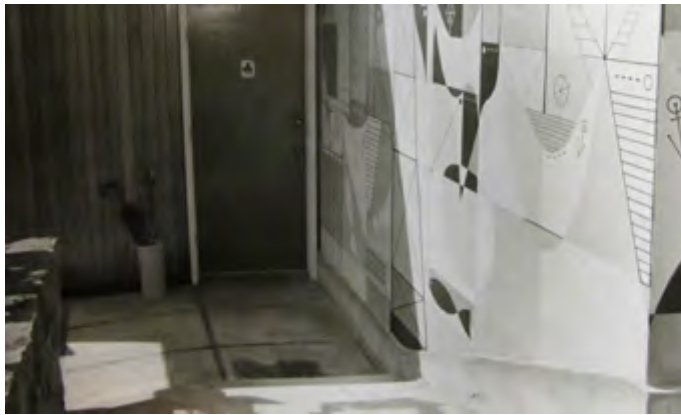
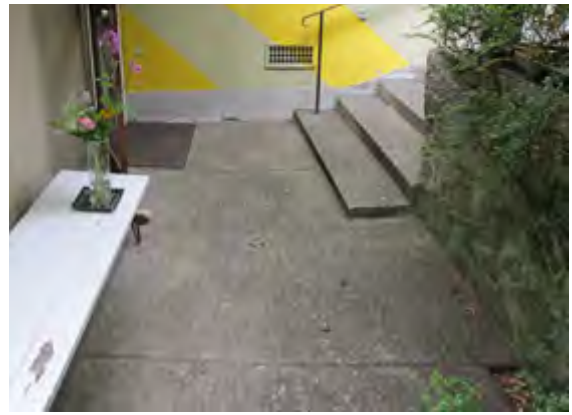
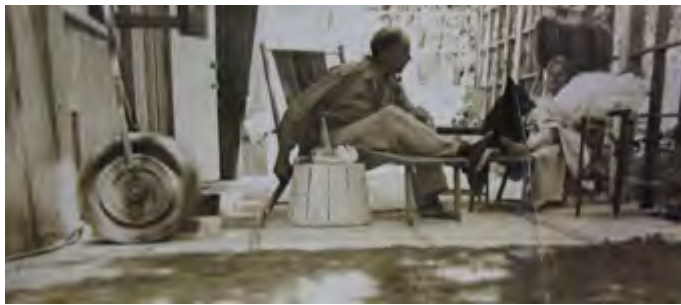
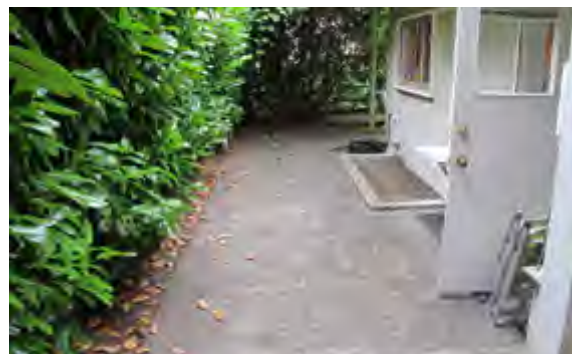
Presumably due to the premature deterioration of the concrete, made of very fine aggregate with a smooth surface, the exterior pattern was later replaced. An additional factor might have been insufficient skid resistance of the concrete, an important performance aspect of exterior pavements on the west coast. The only surviving parallelogram pattern exists in the living room.

The larger replacement panels are made of exposed aggregate concrete with a rough surface and do not follow the layout of the original parallelogram pattern.

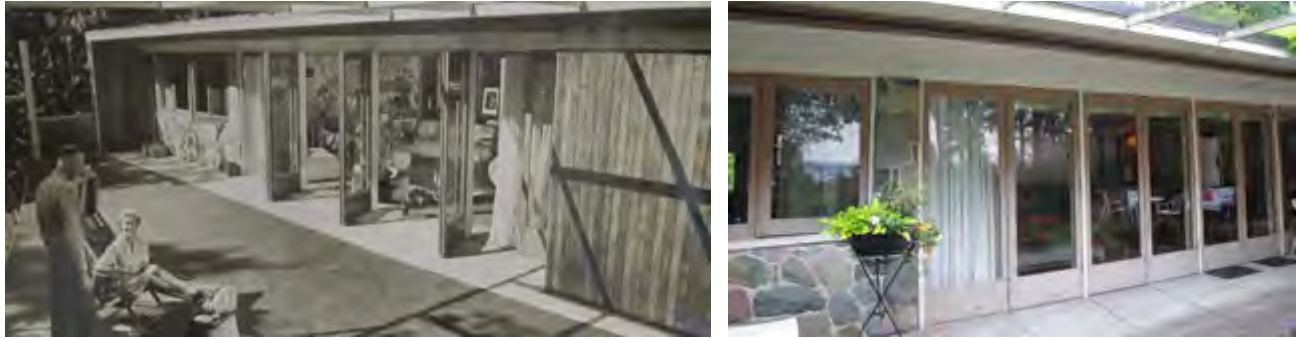
Concrete pavement pattern photos on page 22, left to right: Row 1 – archival image of front entryway pavement and 2011 image of the front entryway pavement; Row 2 – archival image of the east façade pavement and 2011 image of the east façade pavement; Row 3 – archival image of the rear patio pavement and 2011 image of the rear patio pavement.

Binning's design incorporated a trapezoidal leitmotif in several architectural elements. Among them is the concrete paving pattern, featuring parallelogram shapes. This form is presumably derived from an early design scheme of the house (Ground Floor Plan, Sheet 2, 10 March 1941) that included a canted east wall a canted interior masonry wall providing the specific angle for the parallelogram pavement pattern. A later revision of the architectural design and subsequent construction of the house continued the leitmotif of canted walls in an altered version though it incorporated the initial design intent to execute this pattern in the living room as well as south terrace and thus creating an interrelationship between the exterior and interior.

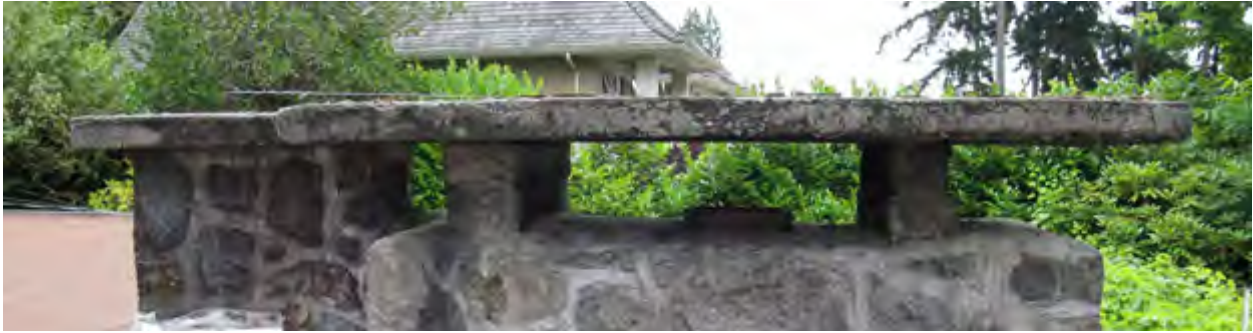
A large rectangular concrete chimney cap made of reinforced exposed aggregate concrete on all sides shows signs of cracking. This is caused by corrosion jacking of exposed steel bars on the underside and subsequent weakening of the load-bearing capacity of the concrete cap. A repair will be necessary.

- Roof / Drainage / Chimney
 - Replace existing roof including sufficient slopes, permanent drainage system and new flashings; review condition of roof ventilation system; repair concrete chimney cap
 - Review options and benefits of roof insulation
 - Review option to install photovoltaic system on roof; coordinate with municipal regulations/Parks Canada
 - Rehabilitate perimeter drains below grade including renewal of concrete pavement to match original in shape but with slip resistant finish
- Structural Timber
 - When existing roof is removed: Review condition of structural timber for damage caused by infestation
- Electrical
 - When existing roof is removed: Assess electrical system from above and update where necessary

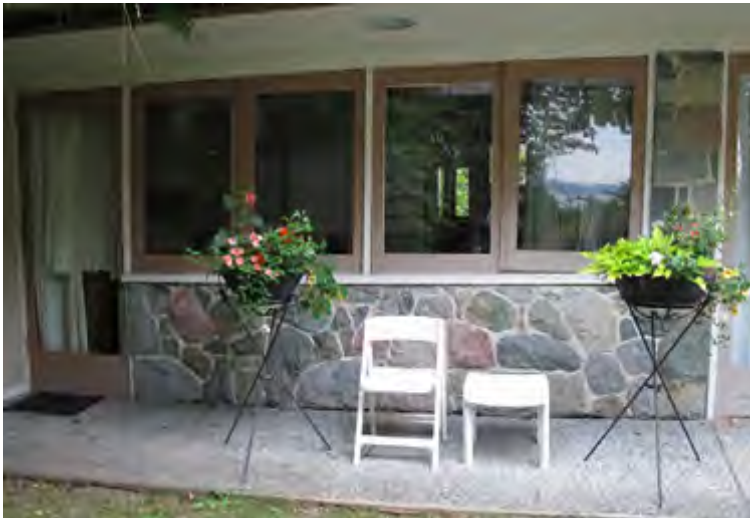
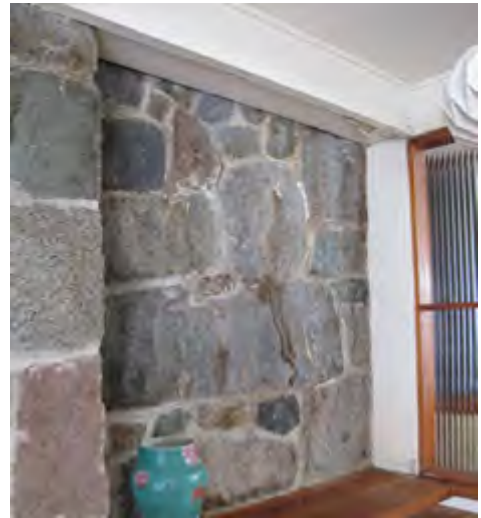
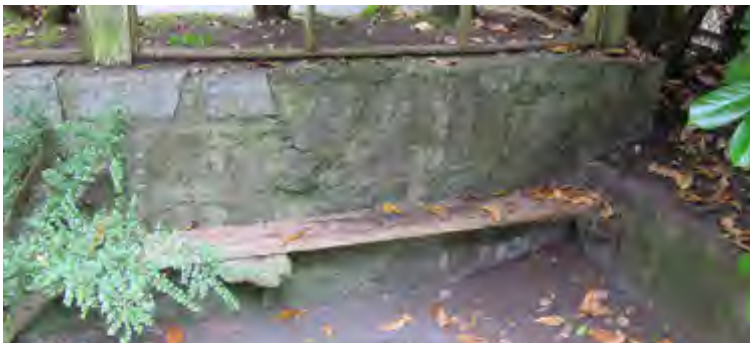
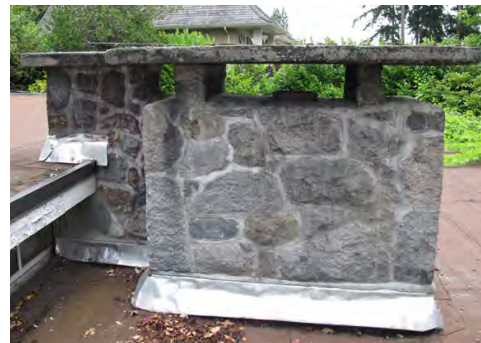
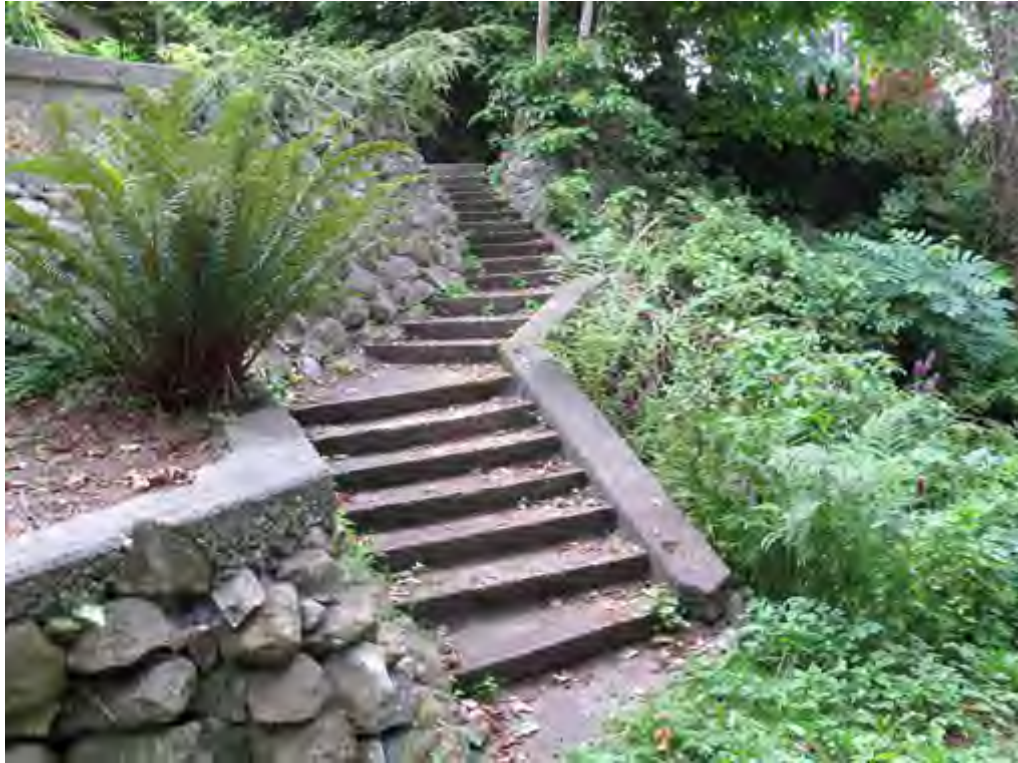
Roughly finished stone blocks, commonly termed “rock face” finishing style, were used in several locations of the house. First on the exterior south wall of the master bedroom, which continues on the inside as the floor to ceiling wall with the open fireplace. Further the rising chimney above the roofline was constructed with these stone blocks.

The fieldstone walls are generally in good condition including their mortar joints. An exception is the exterior rock wall below the master bedroom window. This shows significant cracking due to sagging of the southwest portion of the house constructed presumably on loose fill. The cracking is also evident on the interior side and requires monitoring of the condition and recording of future movement of the wall. Pending of the findings stabilization measures will have to be evaluated.

Additional damage is visible on the interior fieldstone wall in the living room with signs of moisture ingress from above. This is evident in surface staining and accumulated efflorescence on the rock and mortar joints of the northern portion of the wall below the chimney stack. The rear side of the stone chimney, located in the master bedroom, is finished with wood panels and the condition of the masonry could not be reviewed. It can be assumed that water damage to this side is also prevalent. This is likely due to the faulty flashing of the chimney above the roofline described below, which requires immediate remediation.

The rectangular shaped chimney built with fieldstones rises above the lower roof and ties with a second, smaller volume into the upper wall and roof. The concrete cap covering the chimney was mentioned above. It appears that the stacks were recently repointed and the masonry work is in good condition except for some environmental dirt and staining, which is a natural occurrence of such an exposed element. The existing metal flashing was recently installed but is failing. Further damage was evident at the connection between the chimney and the upper clerestory windows,

which is lacking adequate flashing or other means of protection. Water is freely penetrating into an existing cavity causing significant rot of adjacent wood elements and traversing down to the fieldstone wall in the main floor.

- Kitchen
 - Review if existing linoleum floor can be removed to expose the original wood flooring
- Living Room
 - Remove efflorescence and stains from stone wall

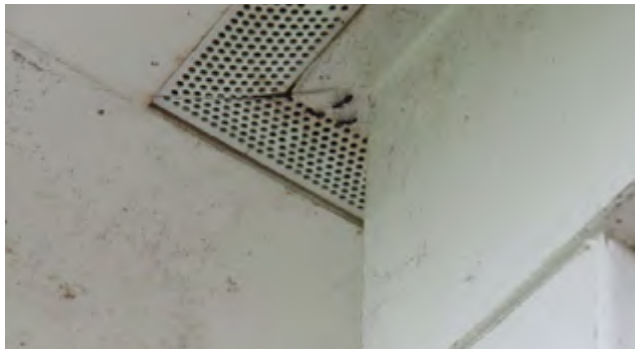
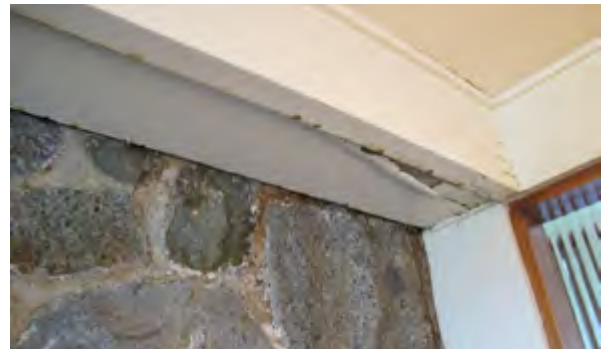
The main structural system of the Binning House is built in post-and-beam above the concrete foundation walls. The post-and-beam structure is clad in most locations and the condition of the wood could not be reviewed.

Notable is insect infestation in some locations, which indicates materials conditions should be further investigated. Carpenter ants, which reside both outdoors and indoors in moist, decaying or hollow wood, cut into the wood grain to provide passageways for movement from section to section of the nest. At the Binning House carpenter ants are visible on the exterior northwest corner of the house, where they access the closed soffit through continuous vents. Interior wood damage and sawdust-like material called frass that ants discard as they tunnel through the wood, are evident on the northwest side of the living room ceiling near the chimney. The discarded frass may be a hint to their nesting location. As outlined above localized damage to the exterior portion of the chimney exists above the frass due to failing flashing. Immediate measures have to be carried out to eliminate the infestation and remediation of the flashing.

- Repair wood cladding in locations with infestation issues
- Exterior and Interior Wood Finishes
 - Remove later paint finishes on wood materials and varnish to match original design intent

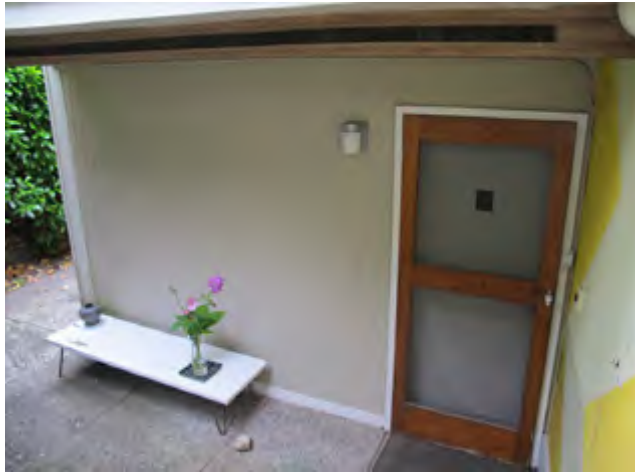
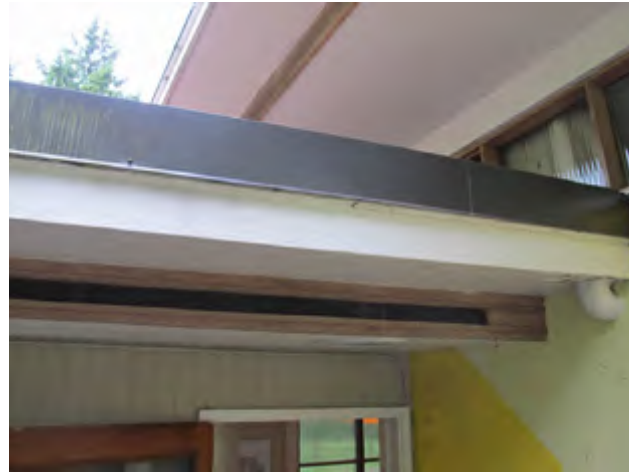
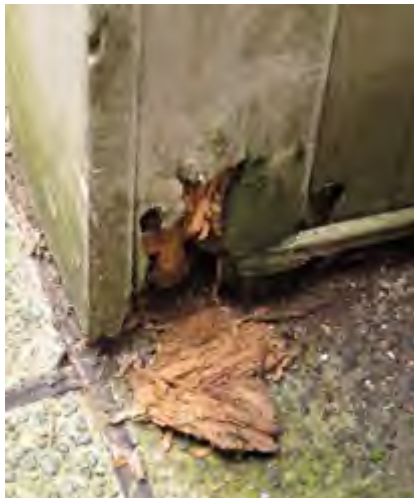
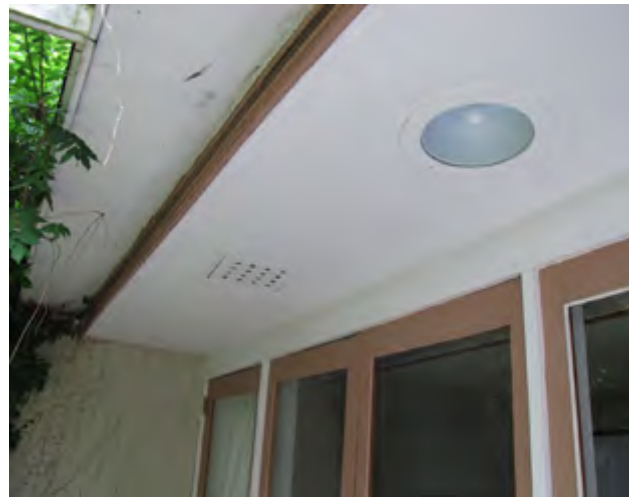
On the exterior walls vertical cedar V-joint panelling exists on all four elevations and was also used on interior feature walls including the hallway. The originally varnished cedar cladding was reportedly early painted off-white presumably due to undesired colour changes due to weathering.² There will need to be an investigation to determine the most sensitive paint-removal approach. The vertical V-joint paneling is protected by large roof overhangs and generally in good to very good condition.

Additional wood cladding exists at the corner locations. The northeast corner boards are exposed to back splashing water from the concrete pavement and show significant water damage, splicing and rot at the bottom. In general exterior wood elements including paneling, corner and baseboards close to the ground or near overhanging trees accumulated dirt and organic growth.

The soffits of the cantilevered roofs are finished with painted wood cladding, which is in good condition.

- Repair damaged wood elements and replace deteriorated wood panels to match original
- Trellis
 - Investigate condition and attachment of existing wood trellis to roof structure and replace with new trellis to match the original, if necessary

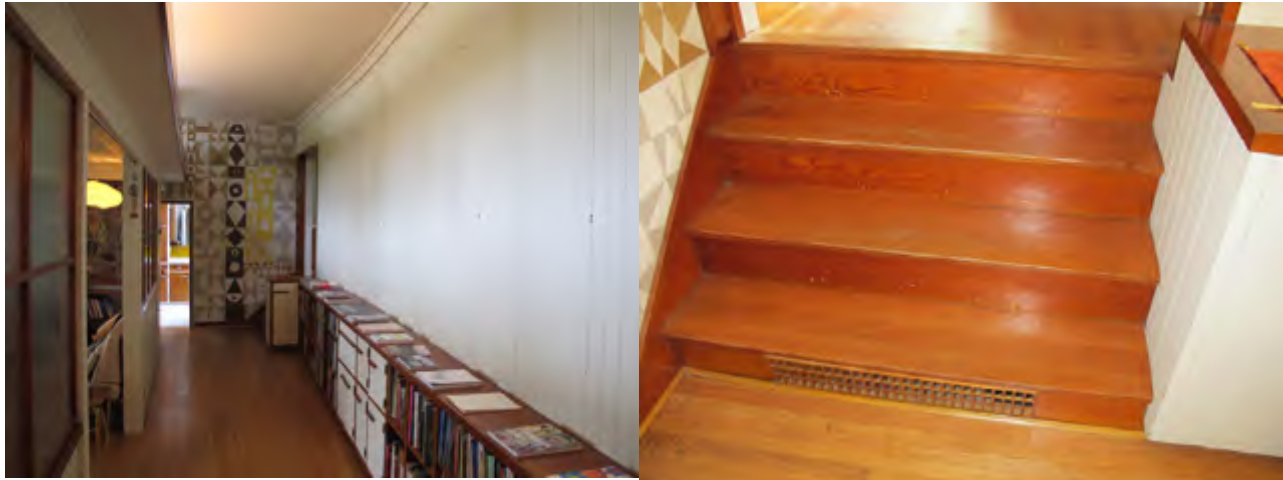
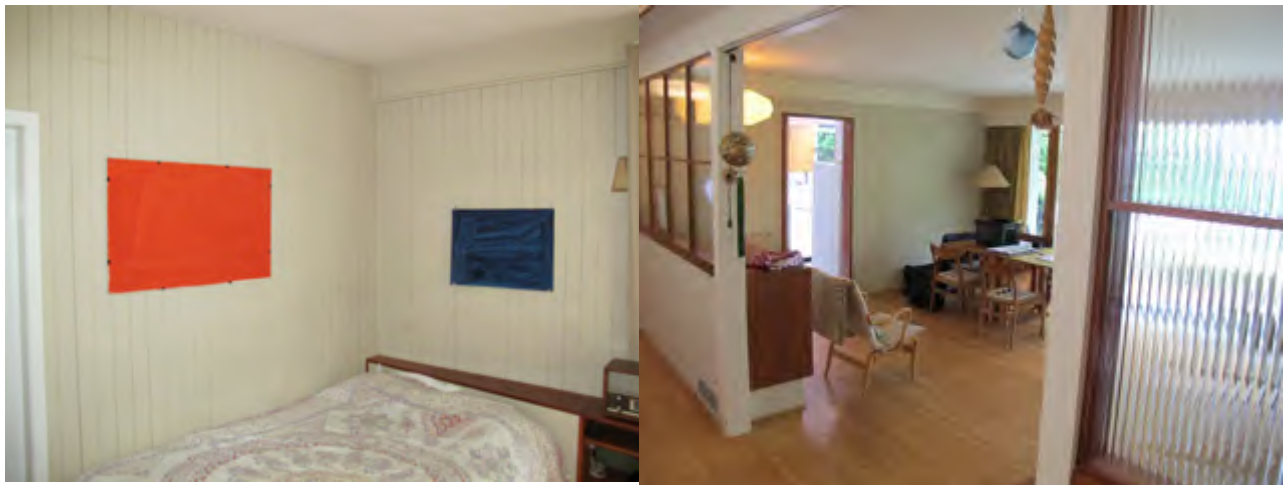
4.5.3 Interior Wood Elements

The vertical cedar V-joint panelling is repeated in interior hallway, a feature wall of the Binning House using locally manufactured and hence affordable material. Originally varnished, the panelling is now painted white. There will need to be an investigation to determine the most sensitive paint-removal approach.

Hardwood flooring exists in the living room and hallway and more economical fir floors in the bedrooms and studio. Fir floors in the kitchen and bathroom are now covered with linoleum. The studio area with Binning's easel is also covered with linoleum. The interior plastered ceilings and walls, wood trim, and wood frames of windows and doors are generally painted off-white.

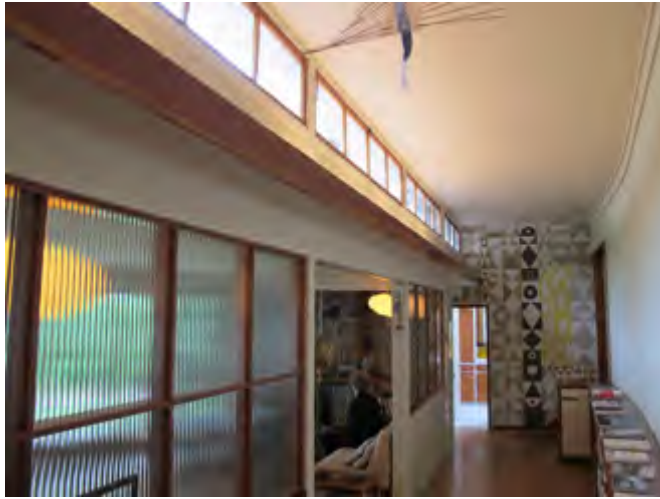
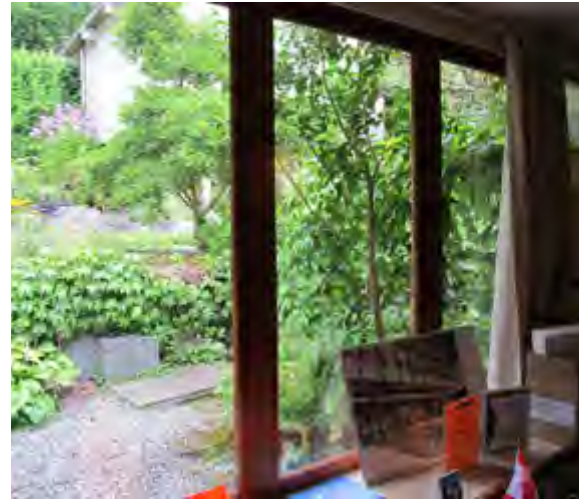
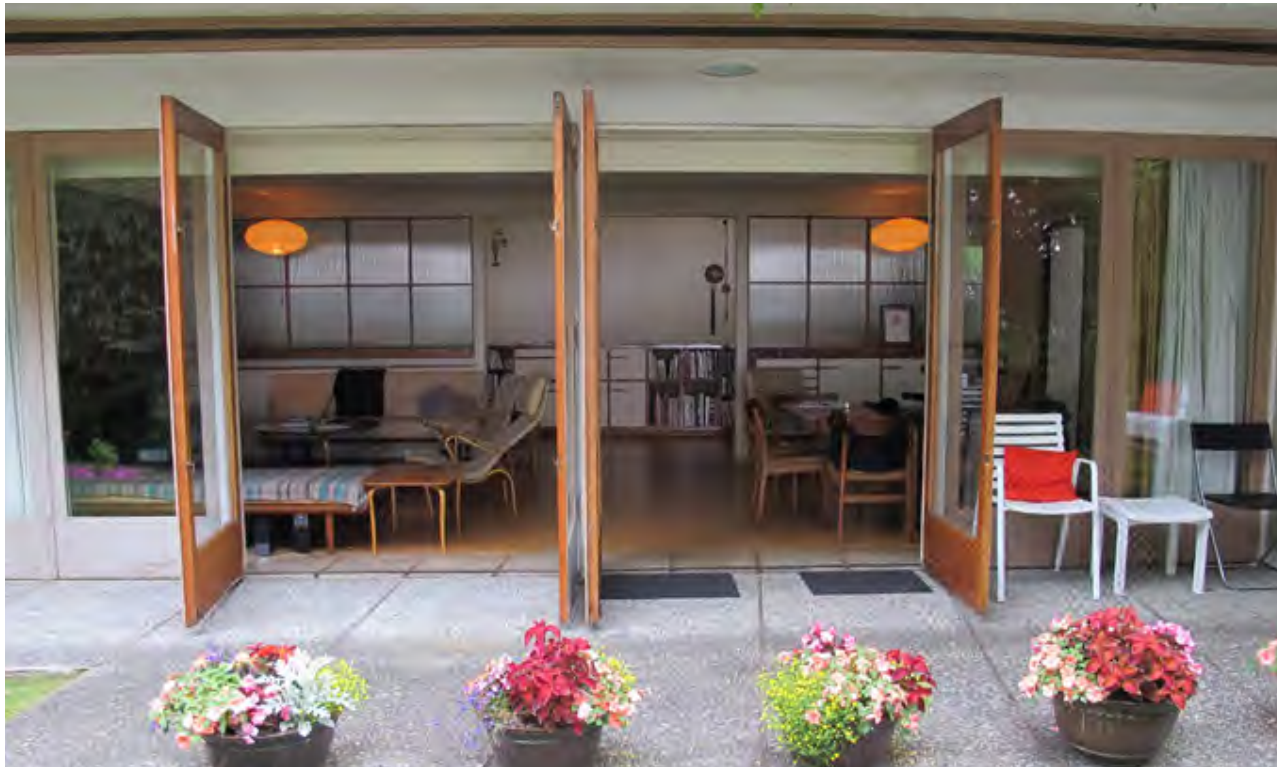
The Binning House incorporates daylight and views as central design features of the architectural design and the window and doorframes are made of local cedar. A continuous floor-to-ceiling window-door assembly on the south elevation opens the living room to the lower garden terrace with vast vistas over the inlet. The simple window and doorframes with clear, single panes are in good condition.

The adjacent south-facing master bedroom receives daylight through a horizontal band of windows terminated at the western end with a single door leading to the lower terrace. The

subsidence of the west portion of the house has caused racking and detachment of window and door frames from the masonry wall. The windows do not open freely and the misalignment of the assembly is causing drafts and thermal discomfort. It is recommended that the setting should be monitored and the window-door assembly carefully restored.

A set of three wood-sash windows provides daylight to the kitchen from the east side. They consist of two casement windows with internal metal screens on either side of a fixed pane and are in good condition. Below at the basement level a wood-sash awning window provides some daylight through the light well on the east side. The wood window frame of the western basement wall is in covered with tarp.

- Repair wood frame windows and door in master bedroom
- Mural
 - Investigate paint system and restore exterior mural near front entrance; work to be done by painting conservator

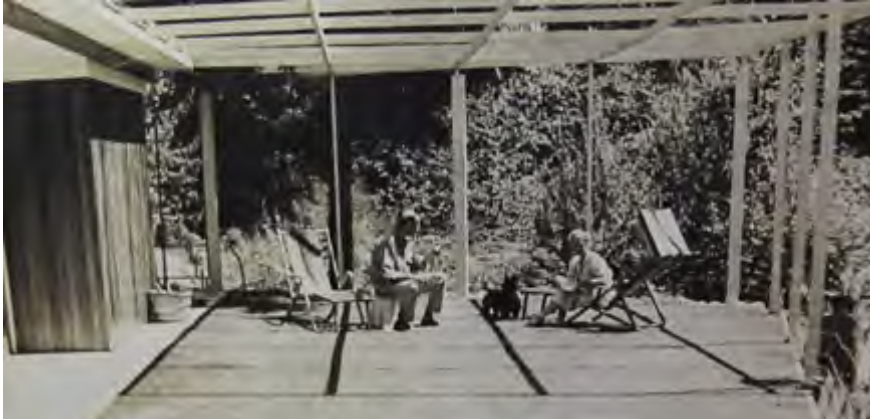
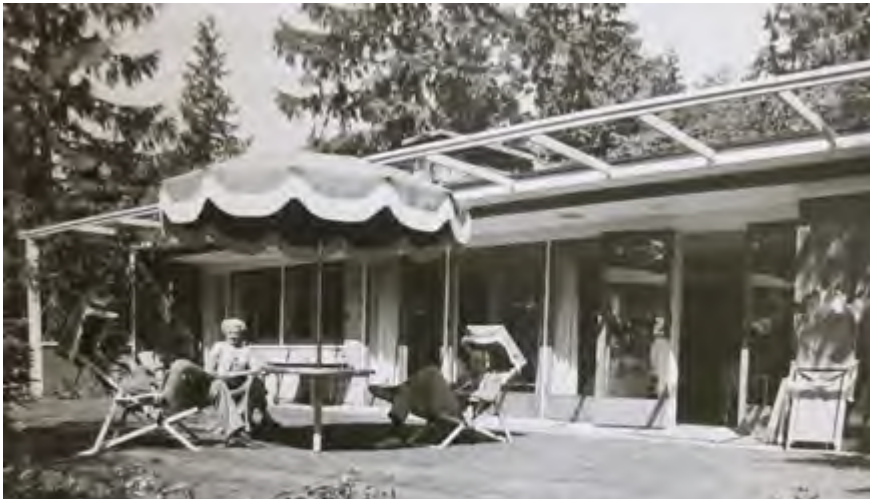
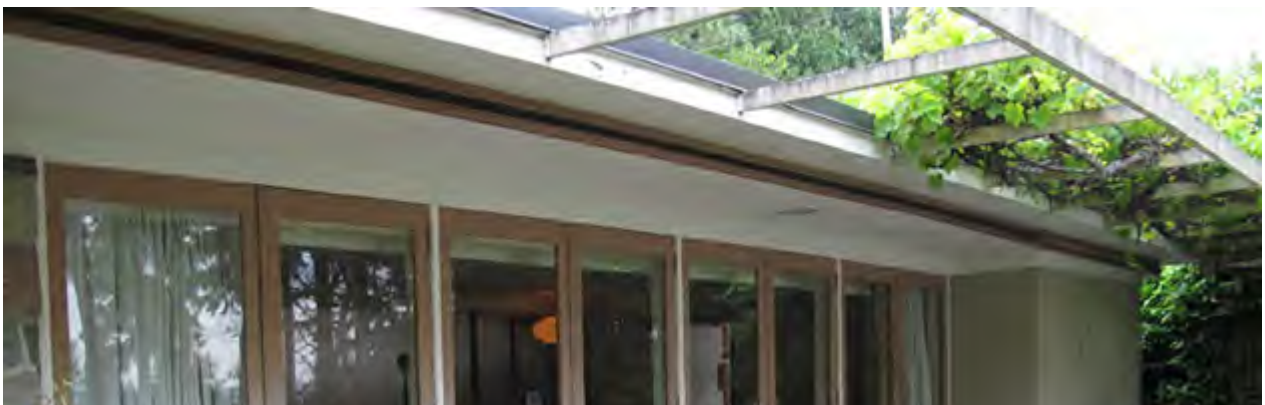
The original large wood trellis appended to the east portion of the south façade is shown in several archival photos from the 1940s. It was later replaced by a shallow trellis, which extends the full-length of the south façade; this second trellis is extant. Both trellises were designed to extend the living room space to the outside. The existing wood trellis is overgrown with vegetation and tied with failing tension rods to the chimney and upper roof. The insufficient fastening of the trellis and its poor condition requires remediation.

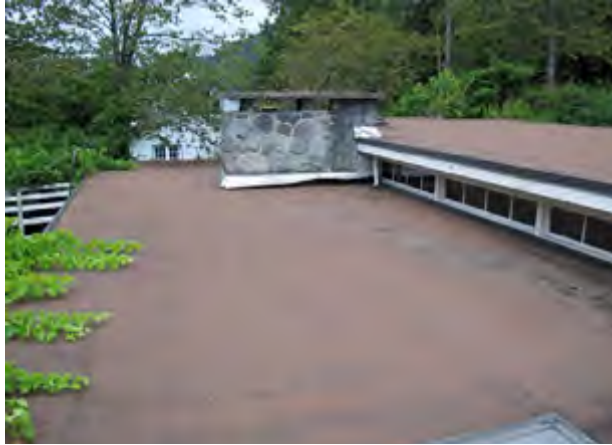
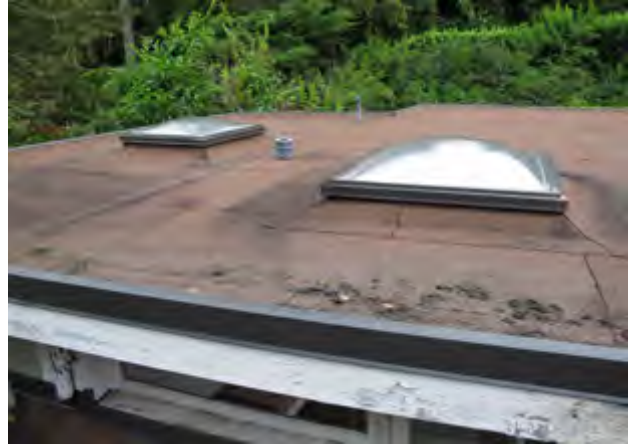
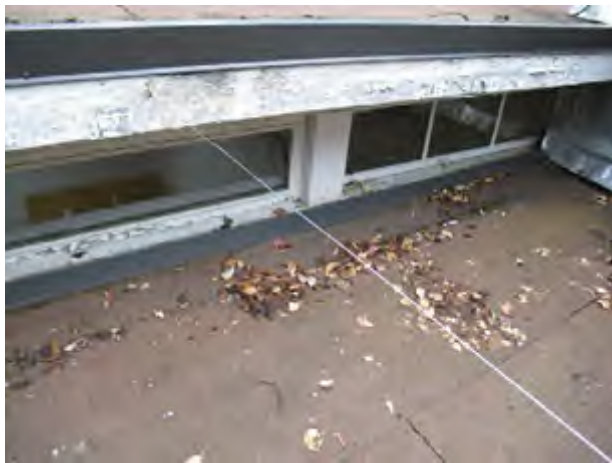
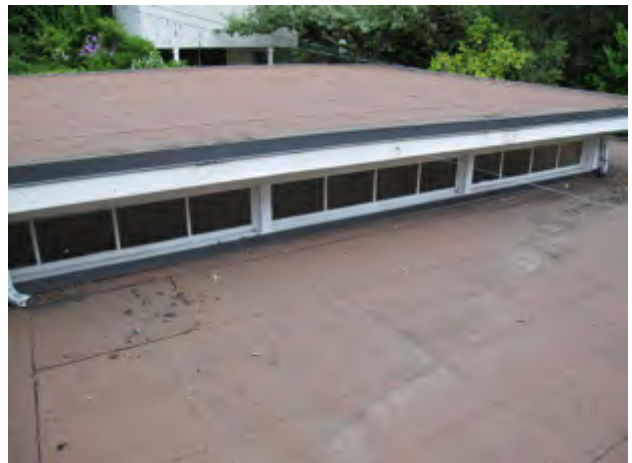
The original tar & gravel roof consists of two planes with slight slopes, large overhangs, and a cantilevered canopy above the front door. Three additional skylights were commissioned, presumably by Jessie, to provide more daylight in the kitchen, bathroom, and later addition. Later roof repairs included the installation of a torch-down roofing material, new aluminum flashings around the chimney and the roof perimeter. The original drainage system appears to remain in place.

Considering that the Binning House is one of the earliest flat-roofed houses on the west coast, inherent design flaws contribute to the present condition of the structure. They include:

- The location of the downspouts from the upper plane is too close to the exterior wall and clerestory windows respectively.
- The slope of the lower plane towards the clerestory windows between the two planes and not away to the south side.
- The free drainage of storm water from the upper roof to the lower plane and lack of rainwater leaders connecting the upper downspouts with the downspouts of the lower roof.
- The rainwater leader above the front entrance is internally routed and seemingly leaking causing damage to the painted mural at the main entrance.

- The lack of maintenance and clogging of guards with organic debris.
- The drainage of storm water away from the house is presumably defunct due to earlier landscaping work and the condition and routing has to be investigated.

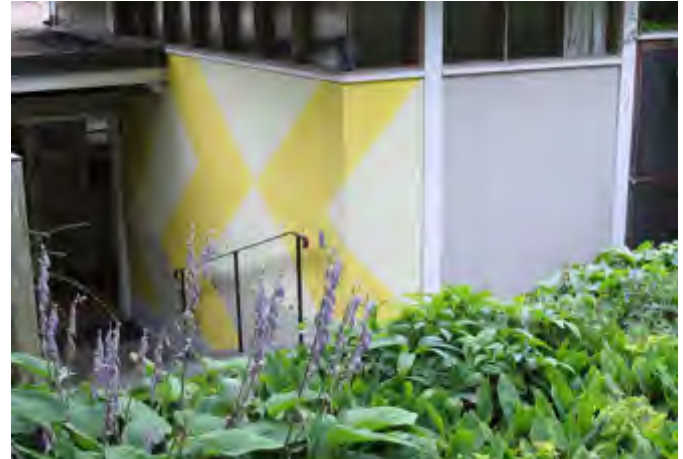
Mural in 2011

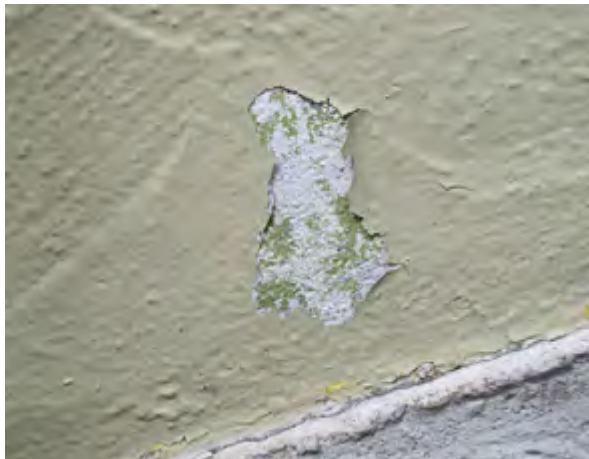
Mural condition, 2011

The only exterior plaster exists on the northeast corner wall leading to the main entrance. The plaster is applied on top of a masonry wall, which has displayed a total of four decorative murals painted by Binning between the 1940s and late 1960s or early 1970s. The last of Binnings' murals, depicting a geometric figure with bright off-white and yellow colours, was recently repainted by a local artist, Gordon Smith.

The paint and underlying plaster are in some locations deteriorated and cracking. Peeling of paint and plaster and missing batches are also evident and are signs of moisture damage presumably from a failing drainage system. In addition, it should be determined if the paint system used for the decorative mural is suitable for the substrate and exterior application.

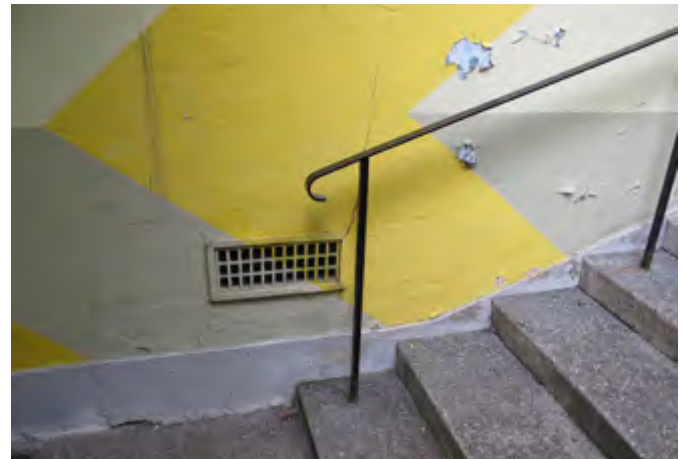
Mural condition, 2011

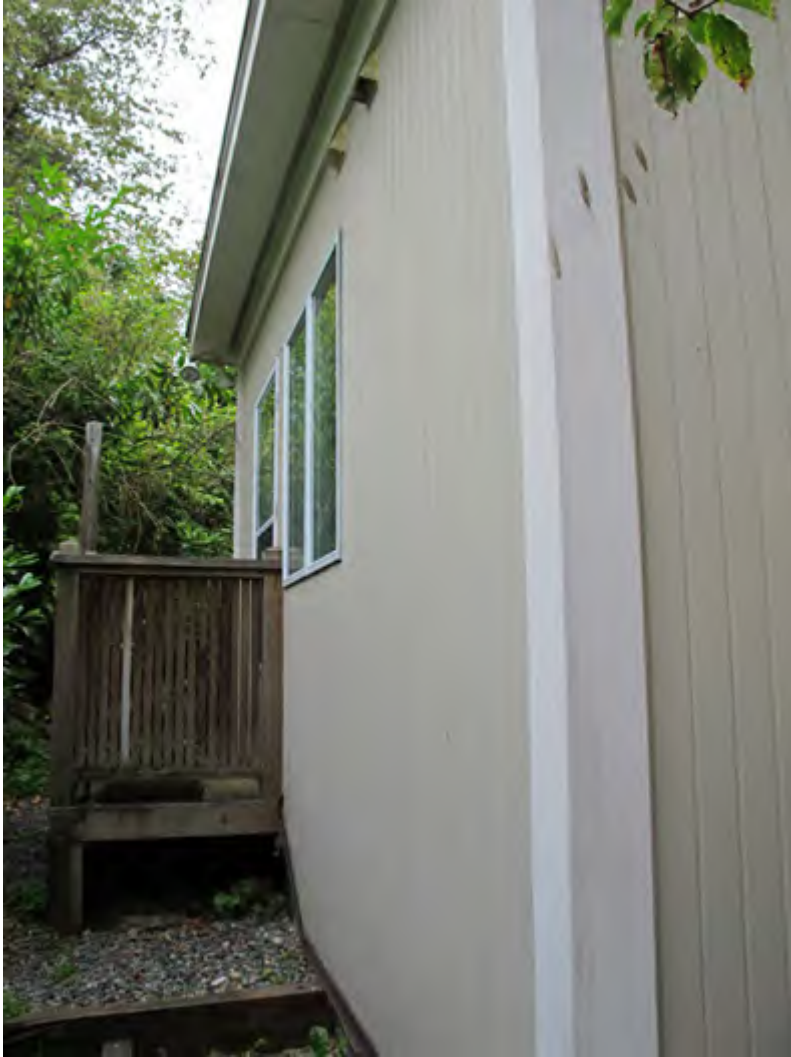
4.8 ADDITION

In 1989, a bathroom that today also accommodates a laundry room was added to the guest bedroom on the west side of the Binning House.

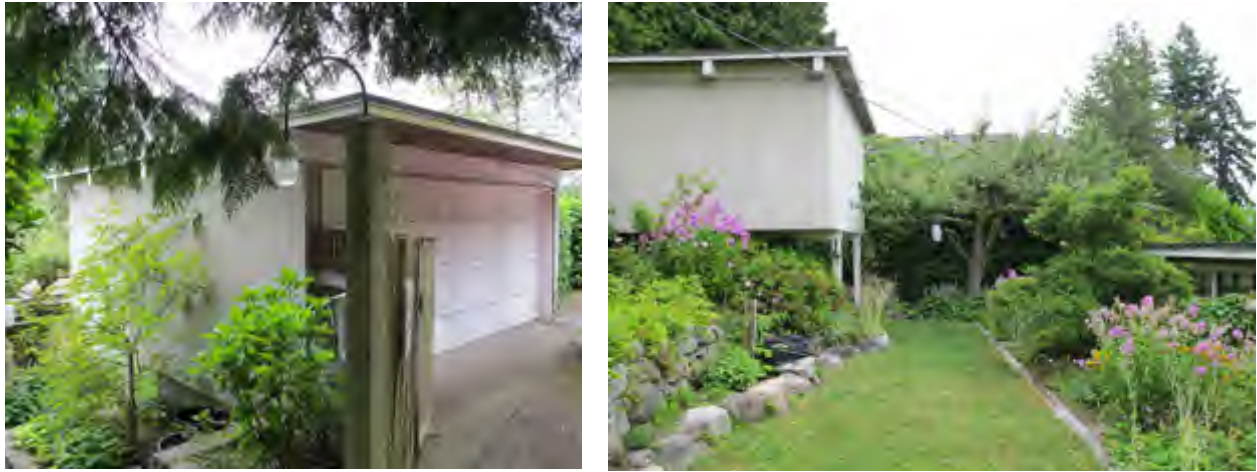
In 1966, the early carport near the street was replaced with a structure built into the sloping hill. The upper level is a post-and-beam structure and used as a car garage with a newer roller shutter and clad with vertical wood siding on all elevations. A large overhang with wood soffit exists above the garage door.

The upper level is cantilevered on the south side and supported with timber posts. This allowed the design of a recessed south wall on the lower level housing a potting shed. Two large windows above a rock-clad wall provide daylight and are located adjacent to the wood door. The lower walls are built with concrete blocks and the dirt floor is covered with pebbles. The flat, torch-on roof is slightly north sloping and the visual review indicates accumulation of organic debris on the roof and clogging of the guard.

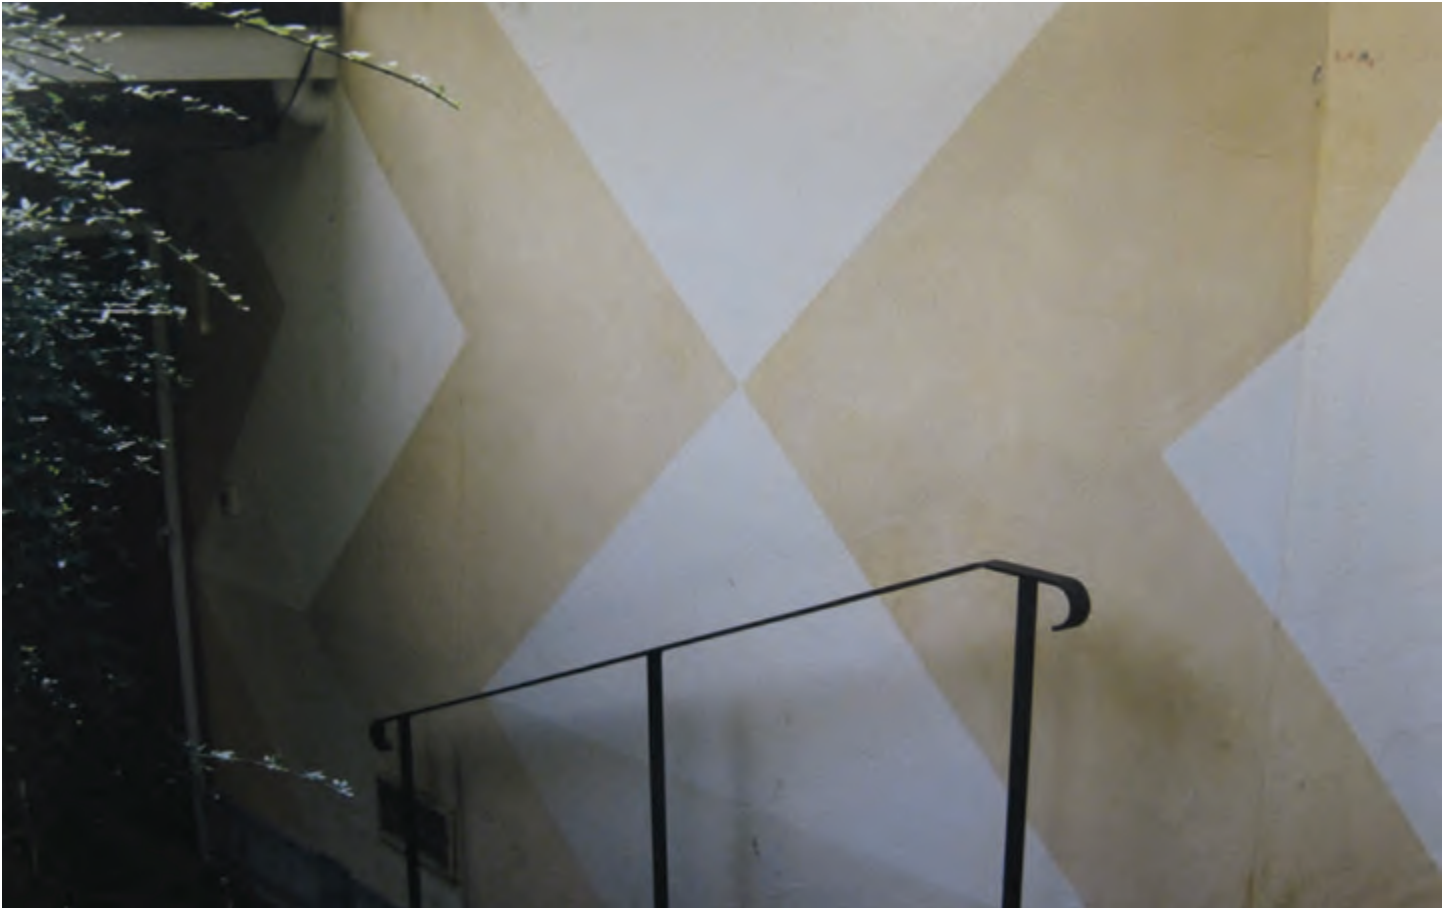
Current mural before Gordon Smith's restoration, Vancouver Art Gallery Archives

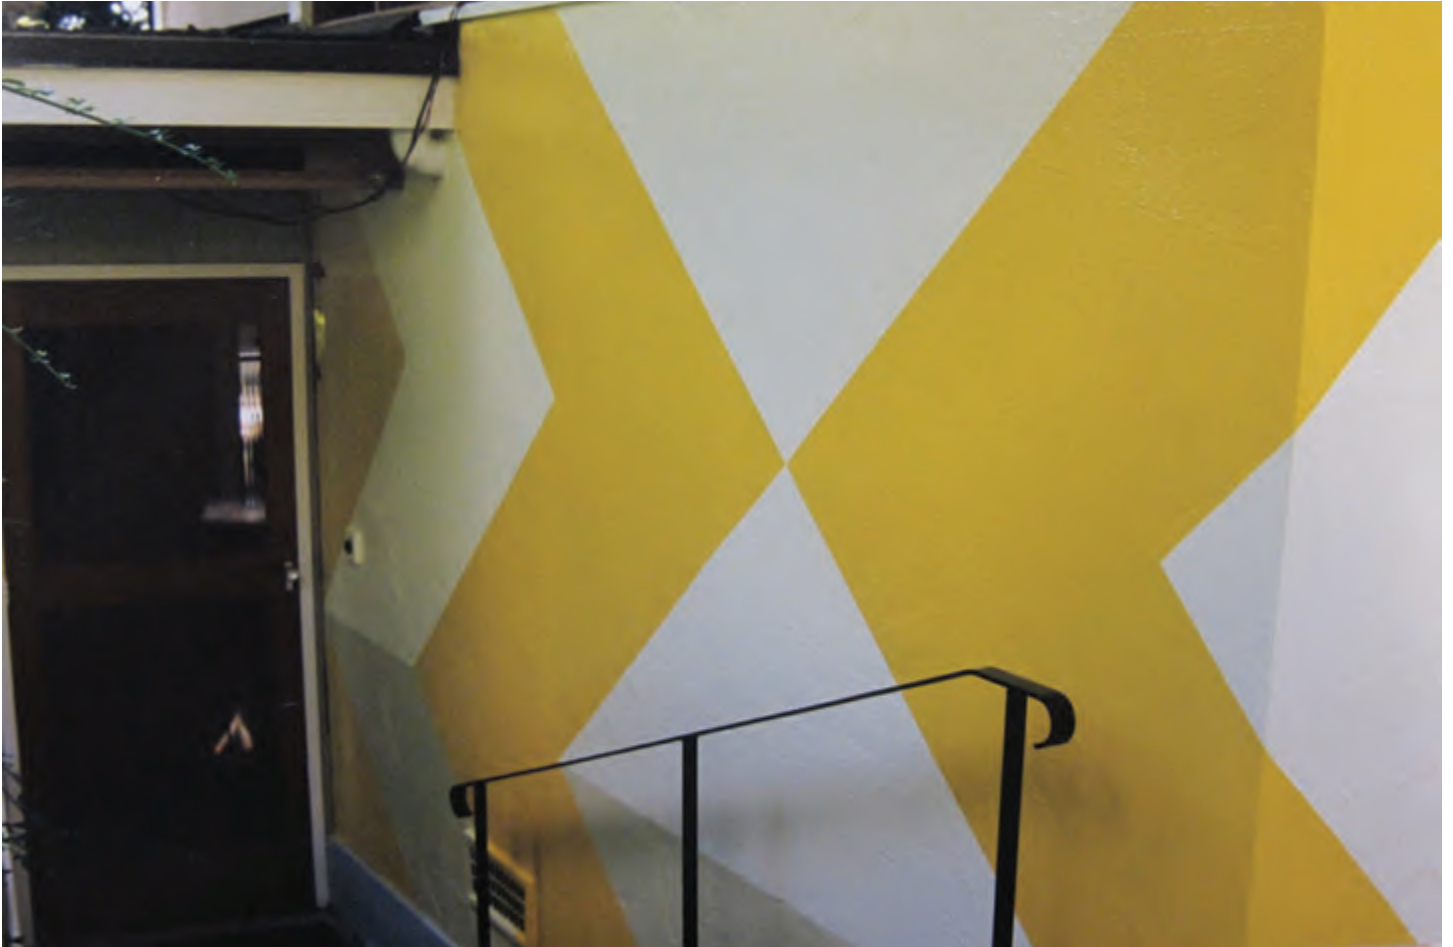
Current mural post-Gordon Smith's restoration, Vancouver Art Gallery Archives

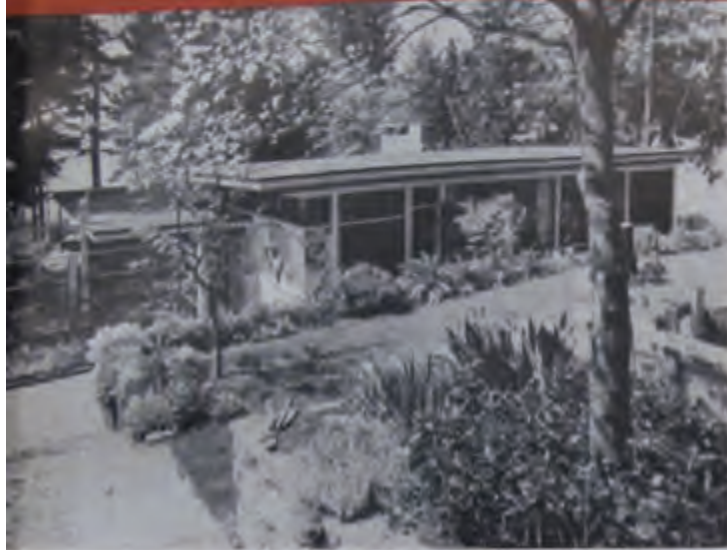
1 You park your car by the carport on the road above, open the wide wooden gate, and below is the Binning house. To the right are lawn and vegetable gardens, above are flowering dogwoods. Full-length windows on the right side of the house provide north light to the artist's studio. From the gate you can just glimpse the wall-size Binning mural at the front entrance. In the background is the sea off West Point Grey.

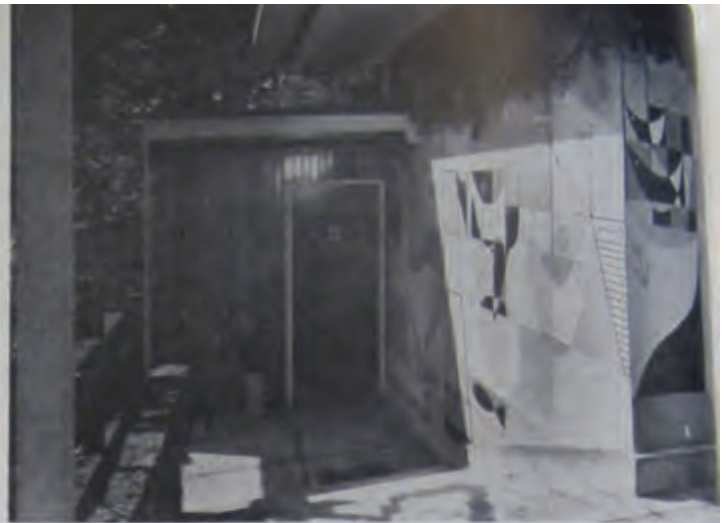
2

A closeup now of the main entry. We guarantee you that this is the only house in Vancouver with a wall-size Binning abstract painted on the entrance wall. The mural is in full color, even to recognizable portions of ship flags. Above the mural are hop vines trailed around the base of clerestory windows that light part of the studio. Centre is the entry door leading to main hall. Concrete flagged terrace leads around to kitchen court at left out of sight. Notice the delicate texture effect achieved by the cedar V-joint beside entry door. Black line above entry door is a wire screen vent that allows air to circulate between the joists of the flat-roofed house, thus preventing moisture condensation and subsequent dry rot.
